UT to Mill Swamp - Monitoring Report Third Monitoring Measurement Second Year of Credit Release

**Onslow County, North Carolina
NCDMS Project ID Number - 95019**

Project Info: Credit Release Year: 2 of 7 (Third site measurement since construction)
Year of Data Collection: 2015
Year of Completed Construction: 2013
Submission Date: January 2016

Report Prepared and Submitted by Michael Baker Engineering, Inc.

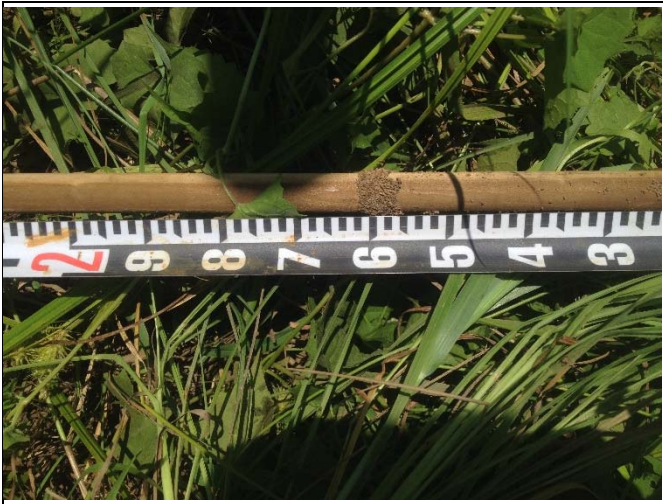
The Site was found to have had at least four post-construction above bankfull events based on the crest gauge readings during Year 2.

Crest gauge reading, 1.61 feet – June 23, 2015

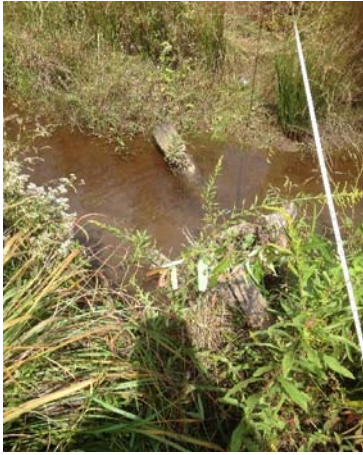
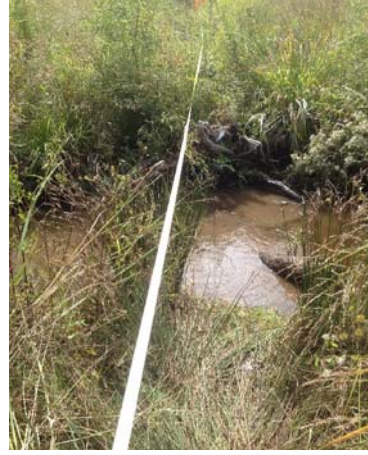
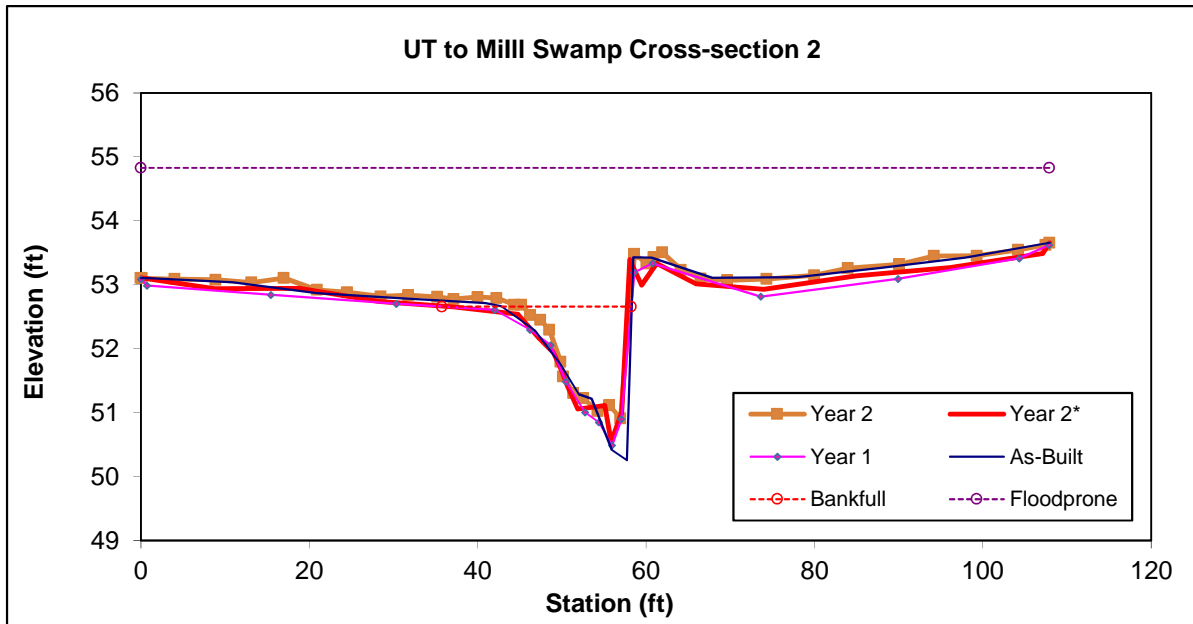
Permanent Cross-section 2

Feature	Stream Type	BKF Area	BKF Width	BKF Depth	Max BKF Depth	W/D	BH Ratio	ER	BKF Elev	TOB Elev
Pool		12.8	12.7	1	1.75	12.64	1.0	8.5	52.66	52.69

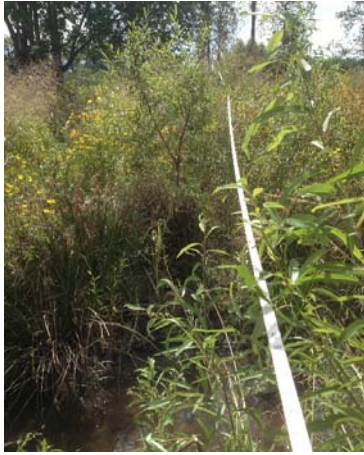
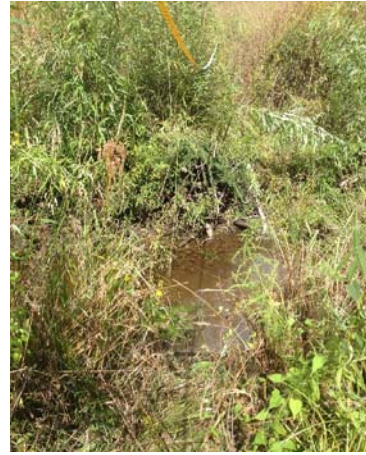
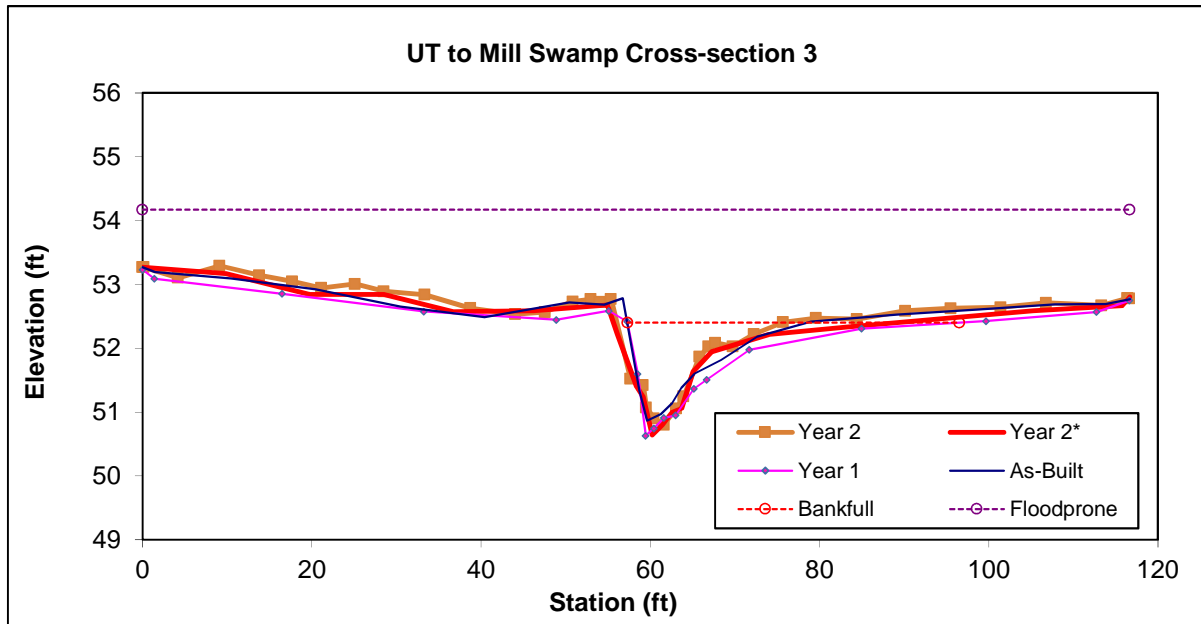
Permanent Cross-section 3

Feature	Stream Type	BKF Area	BKF Width	BKF Depth	Max BKF Depth	W/D	BH Ratio	ER	BKF Elev	TOB Elev
Pool		12.9	19.55	0.66	1.6	29.6	1.0	6.0	52.4	52.41

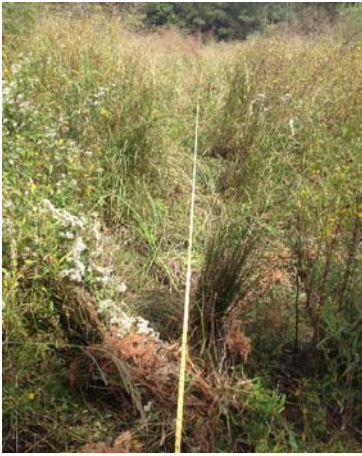
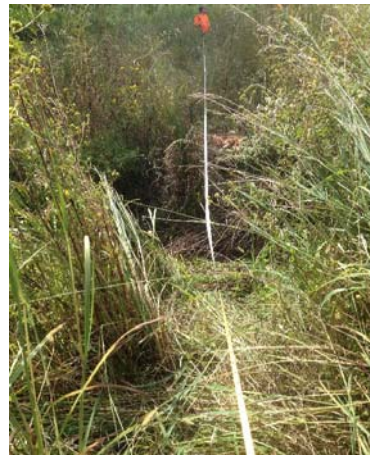
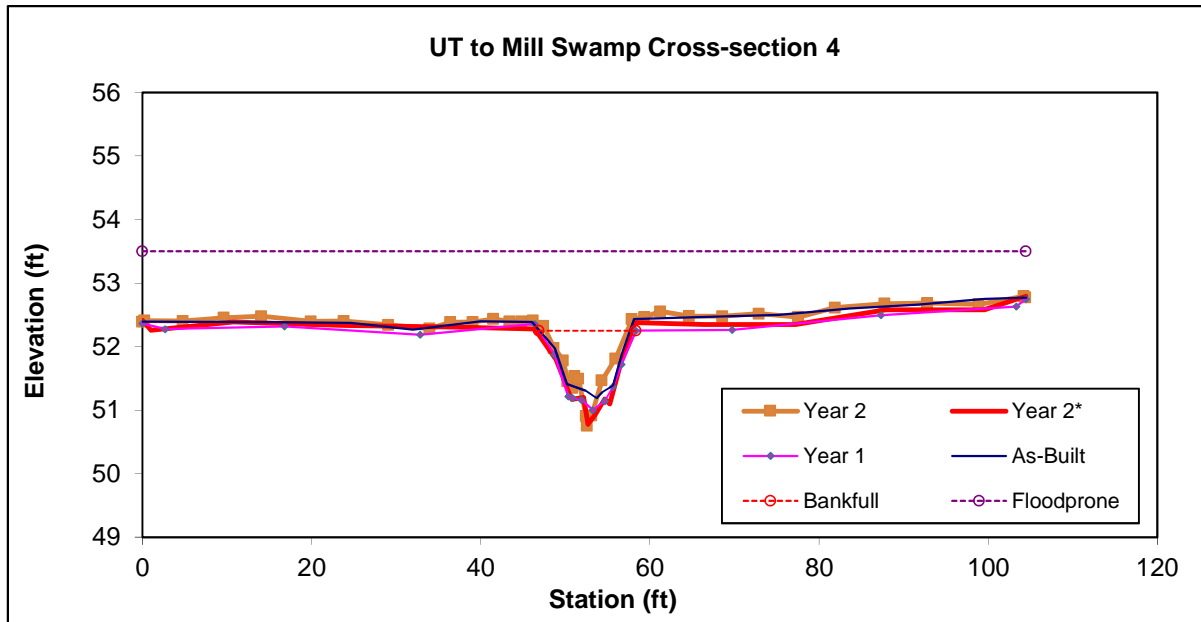
Permanent Cross-section 4

Feature	Stream Type	BKF Area	BKF Width	BKF Depth	Max BKF Depth	W/D	BH Ratio	ER	BKF Elev	TOB Elev
Riffle	Cc	6.3	9.63	0.66	1.5	14.63	1.1	10.8	52.25	52.41

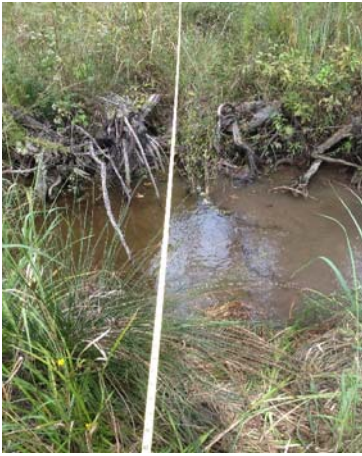
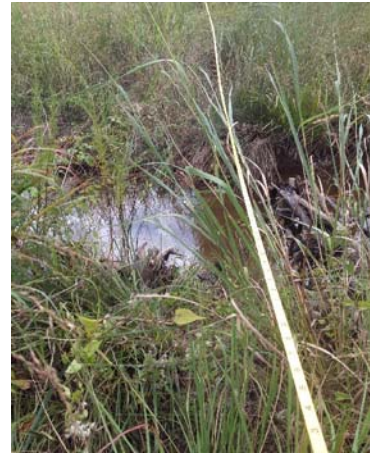
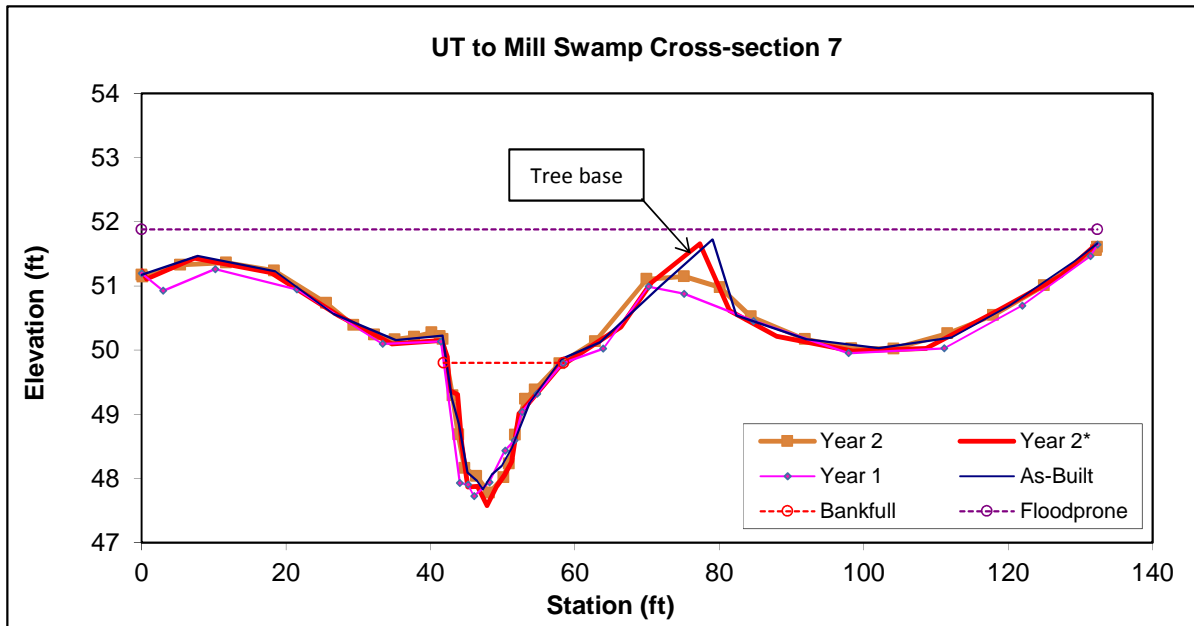
Permanent Cross-section 7

Feature	Stream Type	BKF Area	BKF Width	BKF Depth	Max BKF Depth	W/D	BH Ratio	ER	BKF Elev	TOB Elev
Pool		17.0	15.77	1.08	2.03	14.67	1.0	8.4	49.8	49.79

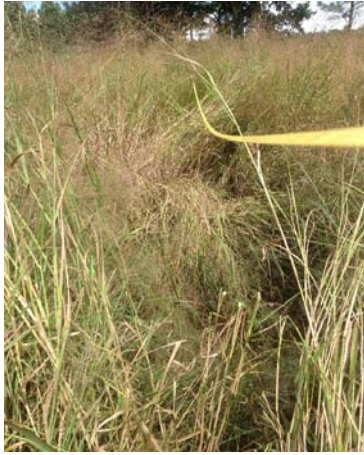
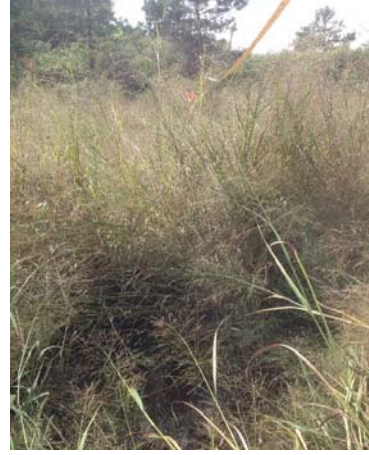
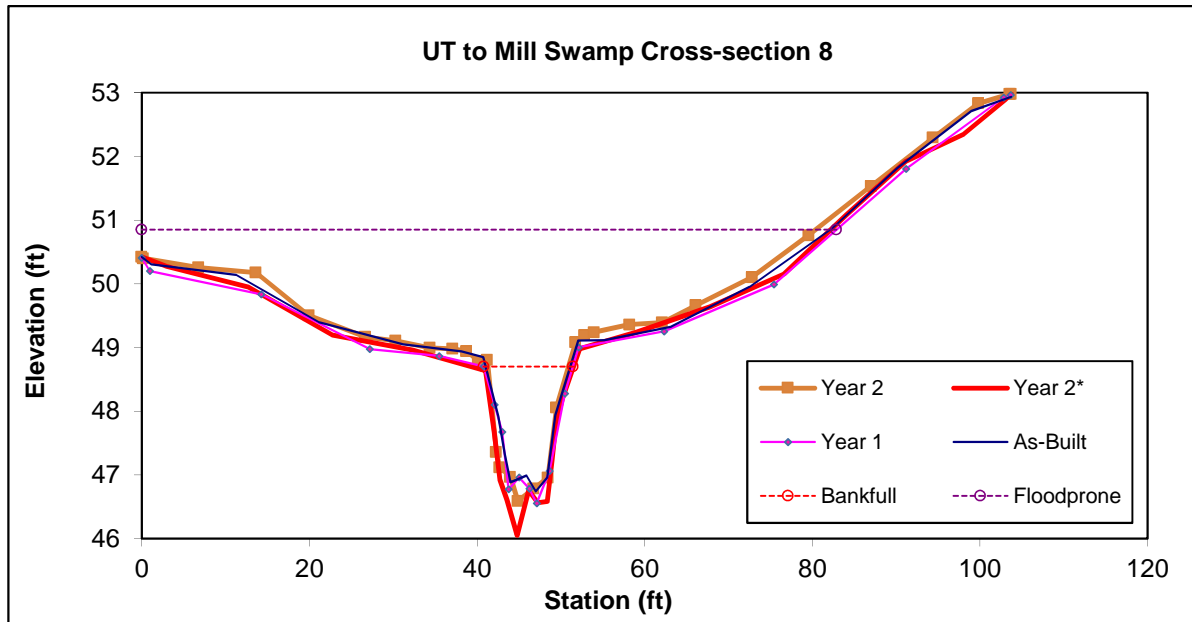
Permanent Cross-section 8

Feature	Stream Type	BKF Area	BKF Width	BKF Depth	Max BKF Depth	W/D	BH Ratio	ER	BKF Elev	TOB Elev
Riffle	C	17.0	15.77	1.08	2.03	14.67	1.0	8.4	49.8	49.79
