UT to Mill Swamp - Monitoring Report Fourth Monitoring Measurement Third Year of Credit Release

**Onslow County, North Carolina
NCDMS Project ID Number - 95019**

Project Info: Credit Release Year: 3 of 7 (Fourth site measurement since construction)
Year of Data Collection: 2016
Year of Completed Construction: 2013
Submission Date: January 2017

Report Prepared and Submitted by Michael Baker Engineering, Inc.

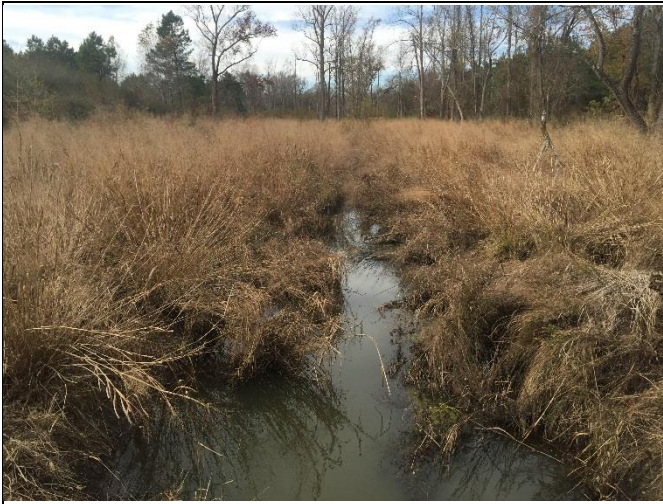
Photo Point 1 – Downstream at Culvert

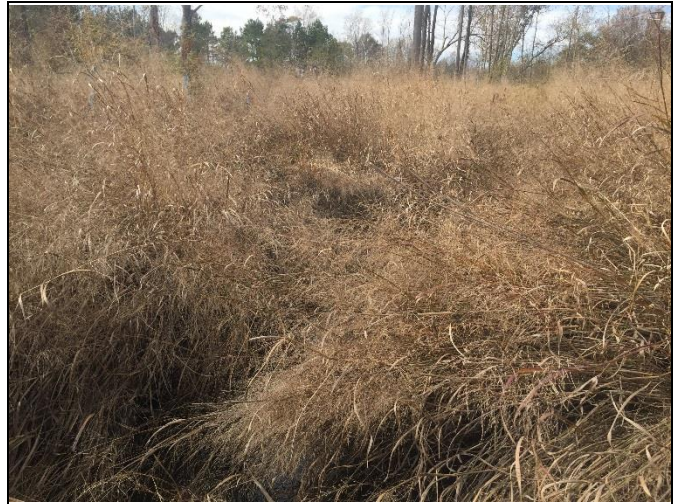
Photo Point 4 – Log Weir/Log Jam
