UT to Mill Swamp Restoration Project Fifth Monitoring Measurement Fourth Year of Credit Release - Final

Onslow County, North Carolina

DMS Project ID Number – 95019, DEQ Contract No. 003992

Report Prepared and Submitted by Michael Baker Engineering, Inc.

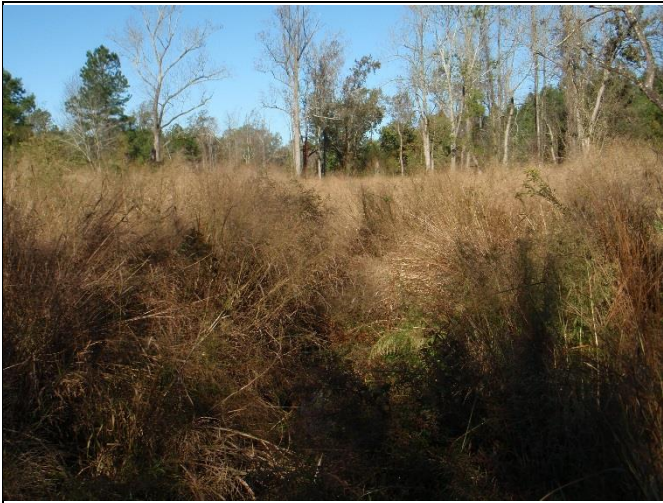
Photo Point 1 – Upstream at Culvert

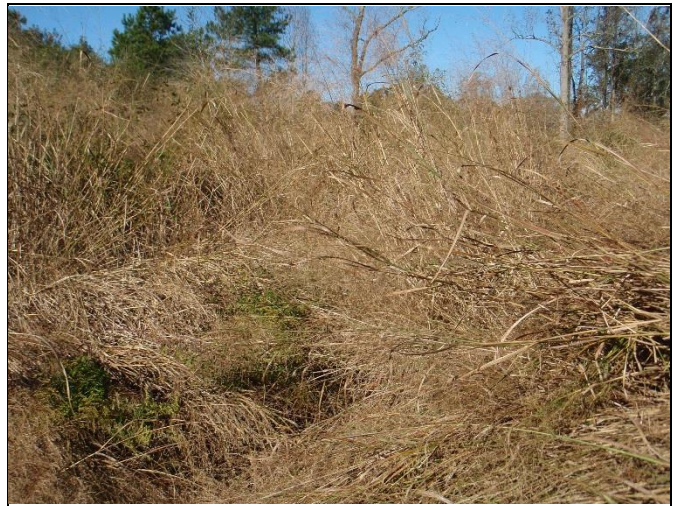
Photo Point 4 – Log Weir/Log Jam

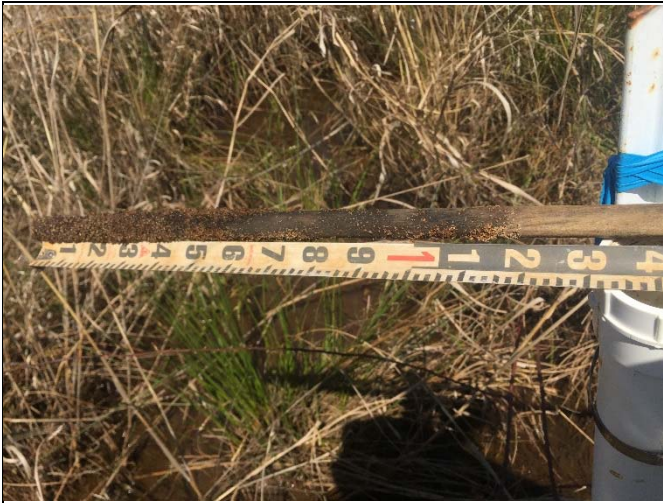
The Site was also found to have had at least two above-bankfull events based on the crest gauge readings during Year 4 monitoring.

Crest gauge reading, 1.18 ft from 1/2/17 storm

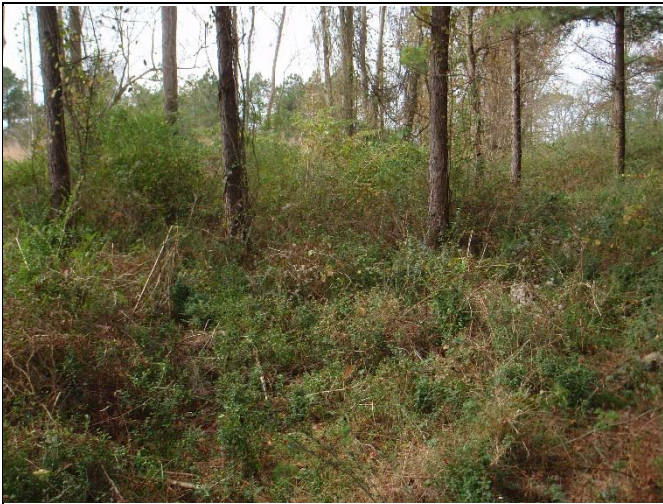
Invasive species areas of concern were observed and documented during Year 4 monitoring. One area of Chinese privet (*Ligustrum sinense*) re-sprouts totaling 0.58 acres was discovered along the left floodplain of the lower section of Reach UT1c. This is an area that had previously been treated for privet in November of 2016, and will again be treated in the upcoming monitoring year.

VPA (*Ligustrum sinense* resprouts) 11/21/2017

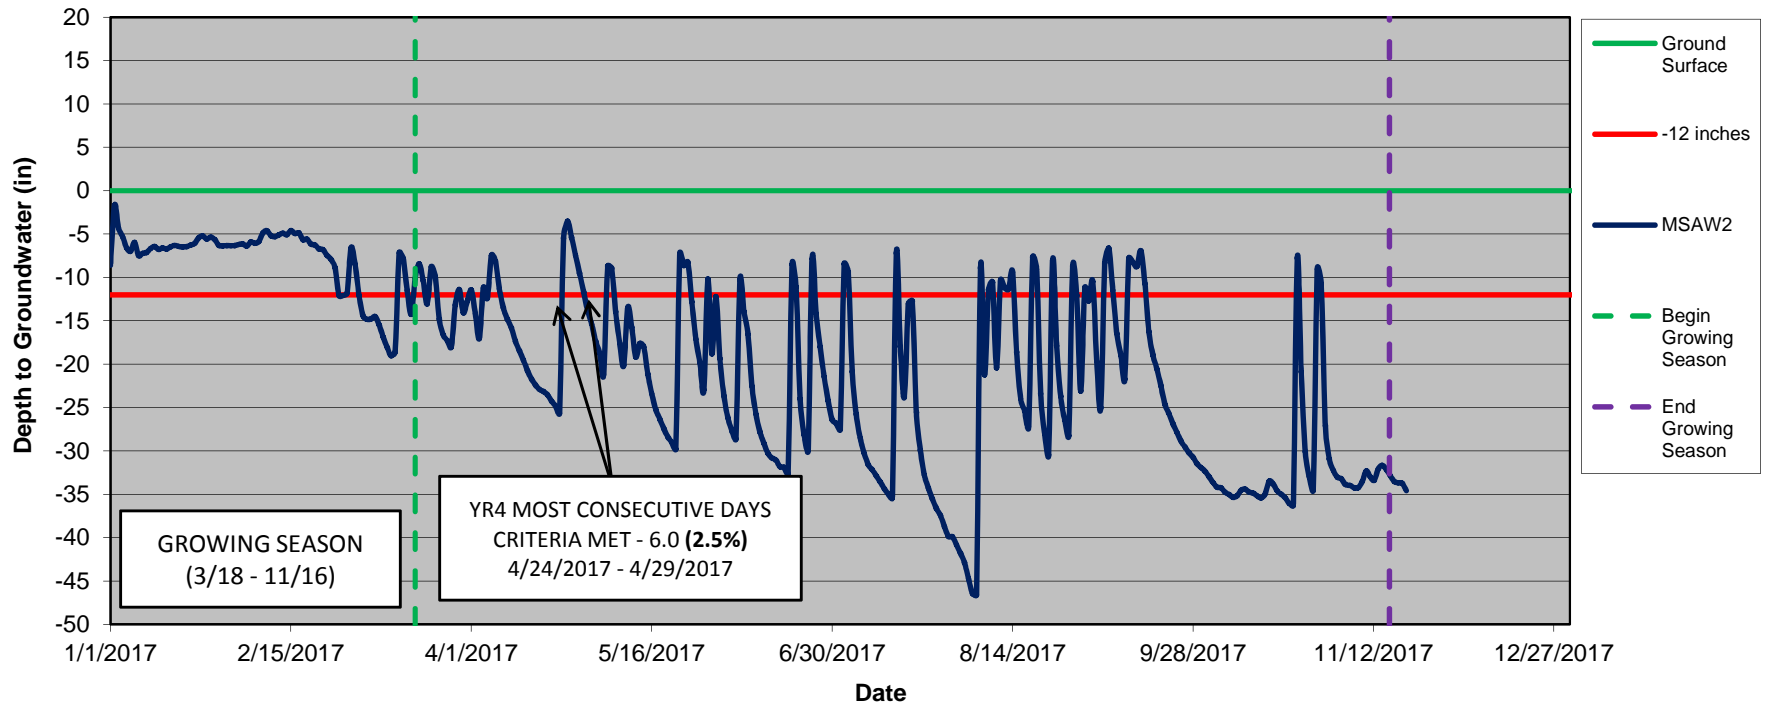
UT to Mill Swamp Wetland Restoration Well (MSAW2)

During Year 4 monitoring, six of the sixteen groundwater monitoring wells located along Reach UT1c met the wetland success criteria as stated in the Site Mitigation Plan. The gauges that met success criteria (MSAW1, MSAW4, MSAW5, MSAW8, MSAW19, and MSAW24) demonstrated consecutive hydroperiods of 12 percent or greater, and ranged from 12.8 to 46.1 percent of the growing season. The gauges that did not meet success criteria (See Table 12) demonstrated consecutive hydroperiods of 12 percent or less which ranged from 0.4 percent to 11.5 percent of the growing season. It should be noted that while MSAW7 is not meeting the success criteria, it is located outside of the wetland restoration and hydric soils boundary in the adjacent *upland* area, while MSAW3 is located on the wetland/upland boundary itself.

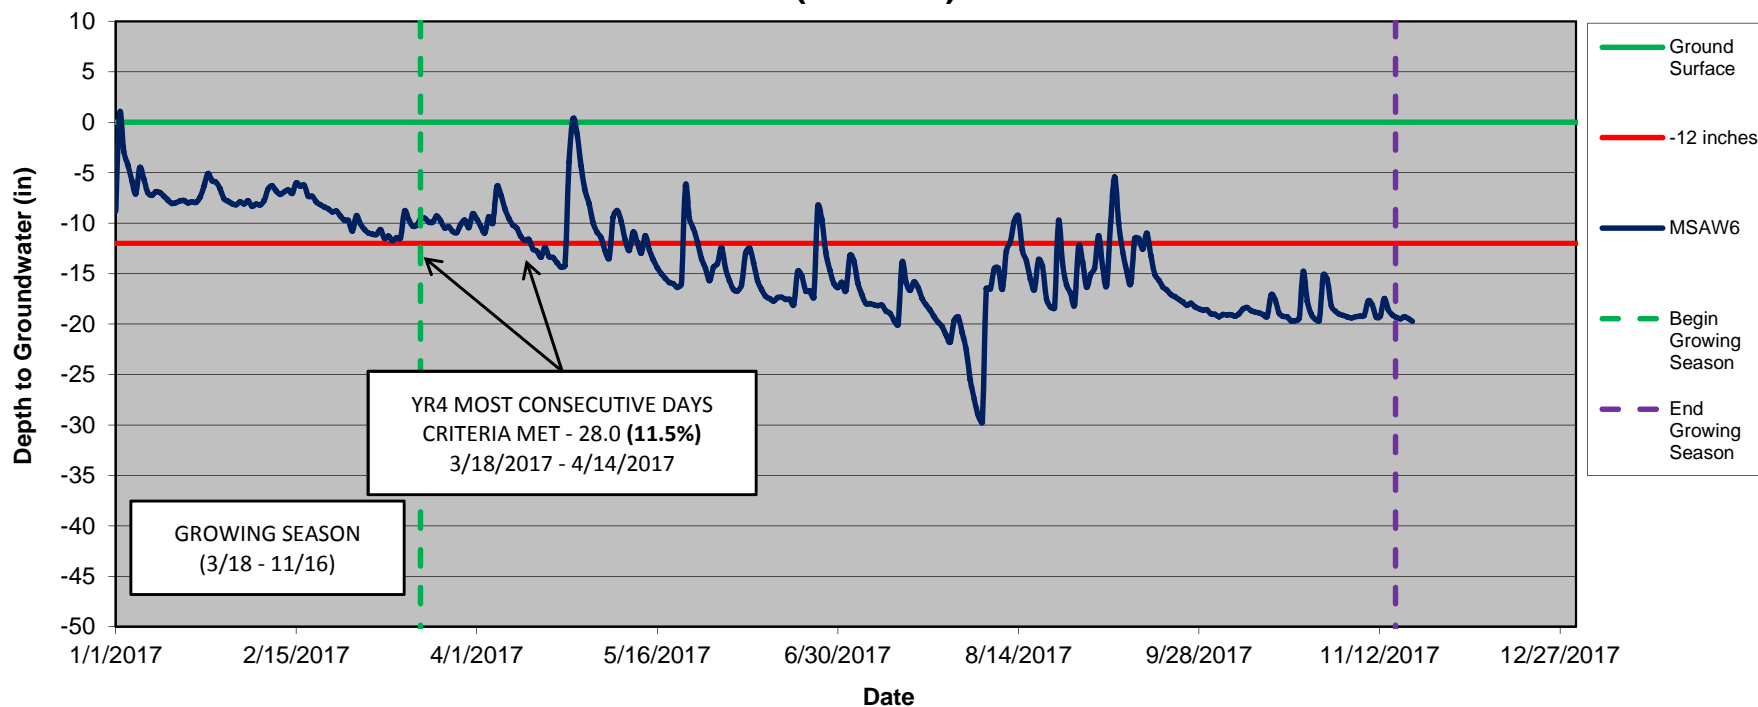
UT to Mill Swamp Wetland Restoration Well (MSAW6)

The noted lack of rainfall observed in the early part of the year was significant in that it negatively affects the hydrology present at the start of the growing season, typically the wettest time of year on the project when the hydrology success criteria is most likely to be met. A closer investigation into the groundwater well results reveals that many of the wells that did not meet the success criteria only missed by a few days out of the 29 days required to make the 12% threshold. In particular, wells MSAW-6 (1-day), MSAW-20 (3-days), and MSAW-21 (3-days) very each very close.

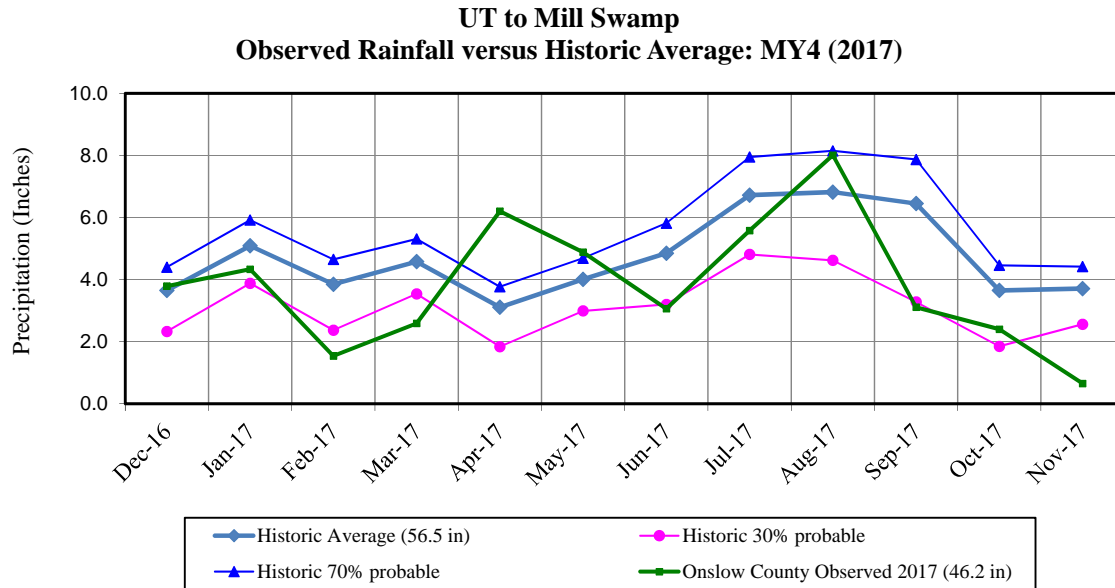
Figure 6. Observed Rainfall versus Historic Average

The total observed rainfall at the Albert Ellis airport (KOAJ) weather station located close to the site in Richlands, NC for the previous 12-month period from December 2016 through November 2017 was 46.2 inches, substantially less than the 30-year historic annual average of 56.5 inches, for a deficit of just over 10” of rainfall. Of particular note for the project this monitoring year, January, February, and March of 2017 were especially dry, with the latter two months recording rainfalls totals below their historic 30% probable averages. Using the NRCS method (Sprecher and Warne, 2000), drier-than-average antecedent conditions were confirmed as being present on site during the early portion of the growing season in the spring of 2017.
