Mitigation Project Name UT to Mill Swamp Restoration Project
 DMS ID 95019
 River Basin White Oak
 Cataloging Unit 03030001

Subject: Task 11: Response Letter to DMS review comments regarding the Draft Year 5 Monitoring Report for the UT to Mill Swamp Restoration Project (#95019)
White Oak River Basin – CU#03030001, Onslow County, North Carolina
DEQ Contract No. 003992, Baker No. 124578

NCDMS Project ID Number – 95019, DEQ Contract No. 003992

Project Info: Credit Release Year: 5 of 7 (Sixth site measurement since construction)
Year of Data Collection: 2018
Year of Completed Construction: 2013
Submission Date: December 2019

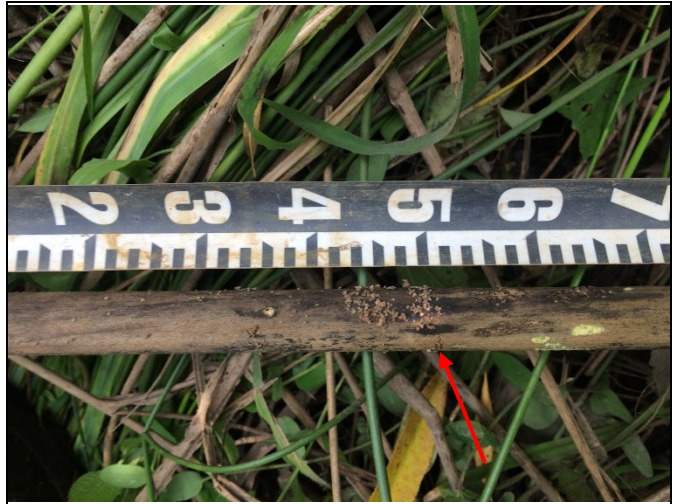
Crest gauge reading: 1.50 ft from 5/31/18 storm

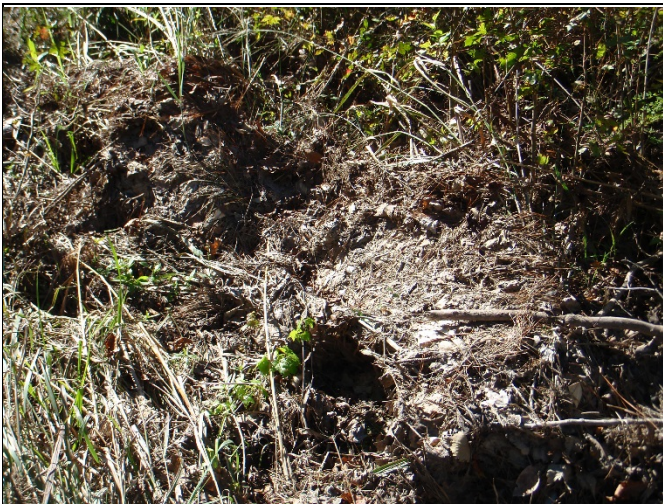
Debris wrack line on floodplain of UT-1c

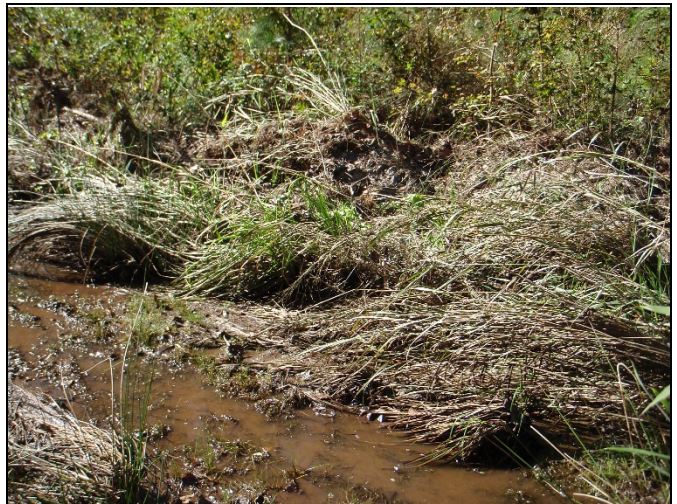
Debris wrack line outside channel on UT-1b

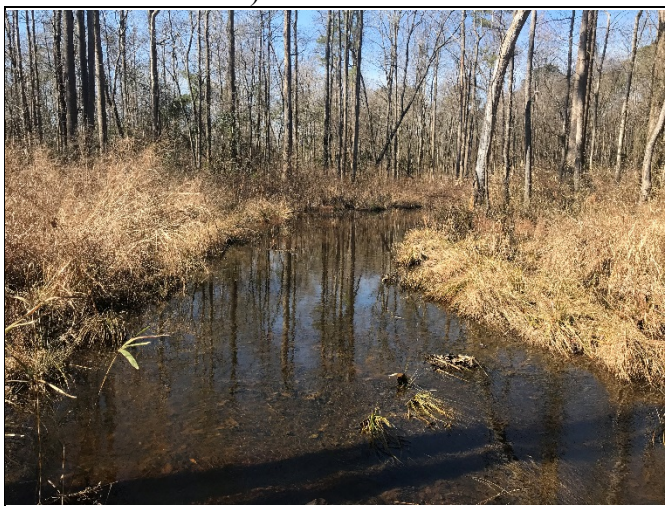
Flow looking upstream on Reach UT1b at Station 19+00 on 2/28/18

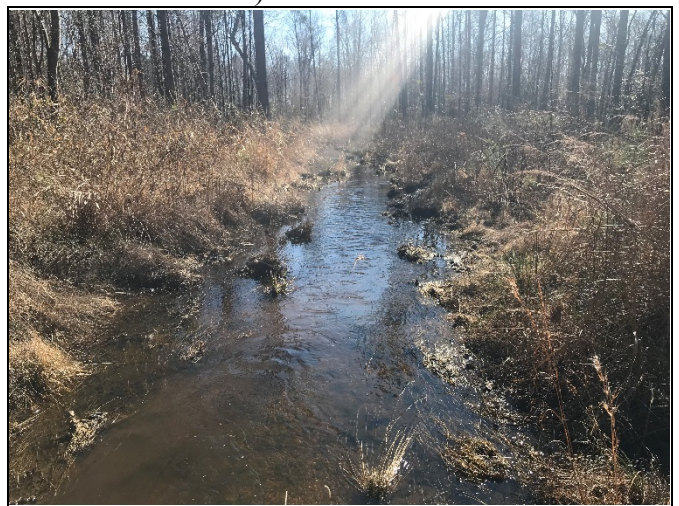
Flow looking downstream on Reach UT1b at Station 19+00 on 2/28/18
