UT to Mill Swamp Restoration Project Seventh Monitoring Measurement Sixth Year of Credit Release - Final

Onslow County, North Carolina

DMS Project ID Number – 95019, DEQ Contract No. 003992

Report Prepared and Submitted by Michael Baker Engineering, Inc.

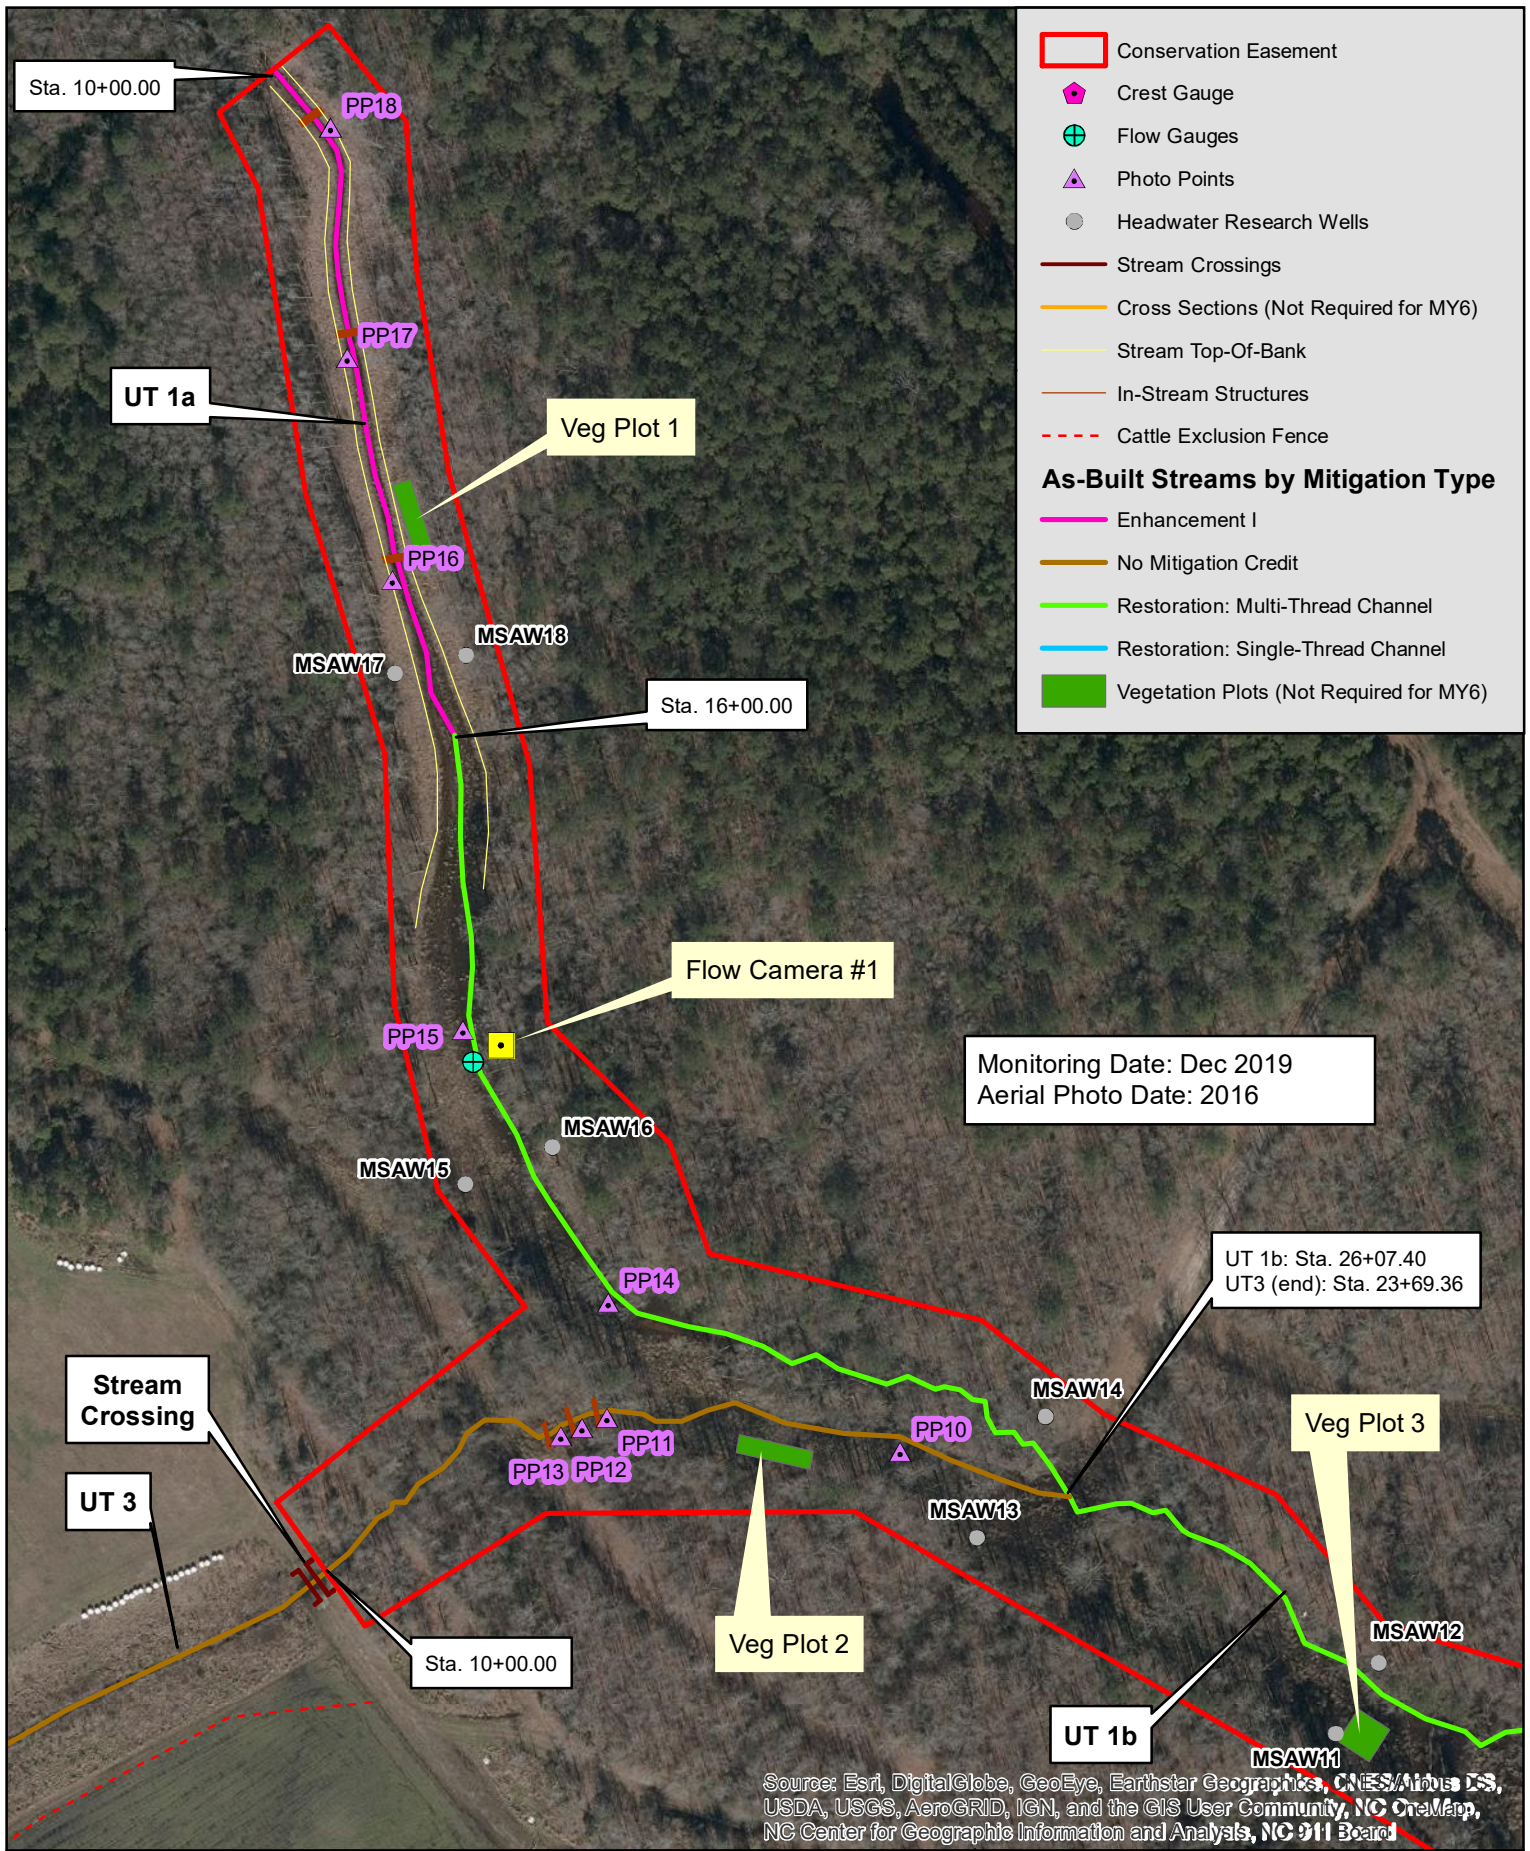
Figure 2 Index Map
Current Condition Plan View
Monitoring Year 6
UT to Mill Swamp Site

Invasive species areas of concern were observed and documented during Year 6 monitoring. Two areas of scattered Chinese privet (*Ligustrum sinense*) re-sprouts totaling 0.96 acres were discovered in portions of the floodplain along both banks of the middle and lower sections of Reach UT1c. They are identified as a Vegetation Problem Area (VPA) in Table 6b and will be treated as soon as temperatures are appropriate for spraying. Much of the VPA area on the left bank had previously been treated for privet in March of 2019. The exact locations of these areas are shown on the CCPV.

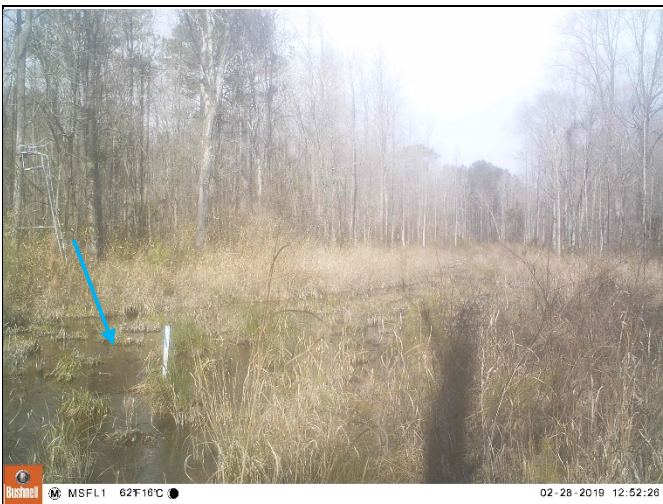
Flow Camera #1 on 2/28/19 (flow in channel)

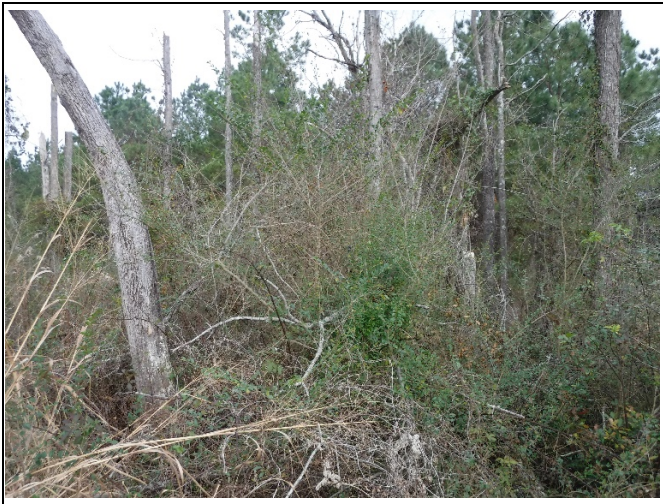
Invasive species areas of concern were observed and documented during Year 6 monitoring. Two areas of scattered Chinese privet (*Ligustrum sinense*) re-sprouts totaling 0.96 acres were discovered in portions of the floodplain along both banks of the middle and lower sections of Reach UT1c. They are identified as a Vegetation Problem Area (VPA) in Table 6b and will be treated as soon as temperatures are appropriate for spraying. Much of the VPA area on the left bank had previously been treated for privet in March of 2019. The

Table 6b. Vegetation Problem Areas (VPAs)			
UT to Mill Swamp Restoration Project: DMS Project ID No. 95019			
Feature Issue	Station Numbers / Location	Suspected Cause	Photos
Chinese privet (<i>Ligustrum sinense</i>)	Found scattered in the floodplain in sections of the middle right bank (~Station 44+00) and the lower left bank (~Stations 46+00 to 50+00) of UT1c. See CCPV for exact locations.	Re-sprouts	See Appendix B

VPA (*Ligustrum sinense* resprouts) 12/6/19

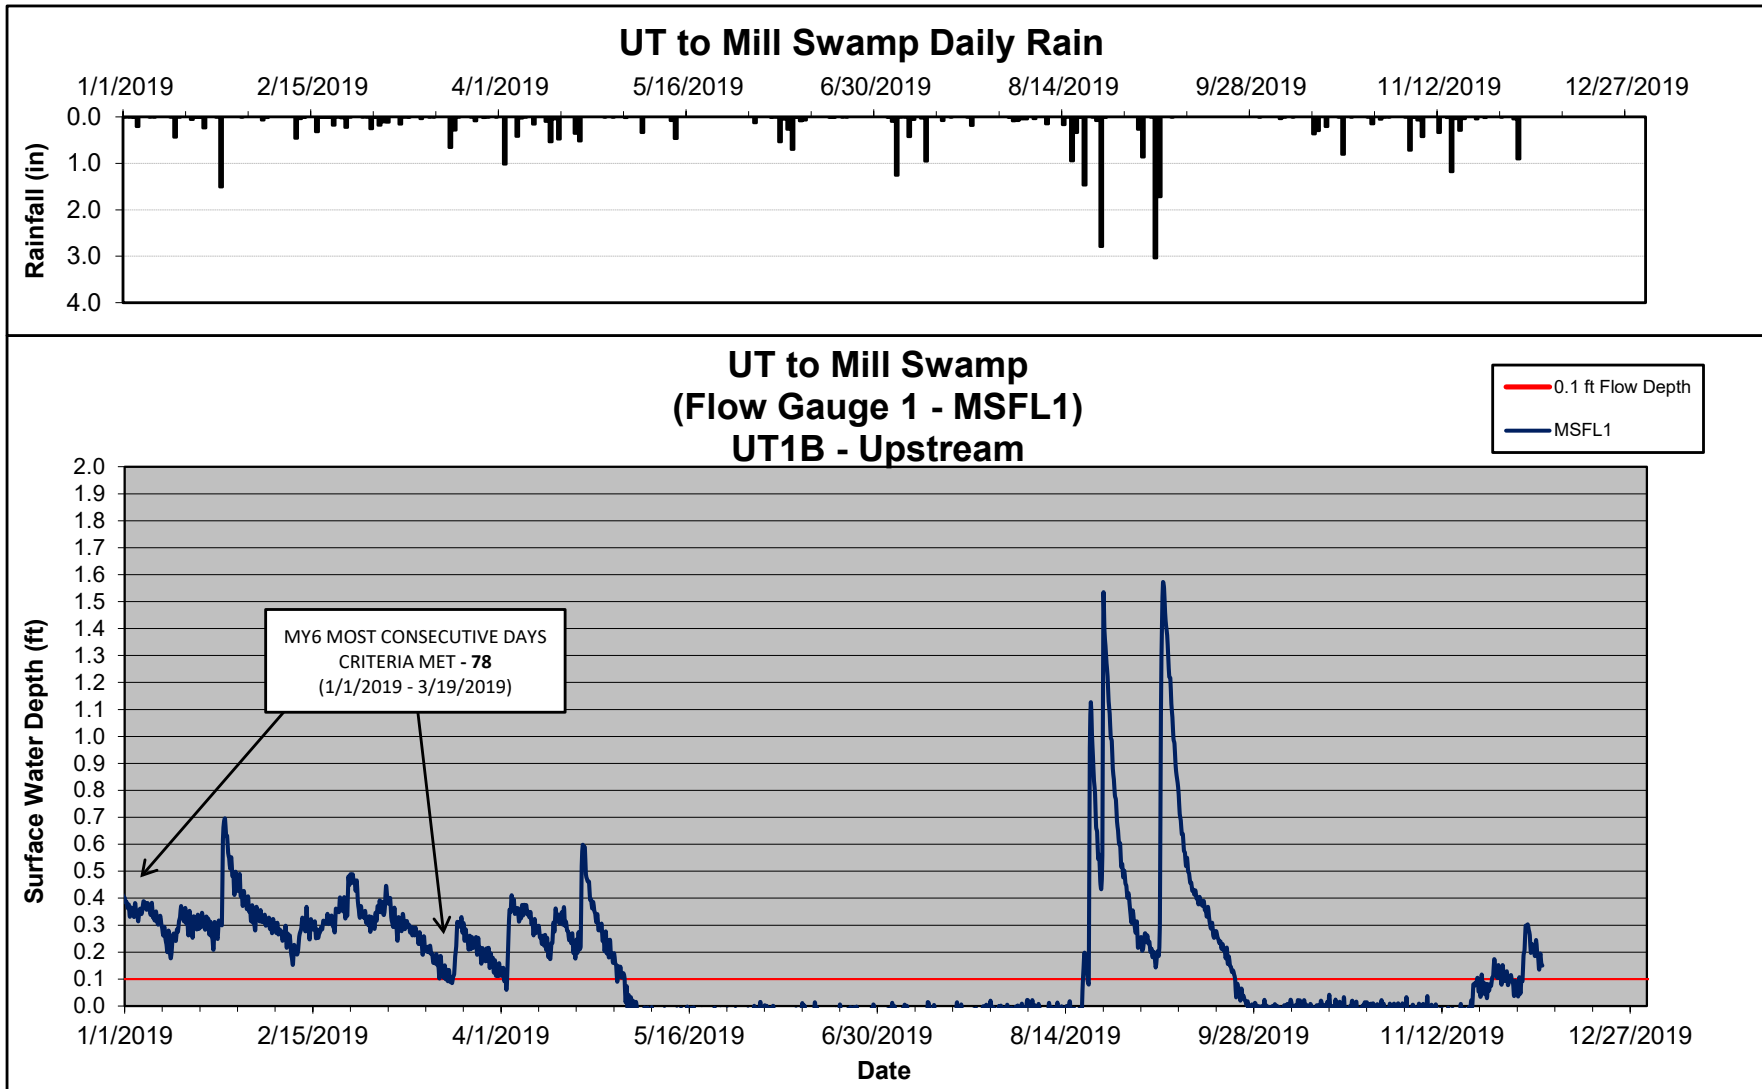
Figure 5. Flow Gauge Graph

Success Criteria per UT to Mill Swamp Mitigation Plan: A surface water flow event will be considered perennial when the recorded flow duration occurs for a minimum of 30 consecutive days during the monitoring year . Two surface water flow events must be documented within a five-year monitoring period; otherwise, monitoring will continue for seven years or until two flow events have been documented in separate years.																
Surface water flow is estimated to have occurred when the pressure transducer reading is equal to or above 0.1 feet in depth.

* Surface water flow is estimated to have occurred when the pressure transducer reading is equal to or above 0.1 feet in depth.

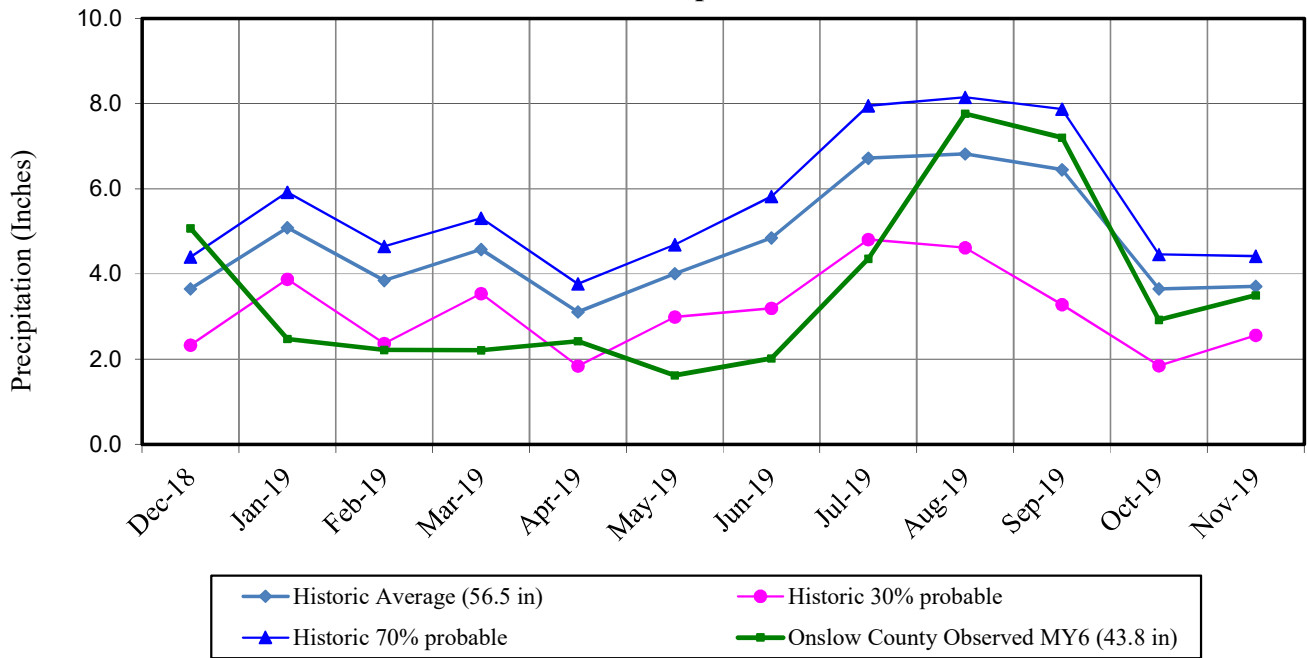
Figure 6. Observed Rainfall versus Historic Average

Total observed rainfall at the Albert Ellis airport (KOAJ) weather station located near Richlands, NC for the previous 12-month period from December 2018 through November 2019 was 43.8 inches. The WETS table for Hoffman Forest station (NC4144) in Onslow County was used to calculate the 30-year average for that same 12-month period and documents an average of 56.5 inches of rainfall, with an historic 30% probable of 51.9 inches and an historic 70% probable of 60.5 inches. Thus, the site appears to have gone below the 30% probable by 8.1 inches. In fact, much of the county was under a Stage D1 Moderate Drought from early May through early September. However, the fall of 2018 and early winter of 2018/2019 had been historically wet (in particular from Hurricane Florence, which dropped approximately 13 inches of rainfall on the site on September 15th alone). Additionally, the rainfall that the site did receive in the early portion of 2019 was evenly distributed, if overall less than normal.

Note: Total Rainfall for MY6 was just 43.8", a deficit of 12.7" from the historic average of 56.5"

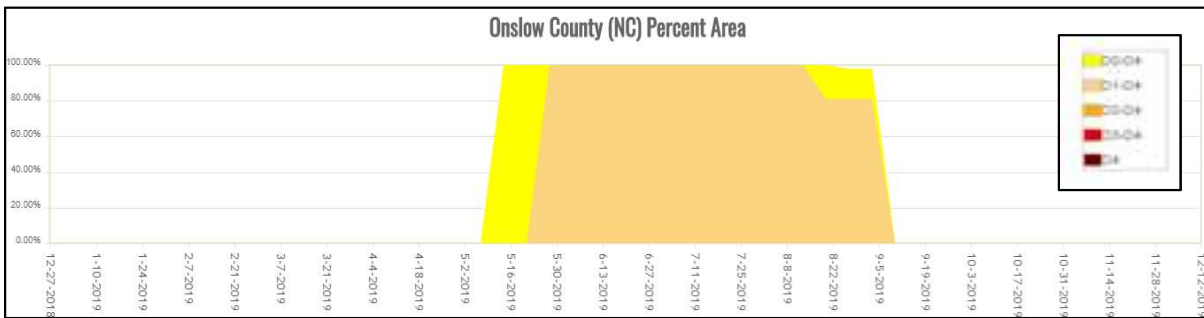
Note: The drought monitor for Onslow County reveals that the entire county was under D1 Moderate Drought conditions from May through August 2019.
