YEAR 5 MONITORING REPORT

UT TO NEUSE RIVER (BIG DITCH) STREAM RESTORATION SITE

Wayne County, North Carolina

DMS Project No.: 92682

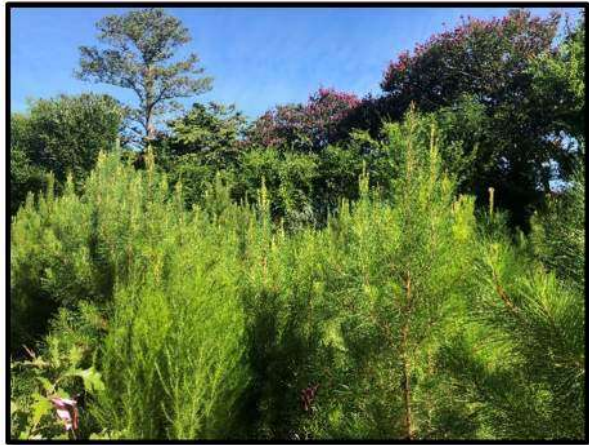
3.7 Vegetation Plot 8

c. Third paragraph, page 2, states that loblolly pine became the dominant species in Plots 8 and 9, but Table 9 in Appendix C does not show any loblolly pines in Plot 9. Make necessary correction either to narrative or Table 9.
