# ***YEAR 1 MONITORING REPORT***

## **UT ROCKY RIVER – HARRIS ROAD MIDDLE**

EEP IMS No. 92383, Contract No. 004346

Submitted: January 3, 2013

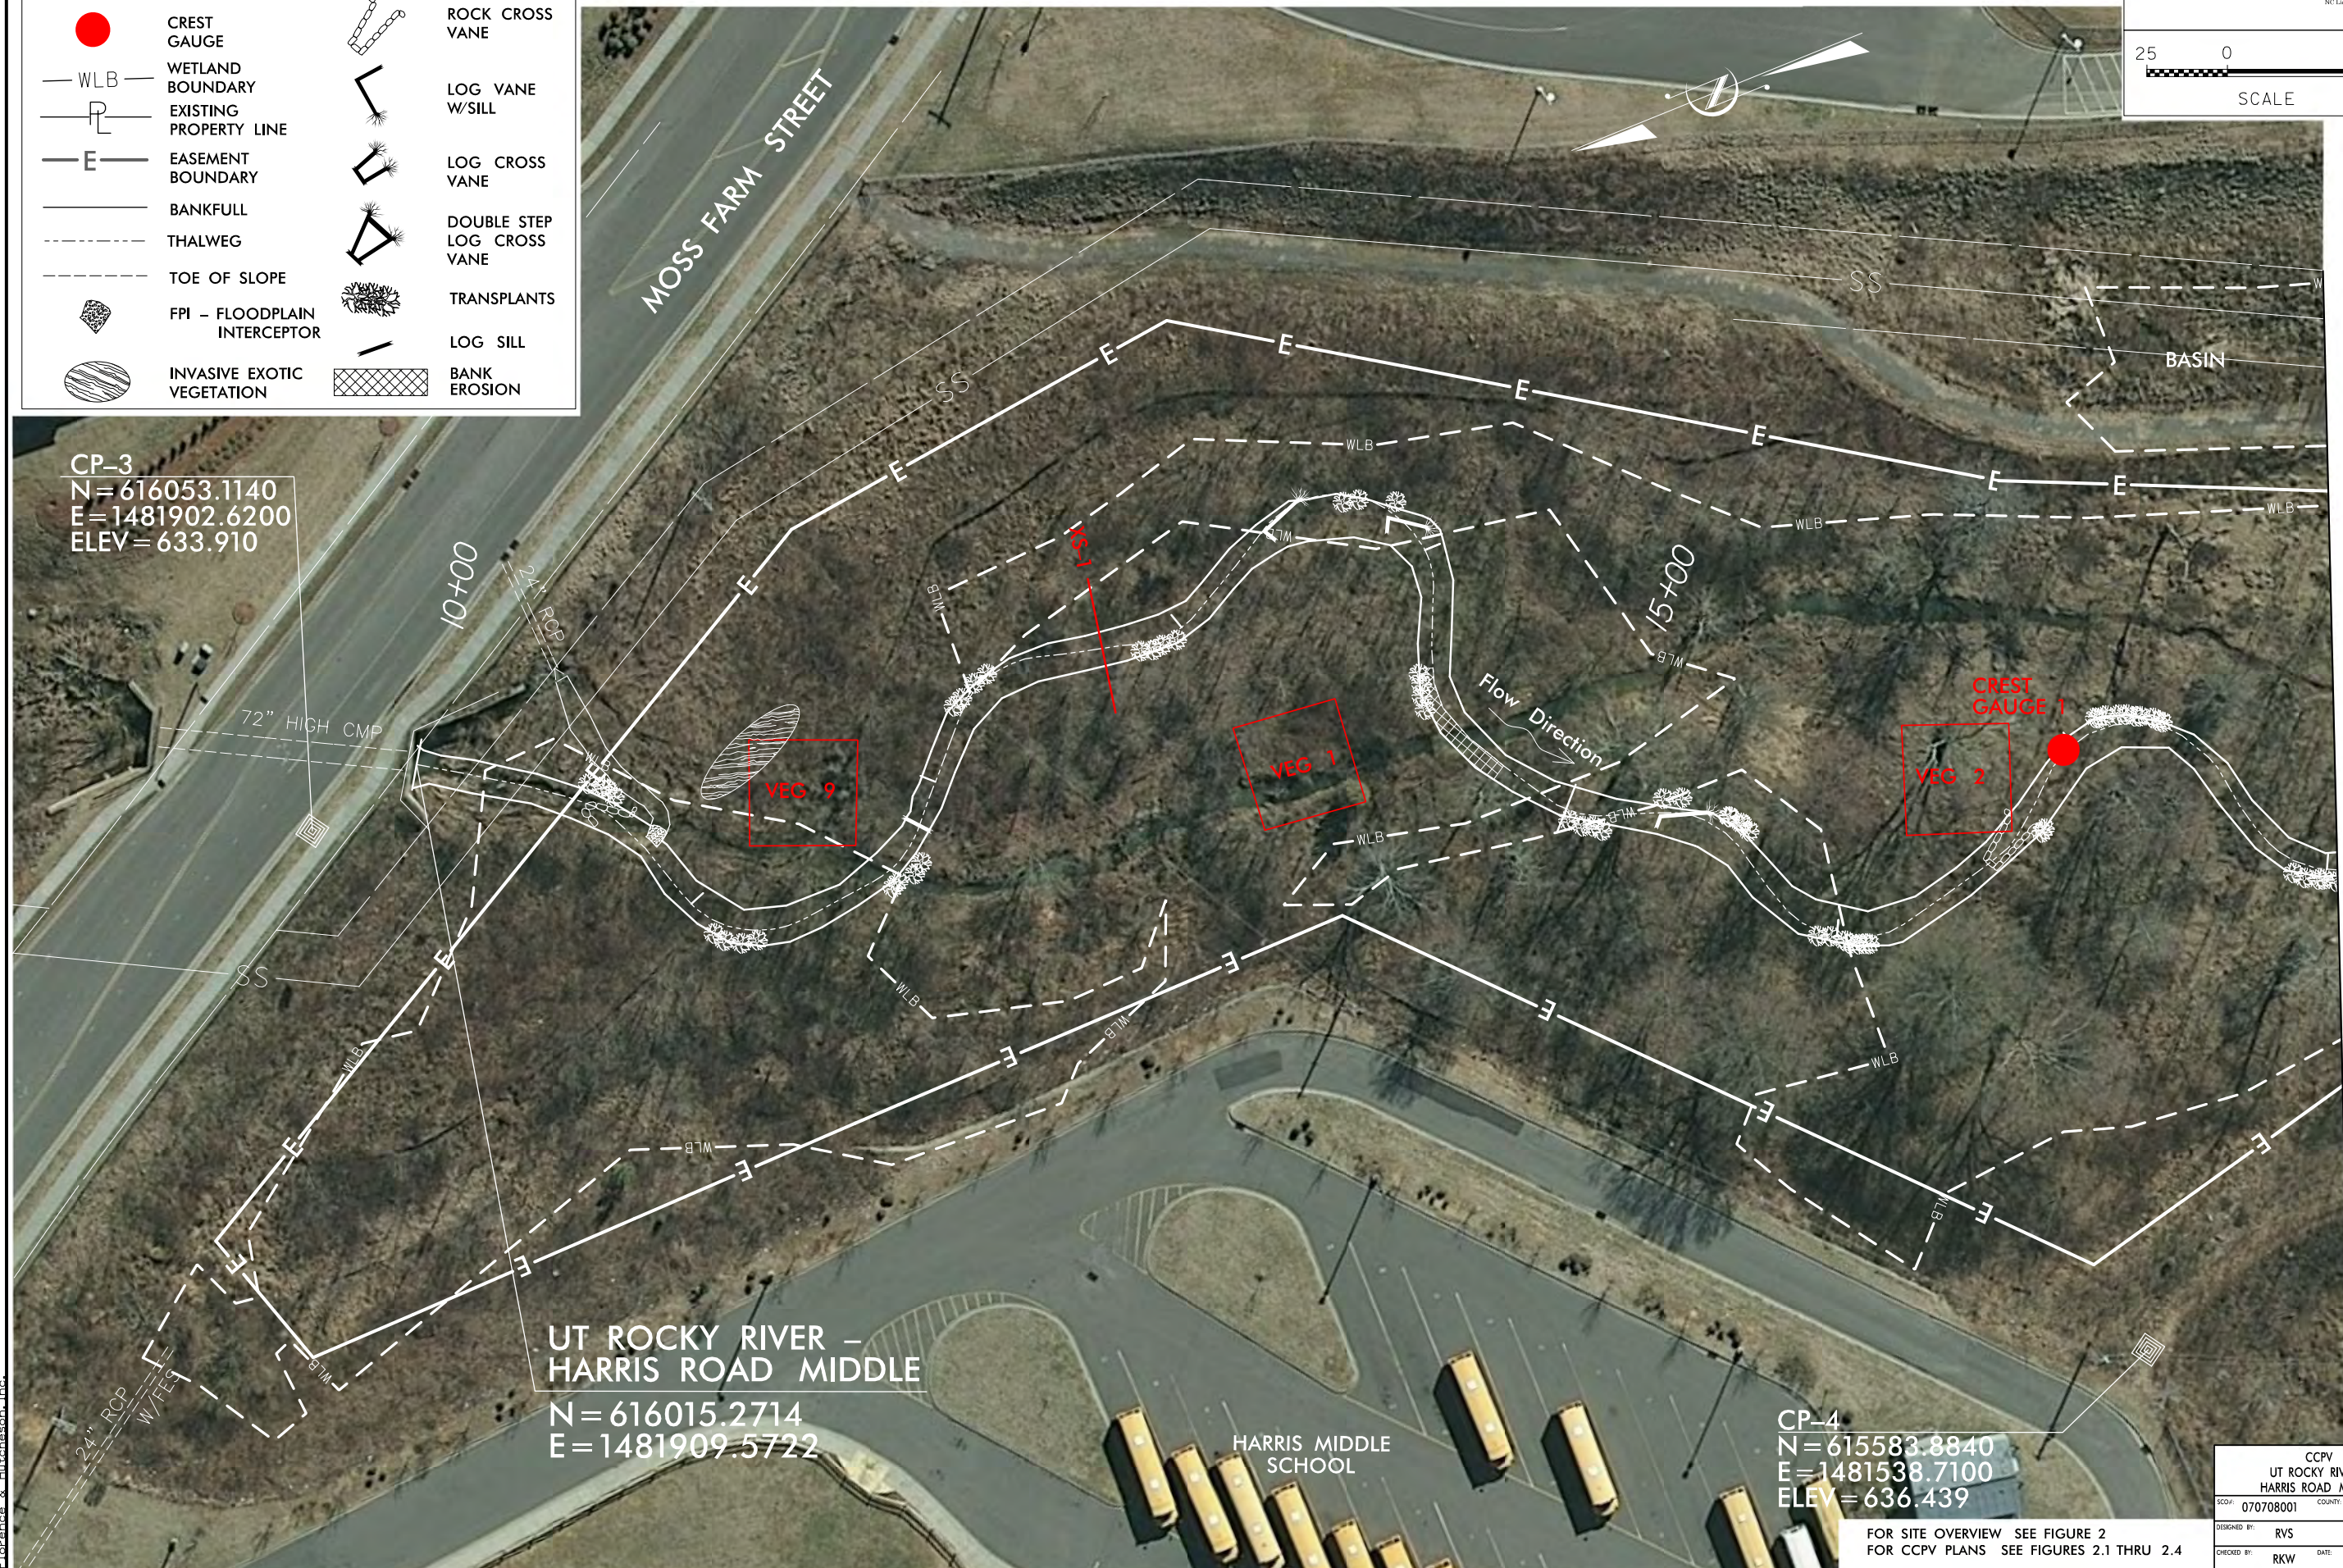
### CURRENT CONDITIONS PLAN VIEW (CCPV)

Table 5, Visual Stream Morphology Stability Assessment, details 99 percent of the stream bed as stable, performing as intended for Year 1 Monitoring. One riffle segment was noted as degrading. This segment is located near station 20+00, where two floodplain drains are entering the stream. The floodplain drains are creating a scour pool as they enter the stream; however, a double step log cross vane immediately downstream of this segment is maintaining grade control. The scour is expected to remain localized near the floodplain drains and will not compromise the overall stability of the stream. Three areas along the bank are experiencing erosion and are depicted on the Current Conditions Plan View (CCPV) located in Appendix B. Photos of each problem area are also included in Appendix B.

Approximately 40 feet of the right bank near station 14+50 has eroded to create a vertical bank; however, woody vegetation is well established in this area, due to live stake plantings and transplants located along the streambank. Woody vegetation should aid in stabilizing this section of streambank, therefore no repairs are recommended at this time.

Approximately 20 feet of the left bank near station 20+90 has scoured allowing higher flows to migrate into the floodplain. The erosion occurs just upstream of a log sill, but the stream has not fully migrated around the log sill at this time. Woody and herbaceous vegetation in the floodplain is slowing the progression of erosion. This area will be watched closely and if the stream continues to migrate around the log sill corrective actions will be recommended to repair the area.

Two structures are experiencing piping as noted in Table 5. The structures are two double step log cross vanes located at stations 20+50 and 22+30. The header logs are functioning as intended and holding grade but water is piping through the second step header and footer log on each structure. Since the header logs and vane arms are functioning as intended, corrective actions are not recommended at this time.

A beaver dam was observed near station 33+30. Backwater from the beaver dam was observed as far upstream as station 30+00. The beaver dam has not had a significant impact on the stability of the stream, and it will be removed prior to Year 2 Monitoring surveys. As noted in Section 1.3, EEP has been informed of the Beaver dam and they have contracted APHIS to trap beaver, remove the dam, and conduct monthly inspections to prevent re-colonization through the monitoring period.

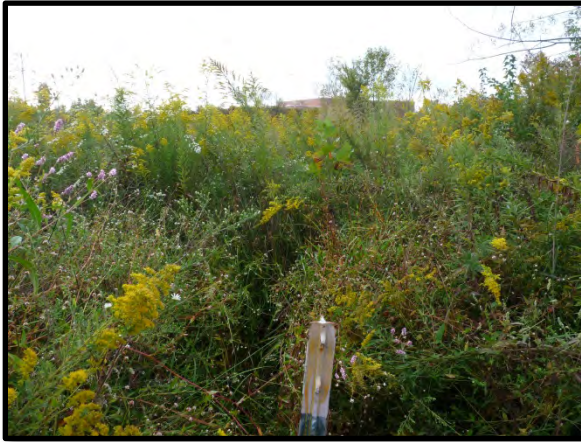
**3.9 Vegetation Plot 9**

A small cluster of *Sericea lespedeza* (*Lespedeza cuneata*) was observed adjacent to Plot 9. Plot 9 is located near Moss Farm Street and a sewer easement that crosses UT Rocky River at the beginning of the project making this area susceptible to encroachment of invasive species. Plot 9 is currently exceeding success criteria goals with 445 planted stems per acre surviving after Year 1; however, this area will be watched closely as monitoring progresses and invasive species will be controlled if they begin to compromise vegetative success at the Site.

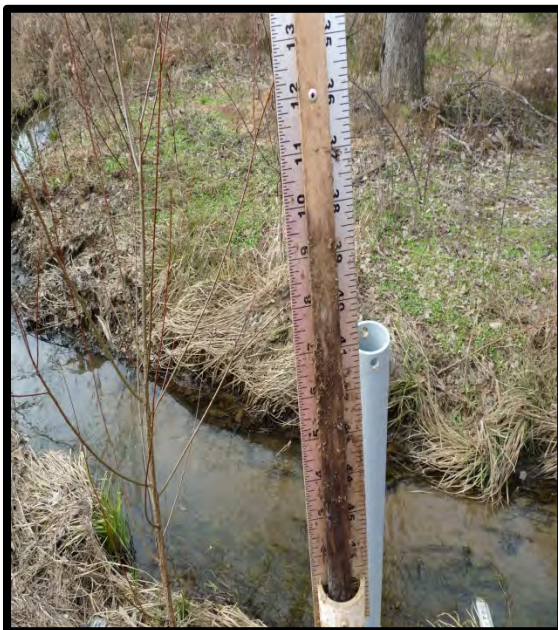
Date	Crest Gauge Info		Gauge Reading (ft)	Gauge Elevation (ft)	Crest Elevation (ft)	Bankfull Elevation (ft)	Height above Bankfull (ft)	Photo
	Site	Sta.						
3/8/2012	1	16+85	0.75	620.65	621.40	621.05	0.35	6.1
10/4/2012	1	16+85	1.13	620.65	621.78	621.05	0.73	6.2
