# ***YEAR 2 MONITORING REPORT***

## **UT ROCKY RIVER – HARRIS ROAD MIDDLE**

EEP IMS No. 92383, Contract No. 004346

Submitted: November 6, 2013

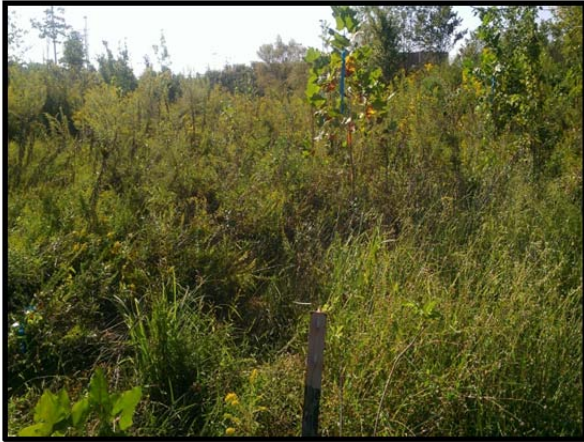
**3.9 Vegetation Plot 9**

A small cluster of *Sericea lespedeza* (*Lespedeza cuneata*) was observed within Plot 9. Plot 9 is located near Moss Farm Street and a sewer easement that crosses UT Rocky River at the beginning of the project making this area susceptible to encroachment of invasive species. Plot 9 is currently not exceeding success criteria goals with 283 planted stems per acre surviving after Year 2; however, the stem count is 567 with natural recruits. EEP does not typically treat *lespedeza* during invasive species treatments; however, if the population continues to have a detrimental effect on the plot and surrounding area in monitoring Year 3, EEP will reassess.

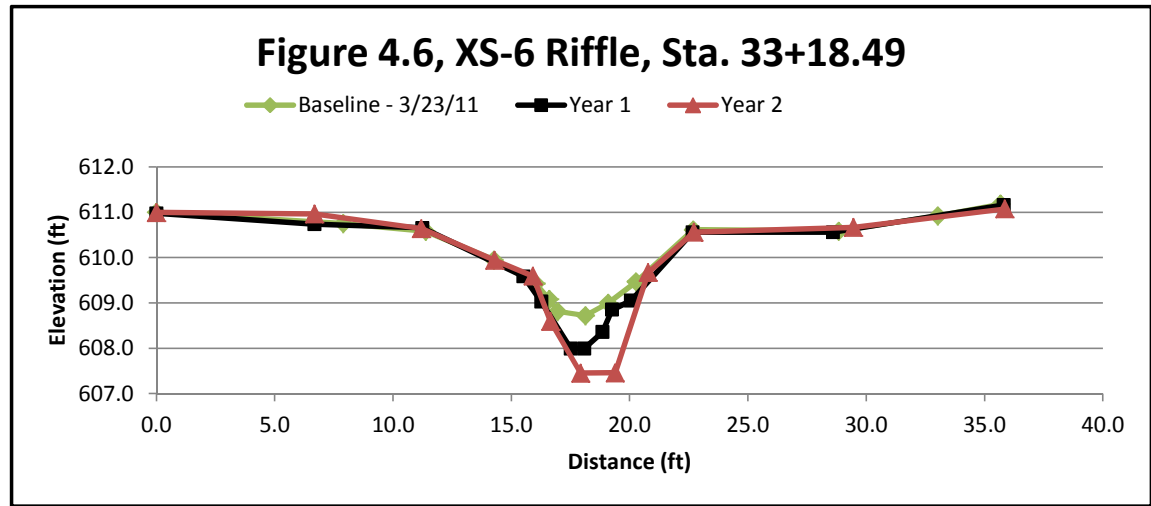
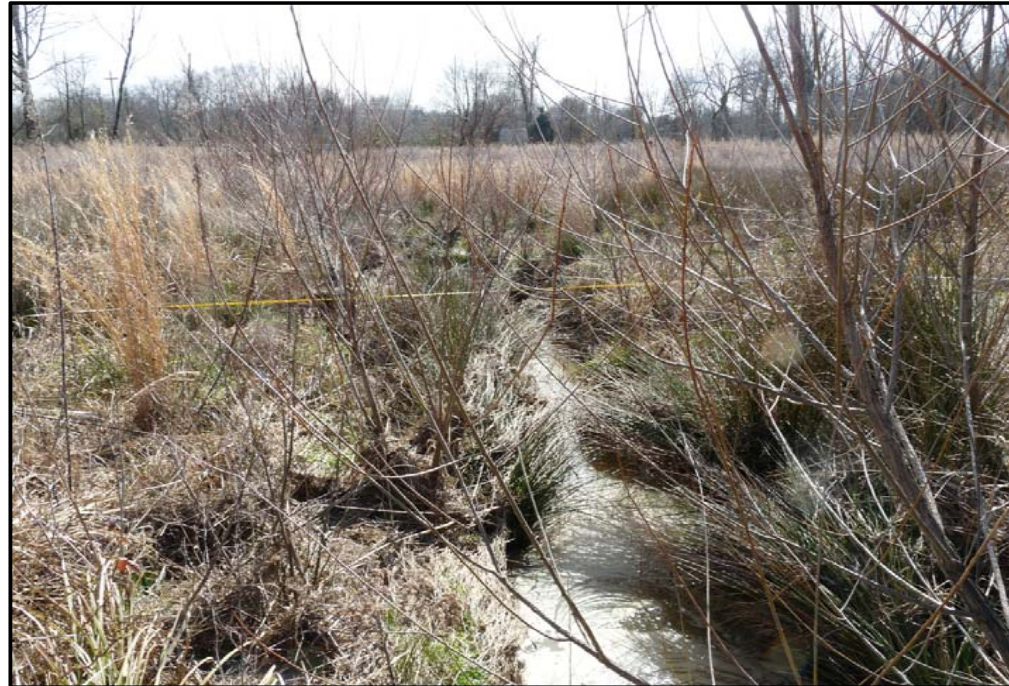
UT Rocky River appears to be stable and functioning as designed. The area formerly affected by the beaver dam is recovering. There is no evidence of trends toward significant change in channel dimension or pattern. Approximately 140 feet of the profile (Station 11+78 – 13+18) around Cross Section 1 show evidence of minor deposition most likely due to a slightly lower slope. Cross-sectional data indicates that the channel has experienced little change in dimension, with the exception of Cross Section 6. Cross Section 6 has continued to deepen in comparison with baseline and Year 1 conditions, resulting in a larger cross sectional area and smaller width to depth ratio. Scour at Cross Section 6 is likely a result of increased shear stress caused by the

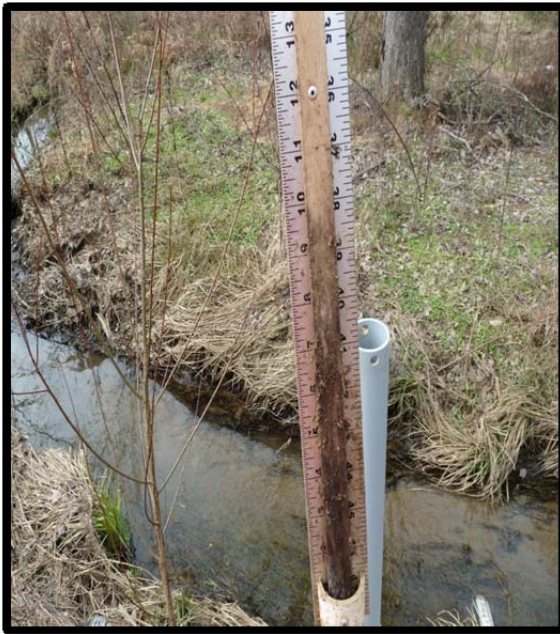
**6.1 Crest Gauge 1 (3/8/2012)**

The site has experienced several bankfull flows throughout the first and second monitoring years. Crest gauges installed on-site were inspected on March 8, 2012; October 4, 2012; March 20, 2013 and September 24, 2013. The crest gauges revealed that a bankfull event occurred at least four times during Year 1 and 2 monitoring. (Table 13). Additional overbank evidence includes debris lines and vegetation bent in the downstream direction. Evidence of bankfull events can be found in Appendix E.

Date	Crest Gauge Info		Gauge Reading (ft)	Gauge Elevation (ft)	Crest Elevation (ft)	Bankfull Elevation (ft)	Height above Bankfull (ft)	Photo
	Site	Sta.						
3/8/2012	1	16+85	0.75	620.65	621.40	621.05	0.35	6.1
10/4/2012	1	16+85	1.13	620.65	621.78	621.05	0.73	6.2
3/20/2013	1	16+85	1.75	620.65	622.40	621.05	1.35	6.3
9/24/2013	2	29+70	1.30	611.80	613.10	612.33	0.77	6.4
