YEAR 3 MONITORING REPORT

UT ROCKY RIVER – HARRIS ROAD MIDDLE

Cabarrus County, North Carolina

EEP IMS No. 92383, Contract No. 004346

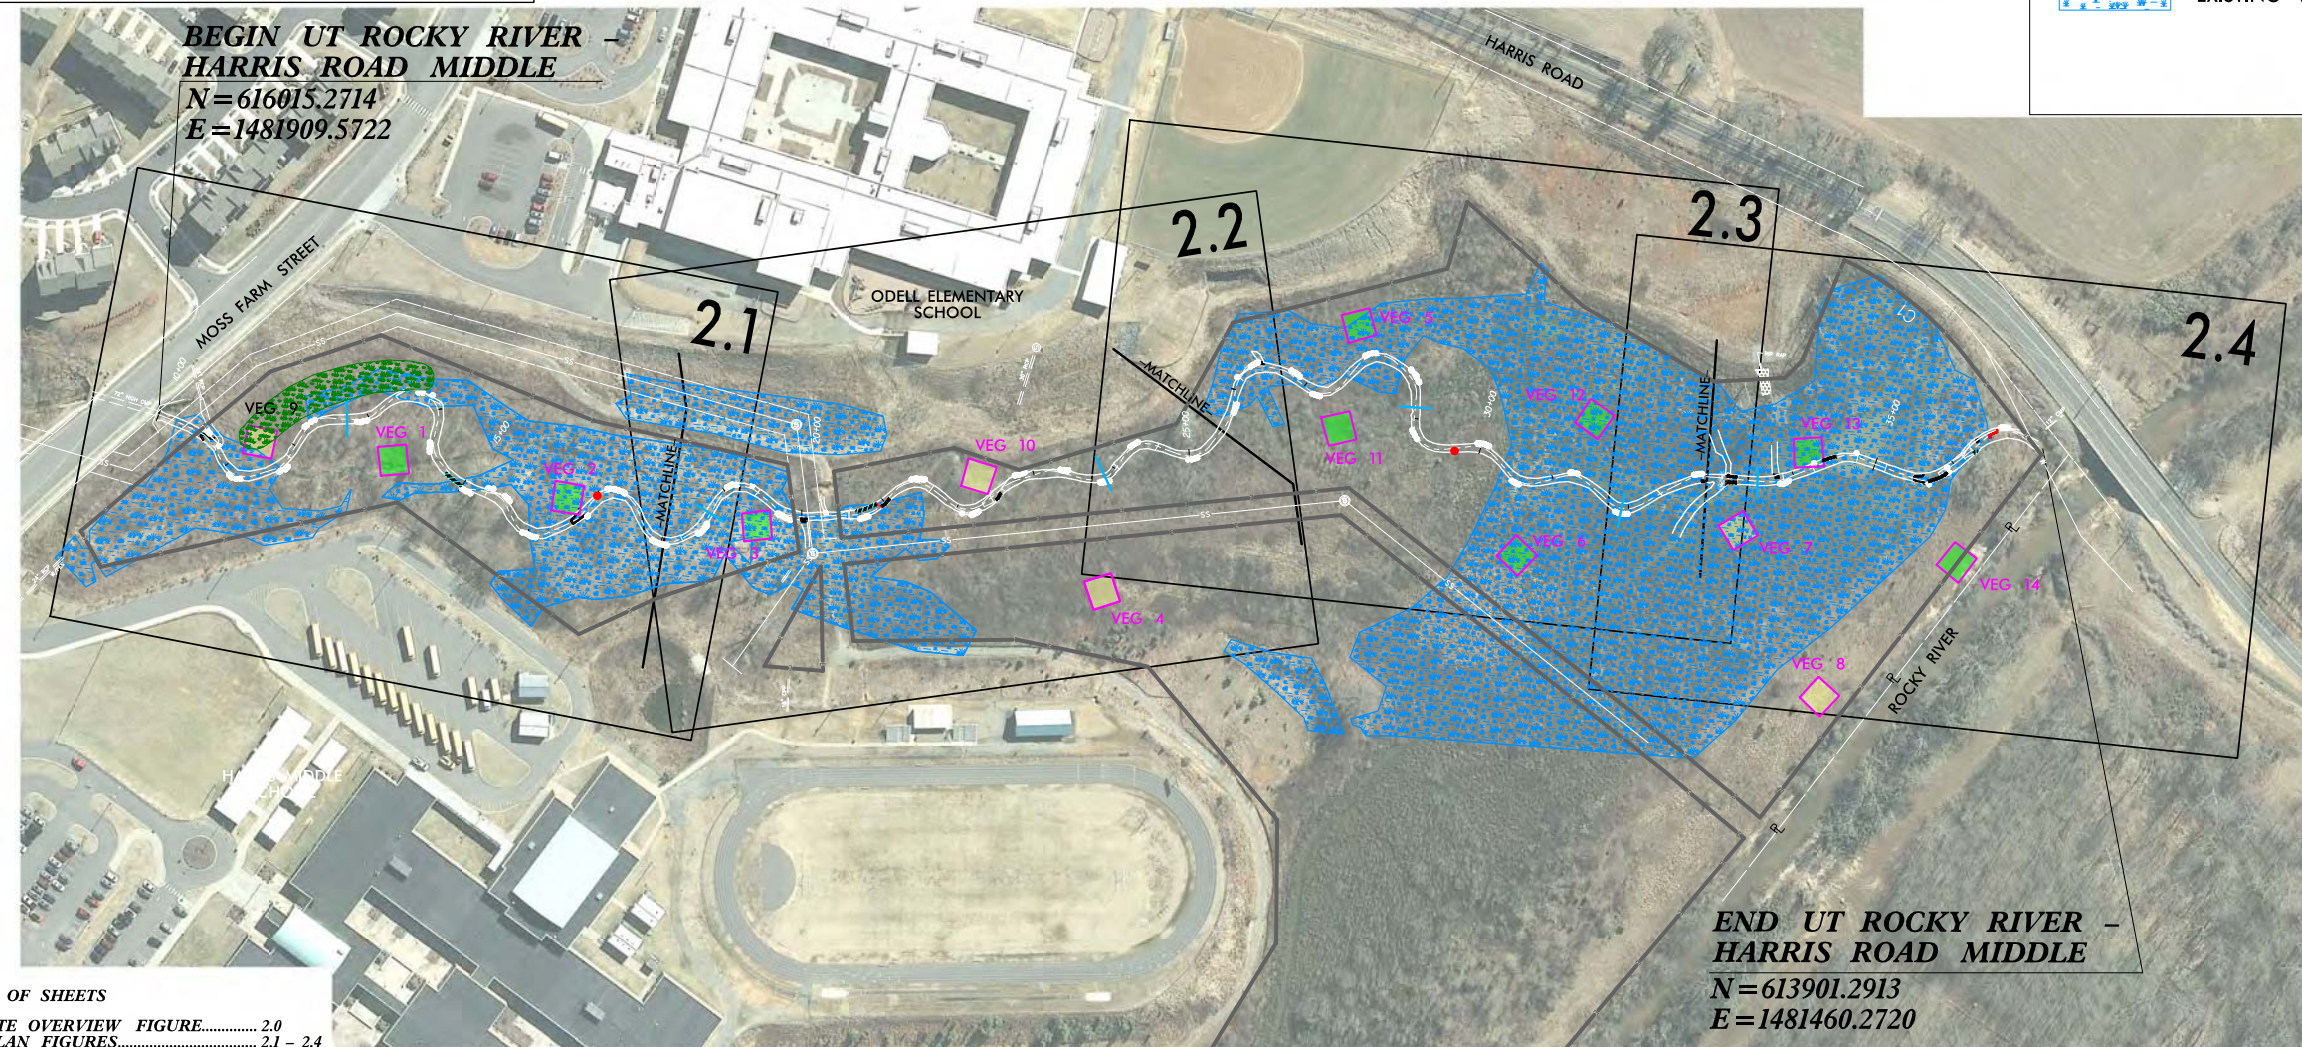
INDEX OF SHEETS	
TITLE SITE OVERVIEW FIGURE.....	2.0
CCPV PLAN FIGURES.....	2.1 - 2.4

Areas of concern can be seen in the Current Conditions Plan View (CCPV) located in Appendix B. Photos of each problem area are also included in Appendix B.

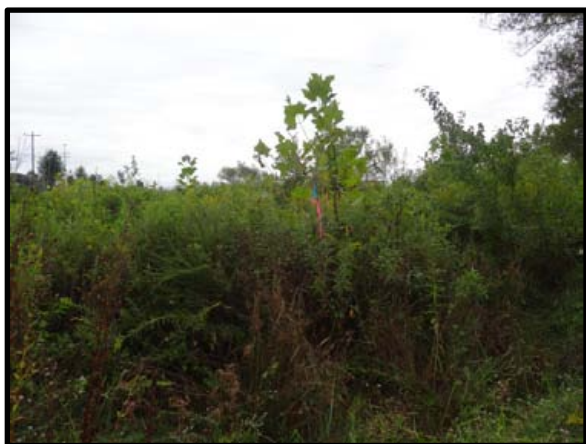
3.9 Vegetation Plot 9

The cluster of serica lespedeza (*Lespedeza cuneata*) observed in Monitoring Year 2 is still present and has expanded in coverage. The cluster is in the vicinity of Plot 9, which is located near Moss Farm Street. A sewer line easement makes the area susceptible to invasive plant species encroachment. While the invasive plant species remain, Plot 9 has improved over the previous monitoring year. The plot is now exceeding success criteria with an average stem density of 364 stems per acre without natural recruits. Invasive plant species should be watched closely in the coming years; however, no action is necessary at this time as affected plots have improved.

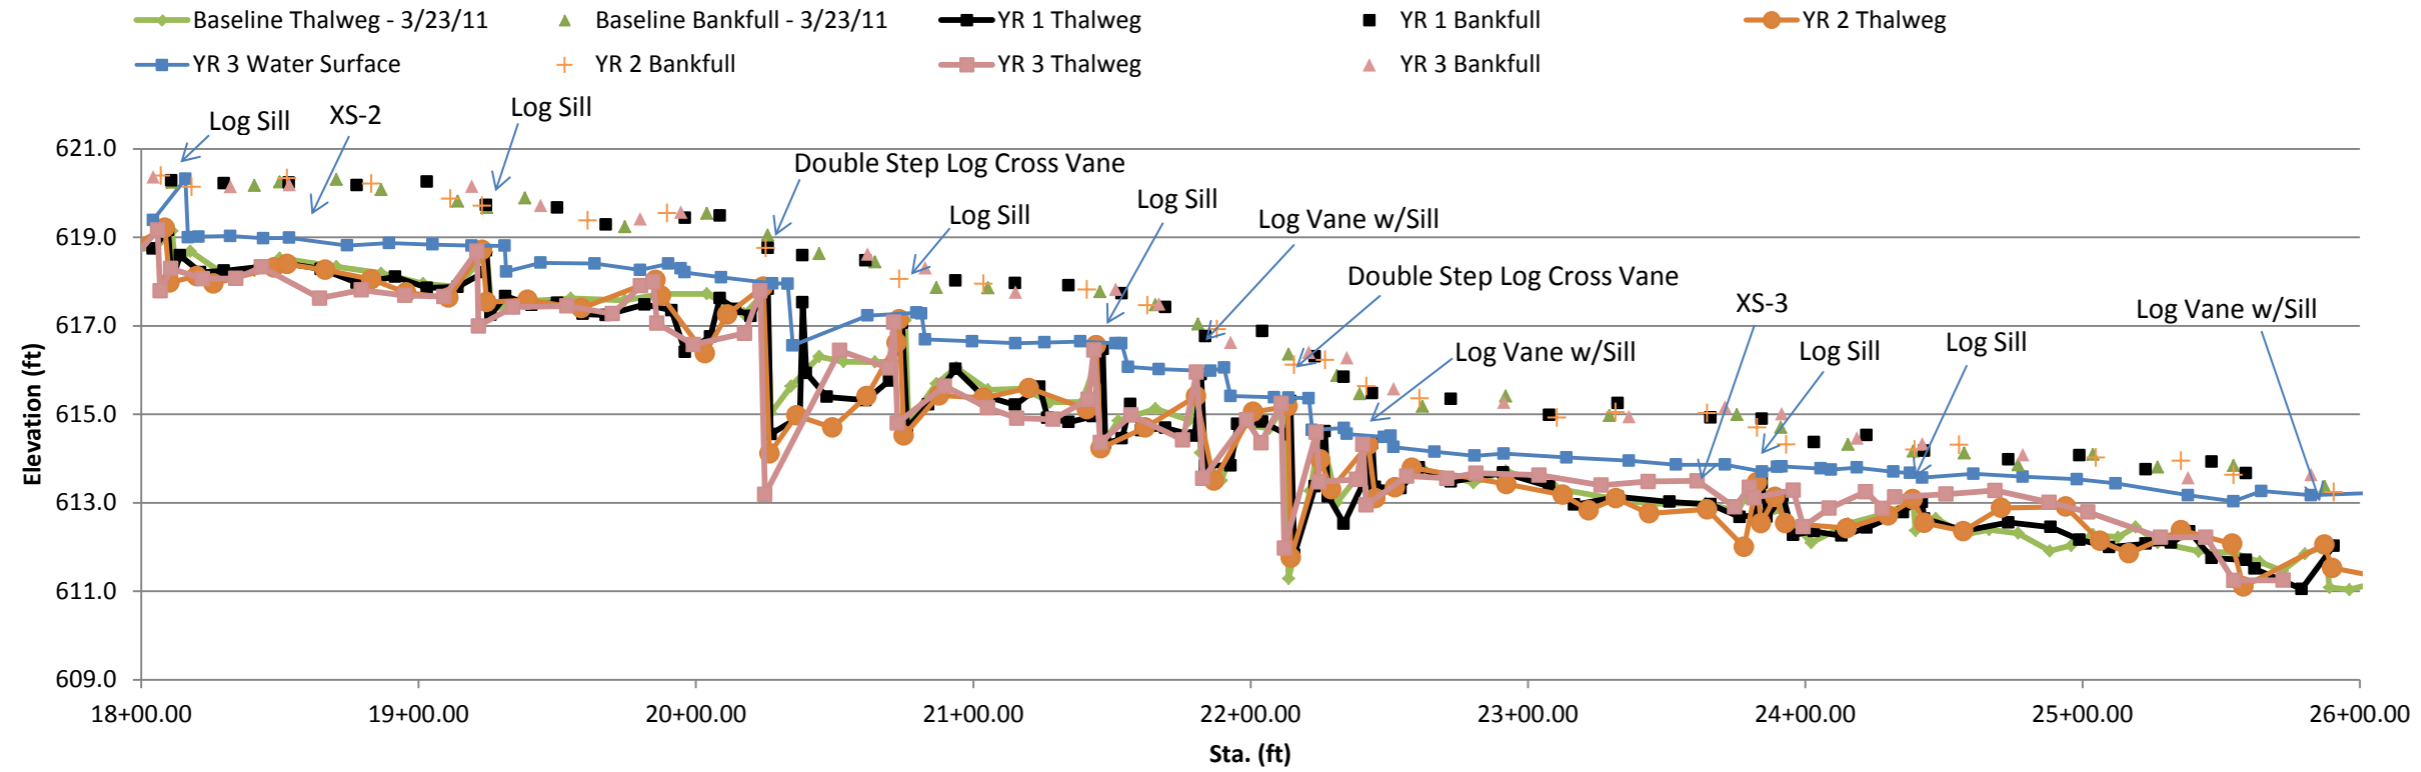
Figure 5.3 UT Rocky River - Longitudinal Profile

UT Rocky River appears to be stable and functioning as designed. The area affected by the beaver dam removed in 2012 is recovering and does not show significant changes from Year 2 Monitoring. However, it appears that the beaver were attempting to rebuild the dam at this location during vegetation surveys in September 2014. Another beaver dam was observed at station 26+46 and is reflected in the longitudinal profile (Figure 5.3). The beaver dam was removed in summer 2014.

Deposition observed in Year 2 has washed out and the profile is aligning closely with baseline. The beaver dam located at station 26+40 caused deposition to occur between station 23+03 – 23+61 and 24+21 – 25+28. With the beaver dam now removed, this deposition is expected to wash out in the coming year.

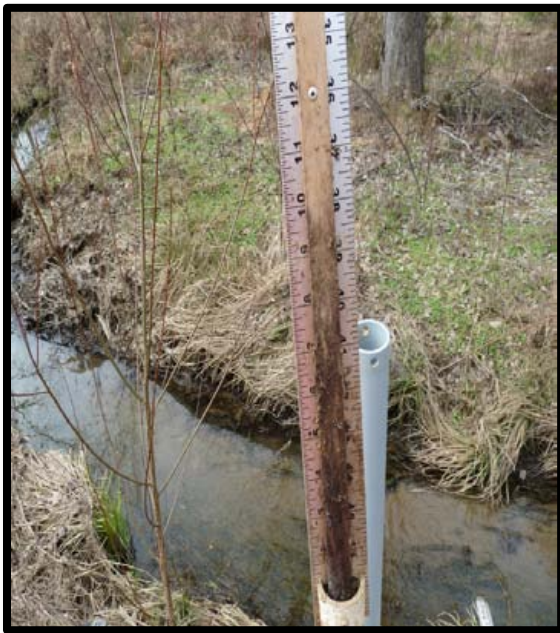
6.1 Crest Gauge 1 (3/8/2012)

The site has experienced several bankfull flows throughout the first three monitoring years. Crest gauges installed on-site were inspected on April 16, 2014 and September 23, 2014. The crest gauges revealed that a bankfull event occurred at least twice during Year 3 monitoring (Table 13). Additional overbank evidence includes debris lines and vegetation bent in the downstream direction. Evidence of bankfull events can be found in Appendix E.
