UT to Rocky River (Smith Tract) Stream and Buffer Restoration, Enhancement, and Preservation

Chatham County, North Carolina

Final Monitoring Report

(Year 1 of 5)

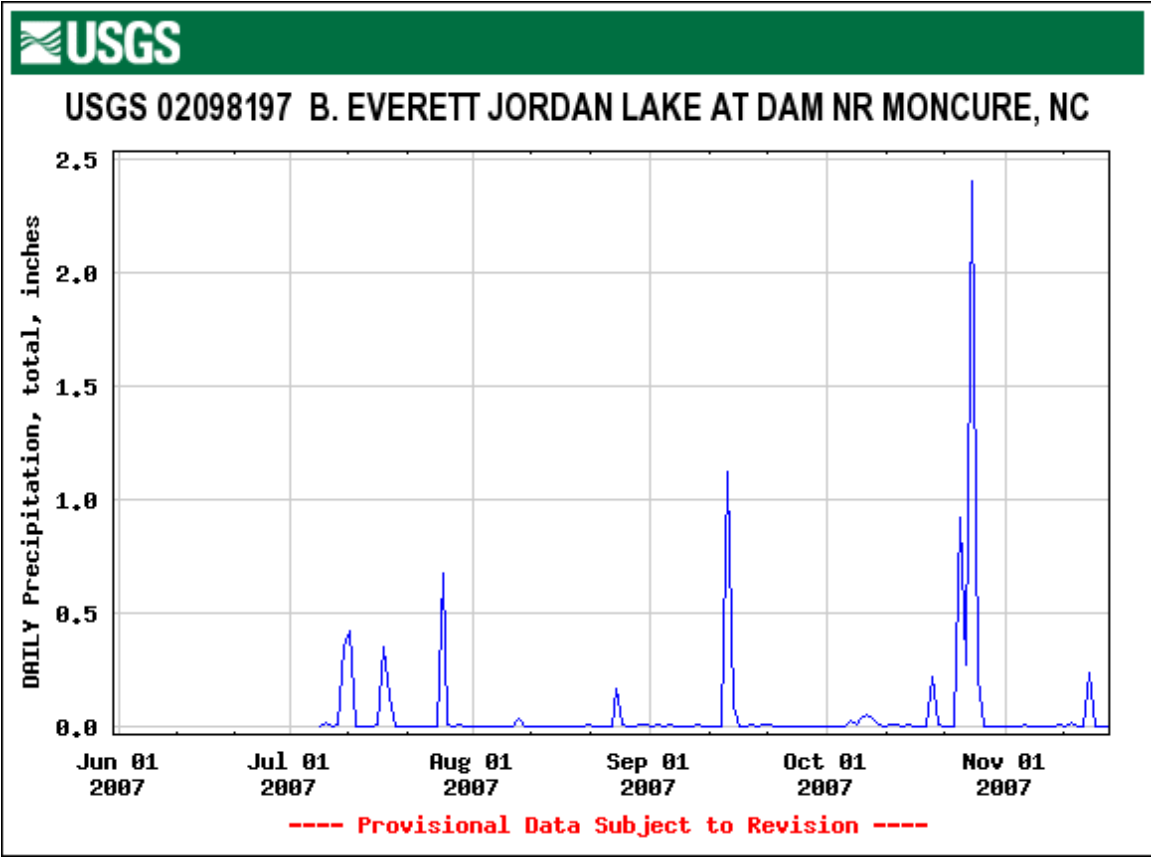
Figure 1. USGS rain gauge in Moncure, NC.

One verified stream bankfull event occurred in October of 2007 on Reach 2. A stream flow level recorder is located on Reach 2 at stream station 2+90, which shows the highest level of water flow through the channel. Table VIII shows this bankfull event and Figure 1 illustrates the recorded rain gauge data that substantiates the date.

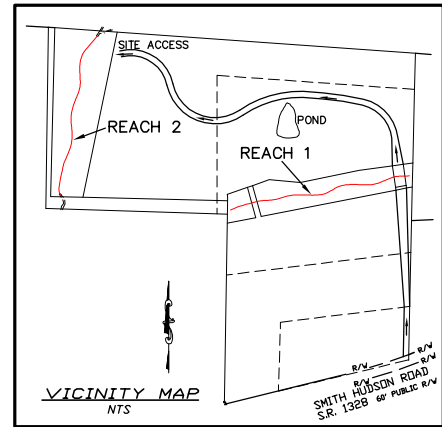
FIGURE NO.
FIGURE 2

Reach 1: The overall stream conditions of the bank repairs and re-alignment are holding up very well. There are only a few areas along the stream that have minor toe erosion however the upper banks in these areas are well vegetated. At stream station 7+50 to 7+75 (photo 381) the bank is very vertical with large tree roots. This area was not part of the original repairs to the stream bank and the extensive tree roots in this area have stabilized the bank. All areas noted in Reach one have been identified as trouble areas that warrant future monitoring.

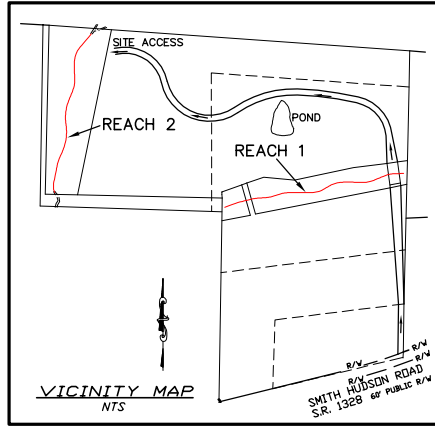
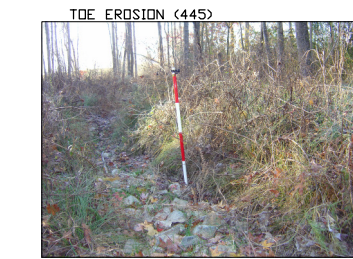
DATE:	30 NOV 2007
REVISIONS:	
PROJECT NAME:	Smith Tract\Year 1
DWG NAME:	Current Conditions
SCALE:	1' = 30'
FIGURE NO.:	FIGURE 3
SHEET NO.:

Shortly after construction was completed the adjacent property owner to the west cleared his entire property. A tributary from this property enters Reach 2 at stream station 3+70. Two locations downstream have experienced channel incision as illustrated in photographs 447 and 449. The channel has become narrower and deeper. At the end of Reach 2 the land owner below the project constructed a road and installed an 18" pipe in the channel. This restriction has caused aggregation of the channel for a distance of approximately 23 feet. The rock cross vane structure is currently buried in sediment. Ms. Melonie Allen the EEP project manager is currently in the process of obtaining an easement from Mr. Pike to allow the replacement of the current 18" pipe with a 36" pipe. This 36-inch pipe will have sufficient capacity to pass the bankfull storm event. As a part of the pipe retrofit the channel incision at stations 1+60 – 1+80 and station 2+35 to 3+45 will also be addressed for repairs.

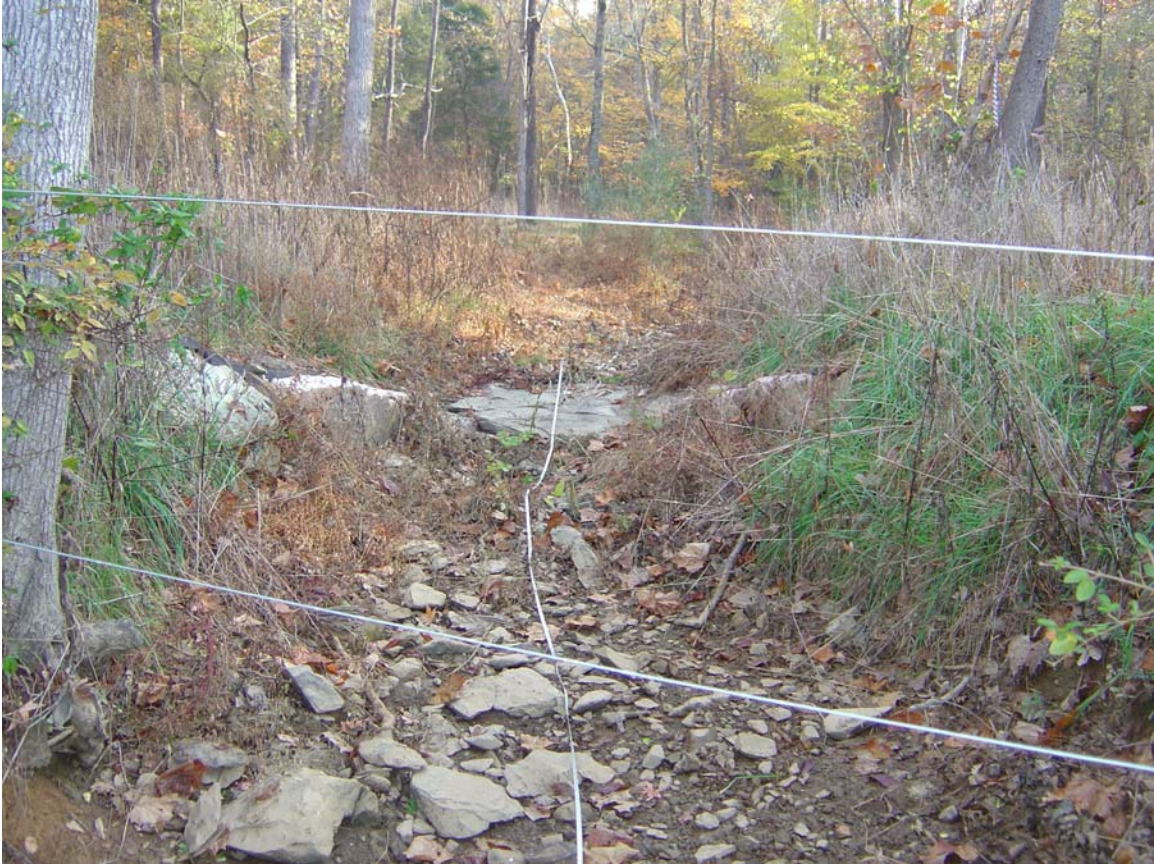
Photo 382 - looking upstream at cross vane Reach 1
