**UT ROCKY RIVER (SMITH TRACT) STREAM RESTORATION – NCEEP
Project #402**

2008 FINAL MONITORING REPORT – YEAR 2

**CONDUCTED FOR THE NORTH CAROLINA DEPARTMENT OF ENVIRONMENT
AND NATURAL RESOURCES**

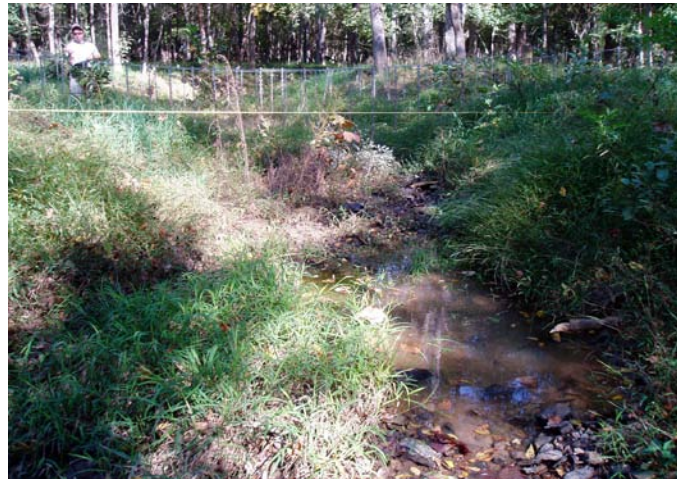
View of UT Rocky River, Reach 1, XS-1 looking upstream

SUMMARY DATA
 Floodprone Elevation (ft) 551.11
 Bankfull Elevation (ft) 548.21
 Floodprone Width (ft) 157.00
 Bankfull Width (ft) 25.26
 Entrenchment Ratio 6.20
 Mean Depth (ft) 1.34
 Maximum Depth (ft) 2.90
 Width/Depth Ratio 18.81
 Bankfull Area (sq ft) 33.91
 Wetted Perimeter (ft) 26.36
 Hydraulic Radius (ft) 1.29

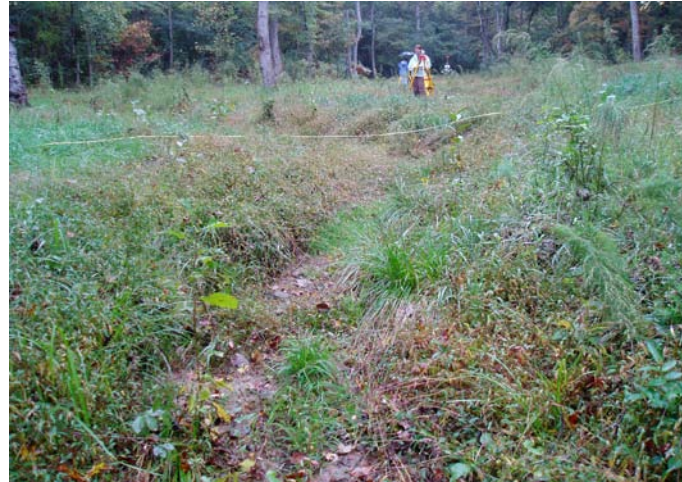
View of UT Rocky River, Reach 2, XS-2 looking upstream

SUMMARY DATA
 Floodprone Elevation (ft) 558.23
 Bankfull Elevation (ft) 556.60
 Floodprone Width (ft) 112.00
 Bankfull Width (ft) 13.15
 Entrenchment Ratio 8.52
 Mean Depth (ft) 74.00
 Maximum Depth (ft) 1.63
 Width/Depth Ratio 17.70
 Bankfull Area (sq ft) 9.77
 Wetted Perimeter (ft) 13.79
 Hydraulic Radius (ft) 0.71

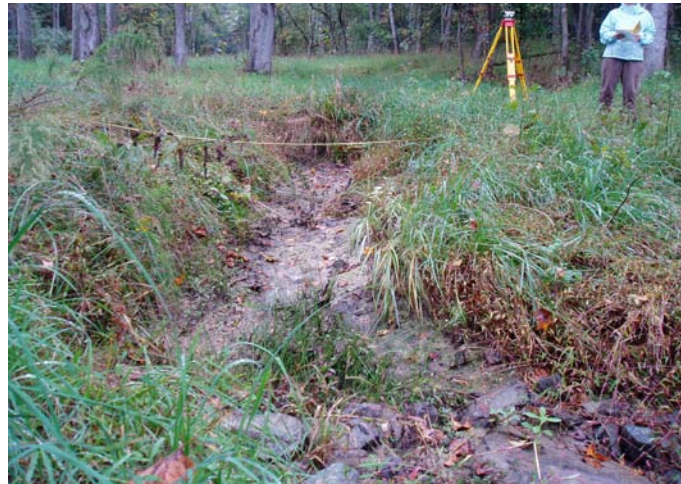
View of UT Rocky River, Reach 2, XS-3 looking upstream

Floodprone Elevation (ft)	553.10
Bankfull Elevation (ft)	551.55
Floodprone Width (ft)	200.00
Bankfull Width (ft)	10.31
Entrenchment Ratio	19.40
Mean Depth (ft)	0.80
Maximum Depth (ft)	1.55
Width/Depth Ratio	12.94
Bankfull Area (sq ft)	8.21
Wetted Perimeter (ft)	10.98
Hydraulic Radius (ft)	0.75

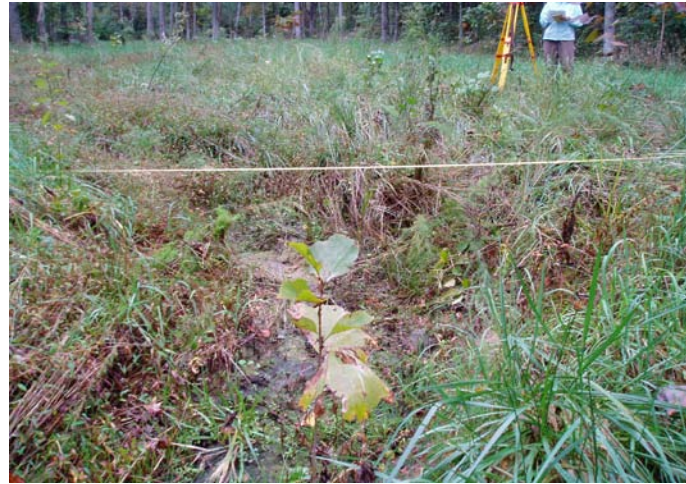
View of UT Rocky River, Reach 2, XS-4 looking upstream

SUMMARY DATA
 Floodprone Elevation (ft) 551.51
 Bankfull Elevation (ft) 549.76
 Floodprone Width (ft) 160.00
 Bankfull Width (ft) 10.90
 Entrenchment Ratio 14.68
 Mean Depth (ft) 1.00
 Maximum Depth (ft) 1.75
 Width/Depth Ratio 10.91
 Bankfull Area (sq ft) 10.89
 Wetted Perimeter (ft) 11.61
 Hydraulic Radius (ft) 0.94
 Stream Type: C

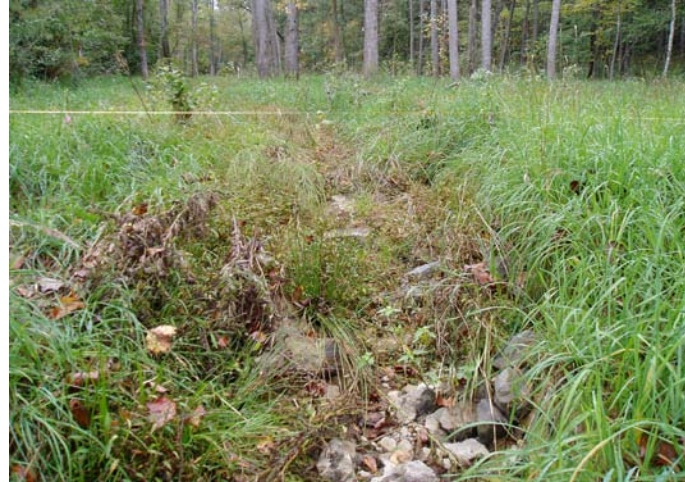
View of UT Rocky River, Reach 2, XS-5 looking upstream

Floodprone Elevation (ft)	549.65
Bankfull Elevation (ft)	547.67
Floodprone Width (ft)	130.00
Bankfull Width (ft)	13.10
Entrenchment Ratio	9.92
Mean Depth (ft)	0.86
Maximum Depth (ft)	1.98
Width/Depth Ratio	15.18
Bankfull Area (sq ft)	11.31
Wetted Perimeter (ft)	14.16
Hydraulic Radius (ft)	0.80
