**UT ROCKY RIVER STREAM RESTORATION – NCEEP Project #402**  
2009 FINAL MONITORING REPORT – YEAR 3

CONDUCTED FOR THE NORTH CAROLINA DEPARTMENT OF ENVIRONMENT  
AND NATURAL RESOURCES

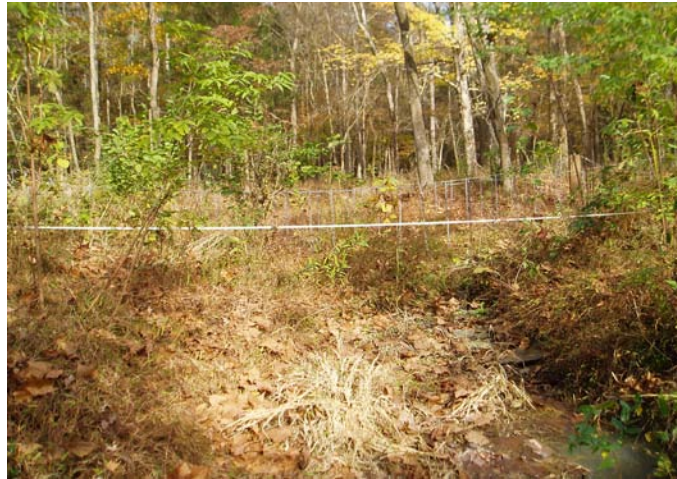
View of UT Rocky River, Reach 1, XS-1 looking upstream

SUMMARY DATA  
 Floodprone Elevation (ft) 550.51  
 Bankfull Elevation (ft) 547.92  
 Floodprone Width (ft) 157.00  
 Bankfull Width (ft) 19.24  
 Entrenchment Ratio 8.16  
 Mean Depth (ft) 1.51  
 Maximum Depth (ft) 2.59  
 Width/Depth Ratio 12.73  
 Bankfull Area (sq ft) 29.1  
 Wetted Perimeter (ft) 20.40  
 Hydraulic Radius (ft) 1.43

Stream Type: C4

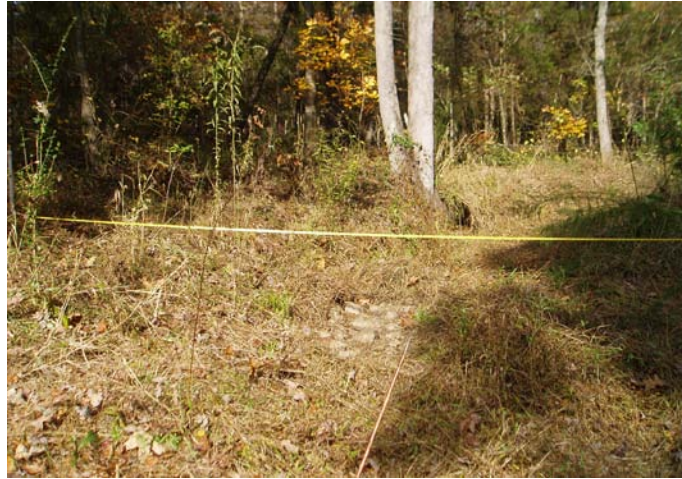
View of UT Rocky River, Reach 2, XS-1 looking upstream

SUMMARY DATA  
 Floodprone Elevation (ft) 560.29  
 Bankfull Elevation (ft) 558.50  
 Floodprone Width (ft) 104.00  
 Bankfull Width (ft) 14.98  
 Entrenchment Ratio 6.94  
 Mean Depth (ft) 0.94  
 Maximum Depth (ft) 1.79  
 Width/Depth Ratio 15.90  
 Bankfull Area (sq ft) 14.12  
 Wetted Perimeter (ft) 15.57  
 Hydraulic Radius (ft) 0.91

Stream Type: C4

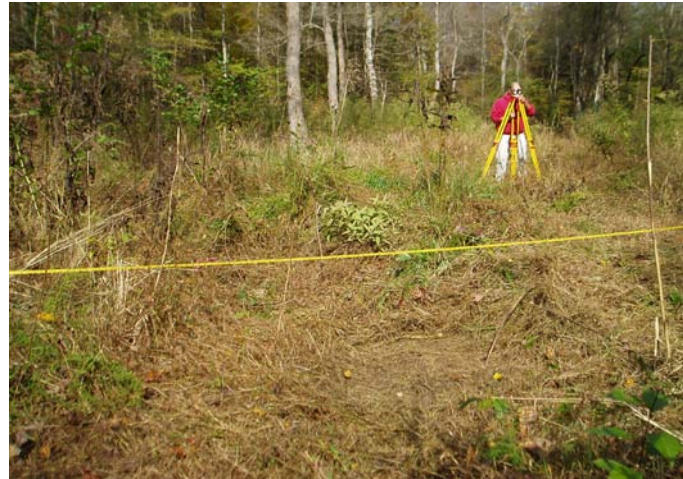
View of UT Rocky River, Reach 2, XS-2 looking upstream

**SUMMARY DATA**  
 Floodprone Elevation (ft) 557.93  
 Bankfull Elevation (ft) 556.42  
 Floodprone Width (ft) 112.00  
 Bankfull Width (ft) 11.39  
 Entrenchment Ratio 9.84  
 Mean Depth (ft) 0.75  
 Maximum Depth (ft) 1.51  
 Width/Depth Ratio 15.25  
 Bankfull Area (sq ft) 8.50  
 Wetted Perimeter (ft) 11.91  
 Hydraulic Radius (ft) 0.71

Stream Type: C6

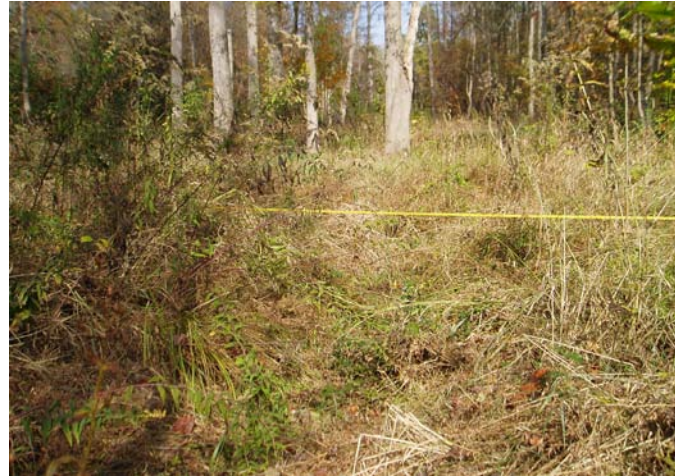
View of UT Rocky River, Reach 2, XS-3 looking upstream

SUMMARY DATA	
Floodprone Elevation (ft)	553.11
Bankfull Elevation (ft)	551.55
Floodprone Width (ft)	200.00
Bankfull Width (ft)	11.81
Entrenchment Ratio	16.94
Mean Depth (ft)	0.70
Maximum Depth (ft)	1.56
Width/Depth Ratio	16.76
Bankfull Area (sq ft)	8.33
Wetted Perimeter (ft)	12.41
Hydraulic Radius (ft)	0.67

Stream Type: C5

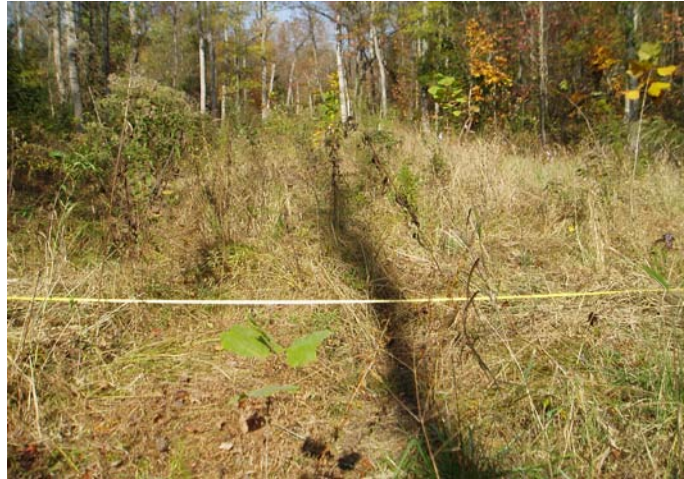
View of UT Rocky River, Reach 2, XS-4 looking upstream

Floodprone Elevation (ft) 551.47  
 Bankfull Elevation (ft) 549.73  
 Floodprone Width (ft) 160.00  
 Bankfull Width (ft) 11.31  
 Entrenchment Ratio 14.15  
 Mean Depth (ft) 0.93  
 Maximum Depth (ft) 1.74  
 Width/Depth Ratio 12.17  
 Bankfull Area (sq ft) 10.51  
 Wetted Perimeter (ft) 12.01  
 Hydraulic Radius (ft) 0.87

Stream Type: C6

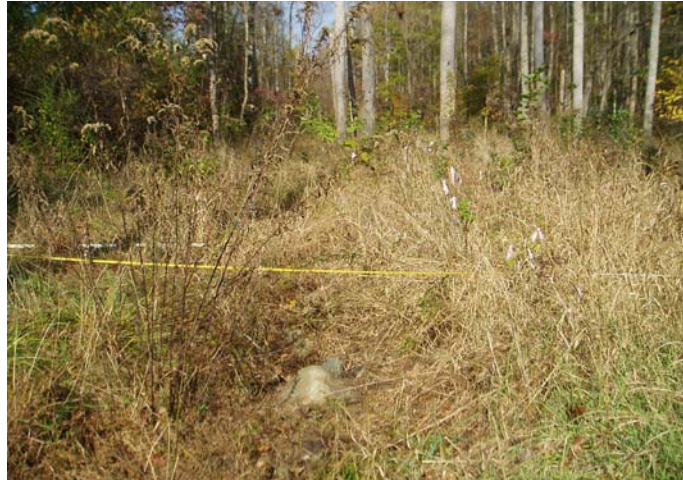
View of UT Rocky River, Reach 2, XS-5 looking upstream
