UT to Sandy Creek
Randolph County, North Carolina

First Year Monitoring Report
State Construction ID: 040611601
USGS HUC 03030003020010
EEP-08030

February 2009

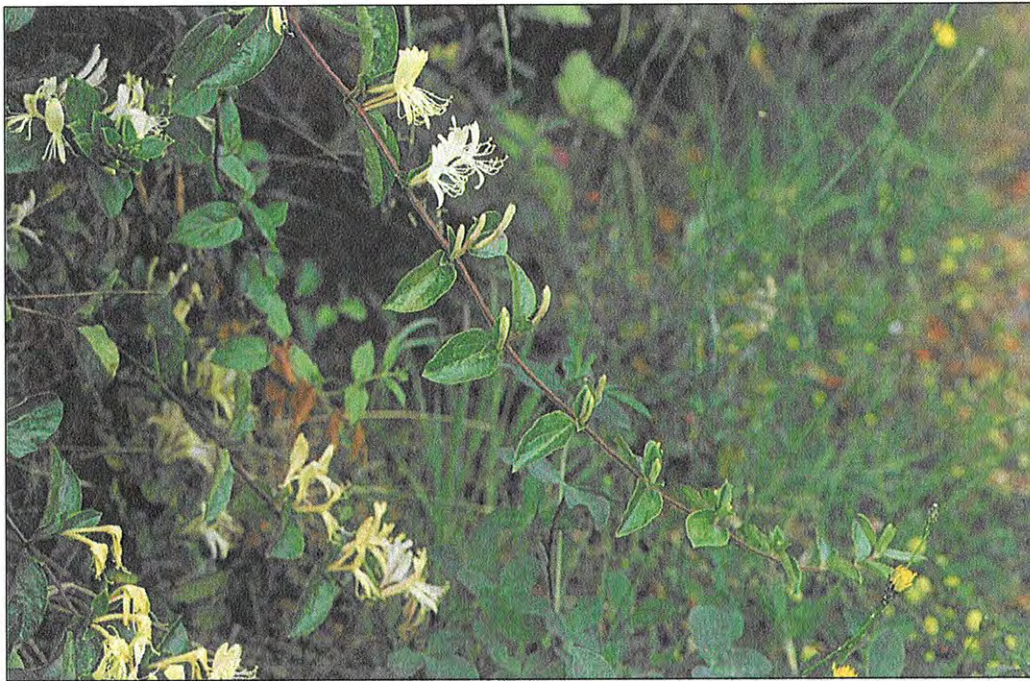
There are areas in which invasive populations have encroached into project area. Areas of Chinese privet (*Ligustrum sinense*), silktree (*Albizia julibrissin*), and Japanese honeysuckle (*Lonicera japonica*) were noted shown on Integrated Problem Area Plan View in **Appendix D**. Additionally, there are areas of Chinese lespedeza (*Lespedeza cuneata*) located around Vegetation Plots 1, 2, and 3.

VEGETATION PROBLEM AREA 3: LONICERA JAPONICA ENCROACHMENT.

Current and future maintenance concerns at this site should be addressed to protect the integrity of the project. Currently a crest gauge needs to be installed as soon as possible, all exotic and invasive vegetation needs to be treated to prevent it from spreading throughout the buffer, and all man-made debris should be removed from the channel. During subsequent monitoring years, noxious insect populations should be controlled if their presence begins to prevent desired establishment of riparian vegetation, and bank scour (STA 116+92) should be addressed if conditions do not improve. Future annual maintenance should include periodic invasive vegetation control. The in-channel vegetation between stations 200+00 and 202+00 should only be removed if lateral and/or vertical instability persists at Monitoring Year 5.

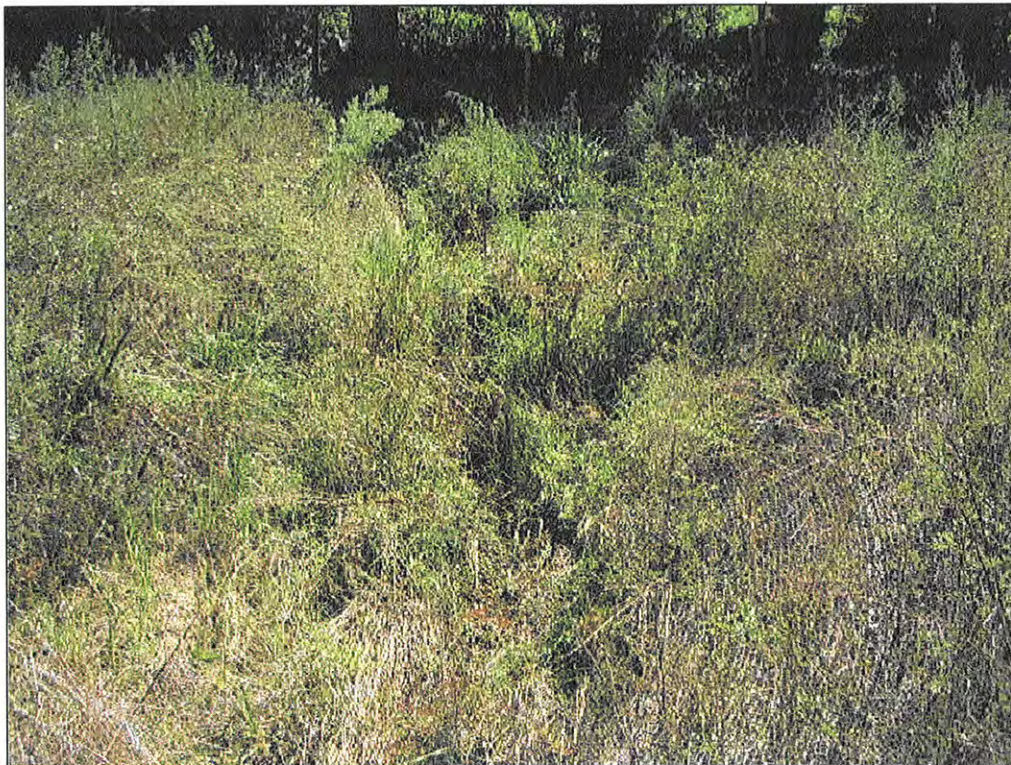
Within the upstream areas of the pond tributary (Stations 200+00 to 202+00), the stream channel contains thick vegetation which maybe due to over seeding and/or low flow or absent flow conditions within the channel. Channel morphology has been influenced by the thick vegetation causing flow patterns within the channel to be altered.

VEGETATION PROBLEM AREA 6. THICK HERBACEOUS GROWTH WITHIN STREAM CHANNEL AT STATION 200+00 - 202+00.

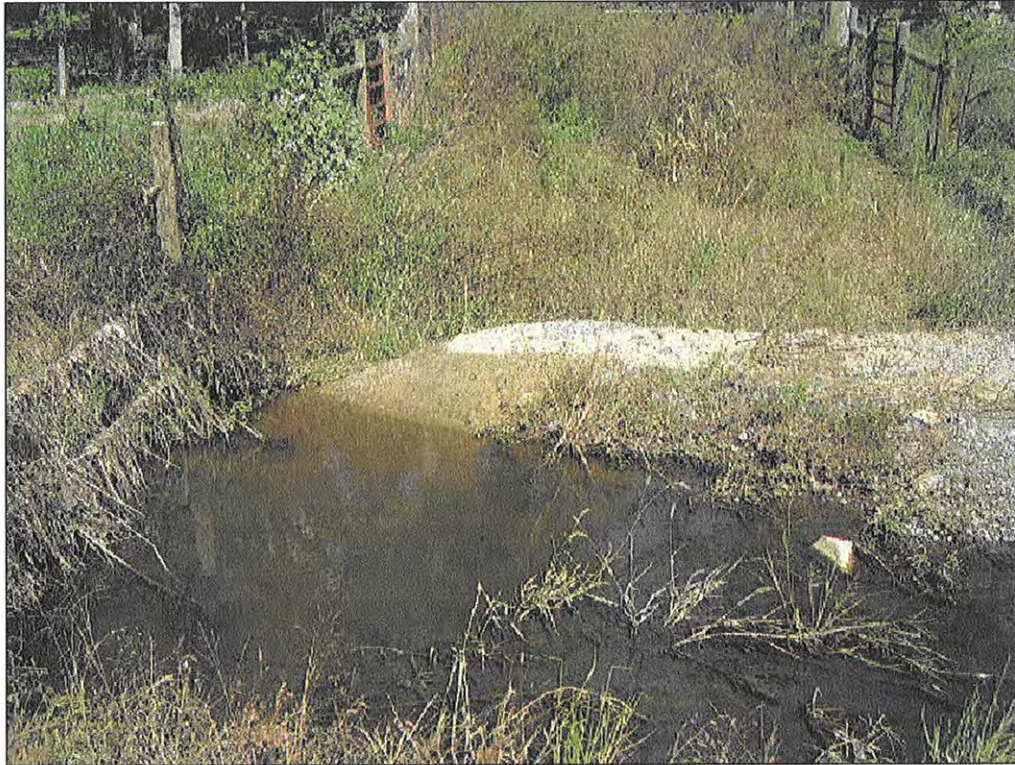
STREAM PROBLEM AREA 5. SIDE CHANNEL BAR AT STATION 111+70 - 111+80.

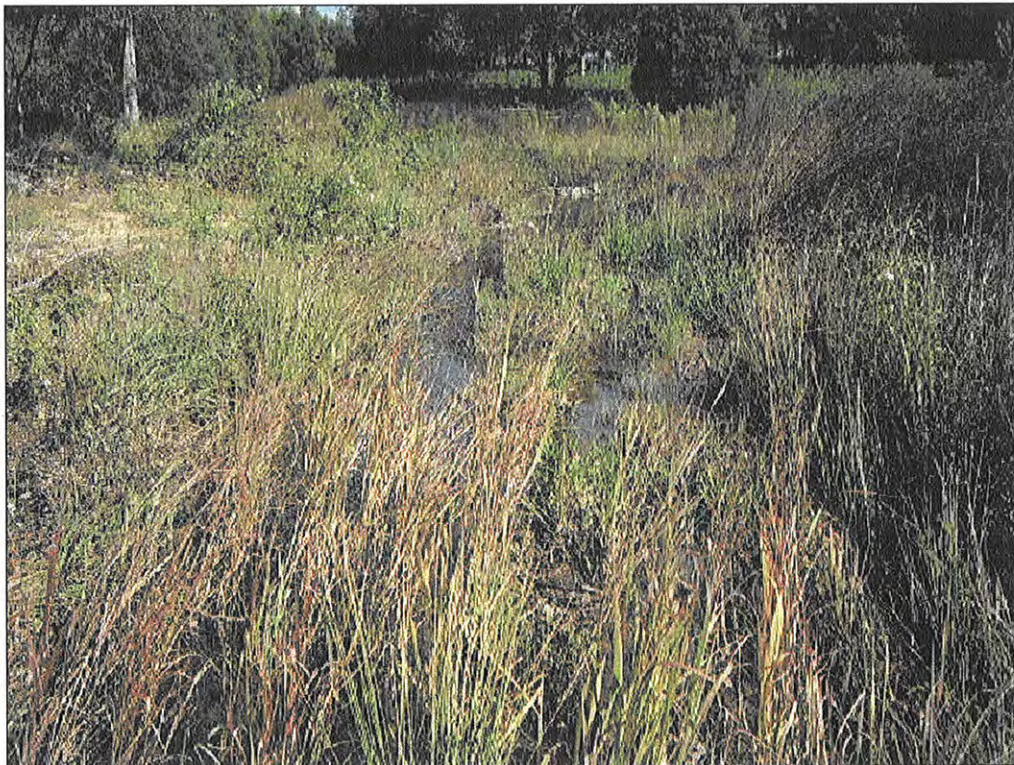
STREAM PROBLEM AREA 6. AGGRADATION AND VEGETATION IN CHANNEL INFLUENCING CHANNEL MORPHOLOGY AT STATION 102+25 - 102+40.

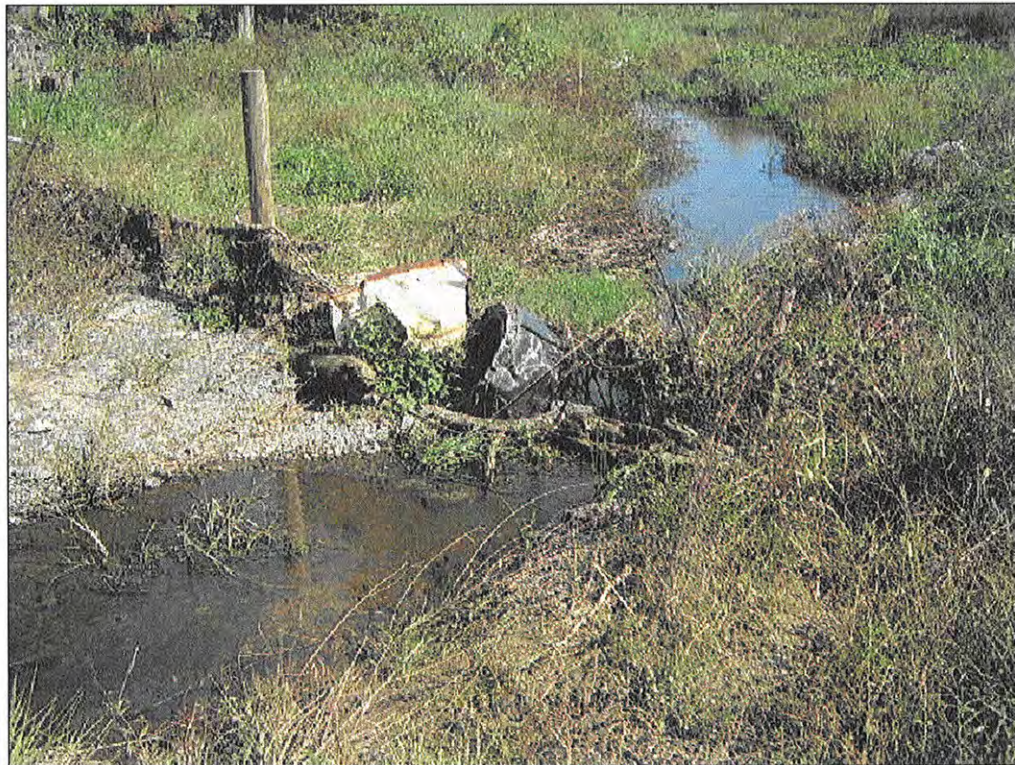
STREAM PROBLEM AREA 8. TRASH IN CHANNEL AT STATION 112+00.

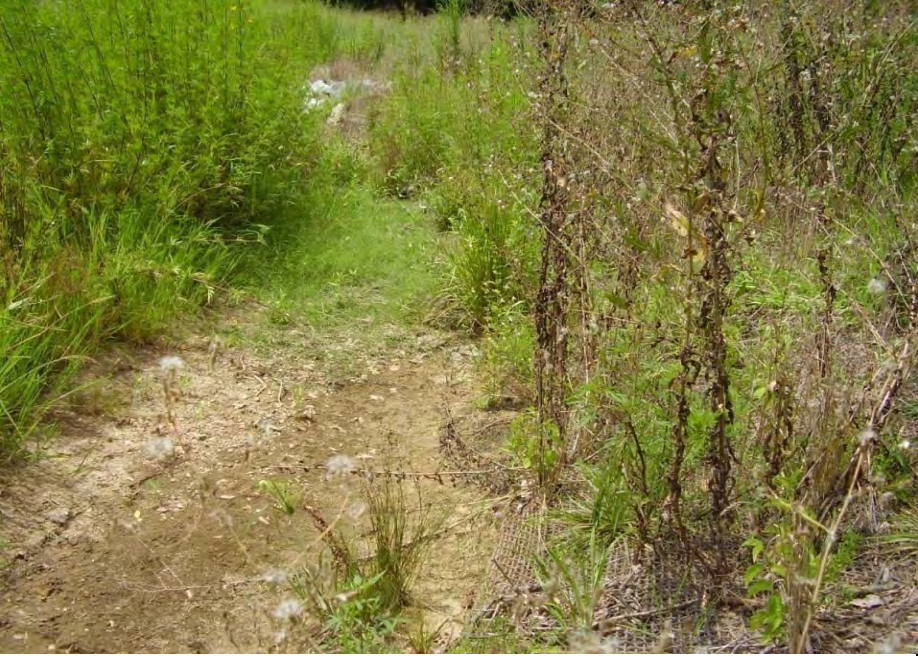
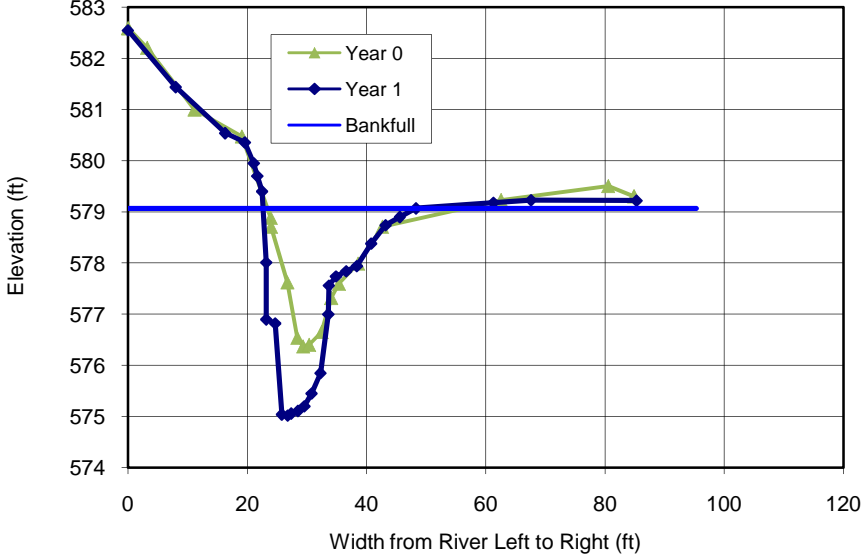
Summary Data All dimensions in feet.			CROSS SECTION PLOT - LOOKING DOWNSTREAM	
Bankfull X-sec area	45.6			
Bankfull Width	25.6			
Bankfull Mean Depth	1.8			
Bankfull Max Depth	4.1			
Width/Depth Ratio	14.4			
Entrenchment Ratio	n/a			
Classification	n/a			
Remarks:

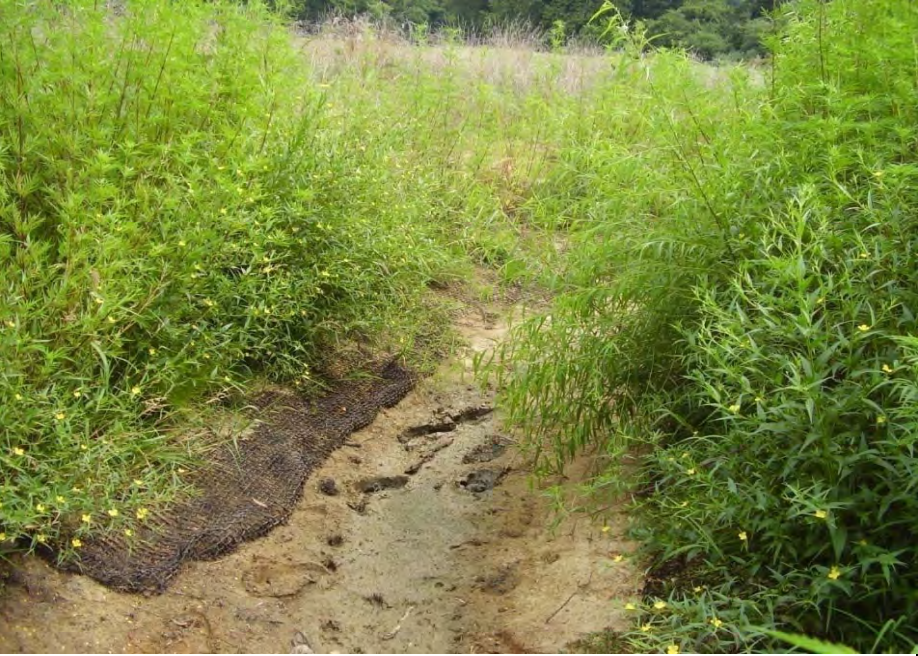
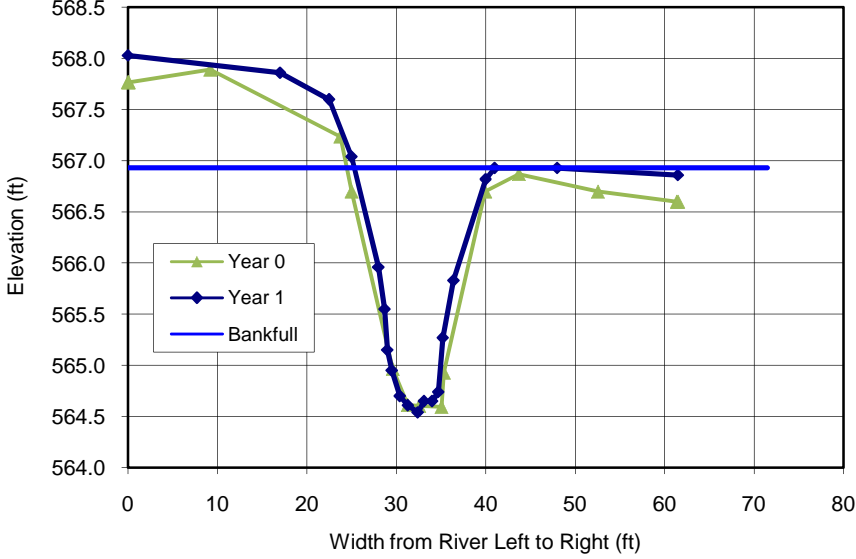
CROSS SECTION PLOT - LOOKING DOWNSTREAM	
Summary Data			Remarks:	
All dimensions in feet.				
Bankfull X-sec area	20.2			
Bankfull Width	15.7			
Bankfull Mean Depth	1.3			
Bankfull Max Depth	2.4			
Width/Depth Ratio	12.2			
Entrenchment Ratio	6.4			
Classification	C

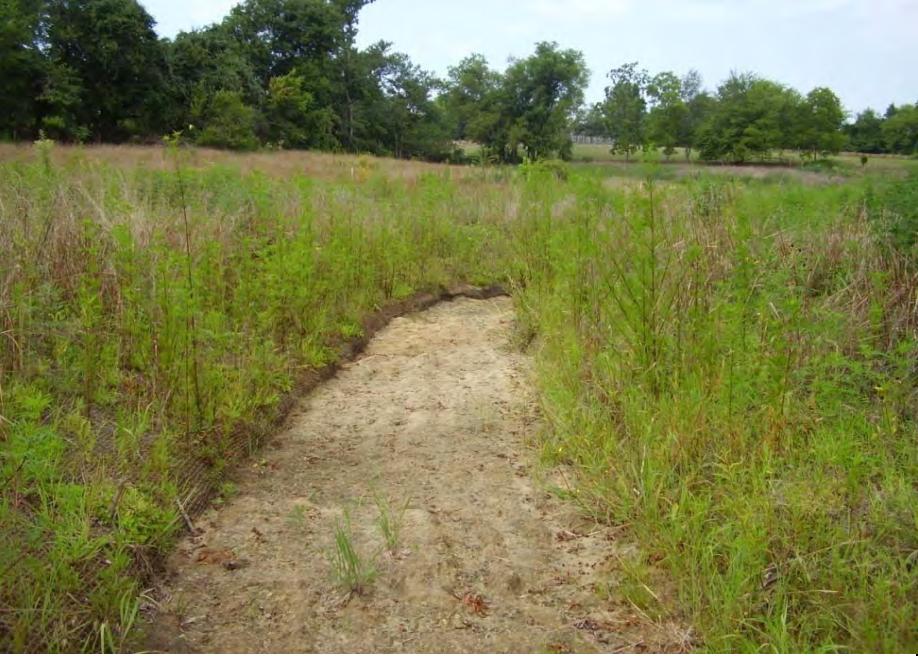
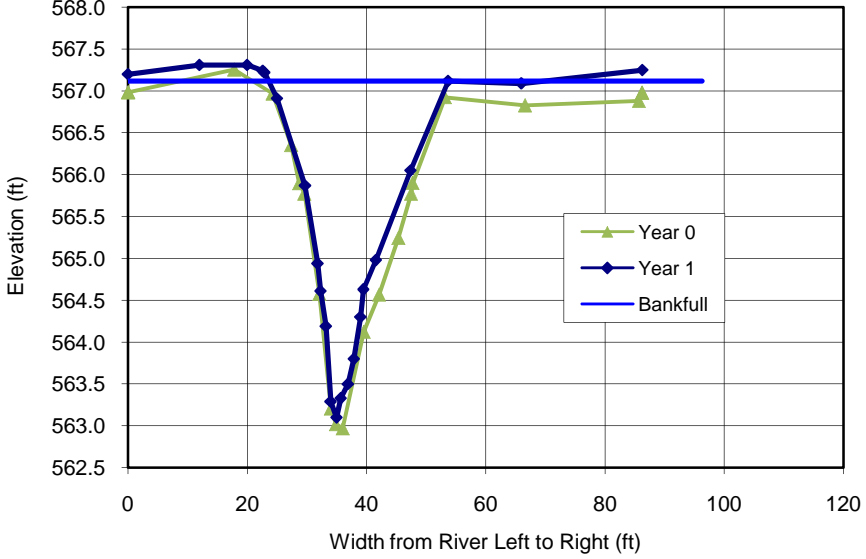
CROSS SECTION PLOT - LOOKING DOWNSTREAM			
Summary Data			Remarks:			
All dimensions in feet.						
Bankfull X-sec area	50.3					
Bankfull Width	30.1					
Bankfull Mean Depth	1.7					
Bankfull Max Depth	4.0					
Width/Depth Ratio	18.0					
Entrenchment Ratio	n/a					
Classification	n/a

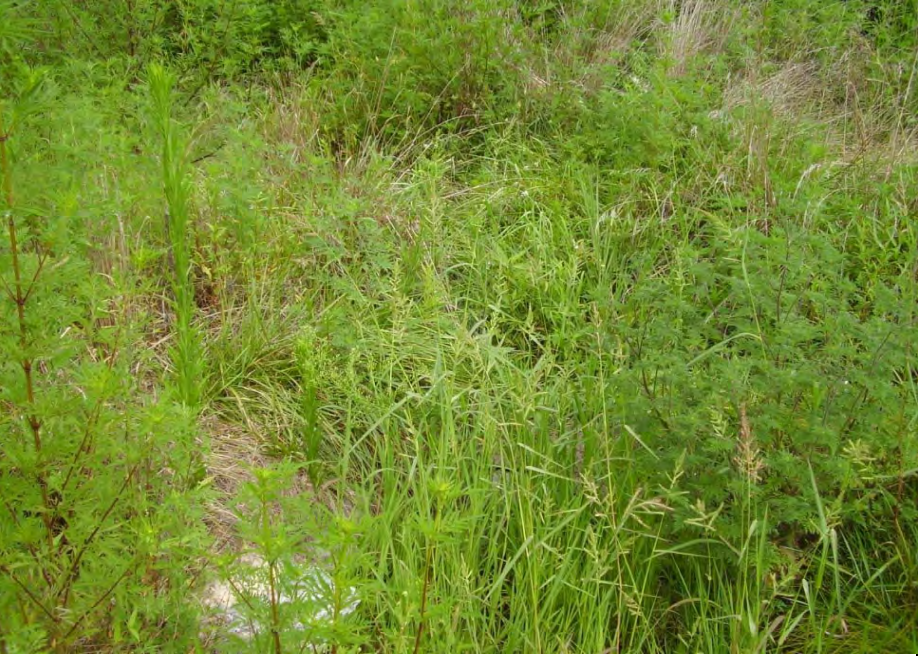
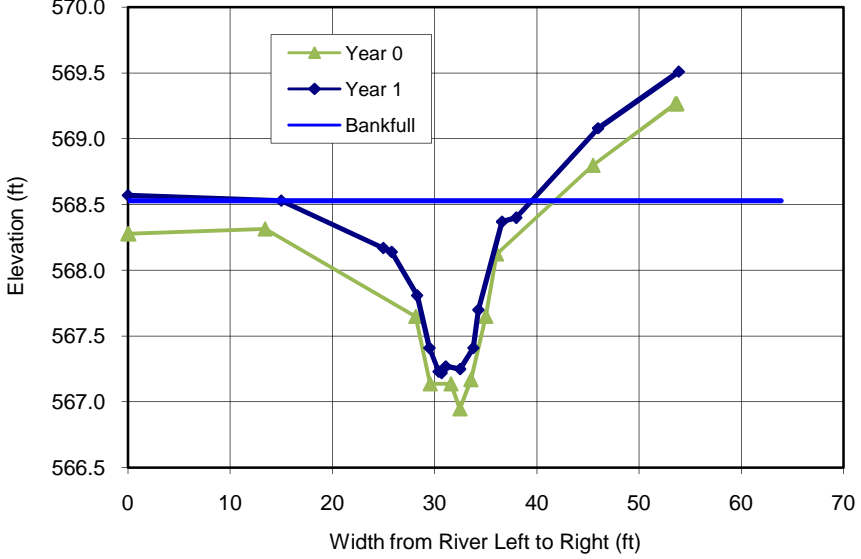
All dimensions in feet.				
Bankfull X-sec area	11.9			
Bankfull Width	24.5			
Bankfull Mean Depth	0.5			
Bankfull Max Depth	1.3			
Width/Depth Ratio	50.8			
Entrenchment Ratio	4.1			
Classification	C			
			Figure	X

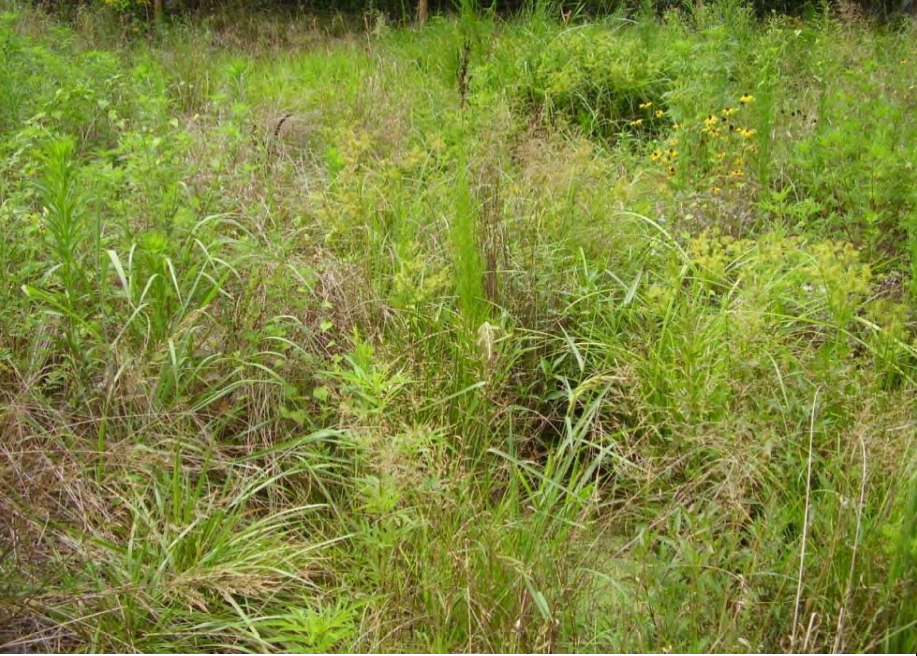
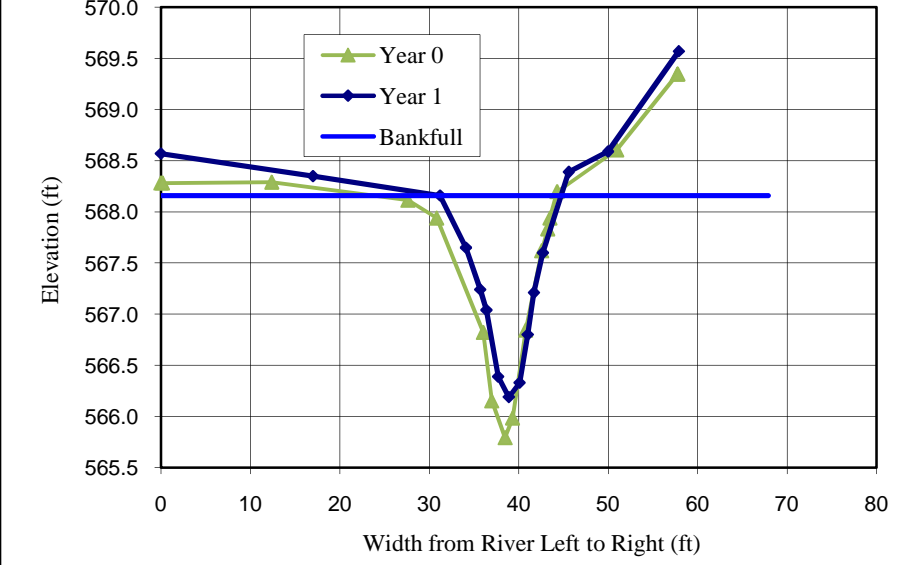
Bankfull X-sec area	12.6				
Bankfull Width	13.6				
Bankfull Mean Depth	0.9				
Bankfull Max Depth	2.0				
Width/Depth Ratio	14.6				
Entrenchment Ratio	7.4				
Classification	n/a				
			CROSS SECTION PLOT - LOOKING DOWNSTREAM
