**UT to South Fork Creek (Stephens)
Stream and Wetland Restoration Project
Alamance County, North Carolina**

**EEP Project #405
Contract #D09079s**

MY-05 Monitoring Report

**Ward Consulting Engineers, P.C.
Firm License Number C-2619
Project Manager: Becky Ward, P.E.
8368 Six Forks Road, Suite 104
Raleigh, NC 27615-5083
Ph: 919-870-0526
Fax: 919-870-5359**

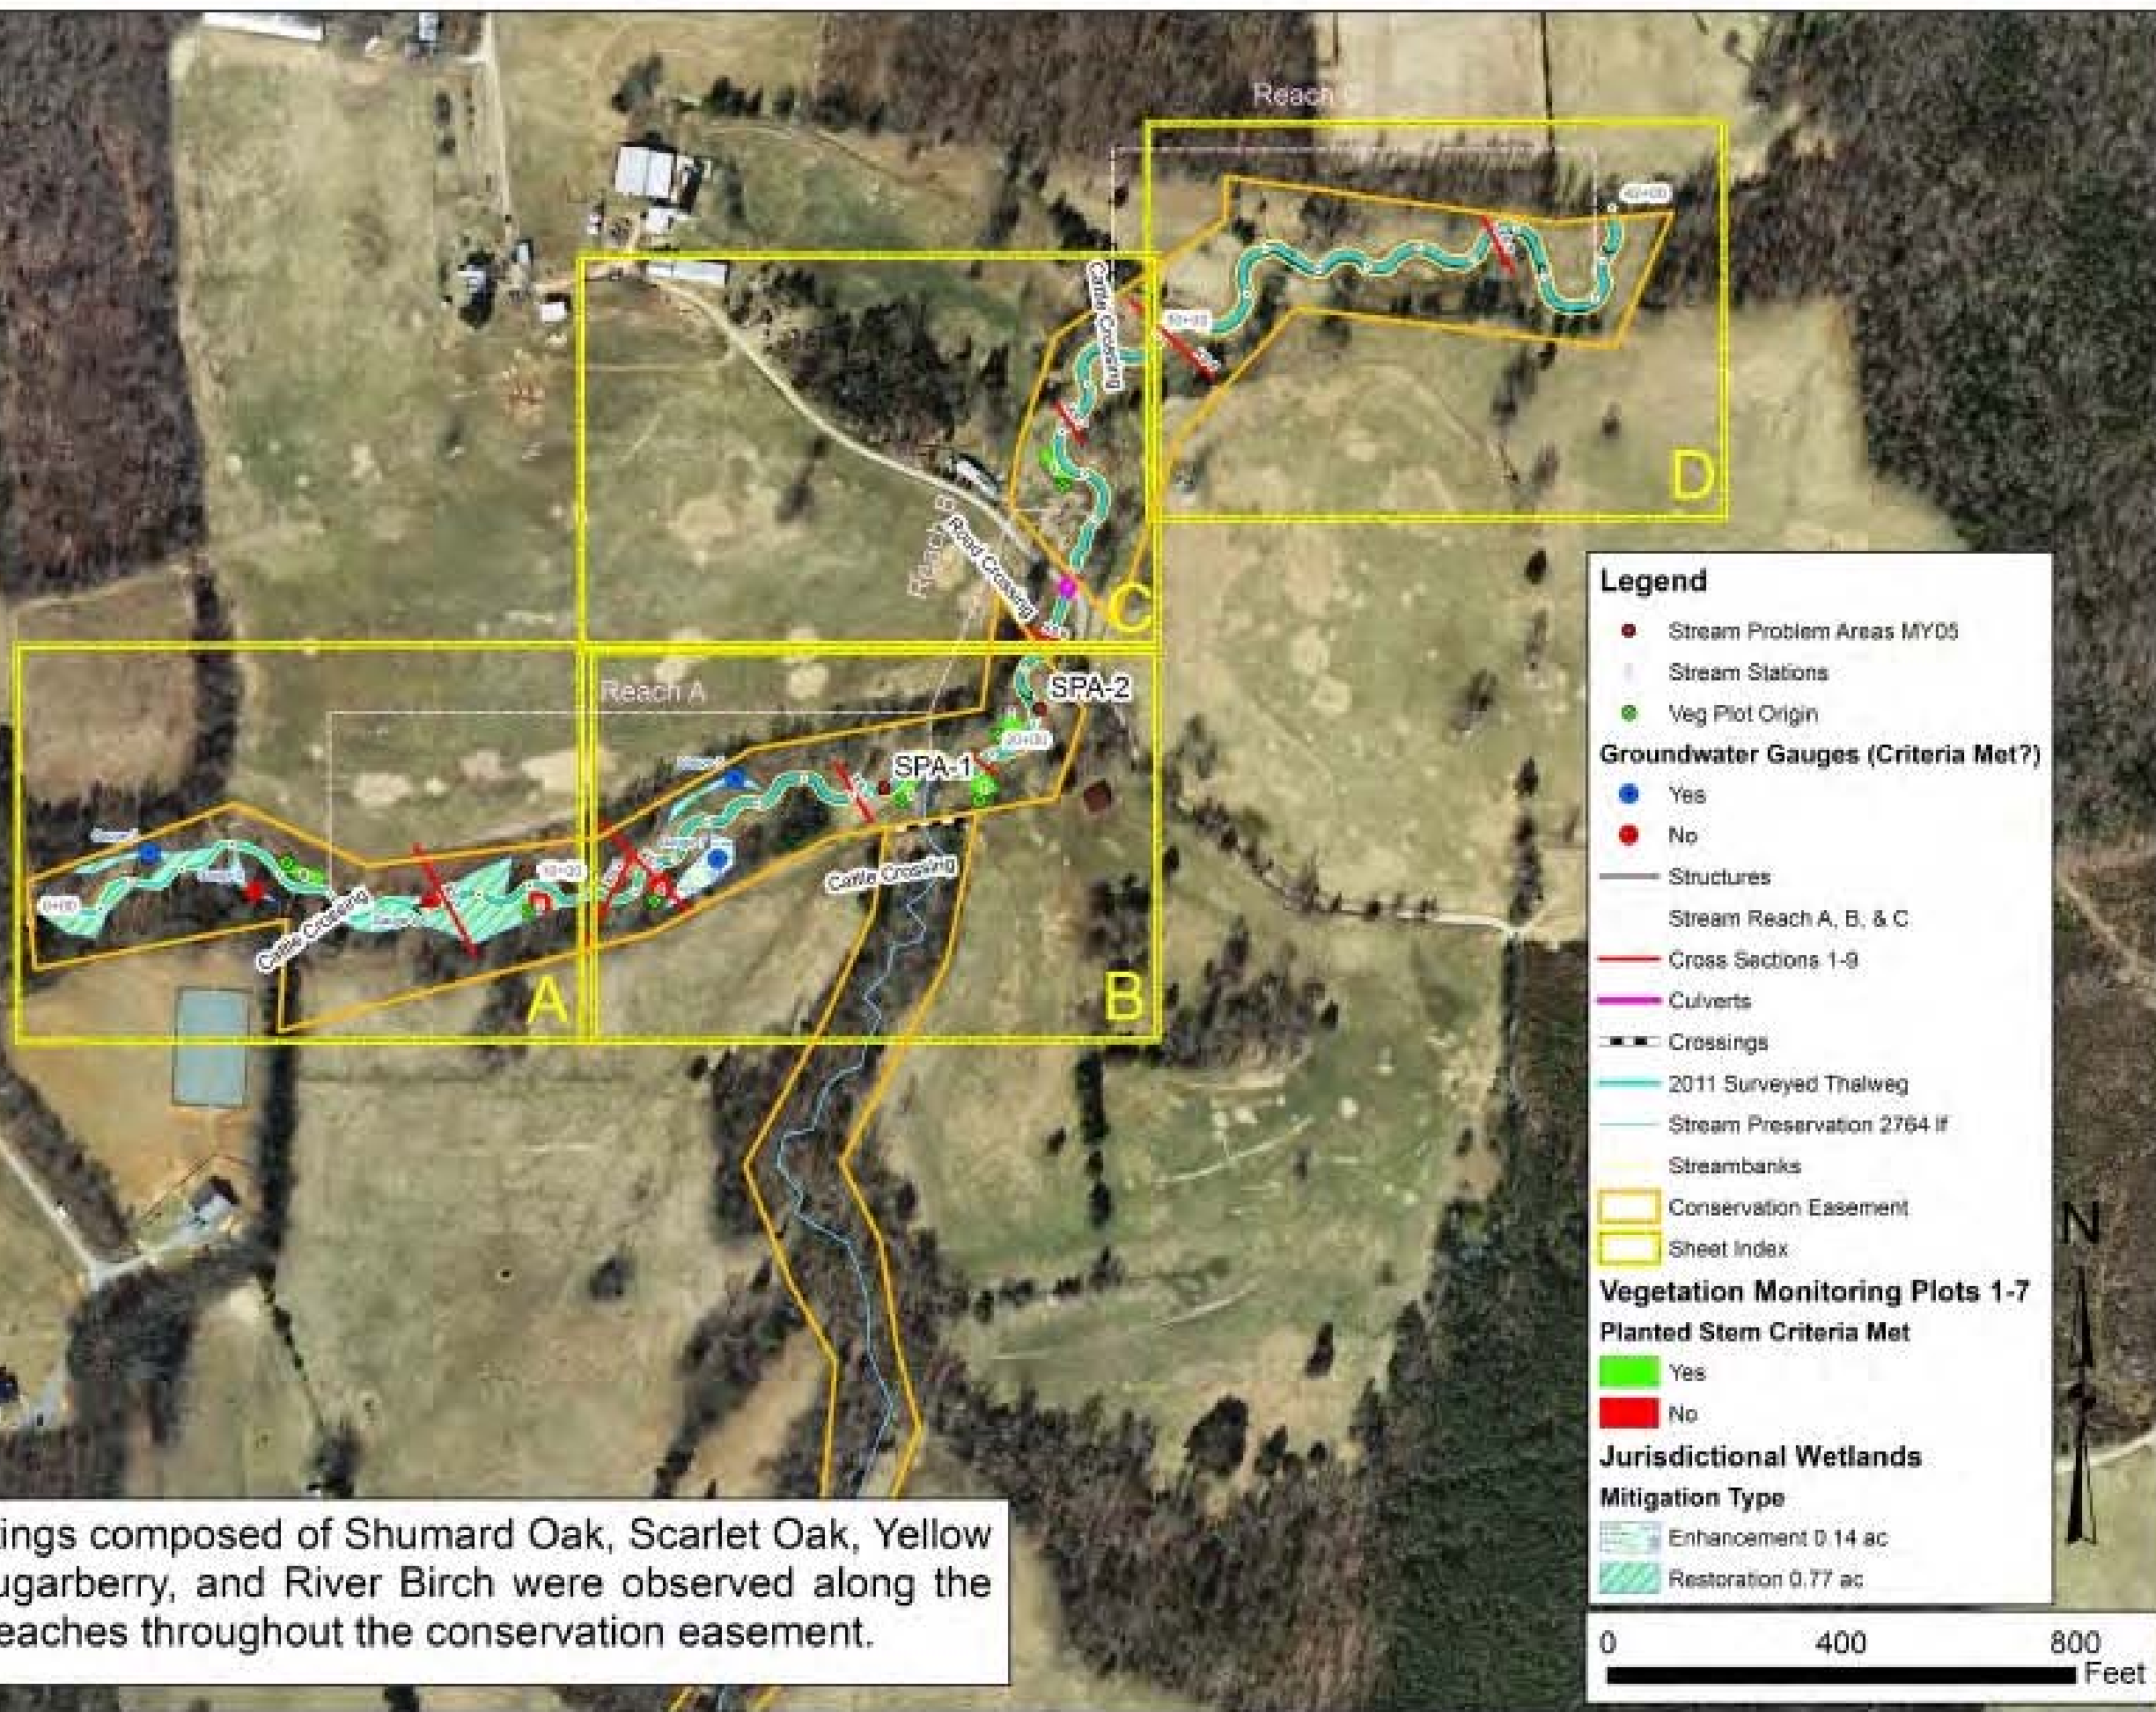
Title:
UT to South Fork Creek
Current Conditions Plan View MY-05
 2010 Aerial Orthophotography
 Source: NC One Maps

The vegetation problem areas consist of some areas with low planted stem densities and some areas of invasive exotic plants. Currently the invasives are in a manageable state and will be monitored to determine if control measures will be necessary. Invasive exotic species observed throughout the conservation easement include, multiflora rose (*Rosa multiflora*), Japanese honeysuckle (*Lonicera japonica*), Japanese stiltgrass (*Microstegium vimineum*), Chinese privet (*Ligustrum sinense*), tree of heaven (*Ailanthus altissima*), tall fescue (*Schedonorus arundinaceus*), and Johnson grass (*Sorghum halapense*). Treatment and removal of targeted invasive exotic plants within the project area was conducted in 2010 and 2011 with the last treatments conducted in October 2011. Multiflora rose, Chinese privet, and tree of heaven were successfully treated and are currently under control. Some living individuals of multiflora rose and Chinese privet were observed scattered mostly within Reach A, B, and C. Many dead individuals as a result of invasive treatment were observed. Some young individuals of tree of heaven were observed in the vicinity to the large dead stands that were treated within Reach C. Japanese honeysuckle was observed scattered throughout Reaches A and B. Japanese stiltgrass is ubiquitous throughout Reach A and B. Tall fescue is located throughout the easement in areas directly adjacent to the pastureland, which historically was pastureland. Johnson grass is dominant along the conservation easement boundary next to the cattle crossing at station 29+00. Although these species have been given different ranks of severity, the functionality of the project is not expected to be impaired significantly. It is likely that all of these species were present in and adjacent to the conservation easement prior to construction. Supplemental planting of the conservation easement was completed on February 2, 2012. Specific areas of the conservation easement were planted with 850 1 gallon containerized trees (Appendix C).

Only one structure throughout the entire stream has been reported as an issue on the Current Condition Plan. The cause of the issue is minor piping at rock cross vane at station 20+80, in monitoring Reach B. This cross vane, although not maintaining its intended water surface elevation, is otherwise functioning. Bank erosion problems are only evident in 1% of Reach A. Previously reported bank erosion areas have apparently stabilized as woody stem vegetation is developing on these banks. No further erosion was observed in these previous bank erosion areas. The current bank erosion contributing to the 1% exists sporadically throughout Reaches A and B, particularly in the vicinity of cross sections 1 and 4, and is attributed to cattle that have entered into the conservation easement. This cattle access issue is considered limited and should continue to be monitored for further signs of encroachment.
