**UT to South Fork Creek (Stephens)
Stream and Wetland Restoration Project
Alamance County, North Carolina
EEP Project #405
Contract #D09079s**

MY-06 Monitoring Report

**UT to South Fork Creek
Stream and Wetland Restoration
EEP Project #405
Liberty, North Carolina
Alamance County**

**MY-06 Monitoring Report
Prepared By:**

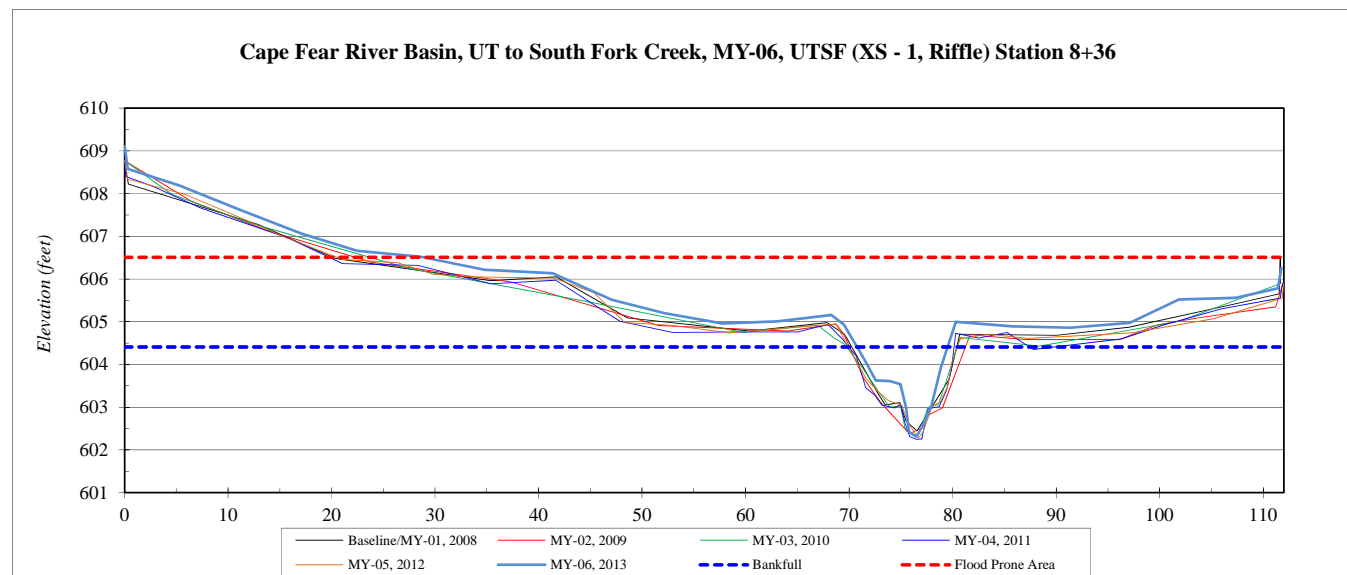
River Basin:	Cape Fear
Watershed:	UT to South Fork Creek, MY-06
XS ID	UTSF (XS - 1, Riffle) Station 8+36
Drainage Area (sq mi):	1.33
Date:	12/13/2013
Field Crew:	T. Seelinger, M. Koss

SUMMARY DATA	
Bankfull Elevation:	604.4
Bankfull Cross-Sectional Area:	8.8
Bankfull Width:	8.7
Flood Prone Area Elevation:	606.5
Flood Prone Width:	>90
Max Depth at Bankfull:	2.1
Mean Depth at Bankfull:	1.0
W / D Ratio:	8.7
Entrenchment Ratio:	10.8
Bank Height Ratio:	1.0

Stream Type E4

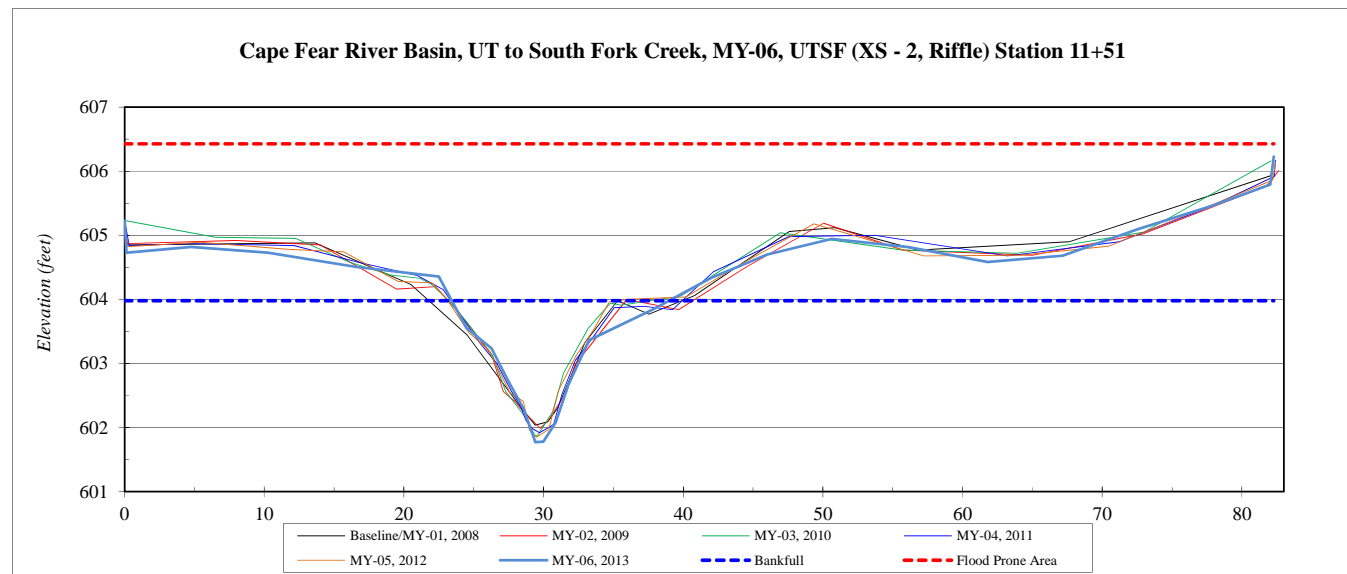
River Basin:	Cape Fear
Watershed:	UT to South Fork Creek, MY-06
XS ID	UTSF (XS - 2, Riffle) Station 11+51
Drainage Area (sq mi):	1.33
Date:	12/13/2013
Field Crew:	T. Seelinger, M. Koss

SUMMARY DATA	
Bankfull Elevation:	604.0
Bankfull Cross-Sectional Area:	15.1
Bankfull Width:	15.1
Flood Prone Area Elevation:	606.2
Flood Prone Width:	>90
Max Depth at Bankfull:	2.2
Mean Depth at Bankfull:	1.0
W / D Ratio:	15.1
Entrenchment Ratio:	5.5
Bank Height Ratio:	1.0

Stream Type E4

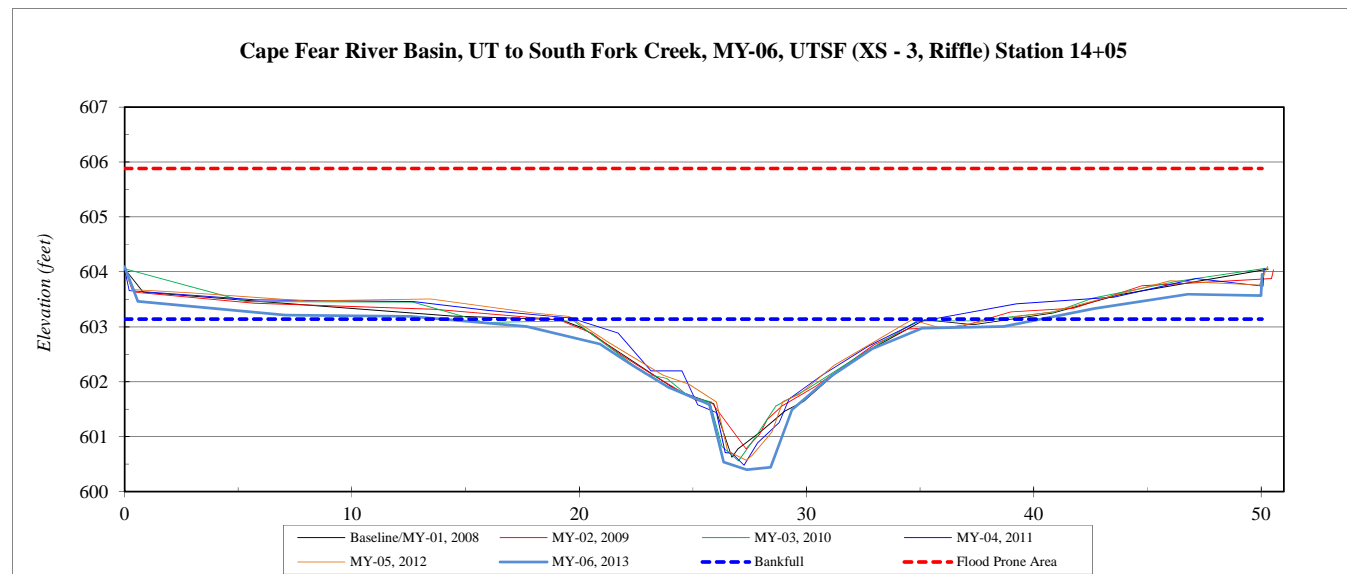
River Basin:	Cape Fear
Watershed:	UT to South Fork Creek, MY-06
XS ID	UTSF (XS - 3, Riffle) Station 14+05
Drainage Area (sq mi):	1.33
Date:	12/13/2013
Field Crew:	T. Seelinger, M. Koss

SUMMARY DATA	
Bankfull Elevation:	603.1
Bankfull Cross-Sectional Area:	20.7
Bankfull Width:	17.4
Flood Prone Area Elevation:	605.9
Flood Prone Width:	>90
Max Depth at Bankfull:	2.7
Mean Depth at Bankfull:	1.2
W / D Ratio:	14.6
Entrenchment Ratio:	2.9
Bank Height Ratio:	1.0

Stream Type E4

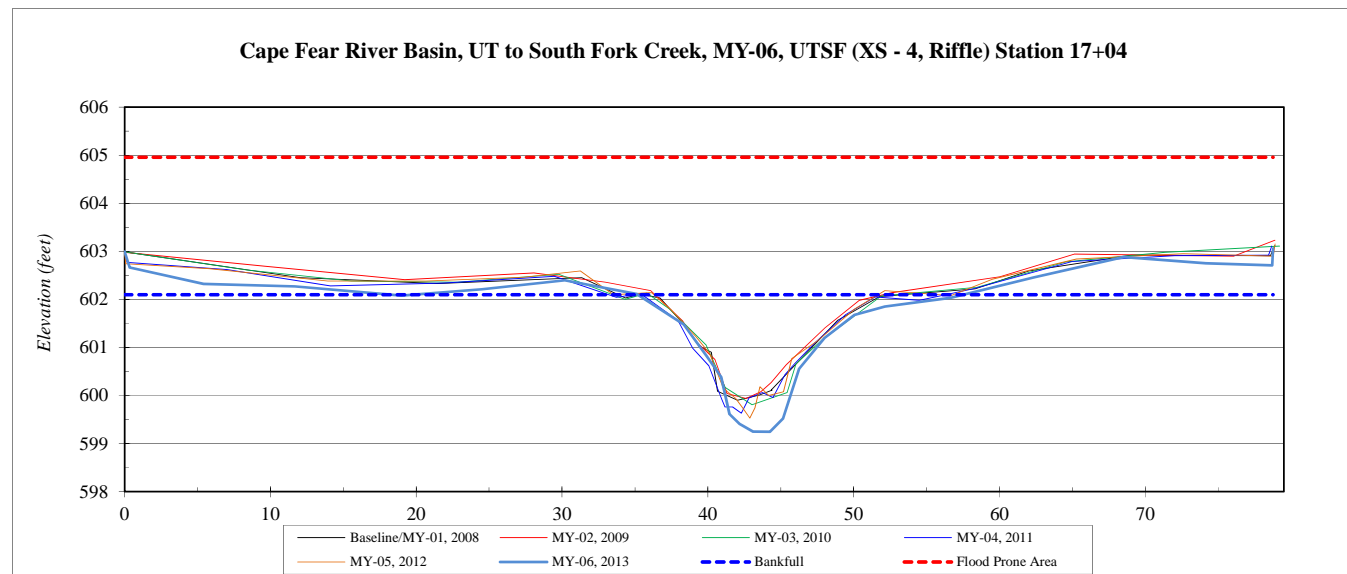
River Basin:	Cape Fear
Watershed:	UT to South Fork Creek, MY-06
XS ID	UTSF (XS - 4, Riffle) Station 17+04
Drainage Area (sq mi):	1.33
Date:	12/13/2013
Field Crew:	T. Seelinger, M. Koss

SUMMARY DATA	
Bankfull Elevation:	602.1
Bankfull Cross-Sectional Area:	24.9
Bankfull Width:	25.3
Flood Prone Area Elevation:	605.0
Flood Prone Width:	>90
Max Depth at Bankfull:	2.9
Mean Depth at Bankfull:	1.0
W / D Ratio:	25.8
Entrenchment Ratio:	3.1
Bank Height Ratio:	1.0

Stream Type E4

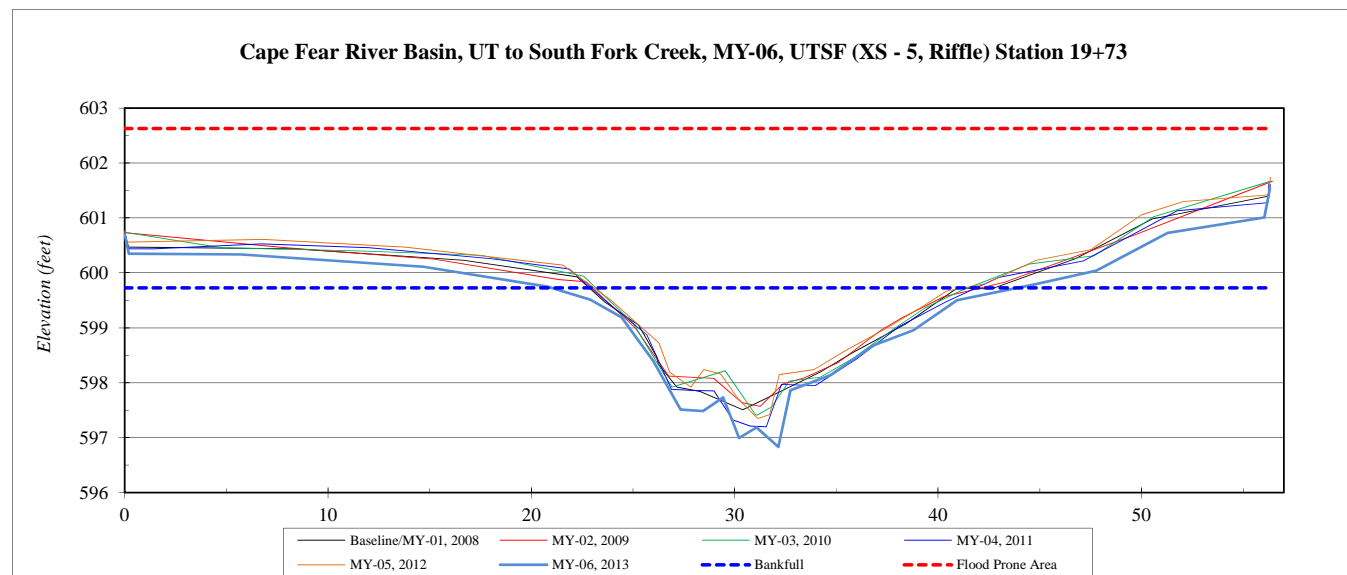
River Basin:	Cape Fear
Watershed:	UT to South Fork Creek, MY-06
XS ID	UTSF (XS - 5, Riffle) Station 19+73
Drainage Area (sq mi):	1.33
Date:	12/13/2013
Field Crew:	T. Seelinger, M. Koss

SUMMARY DATA	
Bankfull Elevation:	599.7
Bankfull Cross-Sectional Area:	27.0
Bankfull Width:	23.0
Flood Prone Area Elevation:	602.6
Flood Prone Width:	>90
Max Depth at Bankfull:	2.9
Mean Depth at Bankfull:	1.2
W / D Ratio:	19.5
Entrenchment Ratio:	2.5
Bank Height Ratio:	1.0

Stream Type E4

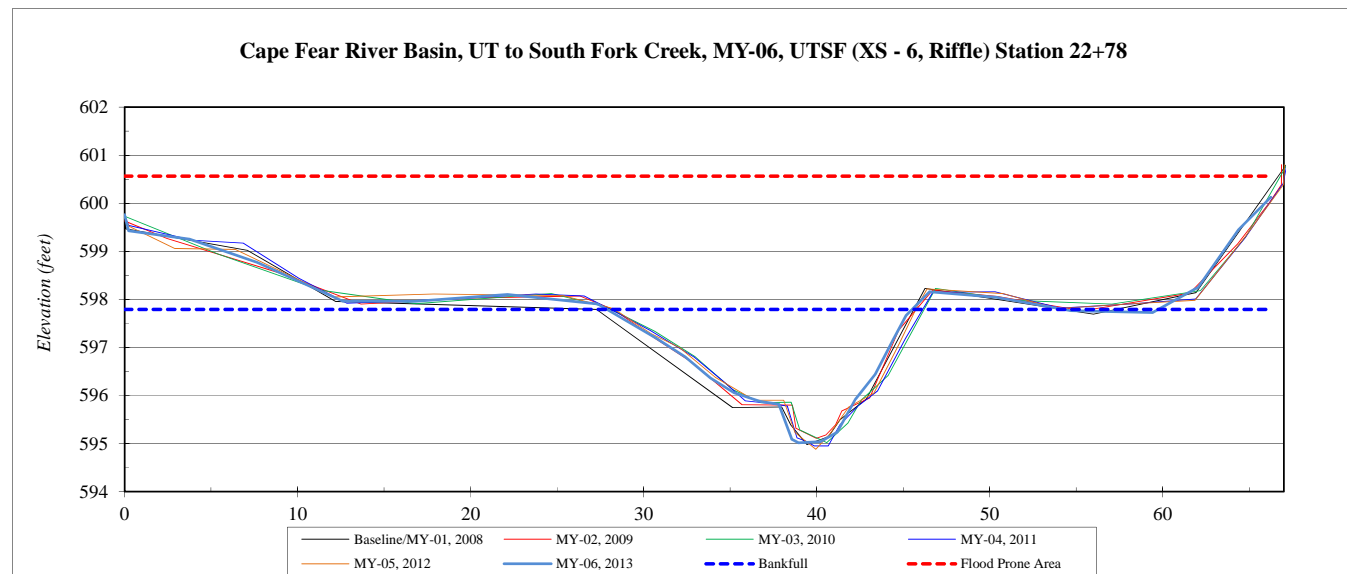
River Basin:	Cape Fear
Watershed:	UT to South Fork Creek, MY-06
XS ID	UTSF (XS - 6, Riffle) Station 22+78
Drainage Area (sq mi):	1.33
Date:	12/13/2013
Field Crew:	T. Seelinger, M. Koss

SUMMARY DATA	
Bankfull Elevation:	597.8
Bankfull Cross-Sectional Area:	25.3
Bankfull Width:	17.6
Flood Prone Area Elevation:	600.6
Flood Prone Width:	>90
Max Depth at Bankfull:	2.8
Mean Depth at Bankfull:	1.4
W / D Ratio:	12.3
Entrenchment Ratio:	3.8
Bank Height Ratio:	1.0

Stream Type E4

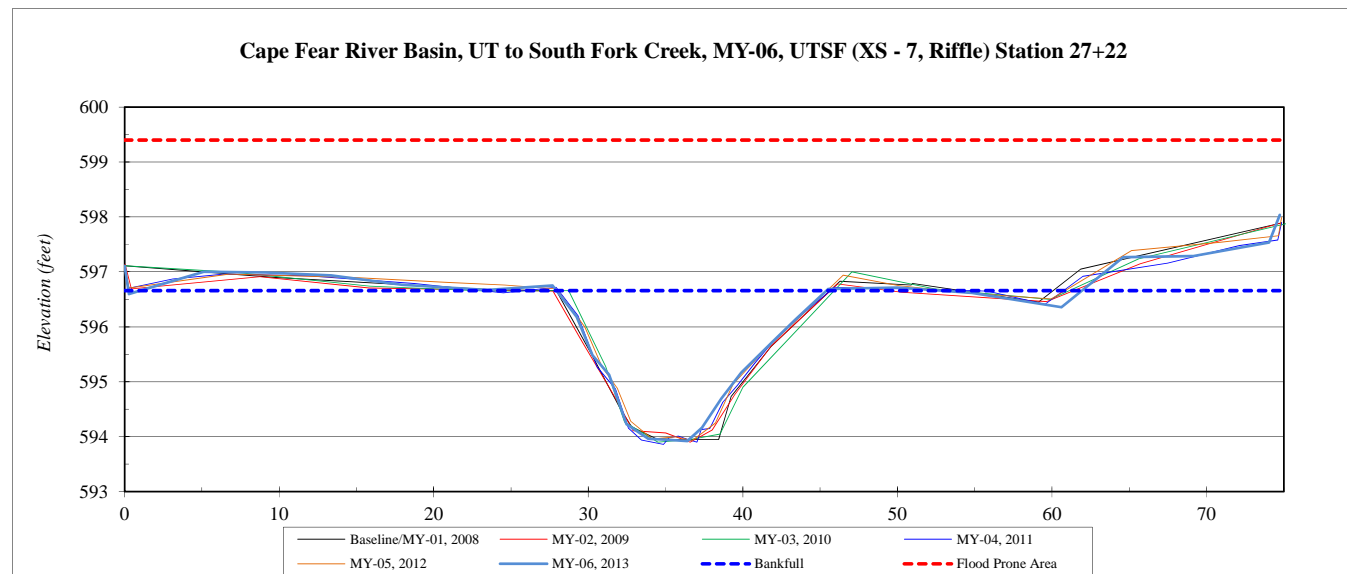
River Basin:	Cape Fear
Watershed:	UT to South Fork Creek, MY-06
XS ID	UTSF (XS - 7, Riffle) Station 27+22
Drainage Area (sq mi):	1.33
Date:	12/13/2013
Field Crew:	T. Seelinger, M. Koss

SUMMARY DATA	
Bankfull Elevation:	596.7
Bankfull Cross-Sectional Area:	22.7
Bankfull Width:	15.8
Flood Prone Area Elevation:	599.4
Flood Prone Width:	>90
Max Depth at Bankfull:	2.7
Mean Depth at Bankfull:	1.4
W / D Ratio:	11.0
Entrenchment Ratio:	4.7
Bank Height Ratio:	1.0

Stream Type E4

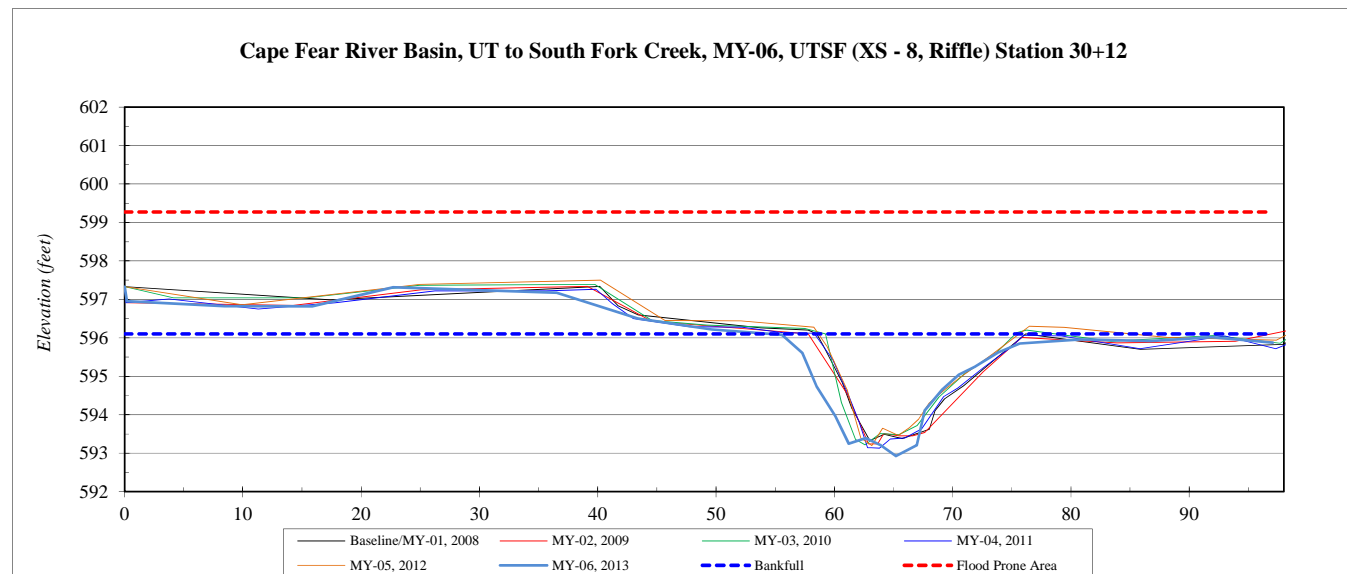
River Basin:	Cape Fear
Watershed:	UT to South Fork Creek, MY-06
XS ID	UTSF (XS - 8, Riffle) Station 30+12
Drainage Area (sq mi):	1.33
Date:	12/13/2013
Field Crew:	T. Seelinger, M. Koss

SUMMARY DATA	
Bankfull Elevation:	596.1
Bankfull Cross-Sectional Area:	27.1
Bankfull Width:	18.5
Flood Prone Area Elevation:	599.3
Flood Prone Width:	>90
Max Depth at Bankfull:	3.2
Mean Depth at Bankfull:	1.5
W / D Ratio:	12.7
Entrenchment Ratio:	5.2
Bank Height Ratio:	1.0

Stream Type E4

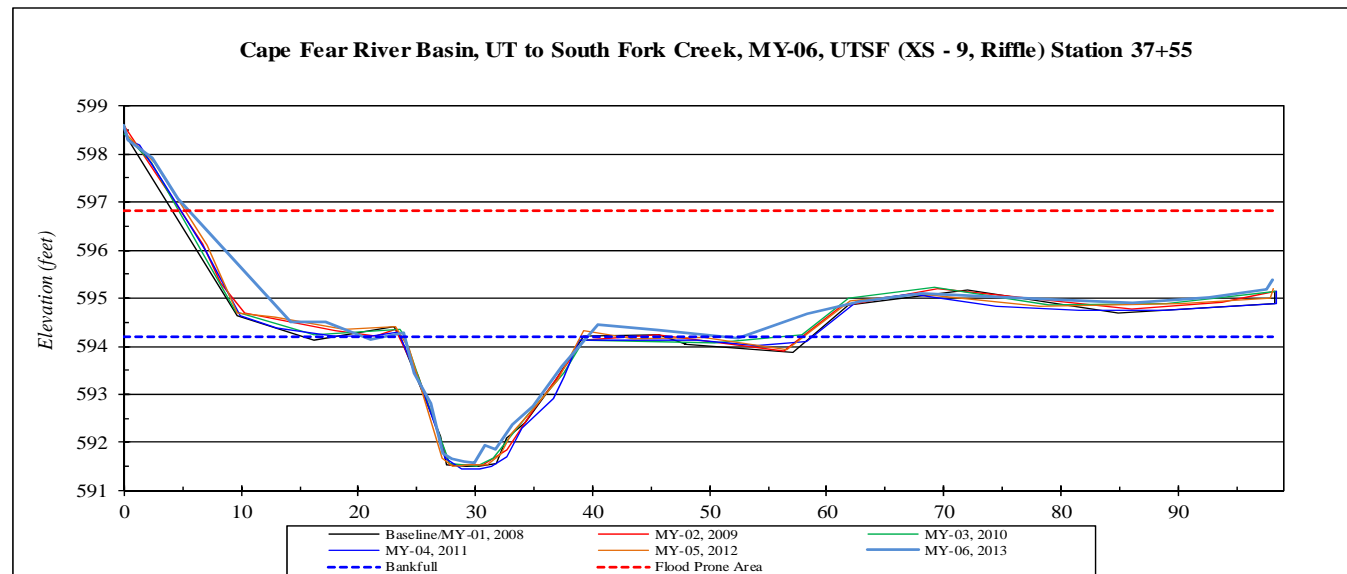
River Basin:	Cape Fear
Watershed:	UT to South Fork Creek, MY-06
XS ID	UTSF (XS - 9, Riffle) Station 37+55
Drainage Area (sq mi):	1.33
Date:	12/13/2013
Field Crew:	T. Seelinger, M. Koss

SUMMARY DATA	
Bankfull Elevation:	594.2
Bankfull Cross-Sectional Area:	21.1
Bankfull Width:	14.7
Flood Prone Area Elevation:	596.8
Flood Prone Width:	>90
Max Depth at Bankfull:	2.6
Mean Depth at Bankfull:	1.4
W / D Ratio:	10.3
Entrenchment Ratio:	6.0
Bank Height Ratio:	1.0

Stream Type E4

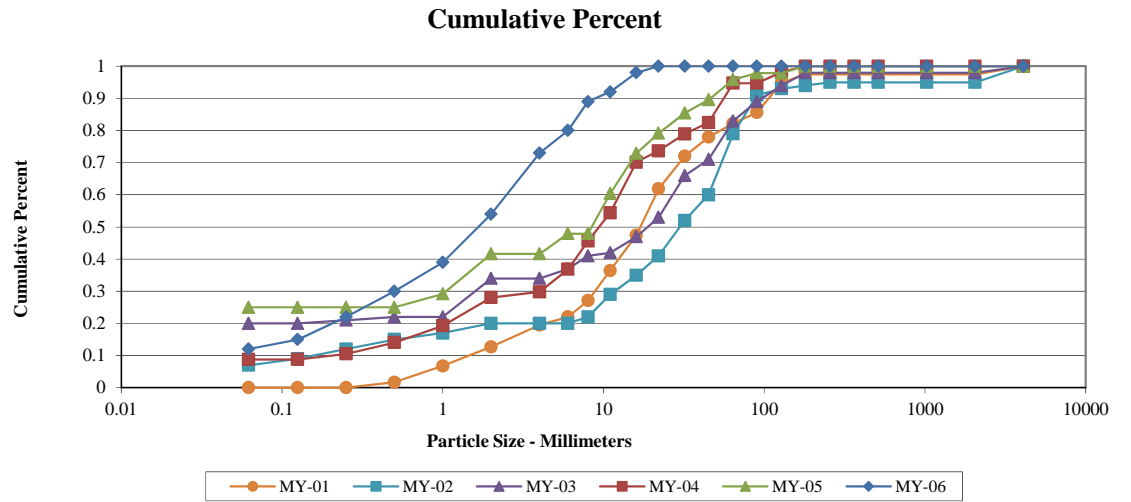
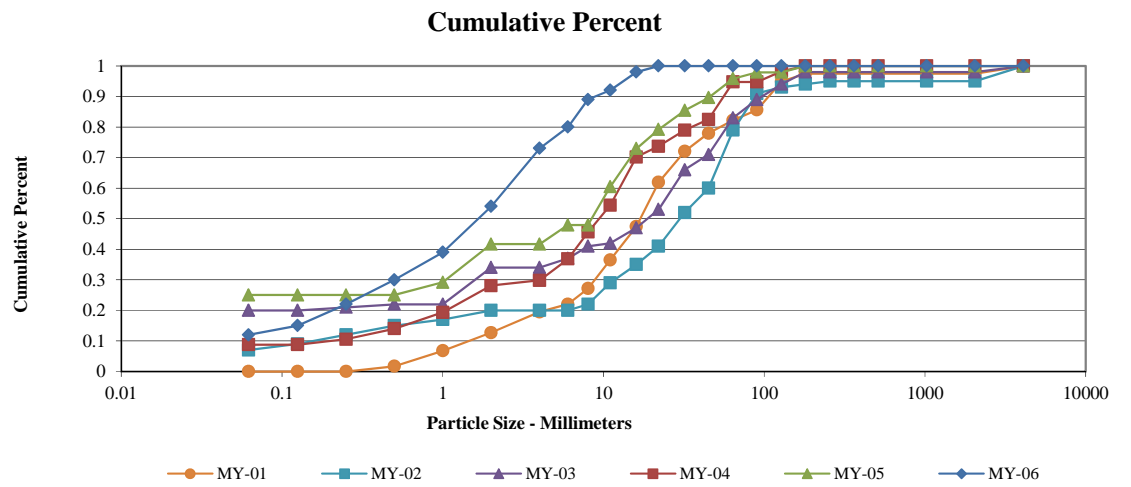
Cross-Section 9 Riffle - UTSF MY-06					
Particle	Millimeter	Material	Count	Item %	Cum %
Silt/Clay	< 0.062	S/C	12	12%	12%
Very Fine	.062 - .125	S	3	3%	15%
Fine	.125 - .25	A	7	7%	22%
Medium	.25 - .50	N	8	8%	30%
Coarse	.50 - 1	D	9	9%	39%
Very Coarse	1 - 2	S	15	15%	54%
Very Fine	2 - 4	G	19	19%	73%
Fine	4 - 5.7		7	7%	80%
Fine	5.7 - 8	R	9	9%	89%
Medium	8 - 11.3	A	3	3%	92%
Medium	11.3 - 16	V	6	6%	98%
Coarse	16 - 22.6	E	2	2%	100%
Coarse	22.6 - 32	L		0%	100%
Very Coarse	32 - 45	S		0%	100%
Very Coarse	45 - 64			0%	100%
Small	64 - 90	C		0%	100%
Small	90 - 128	O		0%	100%
Large	128 - 180	B		0%	100%
Large	180 - 256	L		0%	100%
Small	256 - 362	B		0%	100%
Small	362 - 512	L		0%	100%
Medium	512 - 1024	D		0%	100%
Lrg- Very Lrg	1024 - 2048	R		0%	100%
Bedrock	>2048	BDRK		0%	100%
Total			100	100%	100%
Size (mm)		Type			
D50	1.7	silt/clay	12%		
D84	6.8	sand	42%		
D95	13	gravel	46%		
		cobble	0%
