**UT TO SOUTH FORK
FINAL MONITORING REPORT
YEAR 1 OF 5
2006**

**EEP Project # 435
Alamance County, North Carolina**

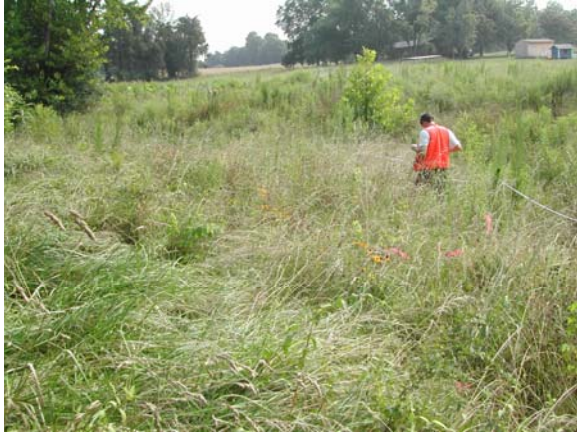
There is good herbaceous vegetation growth along all of the monitored stream reach. In many areas, fescue was prevalent, preventing the establishment of the planted bare root trees. This was particularly noted in Vegetation Plot (VP) #2 where no bare roots were noted. In VP #4, only a single bare root of green ashe was located. In VP #9 and #10, fescue dominates portions of the plot, but not all of the plots. The vegetative plots and problem areas are shown on the plan view sheets in Appendix C.

Photo 1: Fescue dominates left side of plot

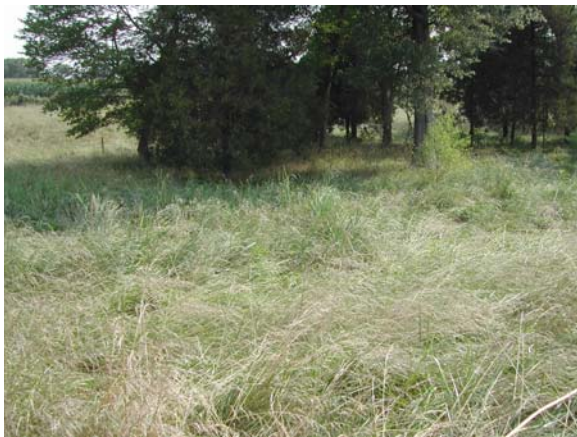
The planted bare root stems in Reach 1 are a concern. No stems were located in VP #2, one stem in VP #4 and few stems were located in VP #1, 3, and 5. The number of stems/acre in VP #1, 2, 4 and 5 are already below the Year 5 goal of 260 stems/acre. VP #3 is a “watch” area as the stem/acre was 280. It was noted that outside of the vegetation plots for Reach 1, as you travel downstream, and VP# 5 in Reach 2, the number of bare root stems increased substantially.

Photo 2: Lack of Bare Roots along Reach 1

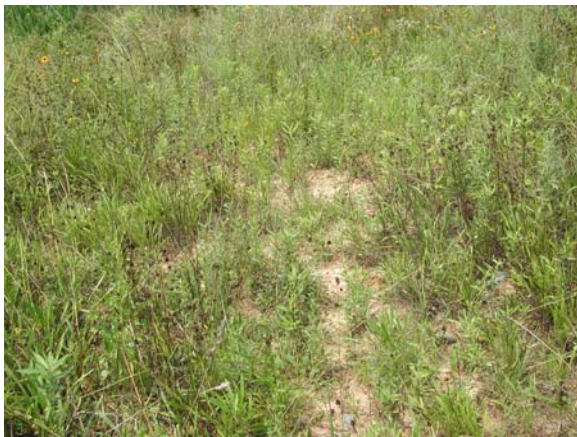
Table VI. Vegetative Problem Areas			
Feature/Issue	Station # / Range	Probable Cause	Photo #
Bare Flood Plain	13+20 - Reach 2 Right Bank	Seed wash and compact ground	3
Invasive/Exotic Populations		species migration from upland off of property	4

Photo 3: Bare area in floodplain

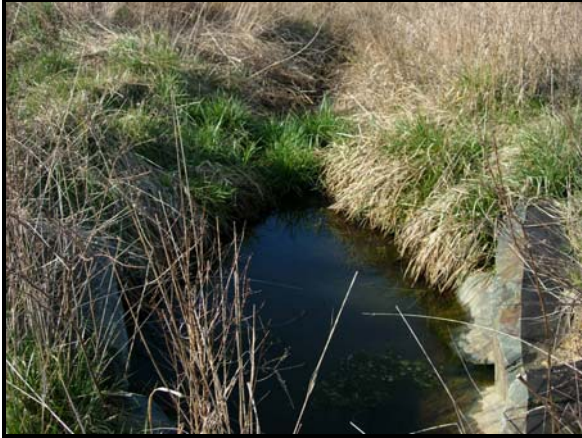
REACH 1

Aggradation below first cross-vane

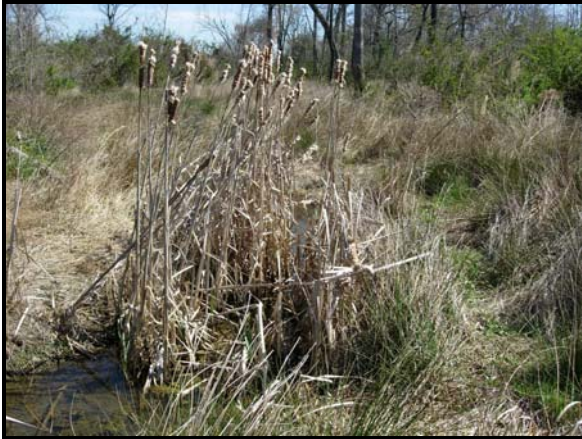
REACH 2

Cattails growing in channel
