**UT TO SOUTH FORK  
FINAL MONITORING REPORT  
YEAR 2 OF 5  
2007**

**EEP Project # 435  
Alamance County, North Carolina**

## Executive Summary

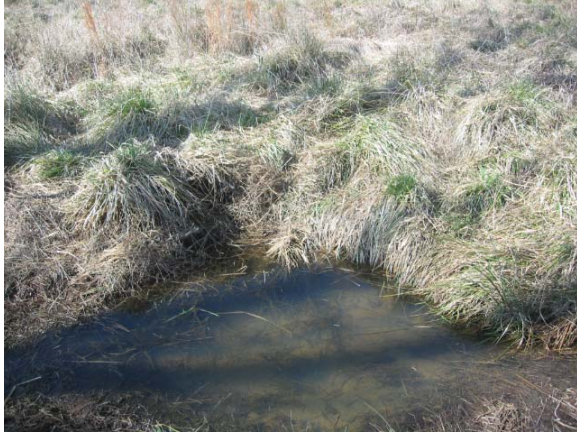
Photo 1: Representative bank erosion problem area (17+60 along plan view).

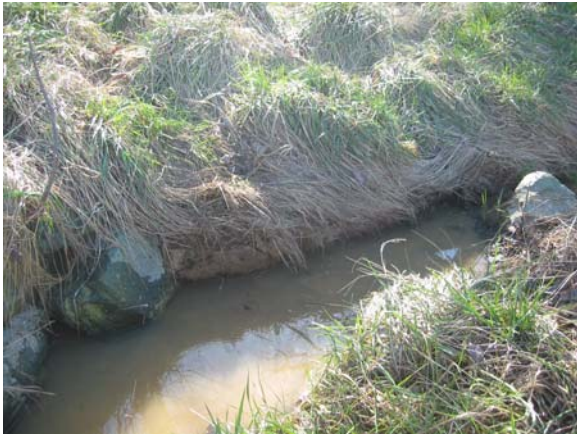
Photo 2: Bank Undercut/Erosion (Jan 31 - IMG 5278 – Pts 837) (Station XX along plan view).

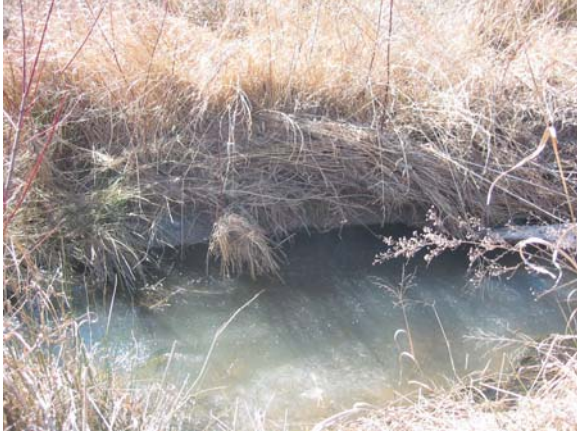
Photo 1: Bank Erosion (Station 17+55 along plan view).

Aggradation (grass)	16+54 16+82	Channel possibly built too wide, naturally narrowing.	
Bank Erosion (left bank)	17+49 17+54	Possibly unstable soil characteristics and/or lack of vegetation at a point of moderate shear stress (outside of slight meander). Channel may be naturally narrowing.	
Aggradation (cattails)	18+20 18+31	Channel possibly built too wide, naturally narrowing.	
Aggradation (cattails)	18+51 18+76	Channel possibly built too wide, naturally narrowing.	
Crossvane	18+56	Missing center rock.	
Aggradation (cattails)	19+27 19+32	Channel possibly built too wide, naturally narrowing.	
Aggradation (cattails)	19+43 19+55	Channel possibly built too wide, naturally narrowing.	
Crossvane	20+22	Piping around structure.	Photo 4

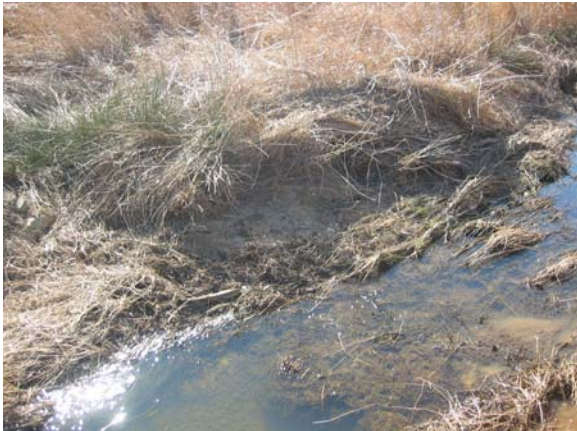
Photo 2: Bank Undercut/Erosion (Station 16+10 along plan view).

Rootwad (severe)	12+99	Exposed, installed too high, bank failures caving in and around structure.	Photo 5
Aggradation (cattails)	13+29 13+49	Channel possibly built too wide, naturally narrowing.	
Aggradation (grass)	13+87 14+02	Riffle narrowing, channel possibly built too wide, naturally narrowing.	
Rootwad	14+18	Some evidence of undercutting, possibly installed too high.	
Aggradation (grass)	14+24 14+44	Channel possibly built too wide, naturally narrowing.	
Rootwad	14+98	Bank failure around structure.	
Bank Erosion (right bank)	14+99 15+03	Possible improper installation of rootwads causing bank to cave in around structures, however area is healing over with new vegetation.	
Rootwad	15+03	Bank failure around structure.	
Aggradation (cattails)	15+38 15+47	Channel possibly built too wide, naturally narrowing.	
Aggradation (grass)	16+02 16+36	Channel possibly built too wide, naturally narrowing.	
Bank Erosion (left bank)	16+03 16+10	Lack of protective vegetation and/or soil stability characteristics.	Photo 3

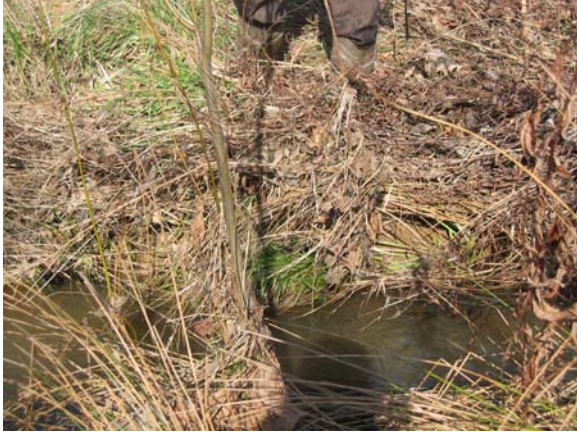
Photo 1: Bank Erosion (Station 11+30 along plan view).

<b>UT to South Fork, Reach 3</b>			
<b>Feature Issue</b>	<b>Station numbers</b>	<b>Suspected Cause</b>	<b>Photo number</b>
<b>Aggradation (cattails)</b>	10+85	Channel possibly built too wide, naturally narrowing.	
	11+14		
<b>Bank Erosion (Right Bank)</b>	11+33	Soil type or lack of vegetation. Perhaps built too wide and is narrowing.	
	11+37		
<b>Aggradation (cattails)</b>	11+85	Channel possibly built too wide, naturally narrowing.	Photo 2
	11+97		
<b>Aggradation (grass)</b>	12+14	Channel possibly built too wide, naturally narrowing.	
	12+34		
<b>Aggradation (grass)</b>	12+66	Channel possibly built too wide, naturally narrowing.	Photo 1
	12+87		
<b>Aggradation (cattails)</b>	13+30	Channel possibly built too wide, naturally narrowing.	
	13+33		
<b>Aggradation (grass)</b>	13+56	Channel possibly built too wide, naturally narrowing.	
	13+60		
<b>Aggradation (cattails)</b>	13+79	Channel possibly built too wide, naturally narrowing.

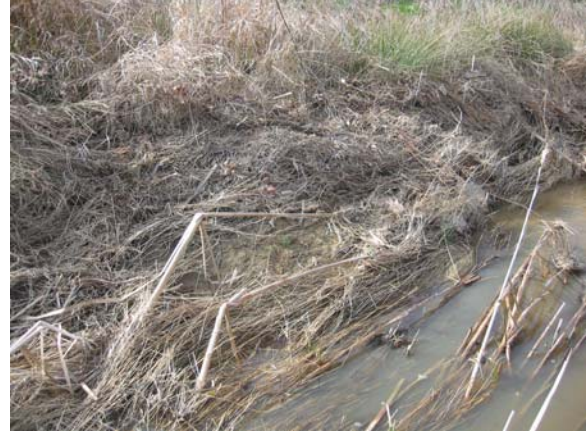
Photo 3. Bank Erosion (Station 16+10) upstream of J-hook

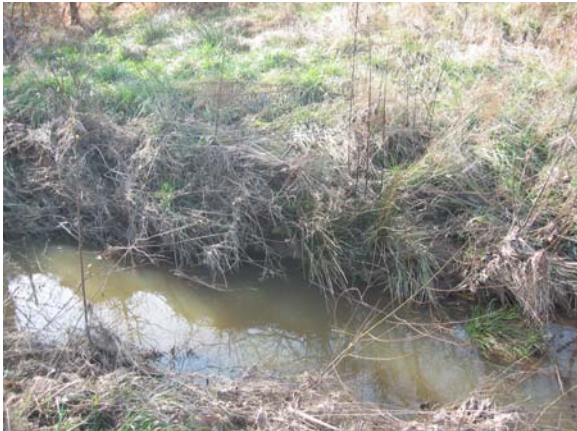
Photo 2: Bank Undercut/Erosion (Station 11+65 along plan view).

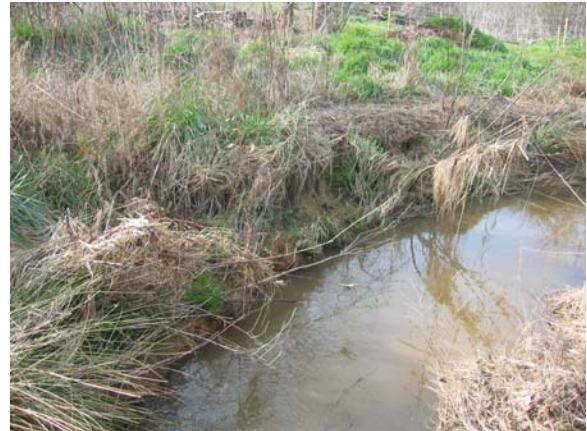
Photo 4. Bank Erosion (Station 19+15 along plan view)

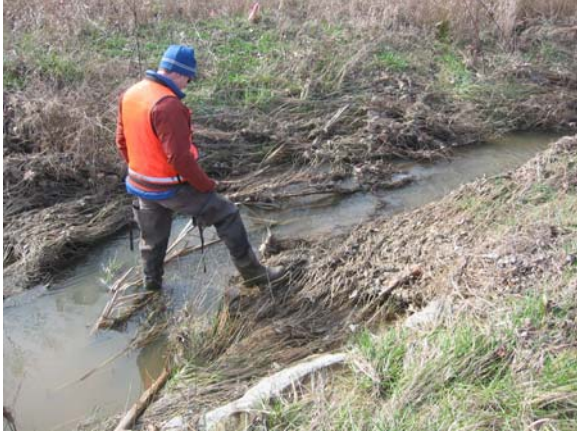
Photo 1: Representative grass aggradation problem area (Station 12+66 along plan view).
