**UT TO SOUTH FORK
FINAL MONITORING REPORT
YEAR 3
2008**

EEP Project # 435
Alamance County, North Carolina

Original Design Firm:
ARCADIS G&M of North Carolina, Inc.
801 Corporate Center Drive, Suite 300
Raleigh, NC 27607

Monitoring Firm:

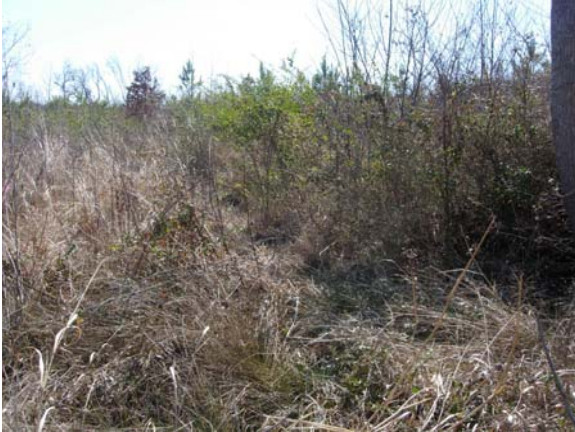
Photo 1: Invasive Chinese privet (*Ligustrum sinense*) problem area. Privet trees in this photo are those with green leaves (2-28-2008).

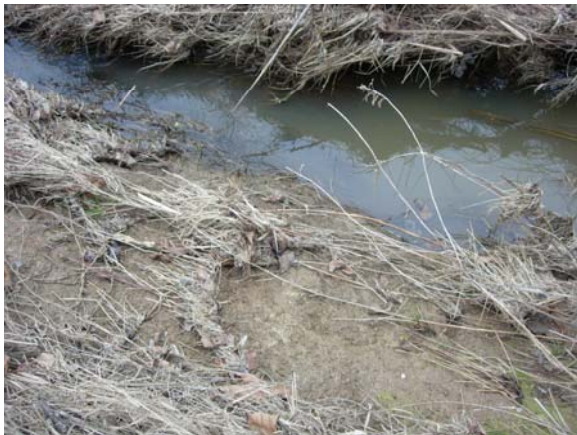
Photo 3. Representative bare bank problem area (Station No. 16+40; view across channel from left bank on 3-18-2008). Bare bank is on left bank (i.e., nearest in photo).

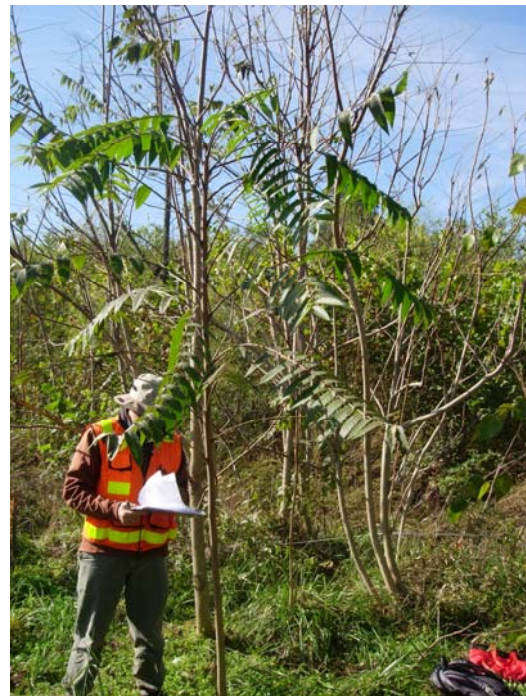
Photo 4: Invasive tree of heaven (*Ailanthus altissima*) problem area (located within vegetation plot 11; photo taken on 10-22-2008).

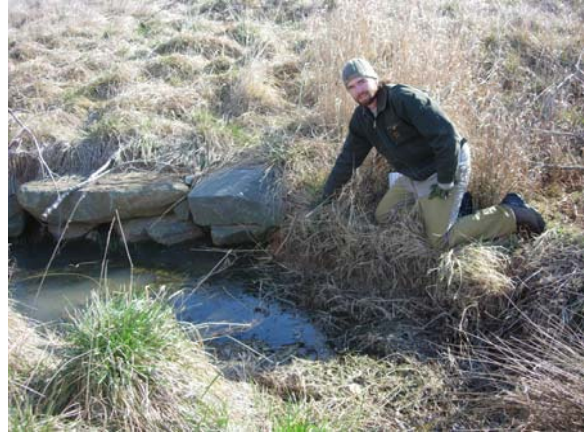
Photo 2: Representative bank erosion problem area (Station No. 18+26 – 18+31.5; view of left bank; 2-28-2008).

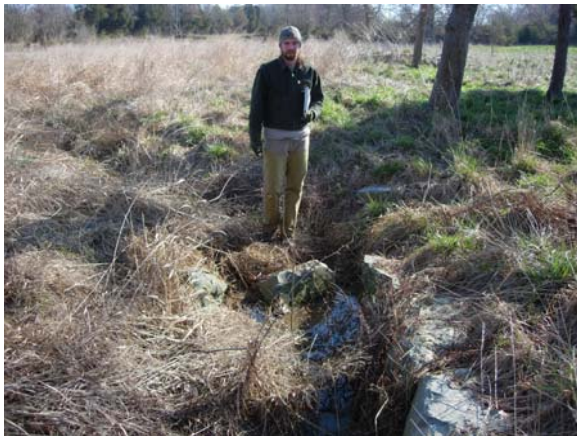
Photo 3: Representative problem J-hook (Station No. 14+92; view upstream; 2-28-2008).

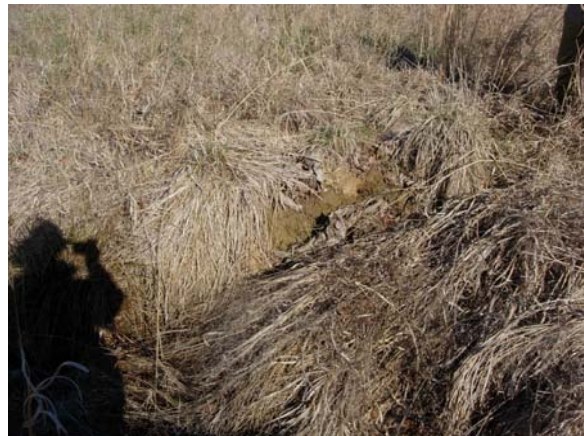
Photo 4: Representative problem Root Wad (Station No. 15+55; view of erosion around footing on right bank; 2-28-2008).

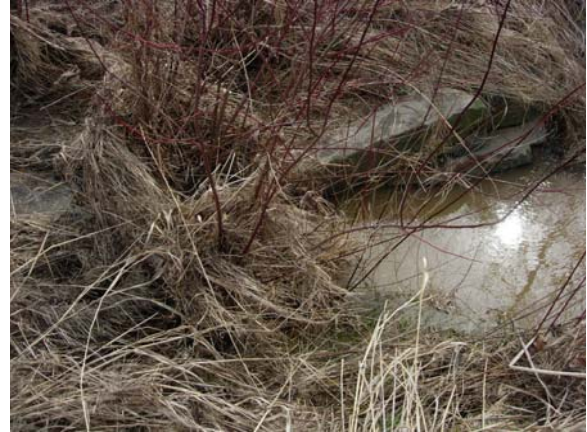
Photo 2: Representative problem cross vane (Station No. 20+34; view of left bank on 3-11-2008). Note current coming out of bank on downstream of left arm (in view), an indication of water piping around the arm.

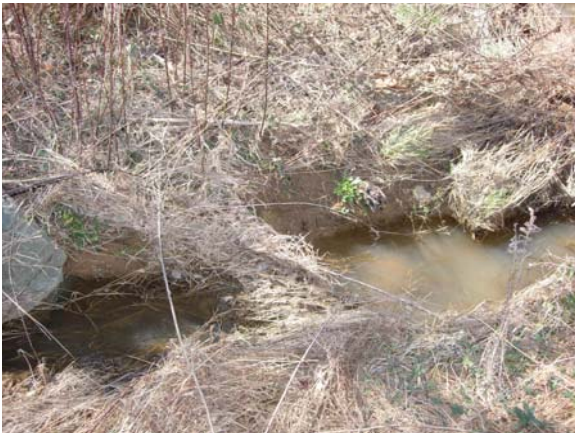
Photo 3: Representative bank erosion problem area (Station No. 10+78; facing left bank on 3-06-2008).

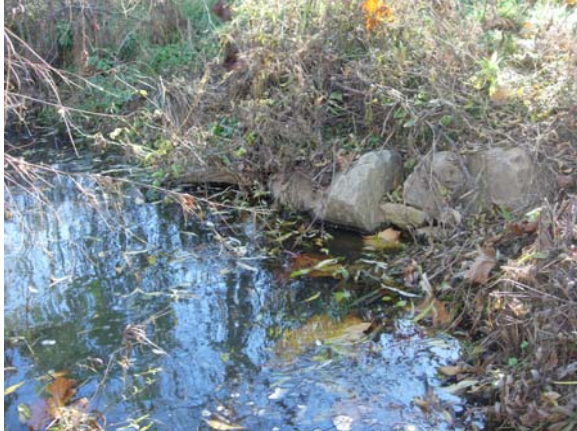
Photo 1: Representative jhook problem area (Station No. 19+45; view of right bank, downstream, 11-6-2008).

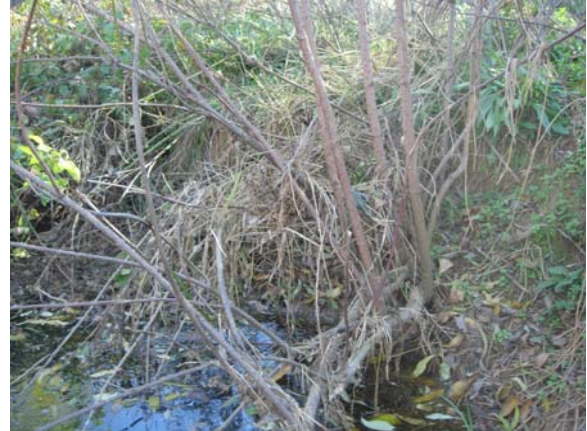
Photo 2: Representative bank erosion problem area (Station No. 19+30; view upstream, right bank; 11-6-2008).

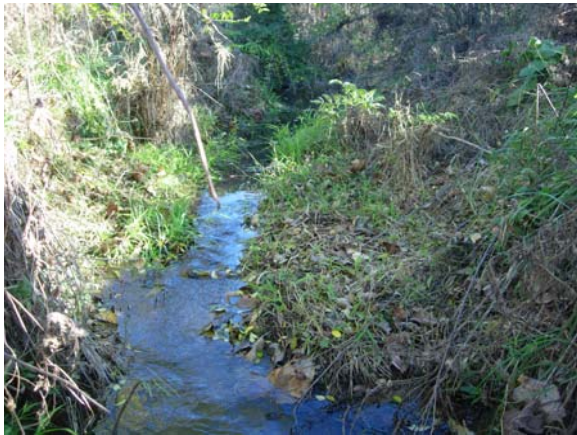
Photo 3: Representative sidebar/aggradation problem area (Station No. 18+29; view upstream; 11-6-2008).

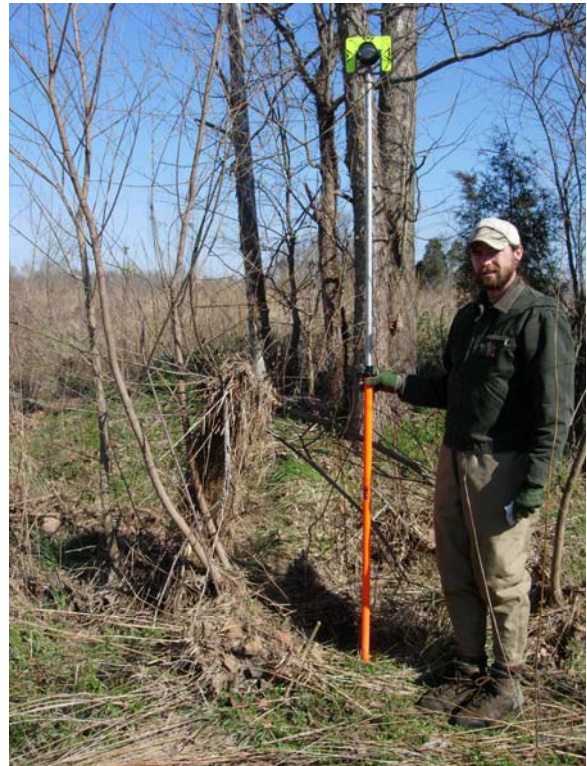
Photo 4: Bankfull flow event evidence (wrack line) at Station No. 10+00; Note foot of pole is resting at bankfull level; 3-16-2008.
