UT to Cane Creek Restoration Project Year 2 Final Monitoring Report

**Alamance County, North Carolina
NC DEQ-DMS Project ID Number – 95729**

Report Prepared and Submitted by Michael Baker Engineering, Inc.
NC Professional Engineering License # F-1084

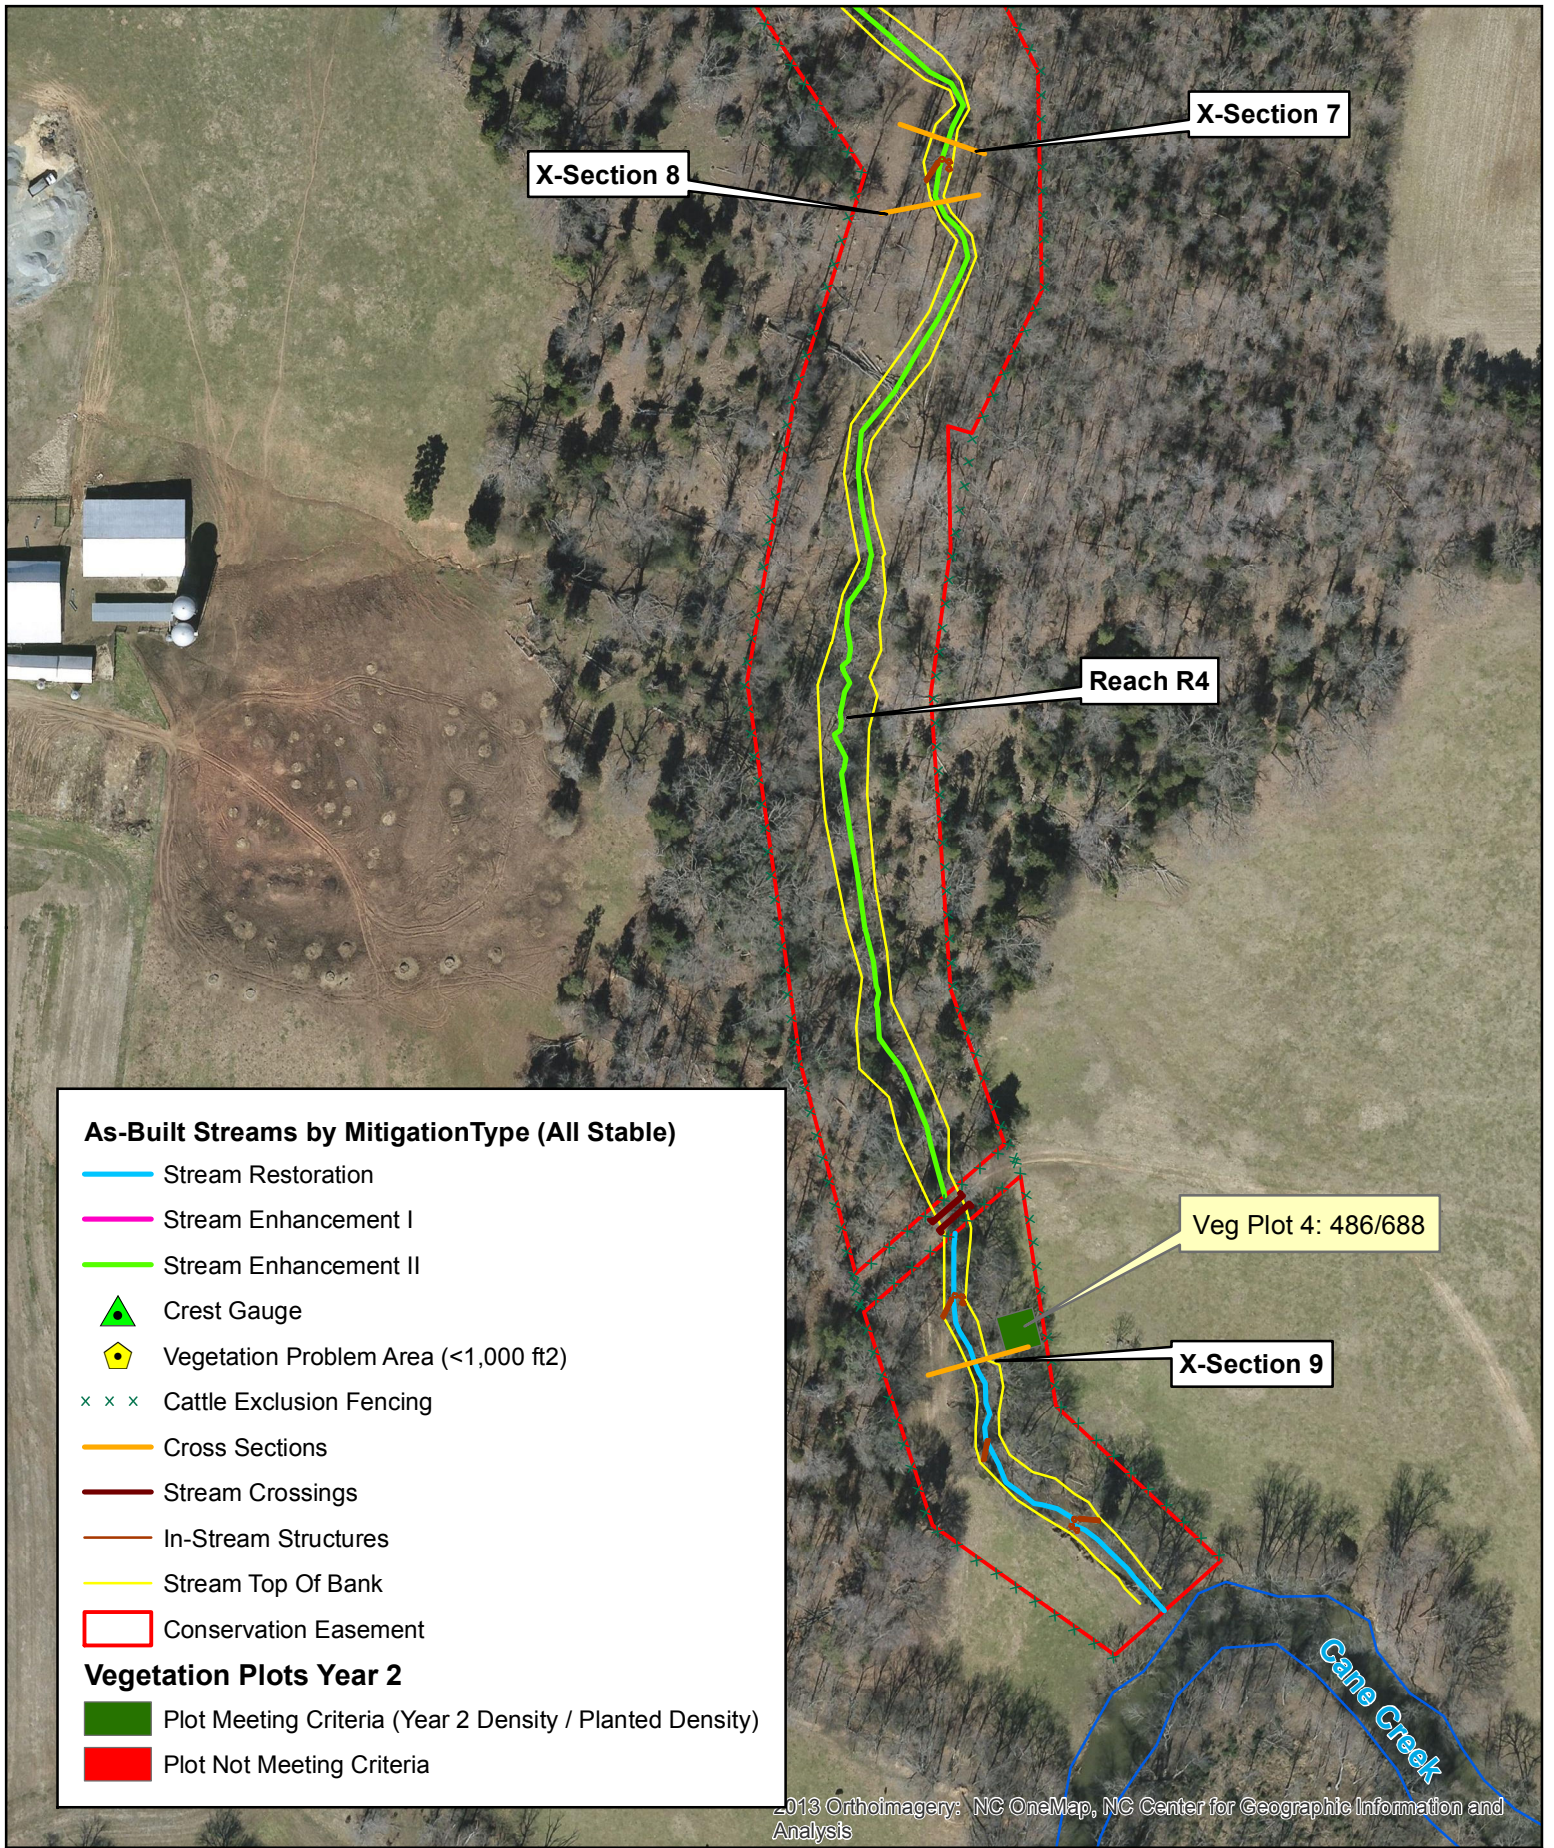
**Current Condition
 Plan View - Figure 4B
 Monitoring Year 2
 UT to Cane Creek Site**

One area of Chinese privet less than 1,000 square feet was noted at Station 28+50 on the downstream portion of Reach 5. This area will be closely monitored during Year 3 and appropriate actions will be taken if deemed necessary.

* See Figure 4B for location of invasive species

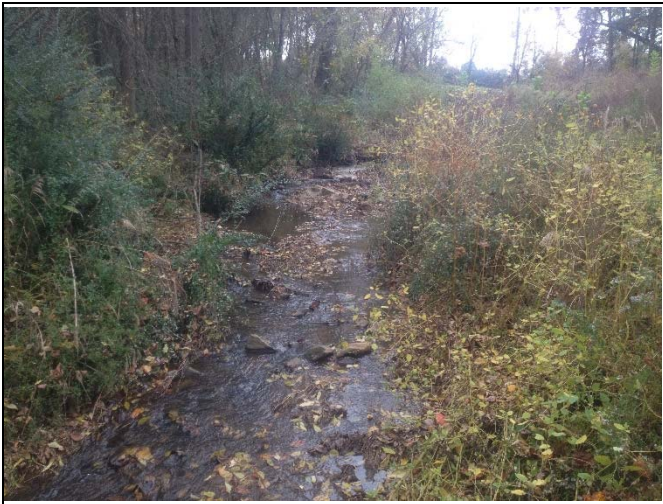
One area of invasive species vegetation was observed during Year 2 monitoring. It is noted that re-sprouts of *Ligustrum sinense* (Chinese privet) was noted along Reach 5 near the confluence with Reach 3. The Chinese privet plants observed consist of an area less than 1000 square feet and is shown on the Current Condition Plan View (CCPV) map in the Appendix B.

Table 6b. Vegetation Problem Areas (VPAs)			
UT to Cane Creek Restoration Project: DMS Project ID No. 95729			
Feature Issue	Station Number	Suspected Cause	Photo Number
Chinese privet (<i>Ligustrum sinense</i>)	*Reach 5, Station ~28+50	Re-sprout	VPA 1, 2, 3

Reach R5 – View upstream, Station 28+50

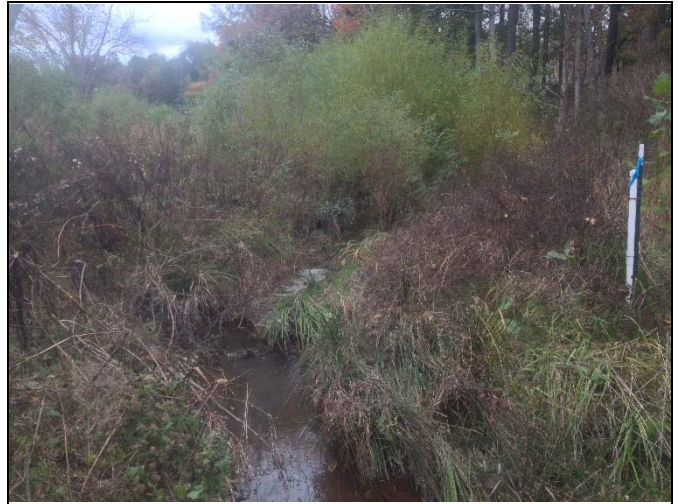
Reach R5 – Crest gauge 1 area. October 26, 2015

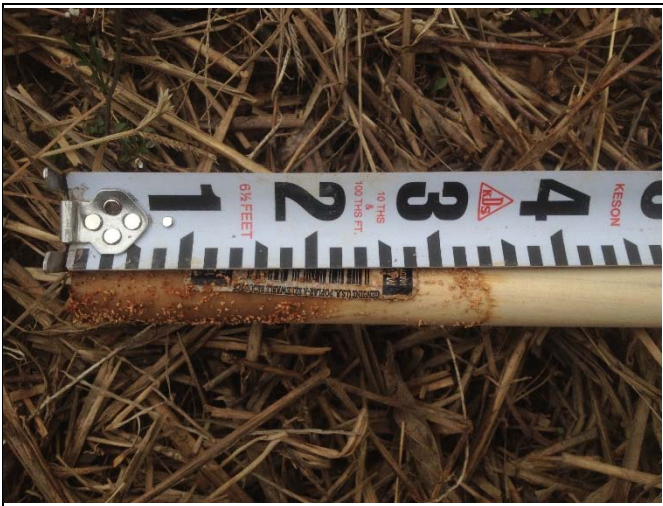
Reach R5– Crest Gauge 2, 0.33 feet. March 26, 2015
