UT to Cane Creek Restoration Project Year 3 Final Monitoring Report

Alamance County, North Carolina

DMS Project ID Number – 95729, DEQ Contract No. 4951

Monitoring Year: 3 of 7

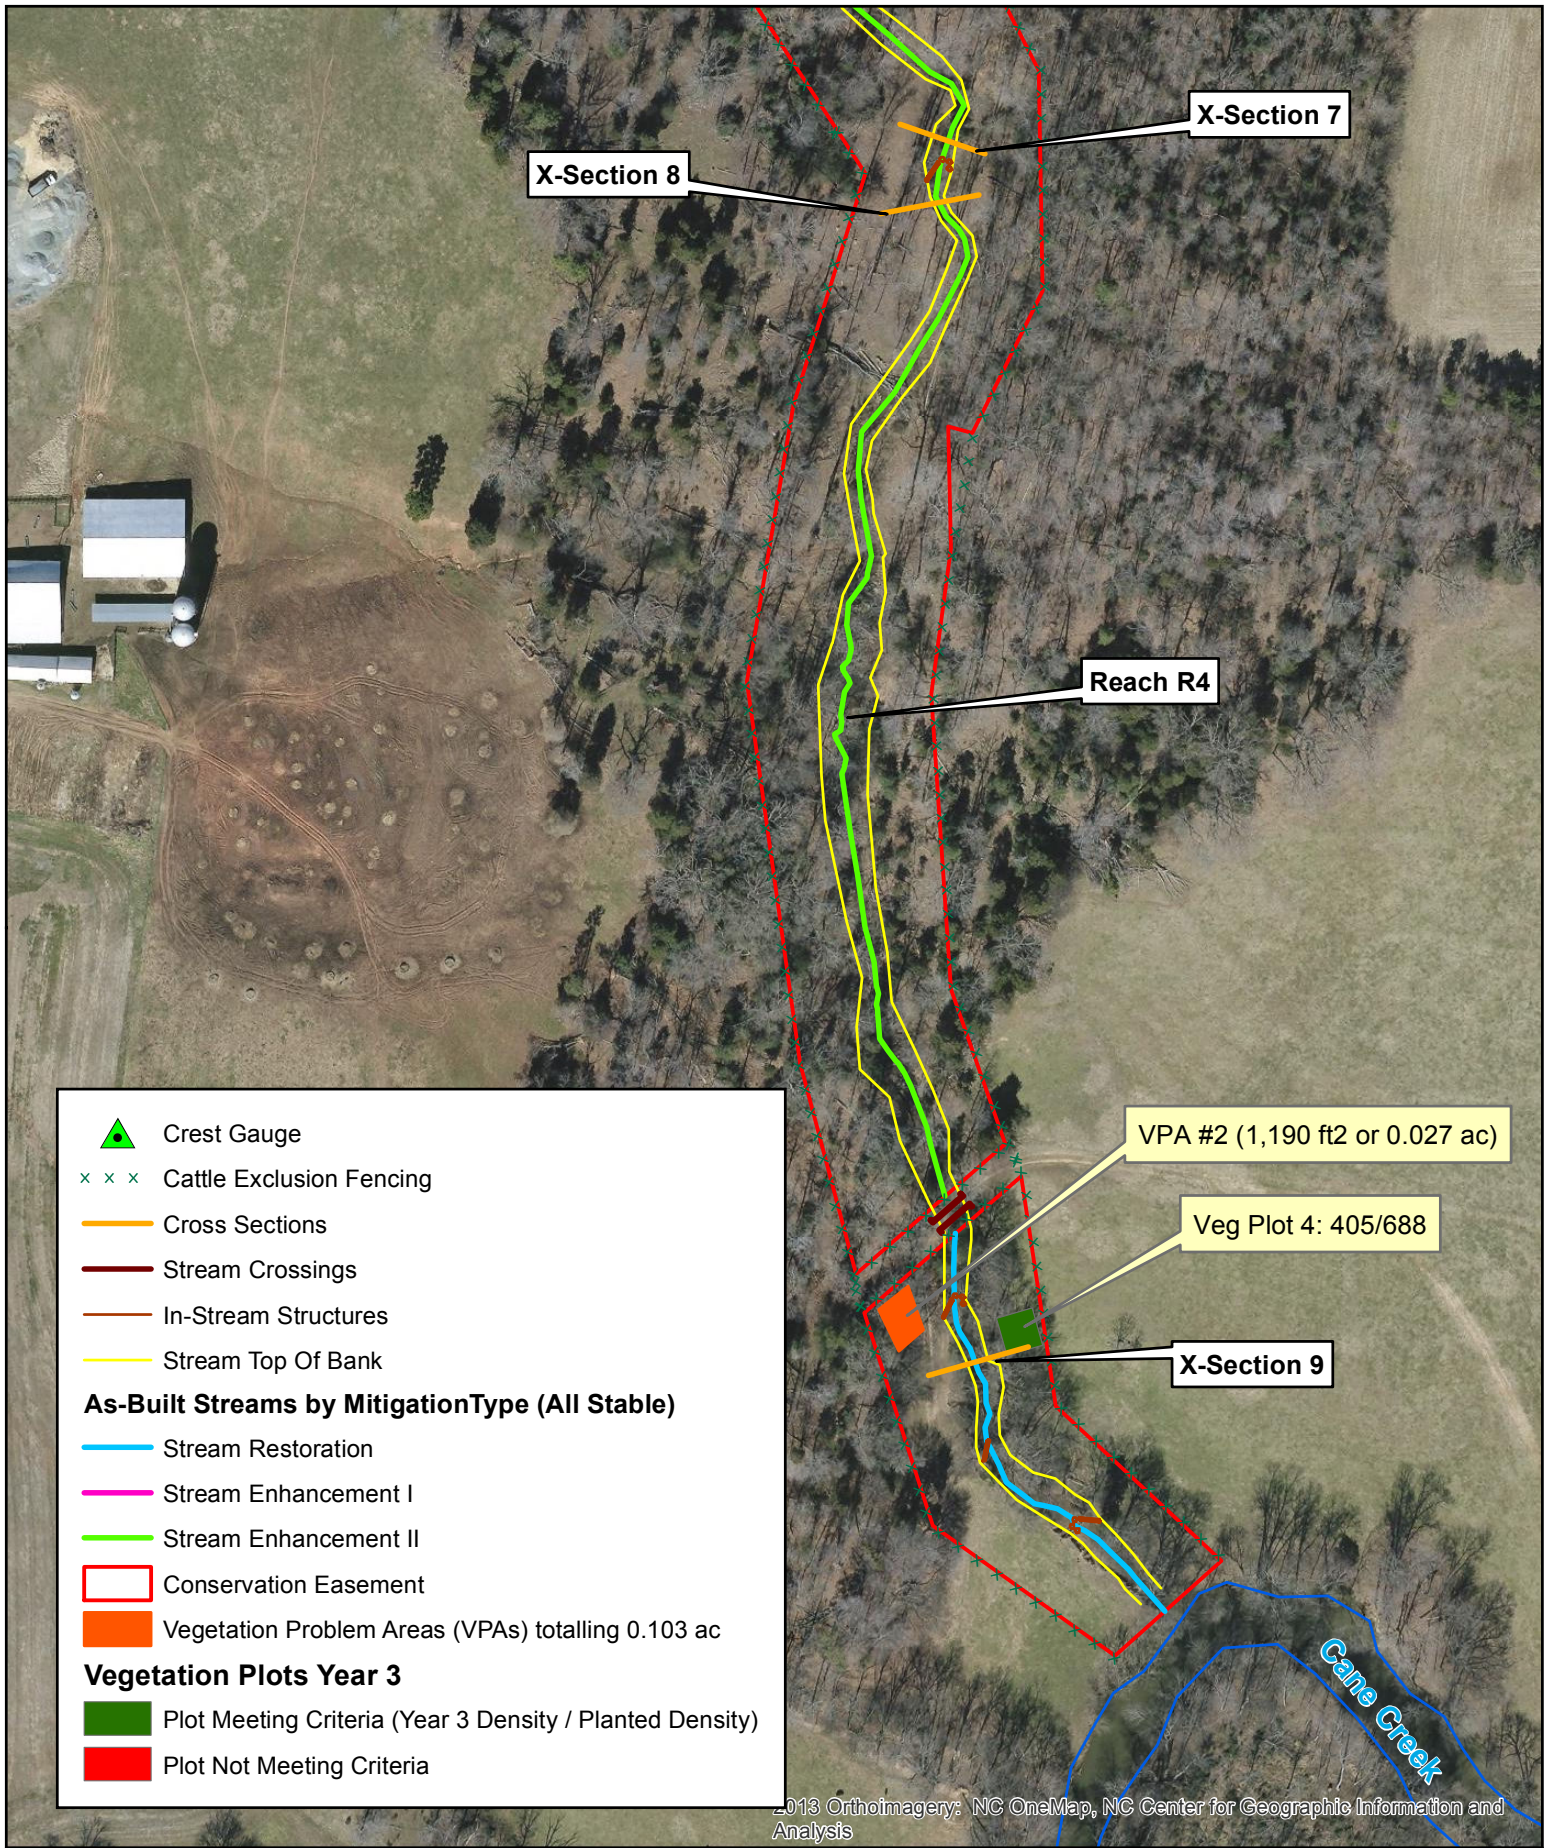
**Current Condition
Plan View - Figure 4C
Monitoring Year 3
UT to Cane Creek Site**

Two areas of Chinese privet totaling a combined 0.103 acres were noted near Station 28+50 on the downstream portion of Reach 5, and along the right bank of Reach 4 just below the lower crossing near Station 53+50 as shown in Figure 4. In order to keep these areas of privet under control, the privet is scheduled to be treated in 2017.

5. Invasive Areas of Concern	Areas of points (if too small to render as polygons at map scale)	1000 ft ²	Yes, Fig. 4C	1	0.027	0.32%
6. Easement Encroachment Areas	Areas of points (if too small to render as polygons at map scale)	none	NA	0	0.00	0.0%
Reach ID: Reach 5						
Planted Acreage: 5.0						
Vegetation Category	Defintions	Mapping Threshold (acres)	CCPV Depiction	Number of Polygons	Combined Acreage	% of Planted Acreage

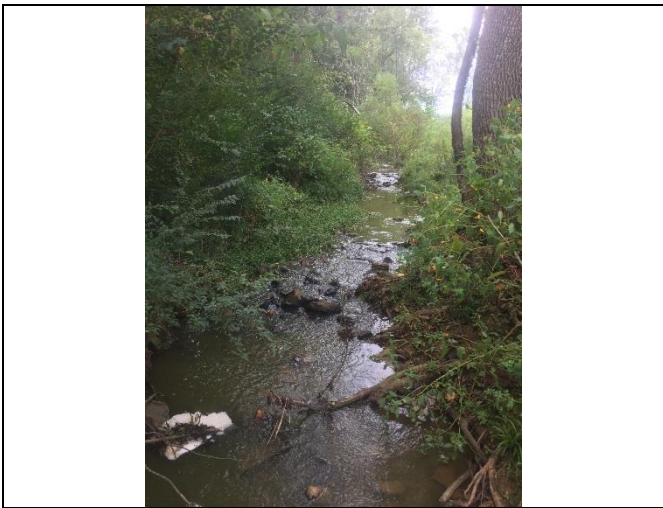
Reach R5 – View upstream, Station 28+50
