# **UT to Cane Creek Restoration Project Year 5 FINAL Monitoring Report**

**Alamance County, North Carolina**

**DMS Project ID Number – 95729, DEQ Contract No. 4951**

Monitoring Year: 5 of 7

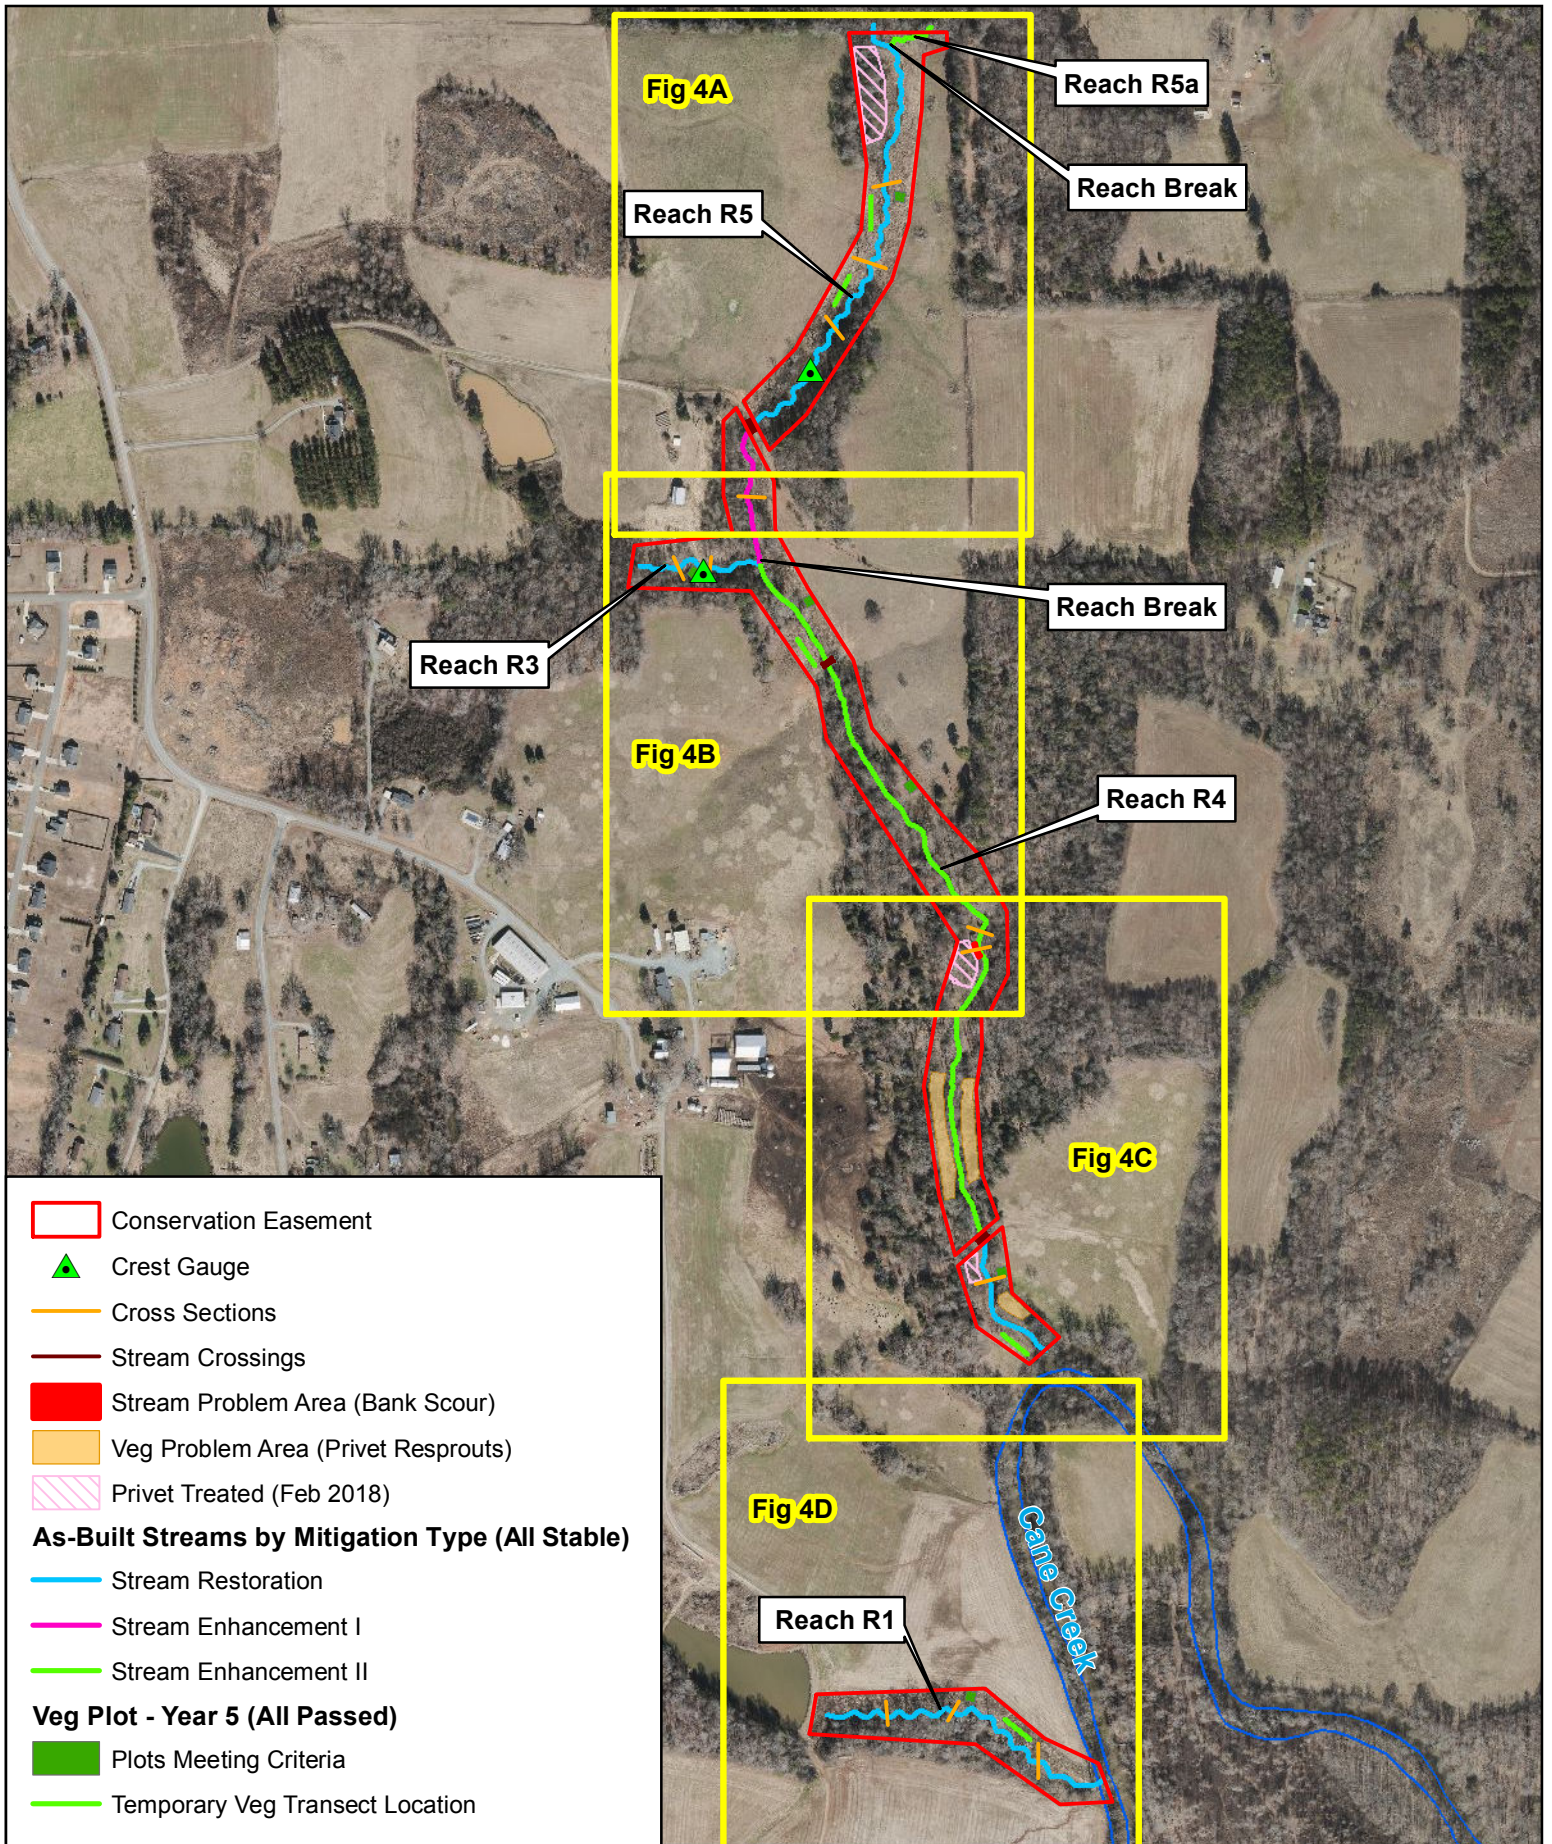
**Current Condition  
Plan View - Figure 4A  
Monitoring Year 5  
UT to Cane Creek Site**

One Stream Problem Area (SPA) was observed during the Year 5 monitoring. During the post-Hurricane Florence site inspection, an approximately 30 ft section of bank scour was discovered along the outer right bank of a pool bend located in the middle of Reach R4. The bank scour was a direct result of the high flows associated with Florence, which dropped approximately six inches of rain on the site over a 24-hour period between September 16 and 17. The bank scour resulted in the loss of a significant portion of the livestake vegetation that had been growing in the bank. Cross-section 8 is located within this section and reveals the resulting scour in its graph. The visual inspection of the bank revealed that there is still a substantial amount of living, established livestake vegetation growing in the bank and during the winter of 2018-2019, Baker will supplement with additional livestakes and transplants, likely consisting of black willow (*Salix nigra*) and silky dogwood (*Cornus amomum*) species. The SPA is reported in Tables 5a and 5b, representative photographs can be found in the photolog, and its exact location is shown on the CCPV, all of which are found in Appendix B.

There was one Vegetation Problem Area (VPA) observed during the Year 5 monitoring. A few small areas of scattered resprouts of the invasive species Chinese privet (*Ligustrum sinense*) were discovered along the middle and lowers sections of Reach R4 as detailed in Table 6a and 6b. The total combined area of the scattered privet is 0.71 acres in size. Their locations are shown on the Current Condition Plan View (CCPV) maps in the Appendix B along with representative photographs.

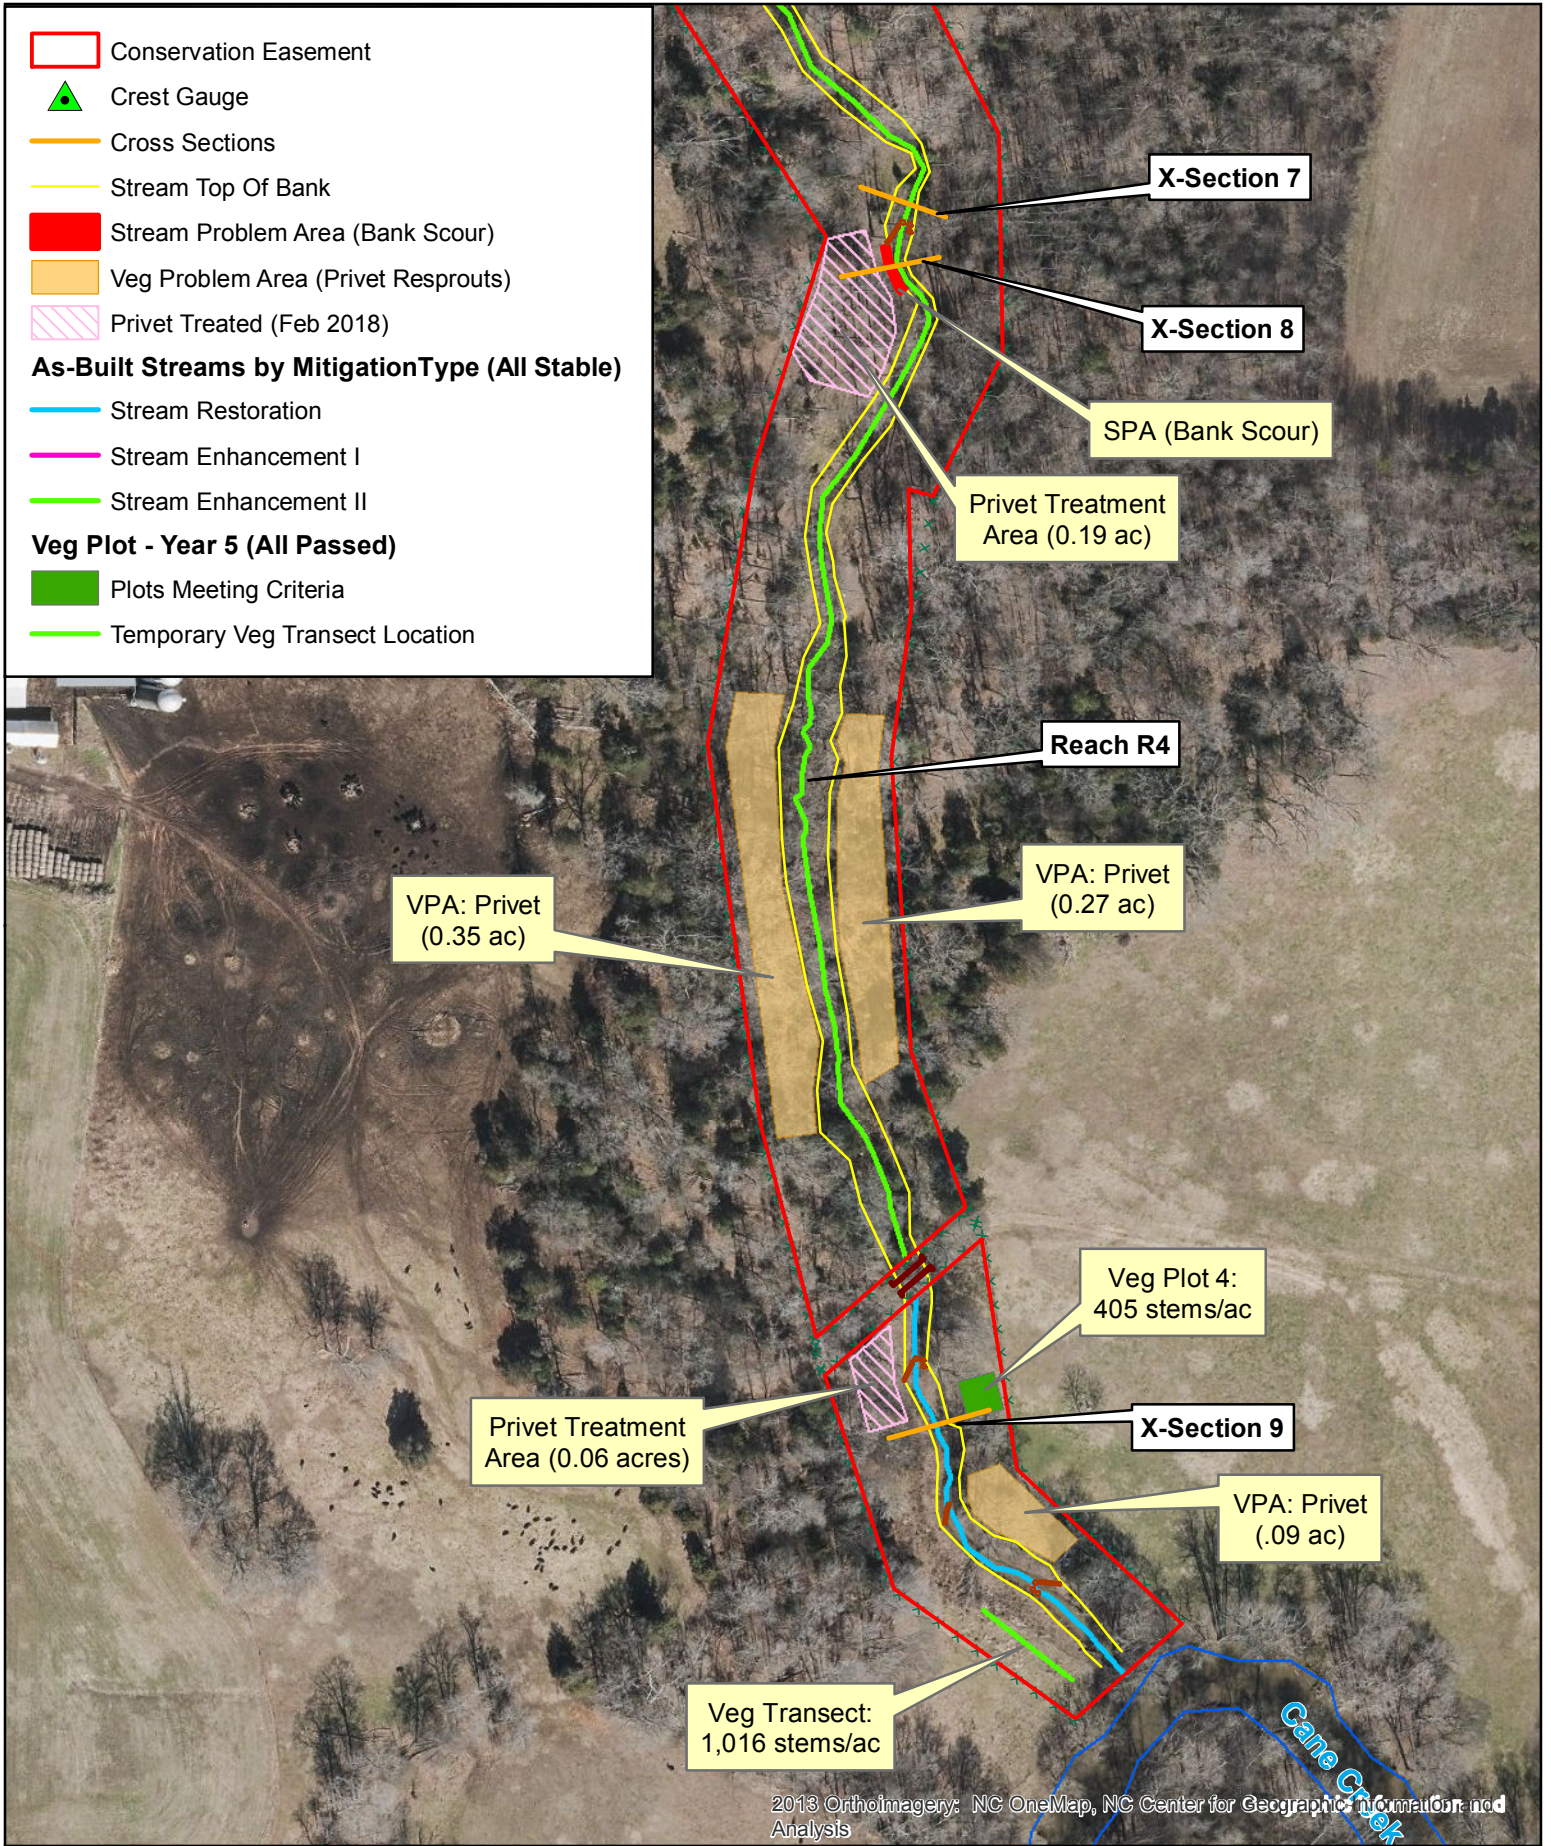
**Current Condition  
Plan View - Figure 4C  
Monitoring Year 5  
UT to Cane Creek Site**

Three areas of scattered Chinese privet (*Ligustrum sinense*) resprouts were discovered along the middle and downstream portions of Reach 4, totaling a combined 0.71 acres, as shown on the CCPV in Appendix B. The privet found in these areas will be treated in 2019.

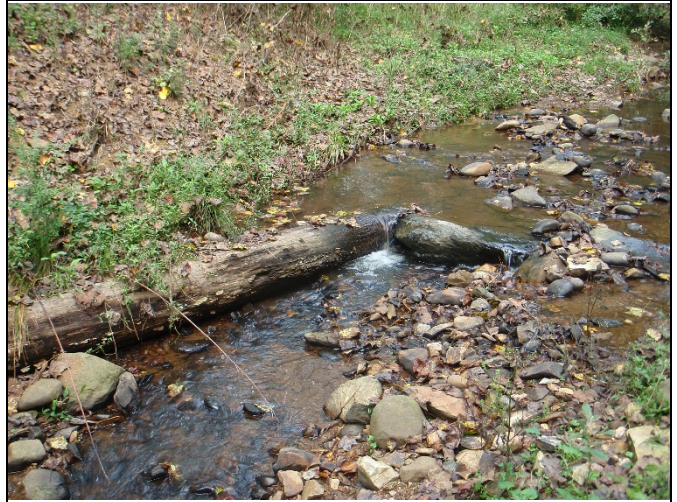
<b>Table 5b. Stream Problem Areas (SPAs)</b>			
<b>UT to Cane Creek Restoration Project: DMS Project ID No. 95729</b>			
<b>Feature Issue</b>	<b>Station Numbers</b>	<b>Suspected Cause</b>	<b>Photos</b>
Bank Scour	43+40 to 43+70 (30' in length)	High flow from Hurricane Florence	Appendix B

Reach R4 – View upstream, enhancement area  
(Log J-Hook), Station 43+50

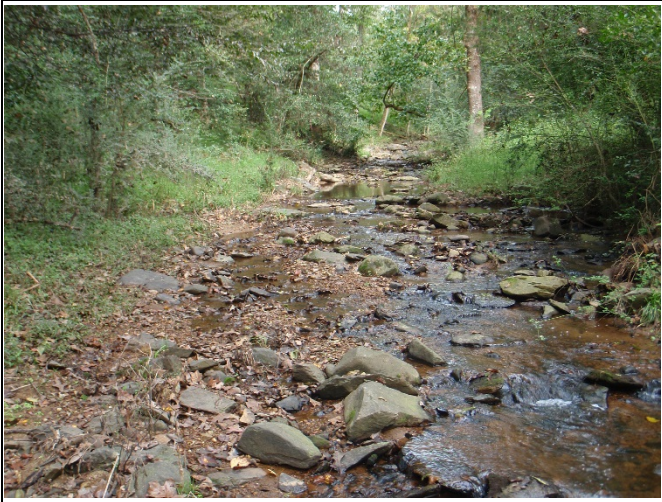
<b>Table 6b. Vegetation Problem Areas (VPAs)</b>			
<b>UT to Cane Creek Restoration Project: DMS Project ID No. 95729</b>			
<b>Feature Issue</b>	<b>Station Numbers</b>	<b>Suspected Cause</b>	<b>Photos</b>
Chinese privet ( <i>Ligustrum sinense</i> )	Reach R4: Stations 47+00 to 51+00 (both banks), and 55+00 to 56+00 (left bank)	Re-sprouts	Appendix B

Reach R4 – View upstream, enhancement area,  
Station 49+00

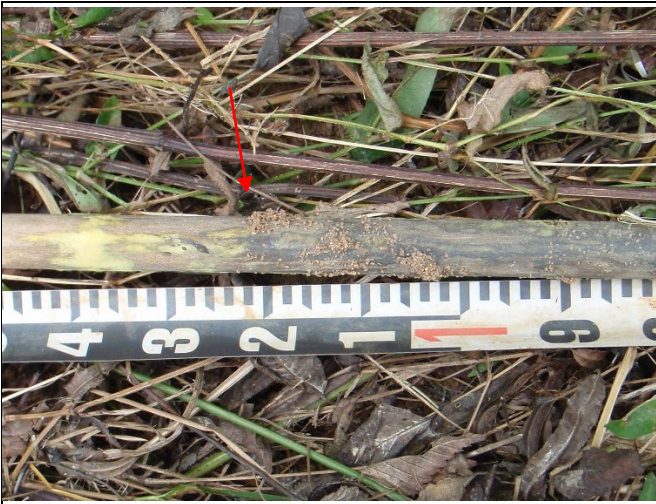
Reach R5: Closeup of Crest Gauge #1 on 9/24/18

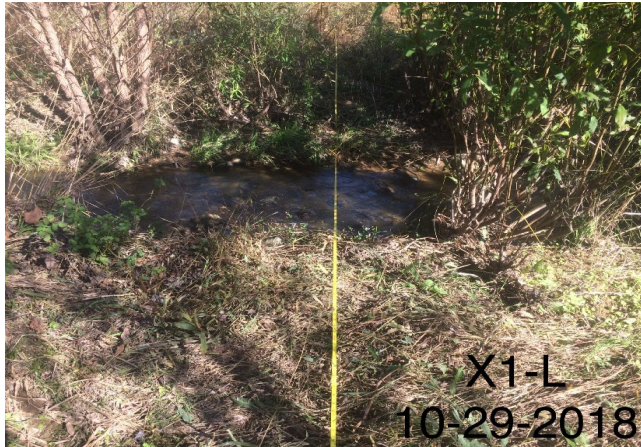
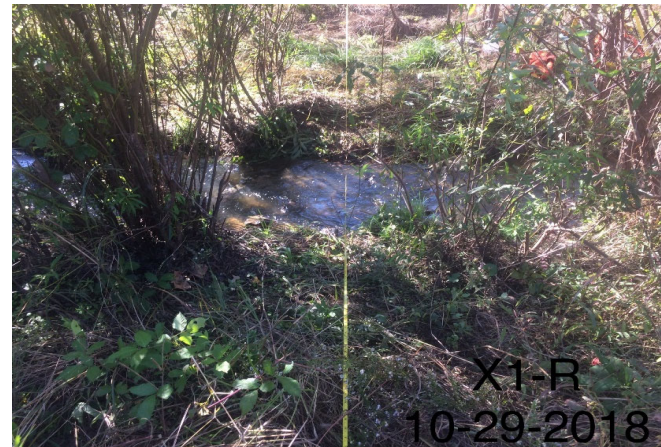
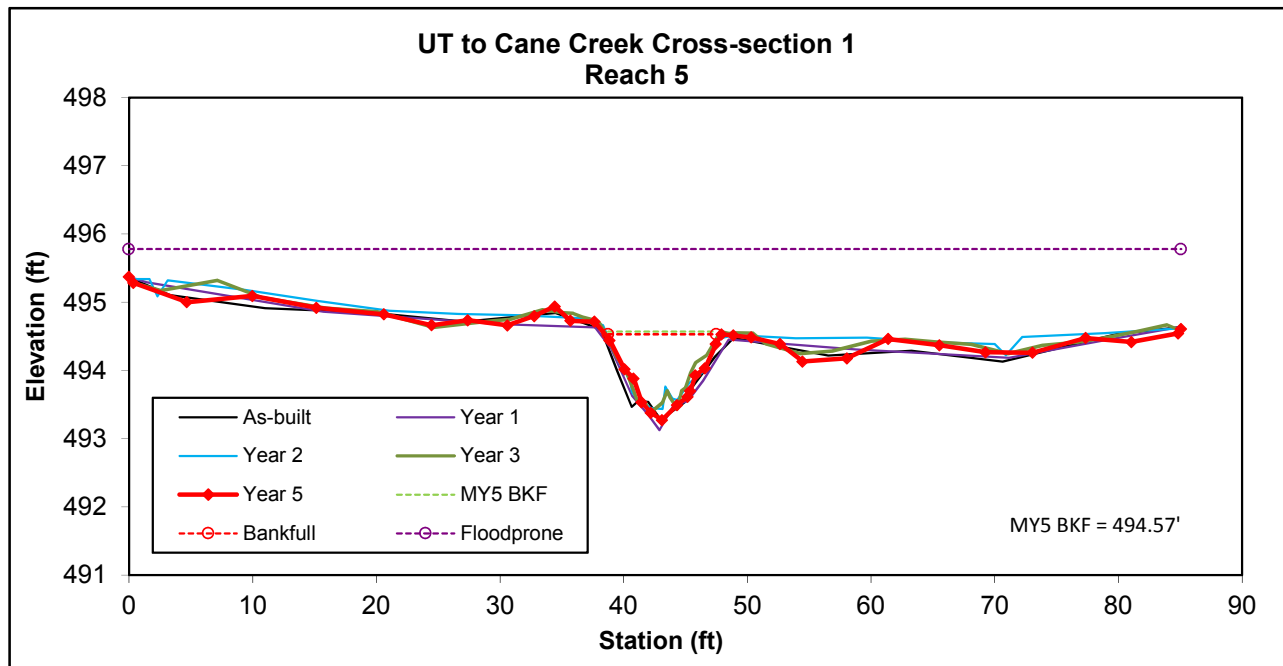
**Permanent Cross-section 1, Reach 5**  
(Year 5 Data - Collected October 2018)

Feature	Stream Type	BKF Area	BKF Width	BKF Depth	Max BKF Depth	W/D	BH Ratio	ER	BKF Elev	TOB Elev
Riffle	C	6.7	9.4	0.7	1.3	13.4	1.0	9.0	494.53	494.53

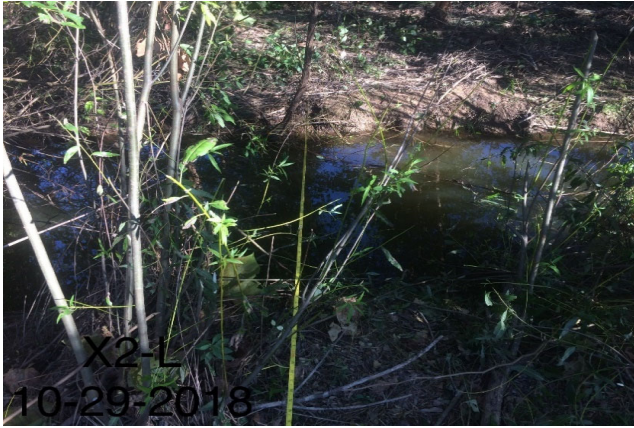
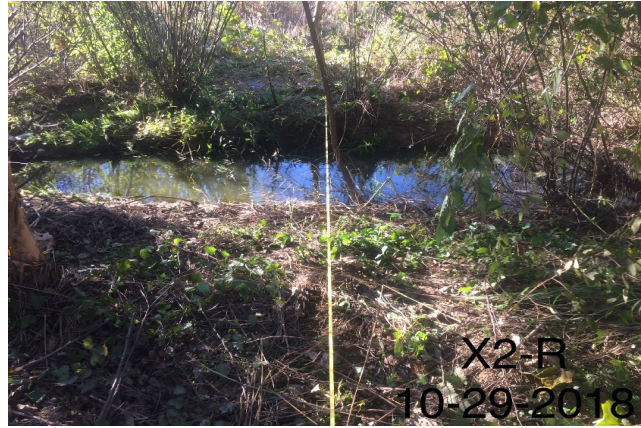
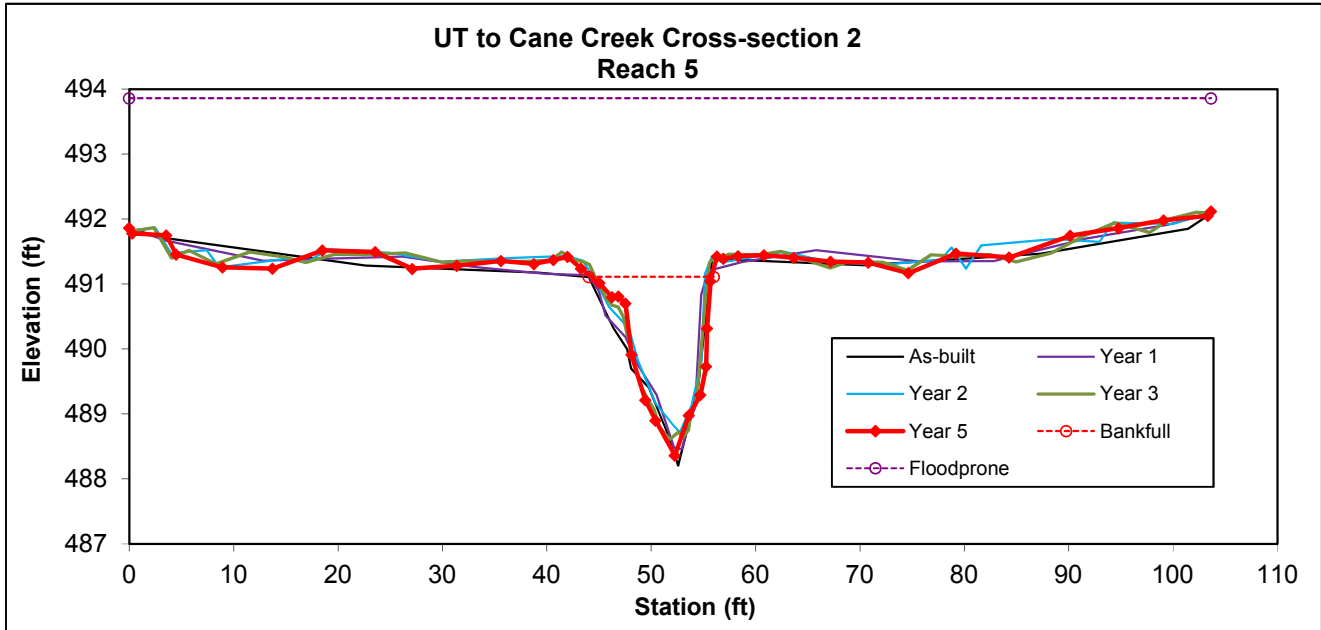
**Permanent Cross-section 2, Reach 5**  
(Year 5 Data - Collected October 2018)

Feature	Stream Type	BKF Area	BKF Width	BKF Depth	Max BKF Depth	W/D	BH Ratio	ER	BKF Elev	TOB Elev
Pool	-	16.4	11.5	1.4	2.7	8.0	-	-	491.11	491.42

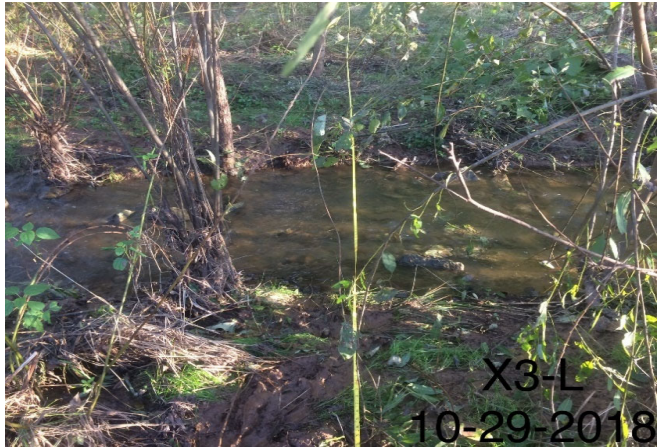
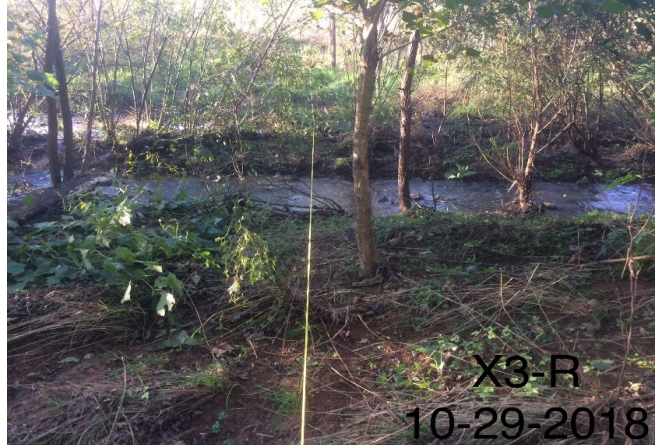
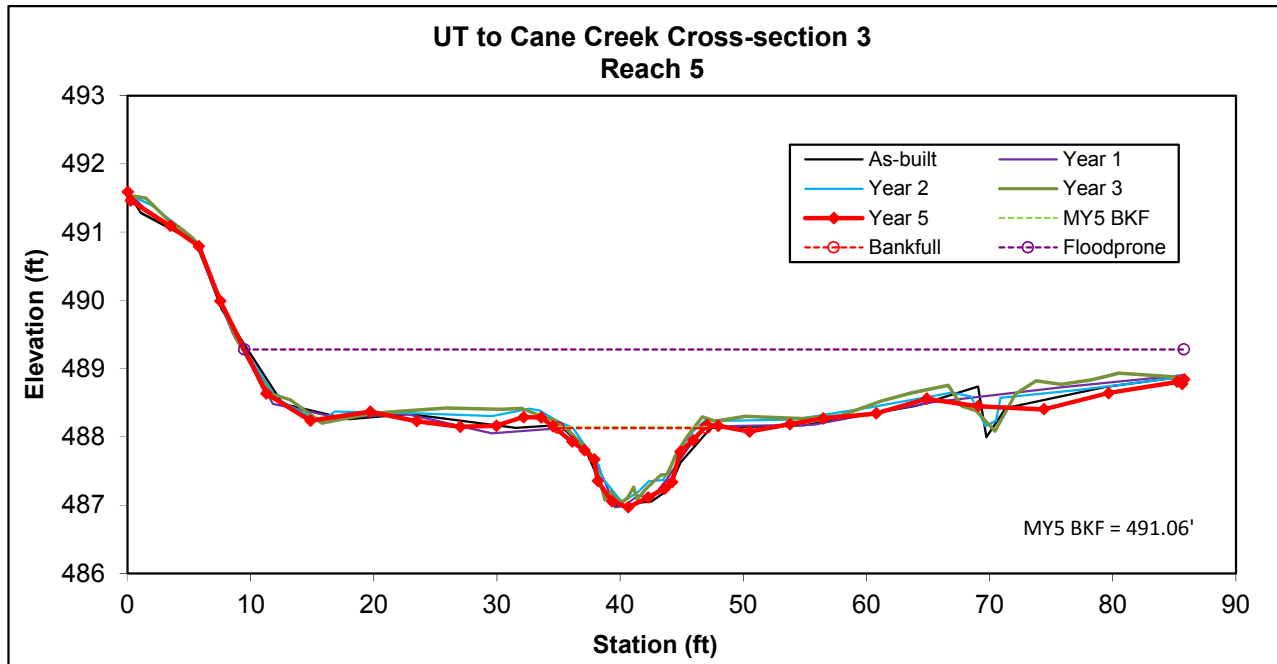
**Permanent Cross-section 3, Reach 5**  
(Year 5 Data - Collected October 2018)

Feature	Stream Type	BKF Area	BKF Width	BKF Depth	Max BKF Depth	W/D	BH Ratio	ER	BKF Elev	TOB Elev
Riffle	C	7.8	15	0.5	1.2	29.2	1.0	5.1	488.13	488.18

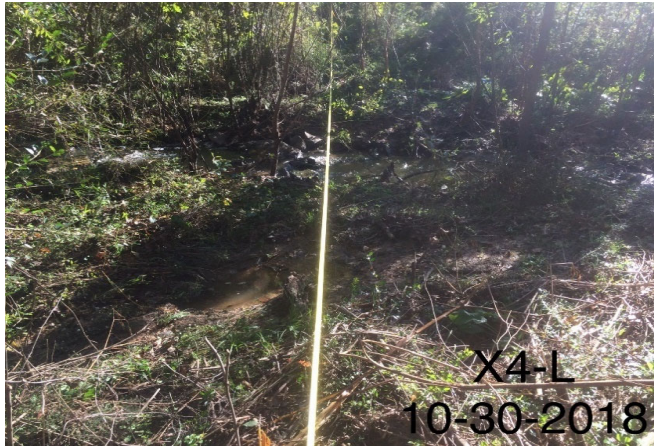
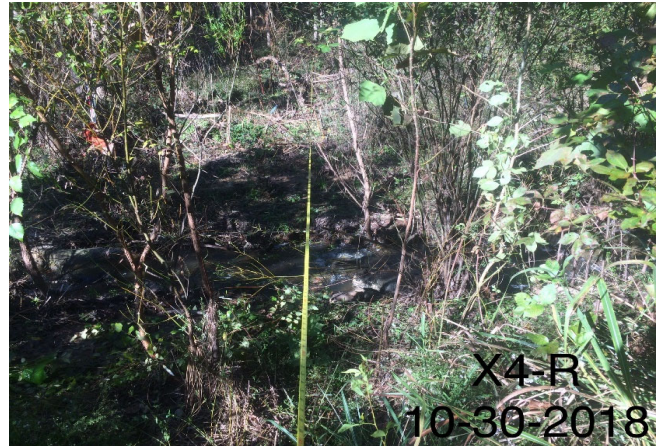
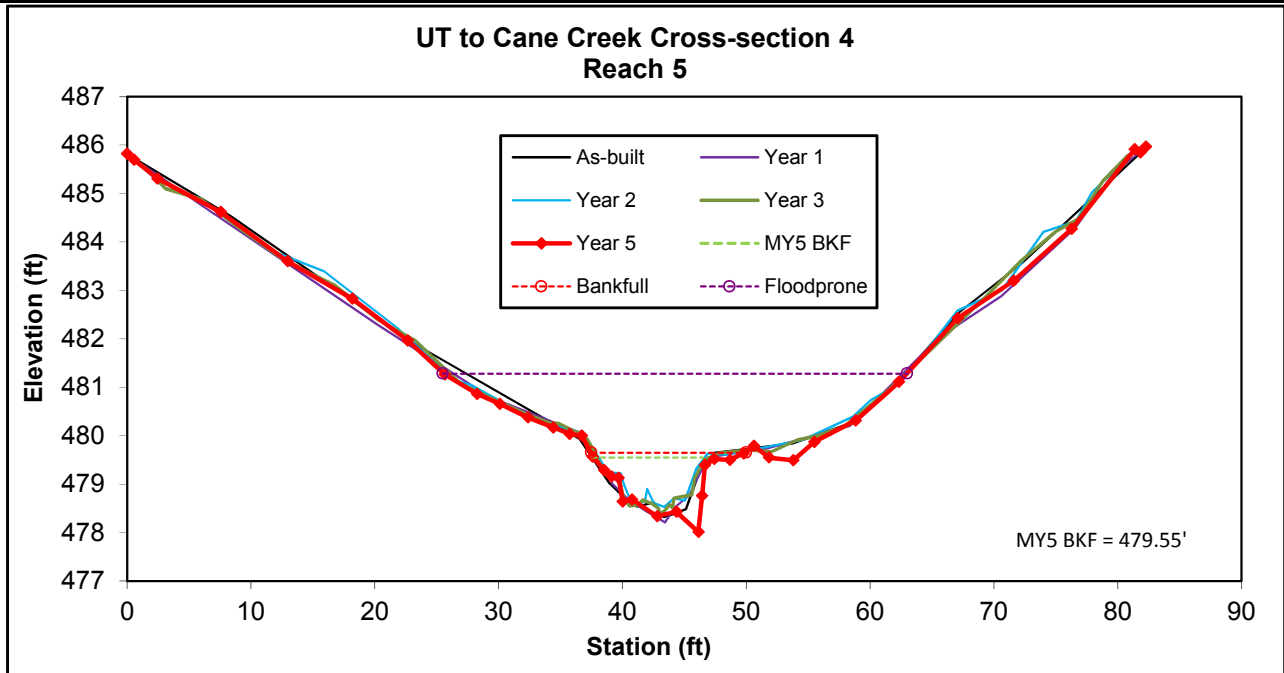
**Permanent Cross-section 4, Reach 5**  
(Year 5 Data - Collected October 2018)

Feature	Stream Type	BKF Area	BKF Width	BKF Depth	Max BKF Depth	W/D	BH Ratio	ER	BKF Elev	TOB Elev
Riffle	C	9.5	12.5	0.8	1.6	16.3	1.1	3.0	479.65	479.78

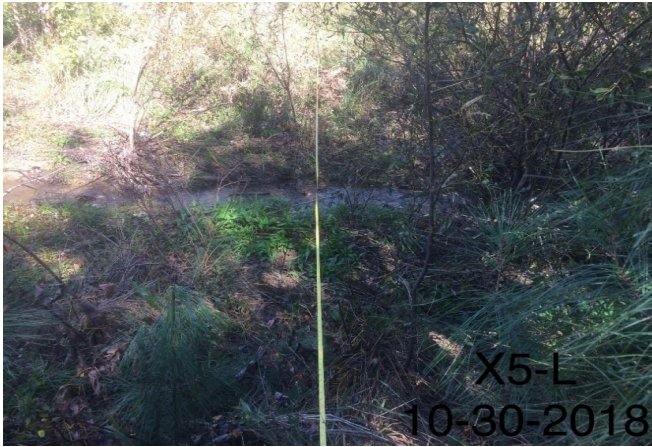
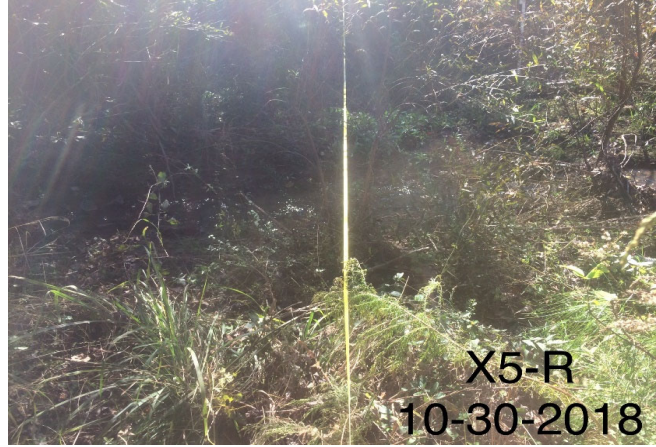
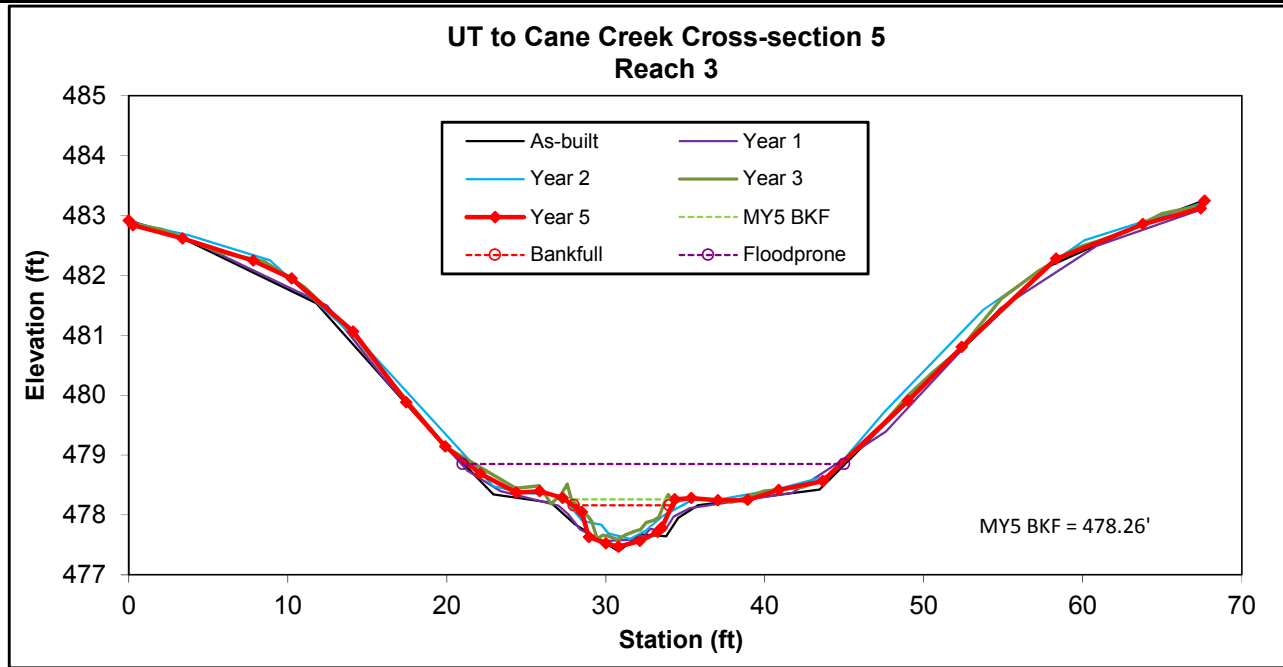
**Permanent Cross-section 5, Reach 3**  
(Year 5 Data - Collected October 2018)

Feature	Stream Type	BKF Area	BKF Width	BKF Depth	Max BKF Depth	W/D	BH Ratio	ER	BKF Elev	TOB Elev
Riffle	C	3.0	6.2	0.5	0.7	13.0	1.0	3.8	478.16	478.26

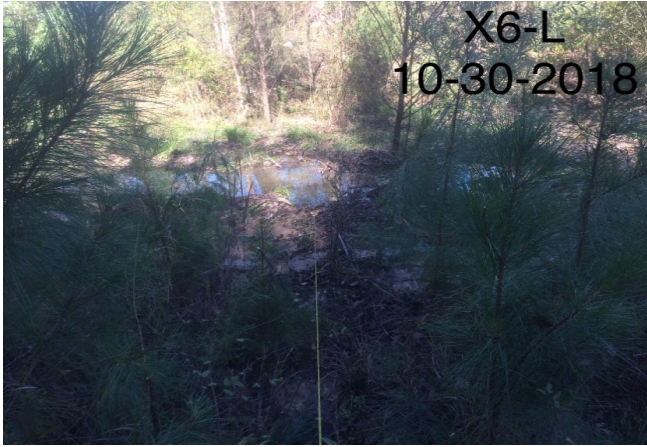
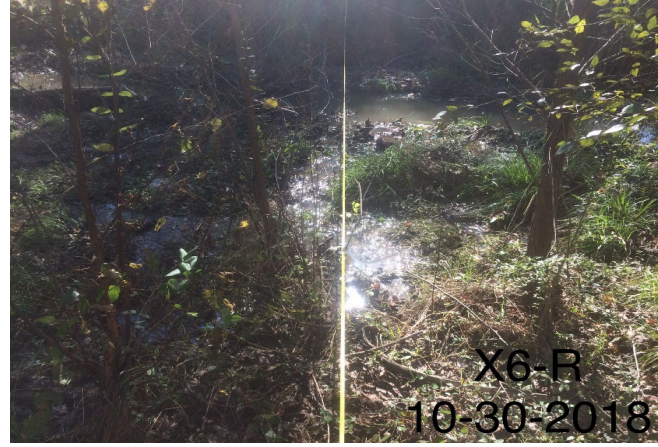
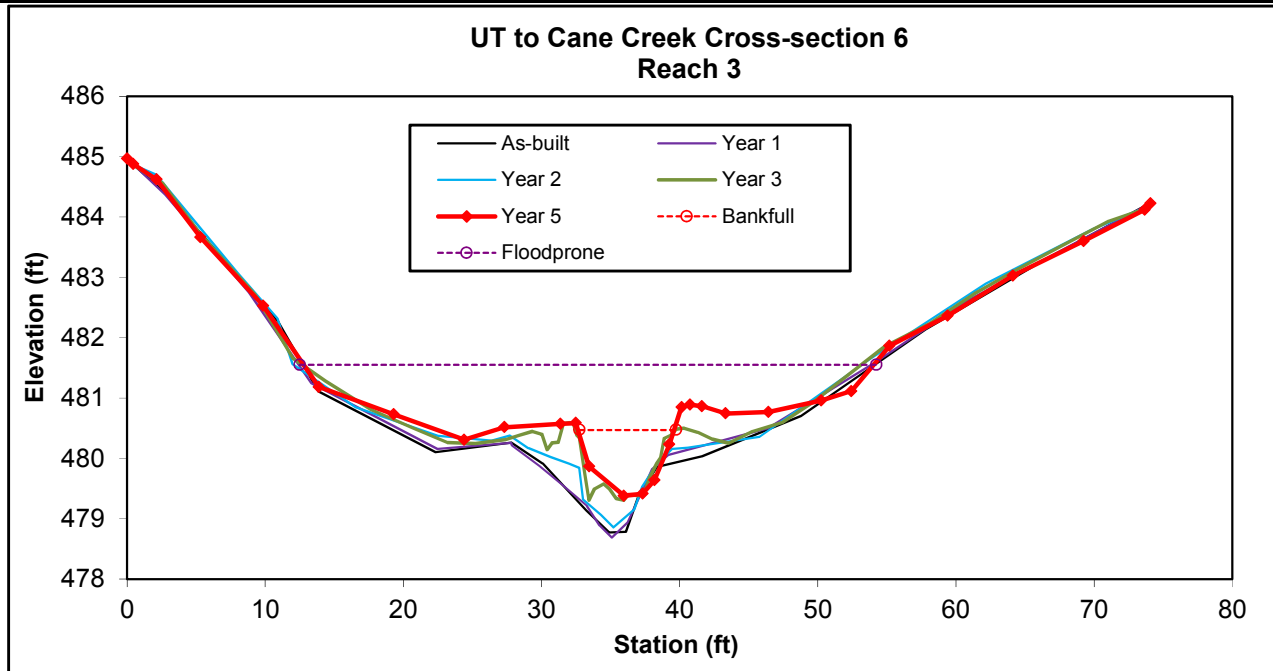
**Permanent Cross-section 6, Reach 3**  
(Year 5 Data - Collected October 2018)

Feature	Stream Type	BKF Area	BKF Width	BKF Depth	Max BKF Depth	W/D	BH Ratio	ER	BKF Elev	TOB Elev
Pool	-	5.2	6.9	0.8	1.1	9.2	-	-	480.47	480.59

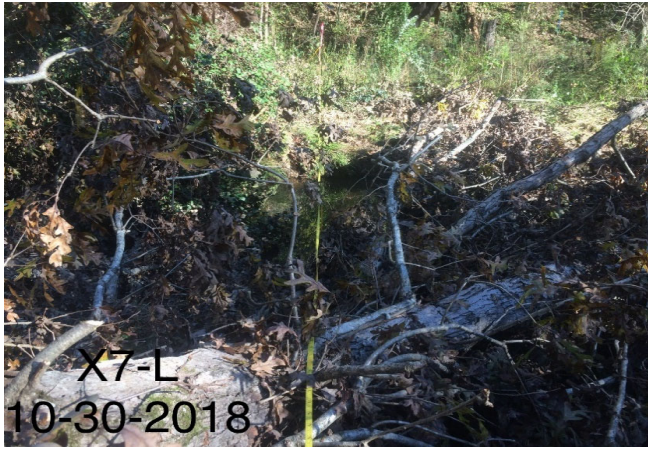
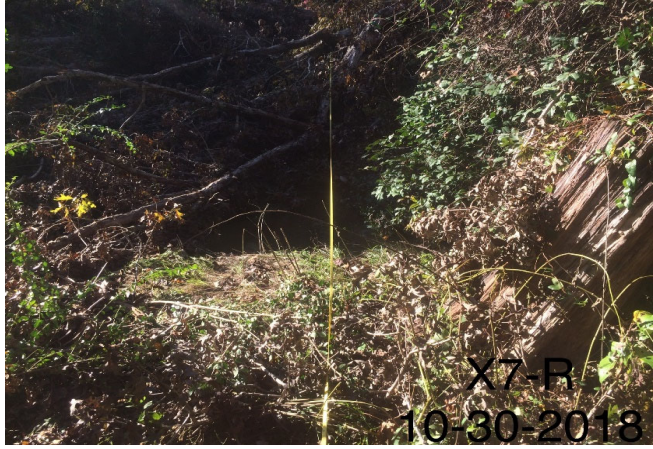
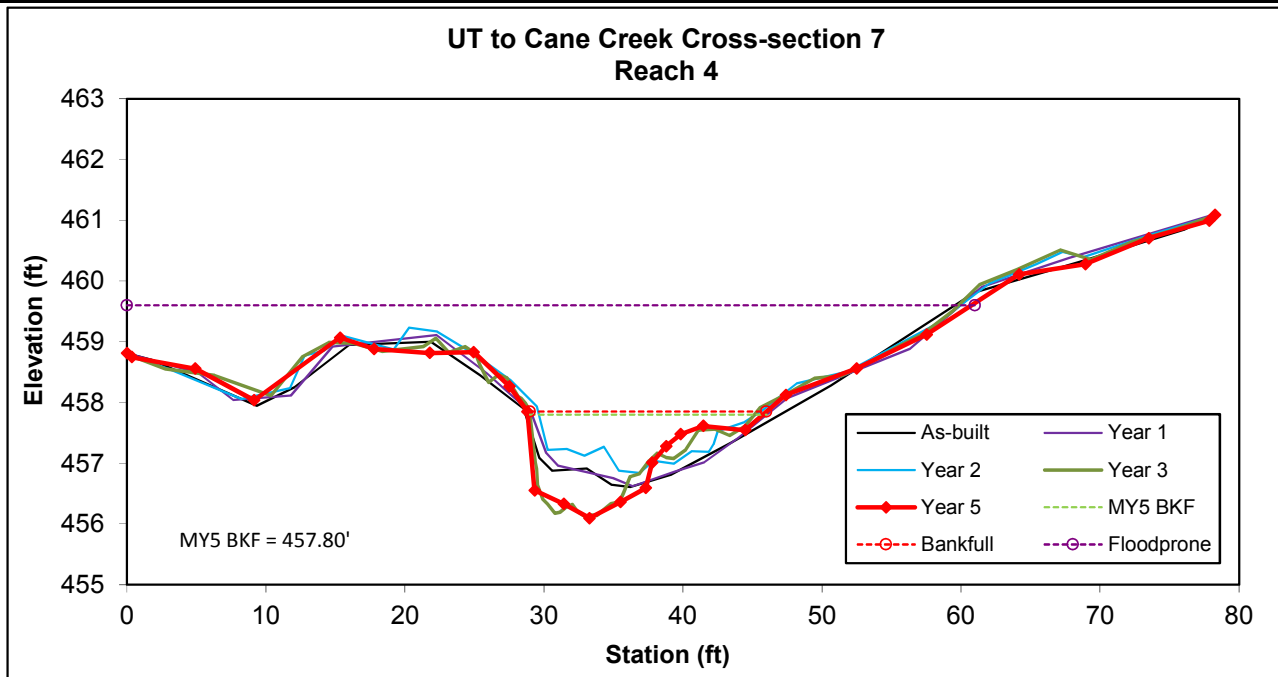
**Permanent Cross-section 7, Reach 4**  
(Year 5 Data - Collected October 2018)

Feature	Stream Type	BKF Area	BKF Width	BKF Depth	Max BKF Depth	W/D	BH Ratio	ER	BKF Elev	TOB Elev
Riffle	C	15.6	17.2	0.9	1.8	18.9	0.9	3.5	457.85	457.48

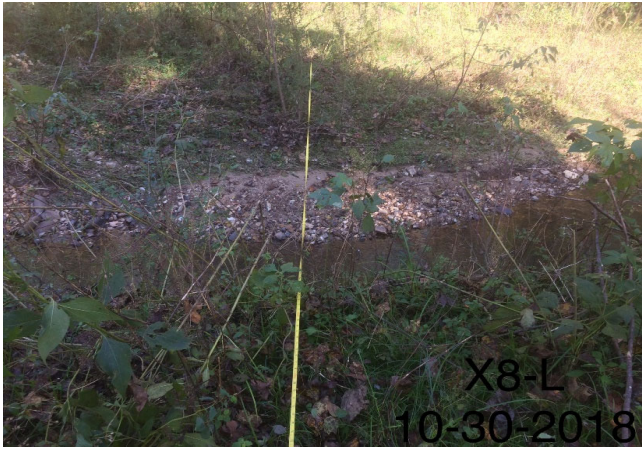
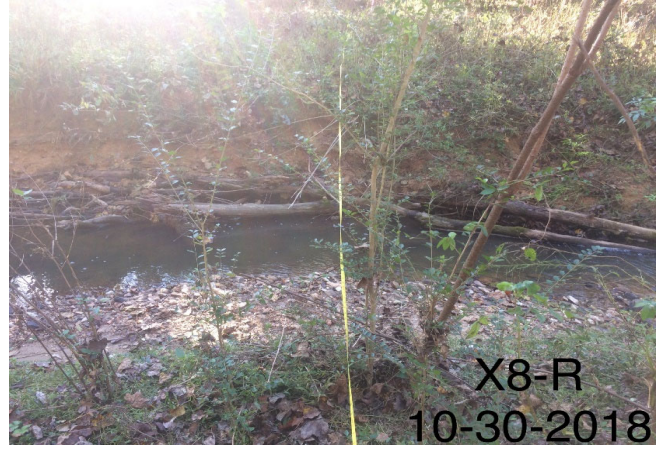
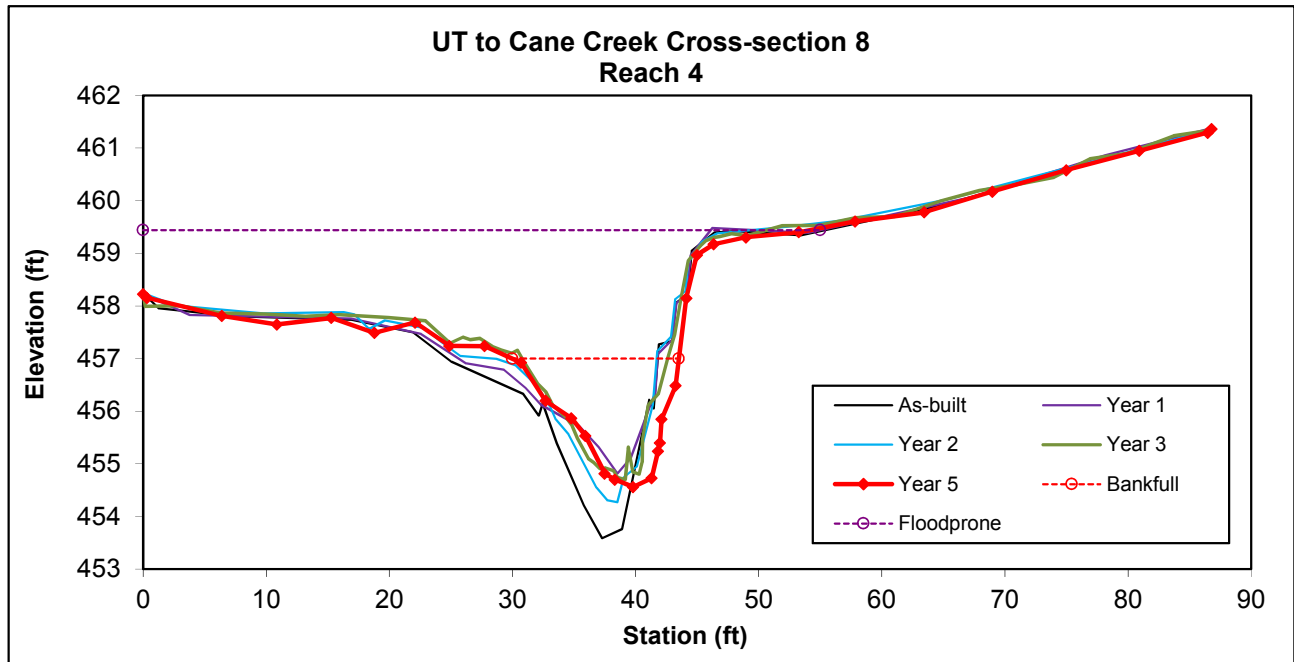
**Permanent Cross-section 8, Reach 4**  
(Year 5 Data - Collected October 2018)

Feature	Stream Type	BKF Area	BKF Width	BKF Depth	Max BKF Depth	W/D	BH Ratio	ER	BKF Elev	TOB Elev
Pool	-	18.7	13.5	1.4	2.4	9.8	-	-	457	457.24

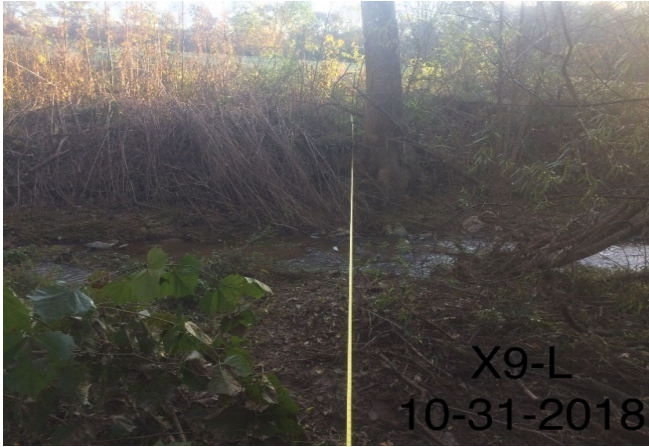
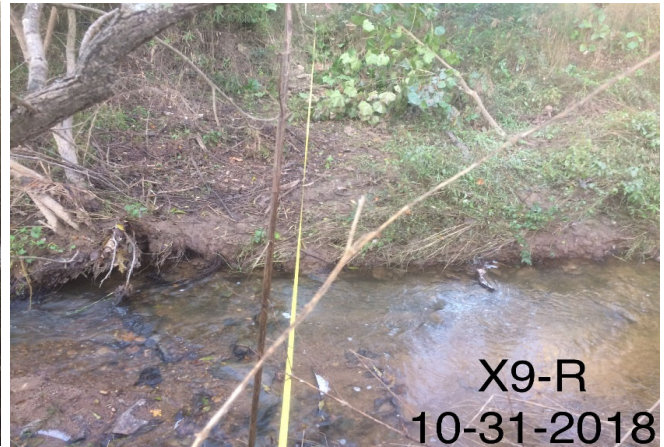
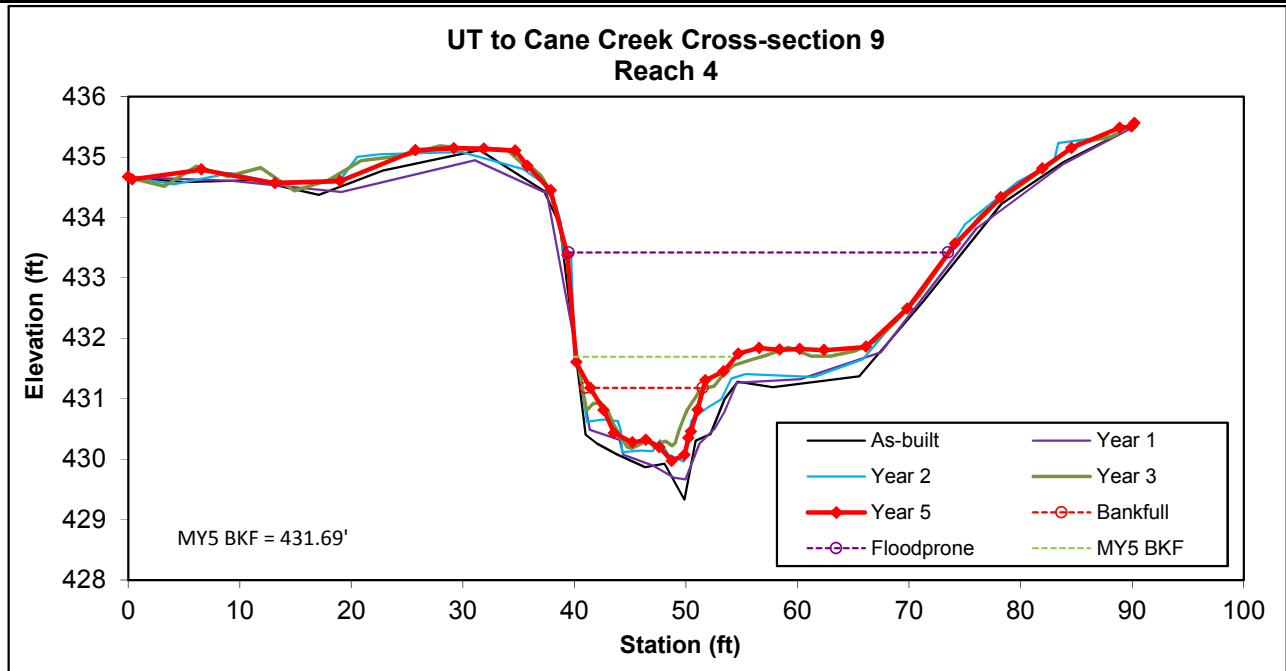
**Permanent Cross-section 9, Reach 4**  
(Year 5 Data - Collected October 2018)

Feature	Stream Type	BKF Area	BKF Width	BKF Depth	Max BKF Depth	W/D	BH Ratio	ER	BKF Elev	TOB Elev
Riffle	C	7.8	10.1	0.8	1.2	13.3	1.1	2.9	431.18	431.84

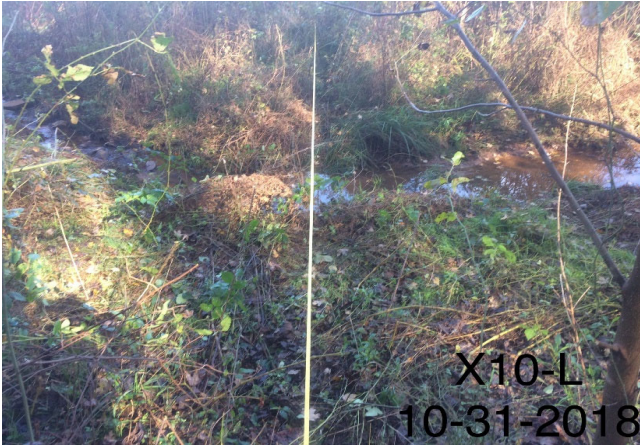
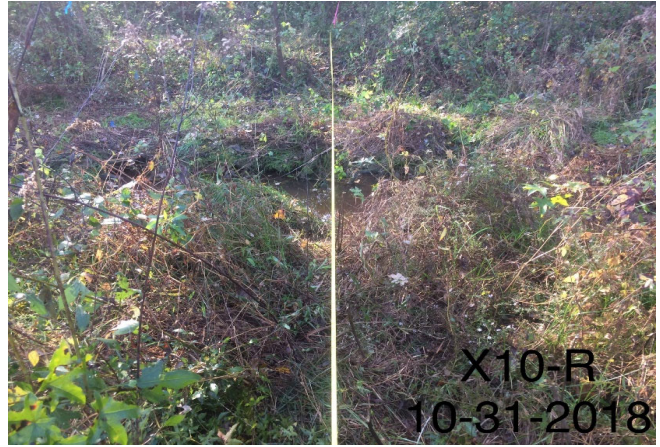
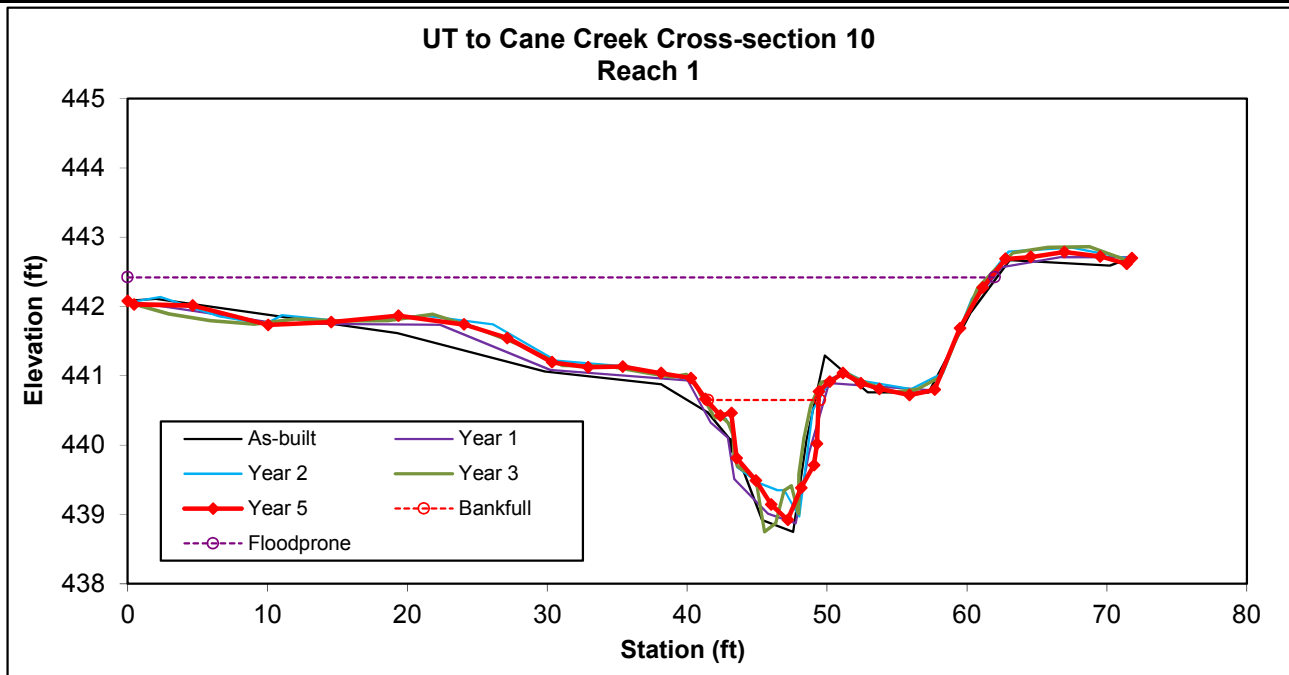
### Permanent Cross-section 10, Reach 1

Feature	Stream Type	BKF Area	BKF Width	BKF Depth	Max BKF Depth	W/D	BH Ratio	ER	BKF Elev	TOB Elev
Pool	-	7.9	8.0	1.0	1.7	8.2	-	-	440.65	440.96
