# **UT to Cane Creek Restoration Project Year 5 FINAL Monitoring Report**

**Alamance County, North Carolina**

**DMS Project ID Number – 95729, DEQ Contract No. 4951**

Monitoring Year: 5 of 7

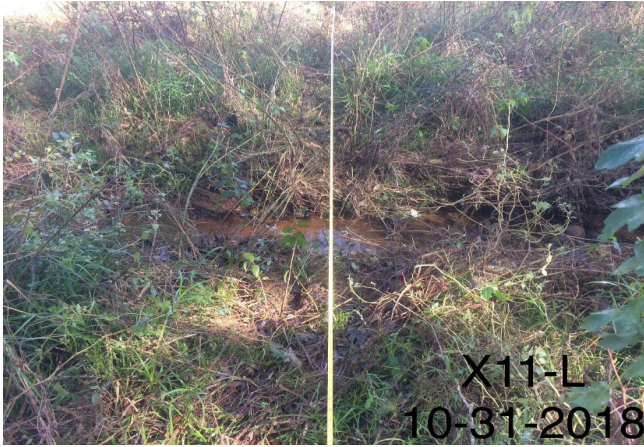
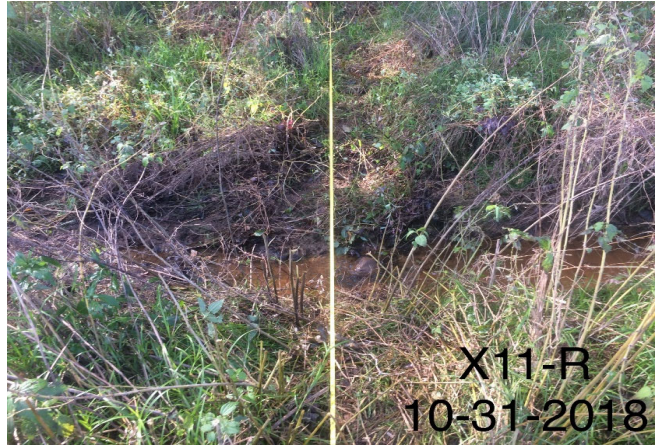
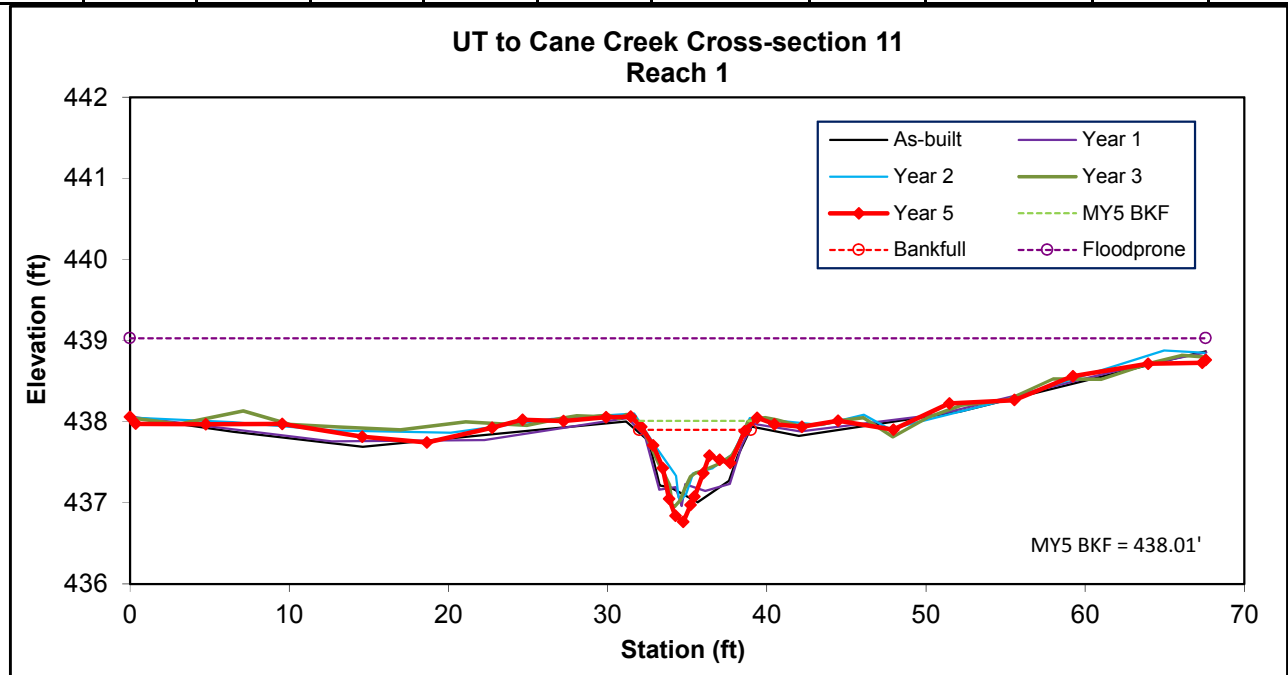
### Permanent Cross-section 11, Reach 1

Feature	Stream Type	BKF Area	BKF Width	BKF Depth	Max BKF Depth	W/D	BH Ratio	ER	BKF Elev	TOB Elev
Riffle	E	3.3	6.4	0.5	1.1	12.2	1.0	10.6	437.9	438.05

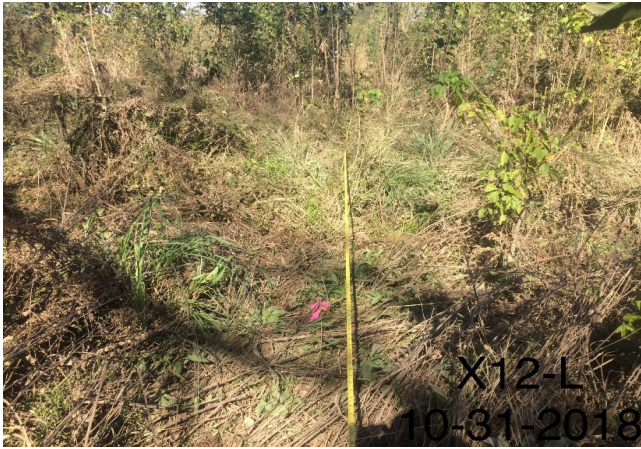
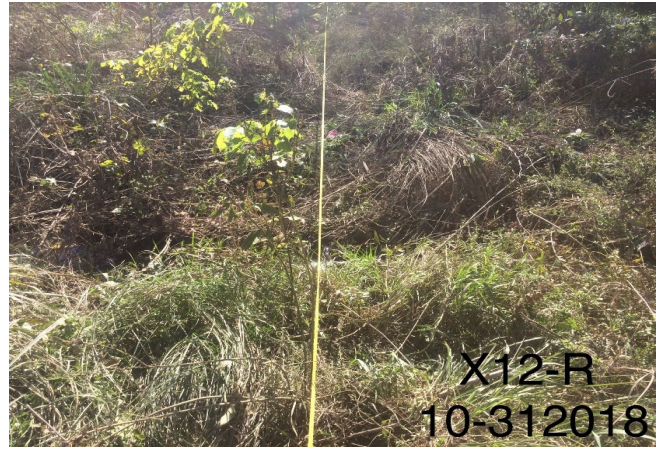
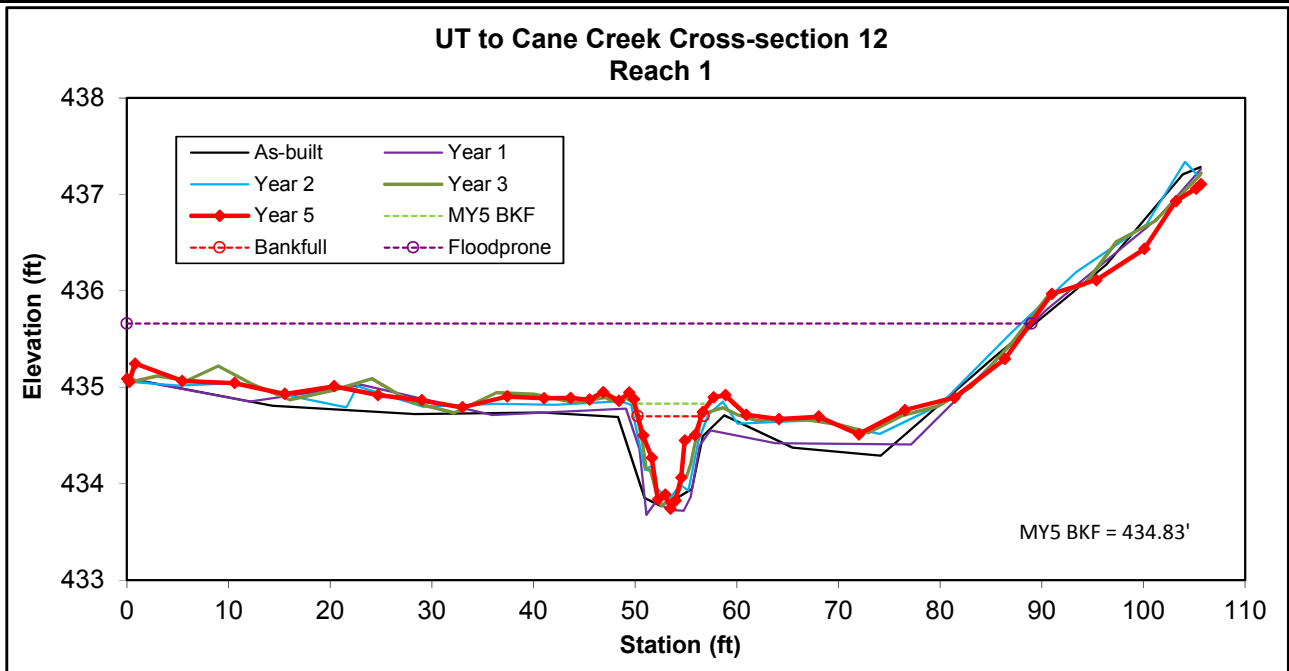
## Permanent Cross-section 12, Reach 1

Feature	Stream Type	BKF Area	BKF Width	BKF Depth	Max BKF Depth	W/D	BH Ratio	ER	BKF Elev	TOB Elev
Riffle	E	3.1	6.2	0.5	1.0	12.6	1.1	14.3	434.70	434.89
