UT to Cane Creek Restoration Project Year 6 Final Monitoring Report

Alamance County, North Carolina

DMS Project ID Number – 95729, DEQ Contract No. 4951

Report Prepared and Submitted by Michael Baker Engineering, Inc.

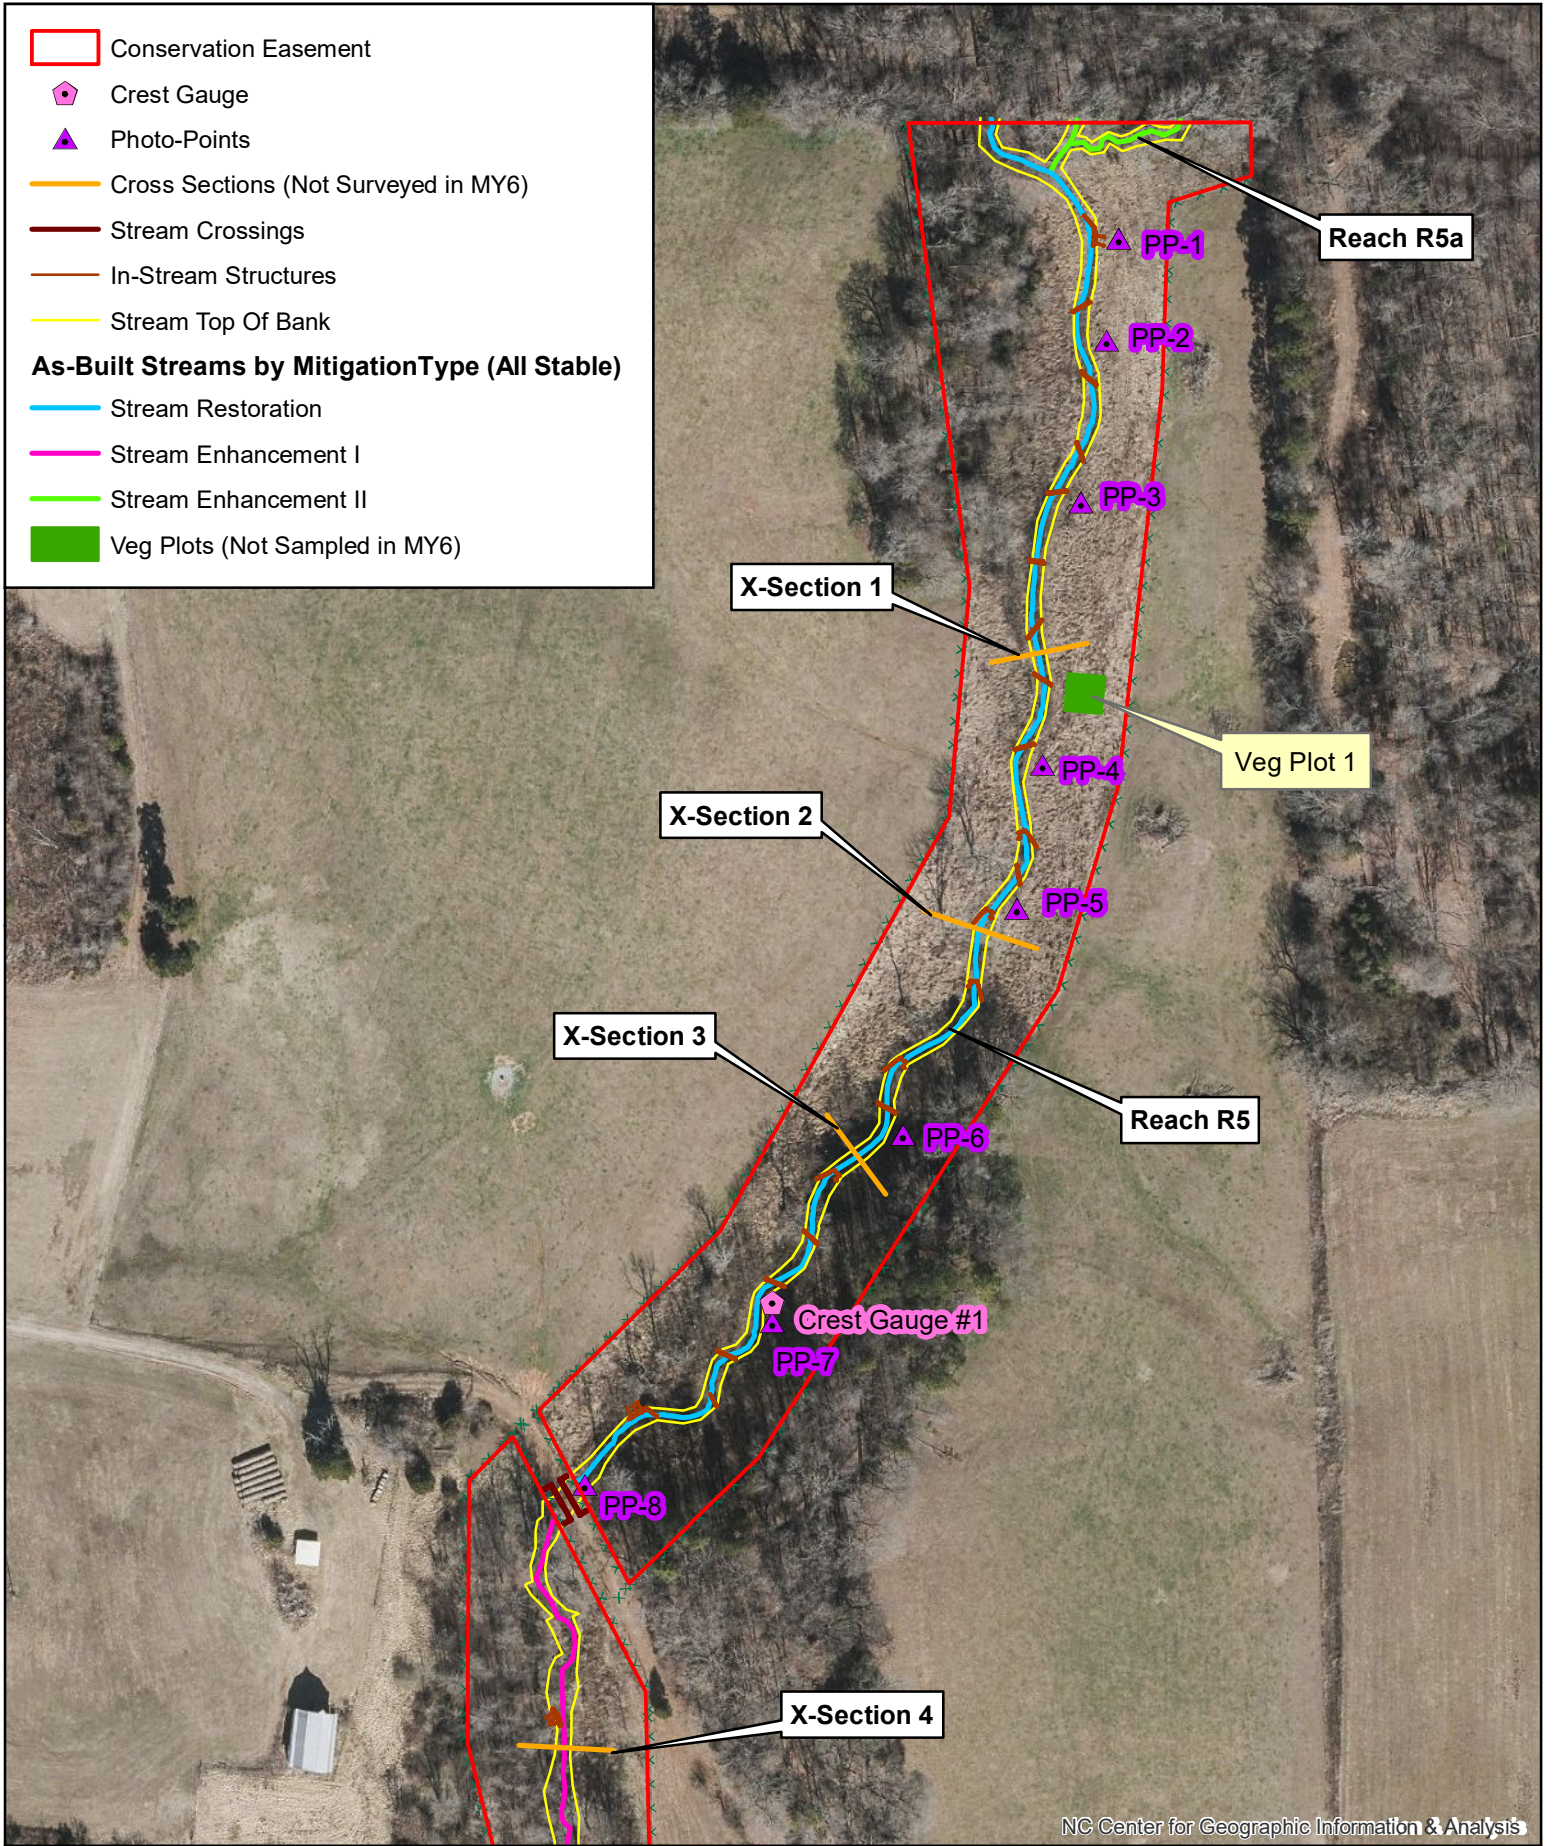
Current Condition
Plan View - Figure 4A
Monitoring Year 6
UT to Cane Creek Site

As discussed in the Year 5 monitoring report, Baker had previously noted a Stream Problem Area (SPA) consisting of a section of bank scour along lower Reach R4 resulting from Hurricane Florence. This section of bank was initially planted with a dense livestake and several one-gallon plants in Feb 2019. However, continued rainfall throughout the late winter and early spring hampered plant establishment, so in June of 2019 the area was graded back in sections and matting was placed along the slope (allowing as many of the previously planted stems to come through the matting as possible). Additional inspections of this area in August and September of 2019 show that the area now appears to be stable and the planted vegetation is establishing. This area will be closely observed in the future to confirm continued stability. This bank repair work is shown on Figure 4 and in the project photographs found in Appendix B.

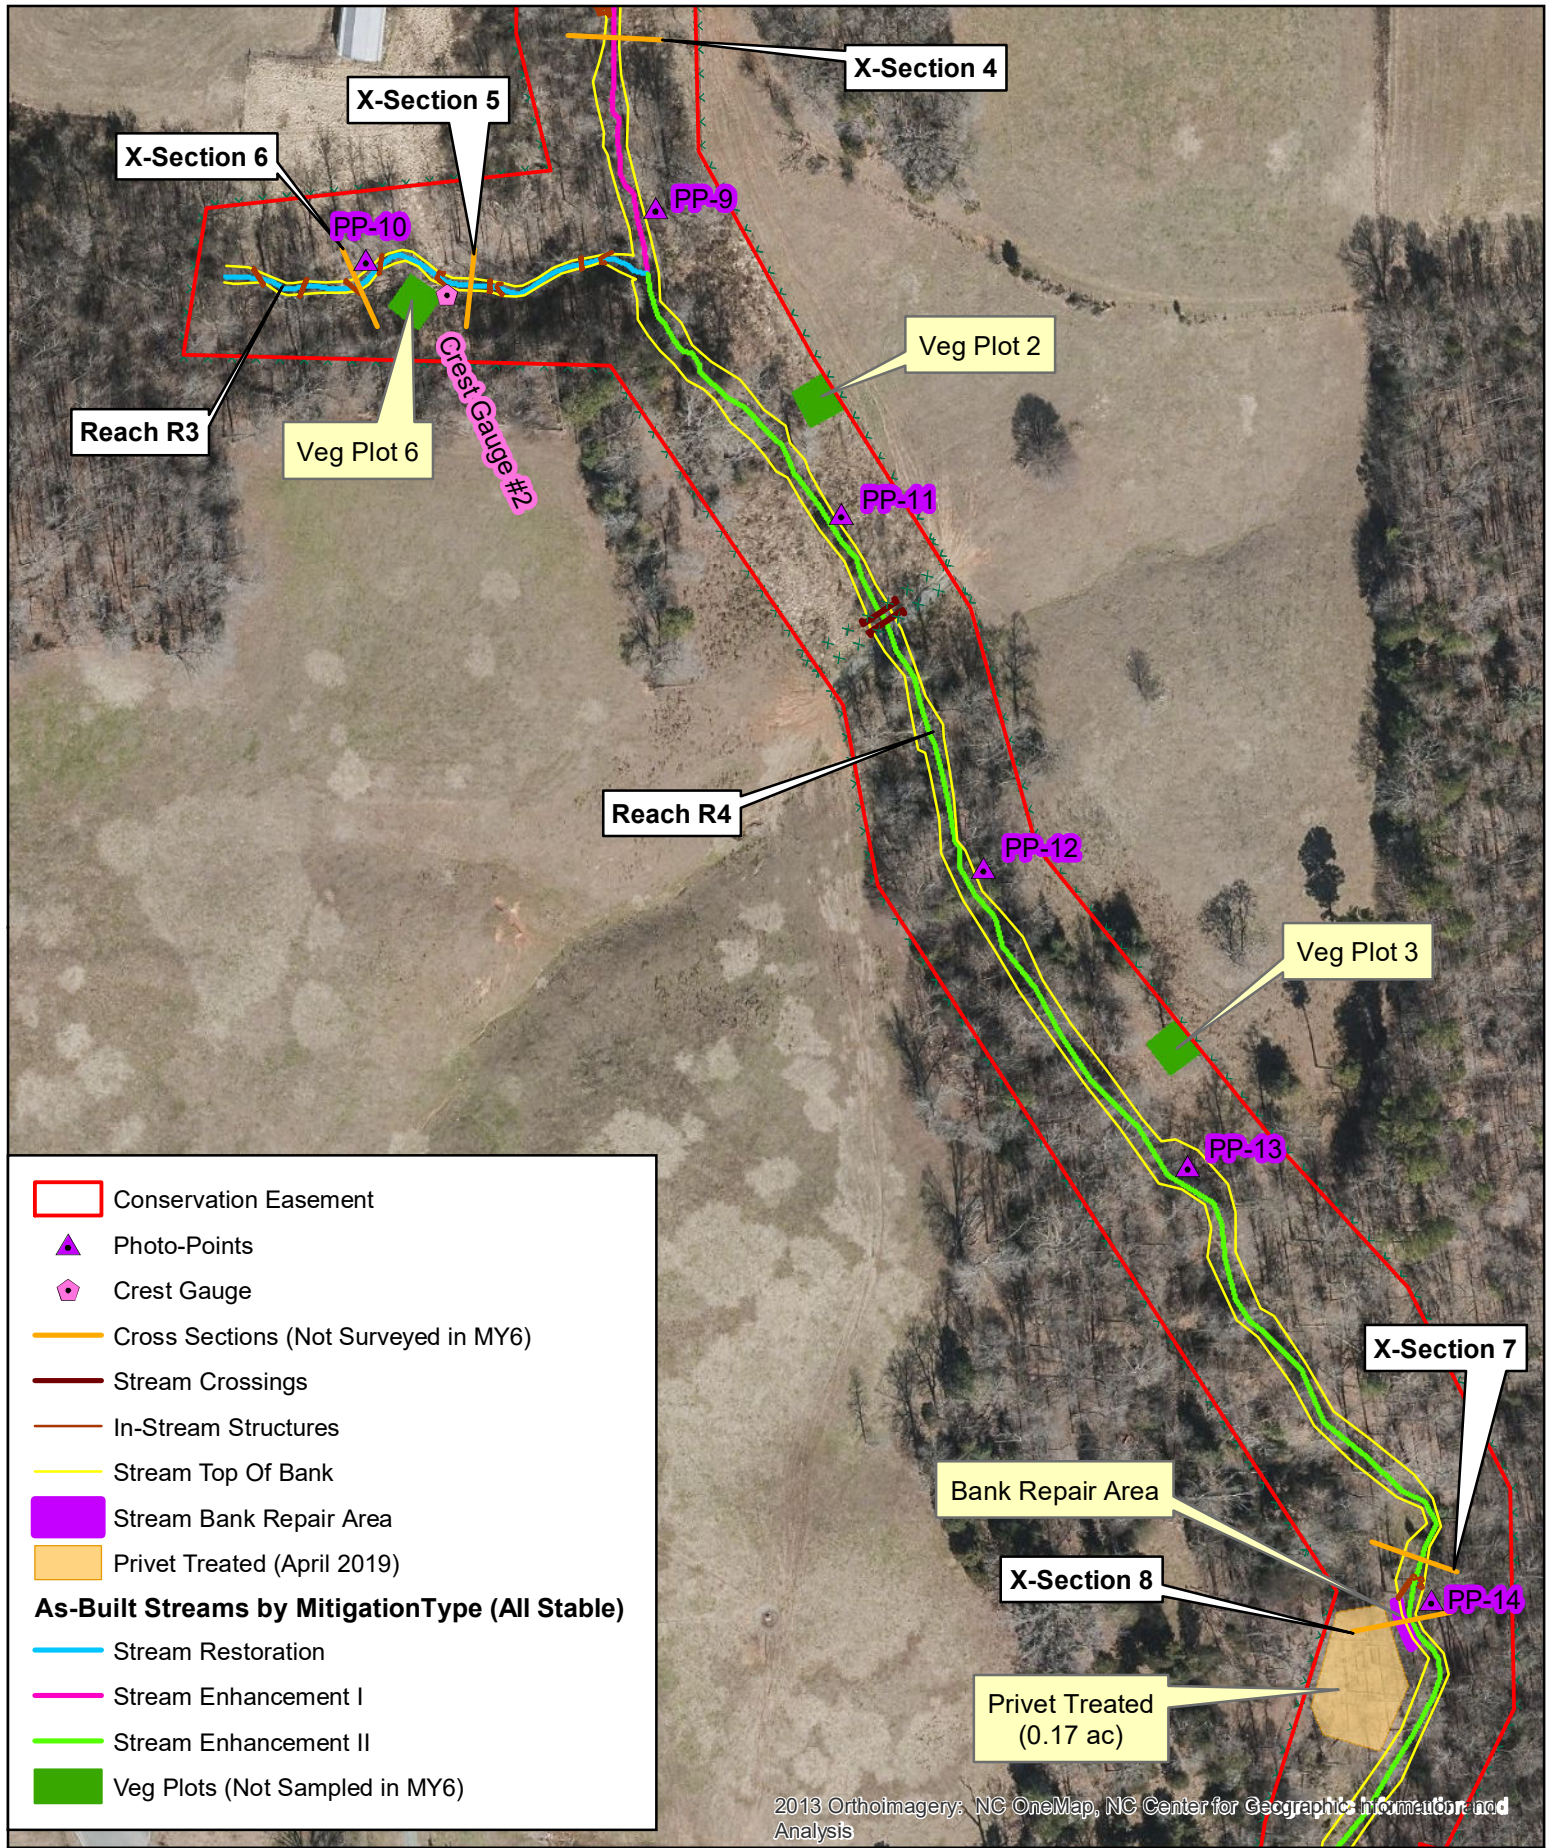
**Current Condition
Plan View - Figure 4B
Monitoring Year 6
UT to Cane Creek Site**

The Year 6 visual inspection monitoring also observed that the planted acreage performance categories were functioning at 100 percent with no eroding or bare areas to report, nor any areas of low stem density, low vigor, or poor growth observed as further detailed in Table 6a (Appendix B). However, a Vegetative Problem Area (VPA) was noted consisting of two sections of scattered Chinese privet (*Ligustrum sinense*) found along both banks within the wooded lower section of Reach R4 as detailed in Table 6b and shown in Figure 4 (Appendix B). These areas will be treated in the spring of 2020, when treatment methods are the most effective.

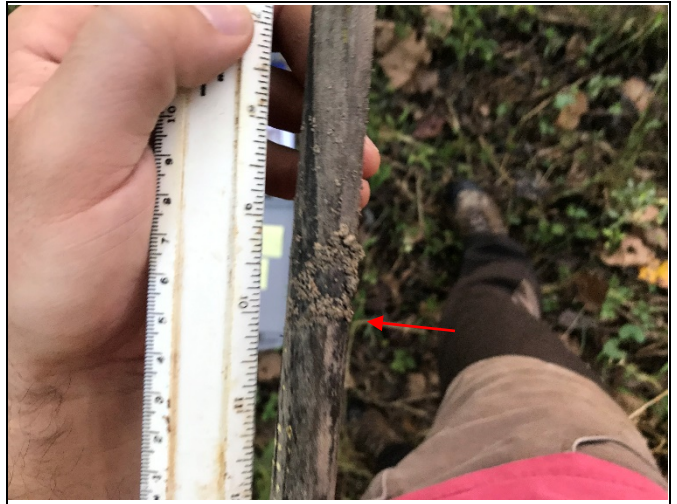
Reach R3: Closeup of Crest Gauge #1 on 6/6/19

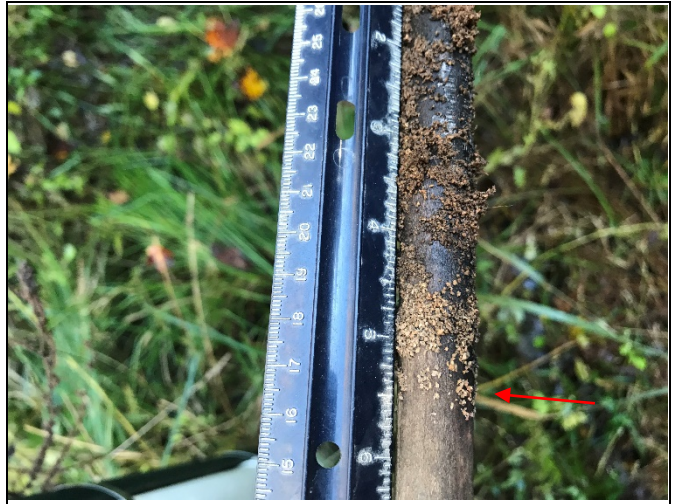
Reach R3: Closeup of Crest Gauge #2 on 6/6/19
