# UT to Cane Creek Restoration Project Year 7 Final Monitoring Report

Alamance County, North Carolina

DMS Project ID Number – 95729, DEQ Contract No. 4951

Monitoring Year: 7 of 7

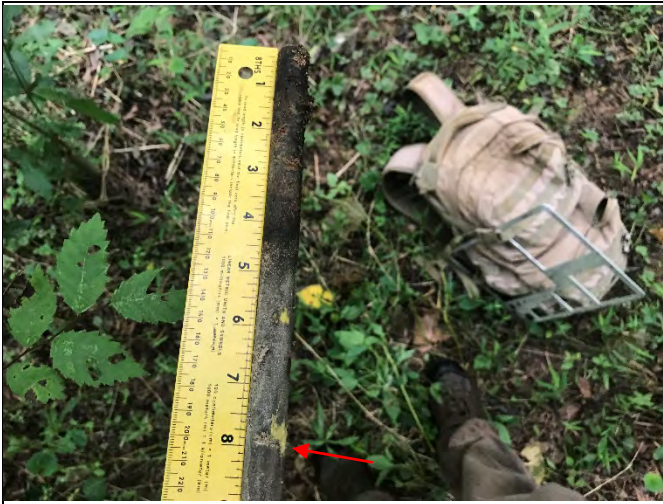
During Year 7 monitoring, the Reach R3 crest gauge (crest gauge #2) documented one bankfull event from the flooding resulting from heavy rainfall over two days in early August. Based on visual evidence of the floodplain it also appears that Reach R5 experienced an overbank event during the same storm but crest gauge #1 was found to have an established ant nest within it which destroyed any potential cork indicator. The crest gauge was thoroughly cleaned out and set back up. All crest gauge reading information is presented in Appendix E.

Reach R3: Crest Gauge #2, 0.67 feet on 8/28/2020 (after 2.47" storm event on 8/4 and 8/5)

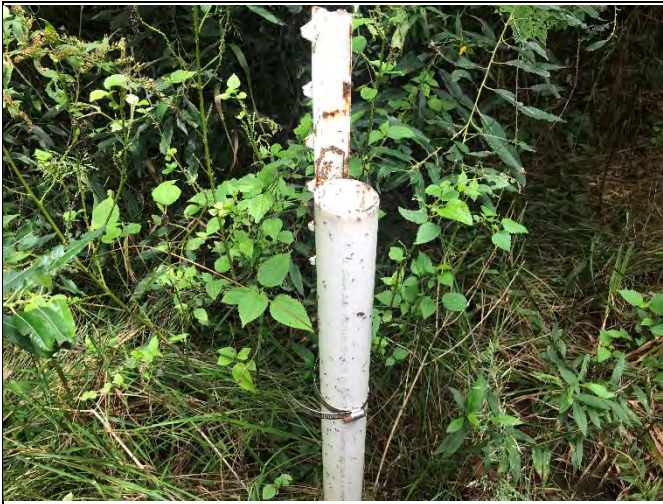
Reach R5: Crest Gauge #1 (ant colony destroyed cork indicators – has been cleaned and restored)

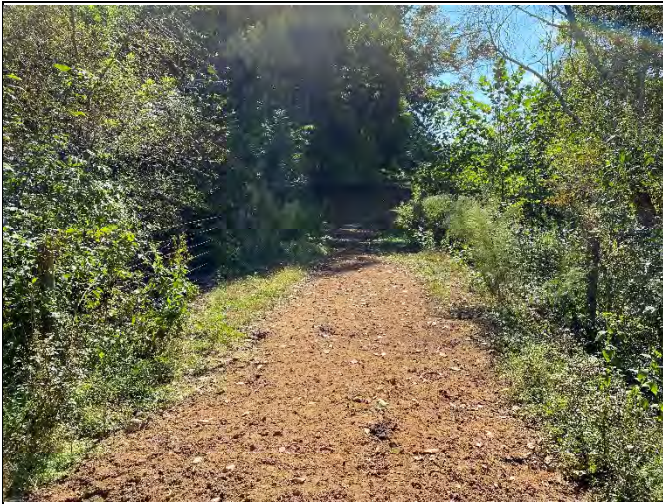
Pipe culvert crossing on lower Reach R5

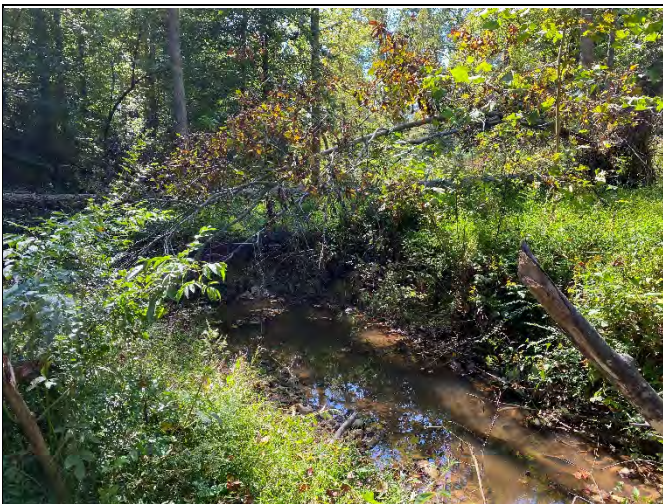
There were no Stream Problem Areas (SPAs) observed during the Year 7 monitoring. The previously reported section of bank scour along Reach R4 from Year 5 has continued to stabilize with livestock vegetation establishing well based on visual observations made during the monitoring year. Baker will continue to evaluate this area and supplement with additional livestock transplants over the winter to ensure continued stability. Additionally, a beaver dam was discovered towards the top of Reach R1 in early 2020 (see CCPV for location) and was removed in March 2020. The beaver likely came up the reach from the adjacent Cane Creek but the dam has not been reestablished. This reach will be closely monitored for additional beaver activity.

Reach R4 Station 43+50: Stabilizing and vegetating from previously documented bank scour from Hurricane Florence in Sept 2018 (photo from Oct 2020)
