**UT to Town Creek Restoration Project – Option A
Year 2 Monitoring Report**

Stanly County, North Carolina

DMS Project ID Number – 94648; NC DEQ Contract No. 003277

Monitoring Year: 2 of 7

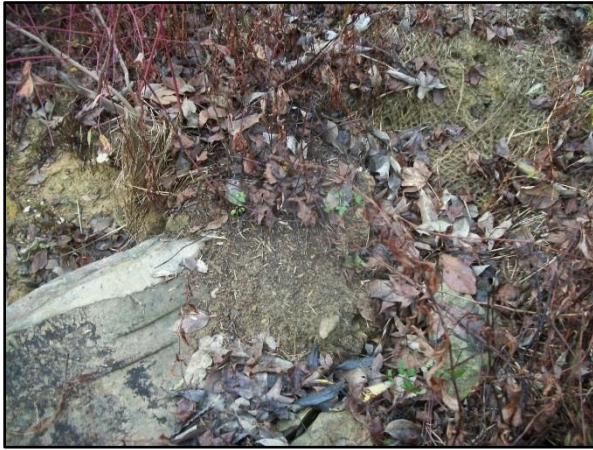
SPA2-1 – Station 16+20 - Erosion around right seal of boulder step. (11/09/17)

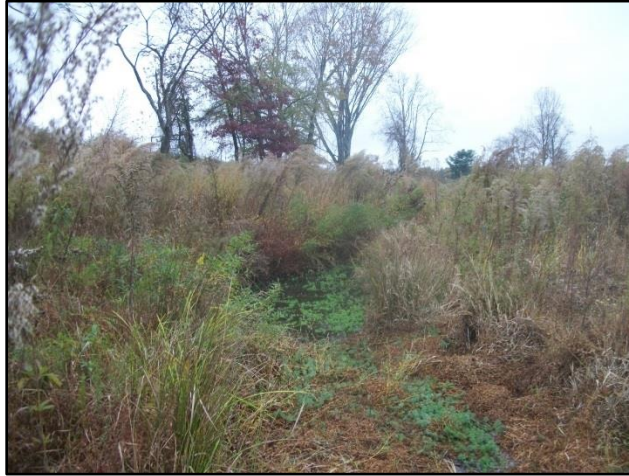
Reach 1			
Feature Issue	Station No.	Suspected Cause	Problem Area / Photo Number
Invasive/Exotic Populations	Reachwide in various locations	Myriophyllum aquaticum (parrot feather) growing in various locations along the channel reach due low flow conditions present during the monitoring assessment.	No VPA was associated with this problem area because it is a reachwide issue that is located in various sections along the Reach 1.
Reach 2			
Feature Issue	Station No.	Suspected Cause	Problem Area / Photo Number
Invasive/Exotic Populations	Reachwide in various locations	Myriophyllum aquaticum (parrot feather) growing in various locations along the channel reach due low flow conditions present during the monitoring assessment.	No VPA was associated with this problem area because it is a reachwide issue that is located in various sections along the Reach 1.
Invasive/Exotic Populations	22+25 - 24+25	<i>Ligustrum sinense</i> (Chinese privet) growing in easement in right floodplain	VPA 2-1

Myriophyllum aquaticum (Parrot feather) - Reach 1

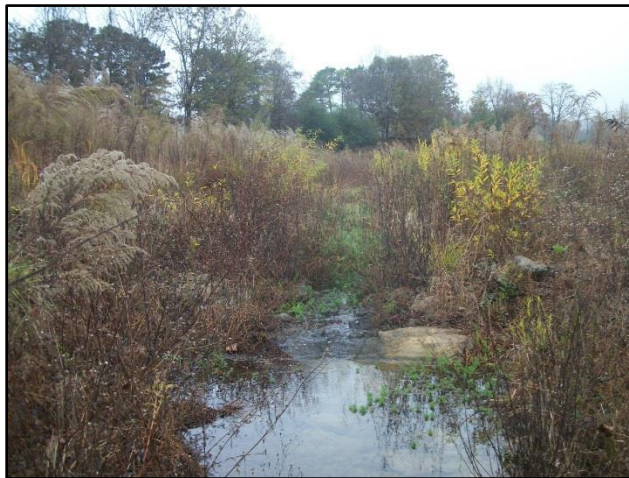
Myriophyllum aquaticum (Parrot feather) - Reach 2

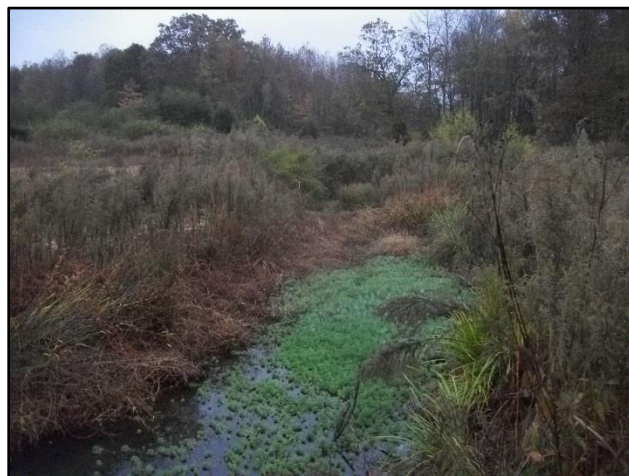
Reach 3			
Feature Issue	Station No.	Suspected Cause	Problem Area / Photo Number
Invasive/Exotic Populations	Reachwide in various locations	Myriophyllum aquaticum (parrot feather) growing in various locations along the channel reach due low flow conditions present during the monitoring assessment.	No VPA was associated with this problem area because it is a reachwide issue that is located in various sections along the Reach 1.
Bare Floodplain	46+50 - 48+00	Poor soils	VPA 2-2
Reach 4			
Feature Issue	Station No.	Suspected Cause	Problem Area / Photo Number
Invasive/Exotic Populations	13+80 - 14+50	<i>Ligustrum sinense</i> (Chinese Privet) and <i>Rosa multiflora</i> (Multi-flora rose) growing in easement along left bank.	VPA 2-6
Reach 5			
Feature Issue	Station No.	Suspected Cause	Problem Area / Photo Number
No Problems	N/A	-	-
Reach 6			
Feature Issue	Station No.	Suspected Cause	Problem Area / Photo Number

Myriophyllum aquaticum (Parrot feather) - Reach 3

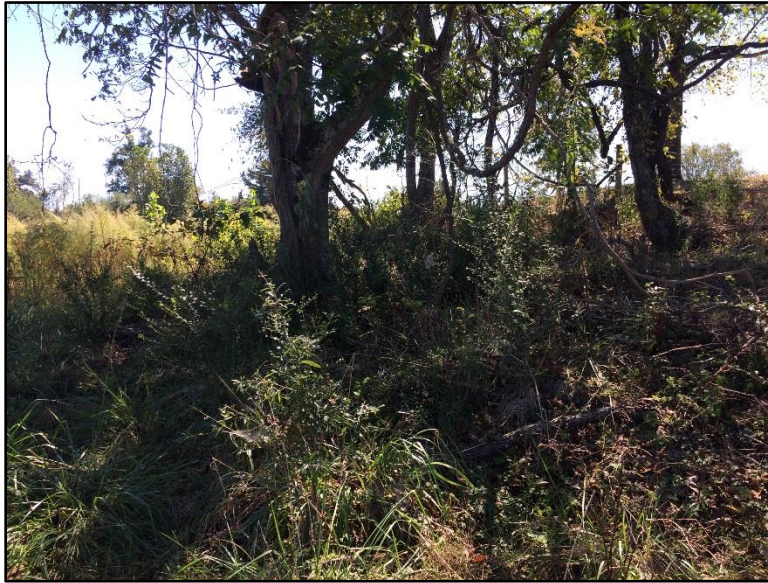
VPA 2-1 – *Ligustrum sinense* in Right Floodplain (10/16/17)

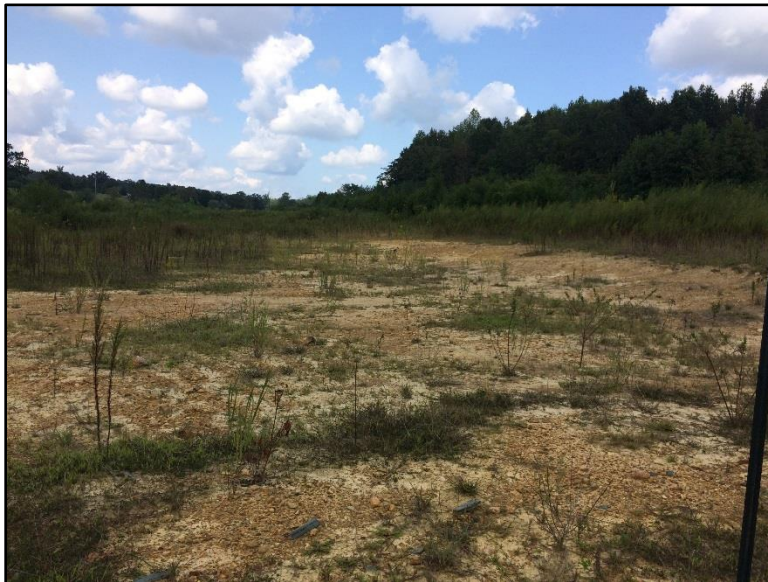
VPA 2-2 – Bare Area in Left Floodplain from Station 46+50 – 48+00 (09/19/17)

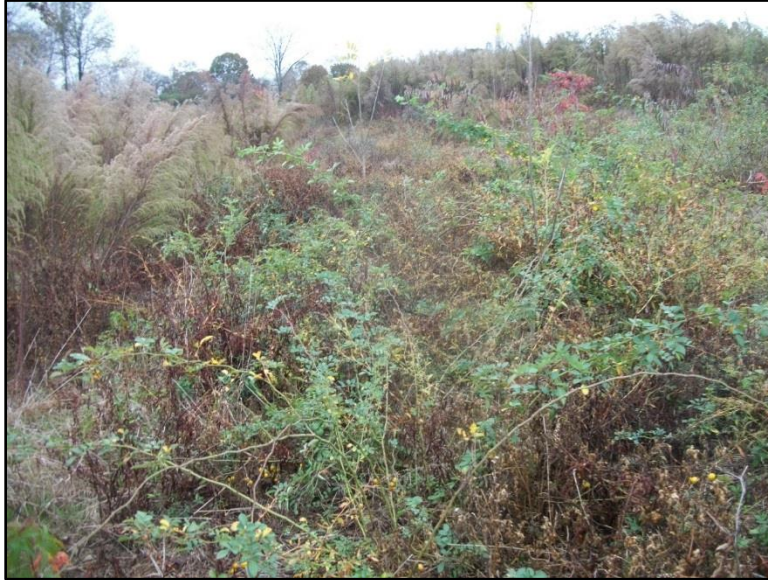
**VPA2-4 – *Rosa multiflora* in Right Floodplain from Station 19+60 – 20+25
(11/09/17)**

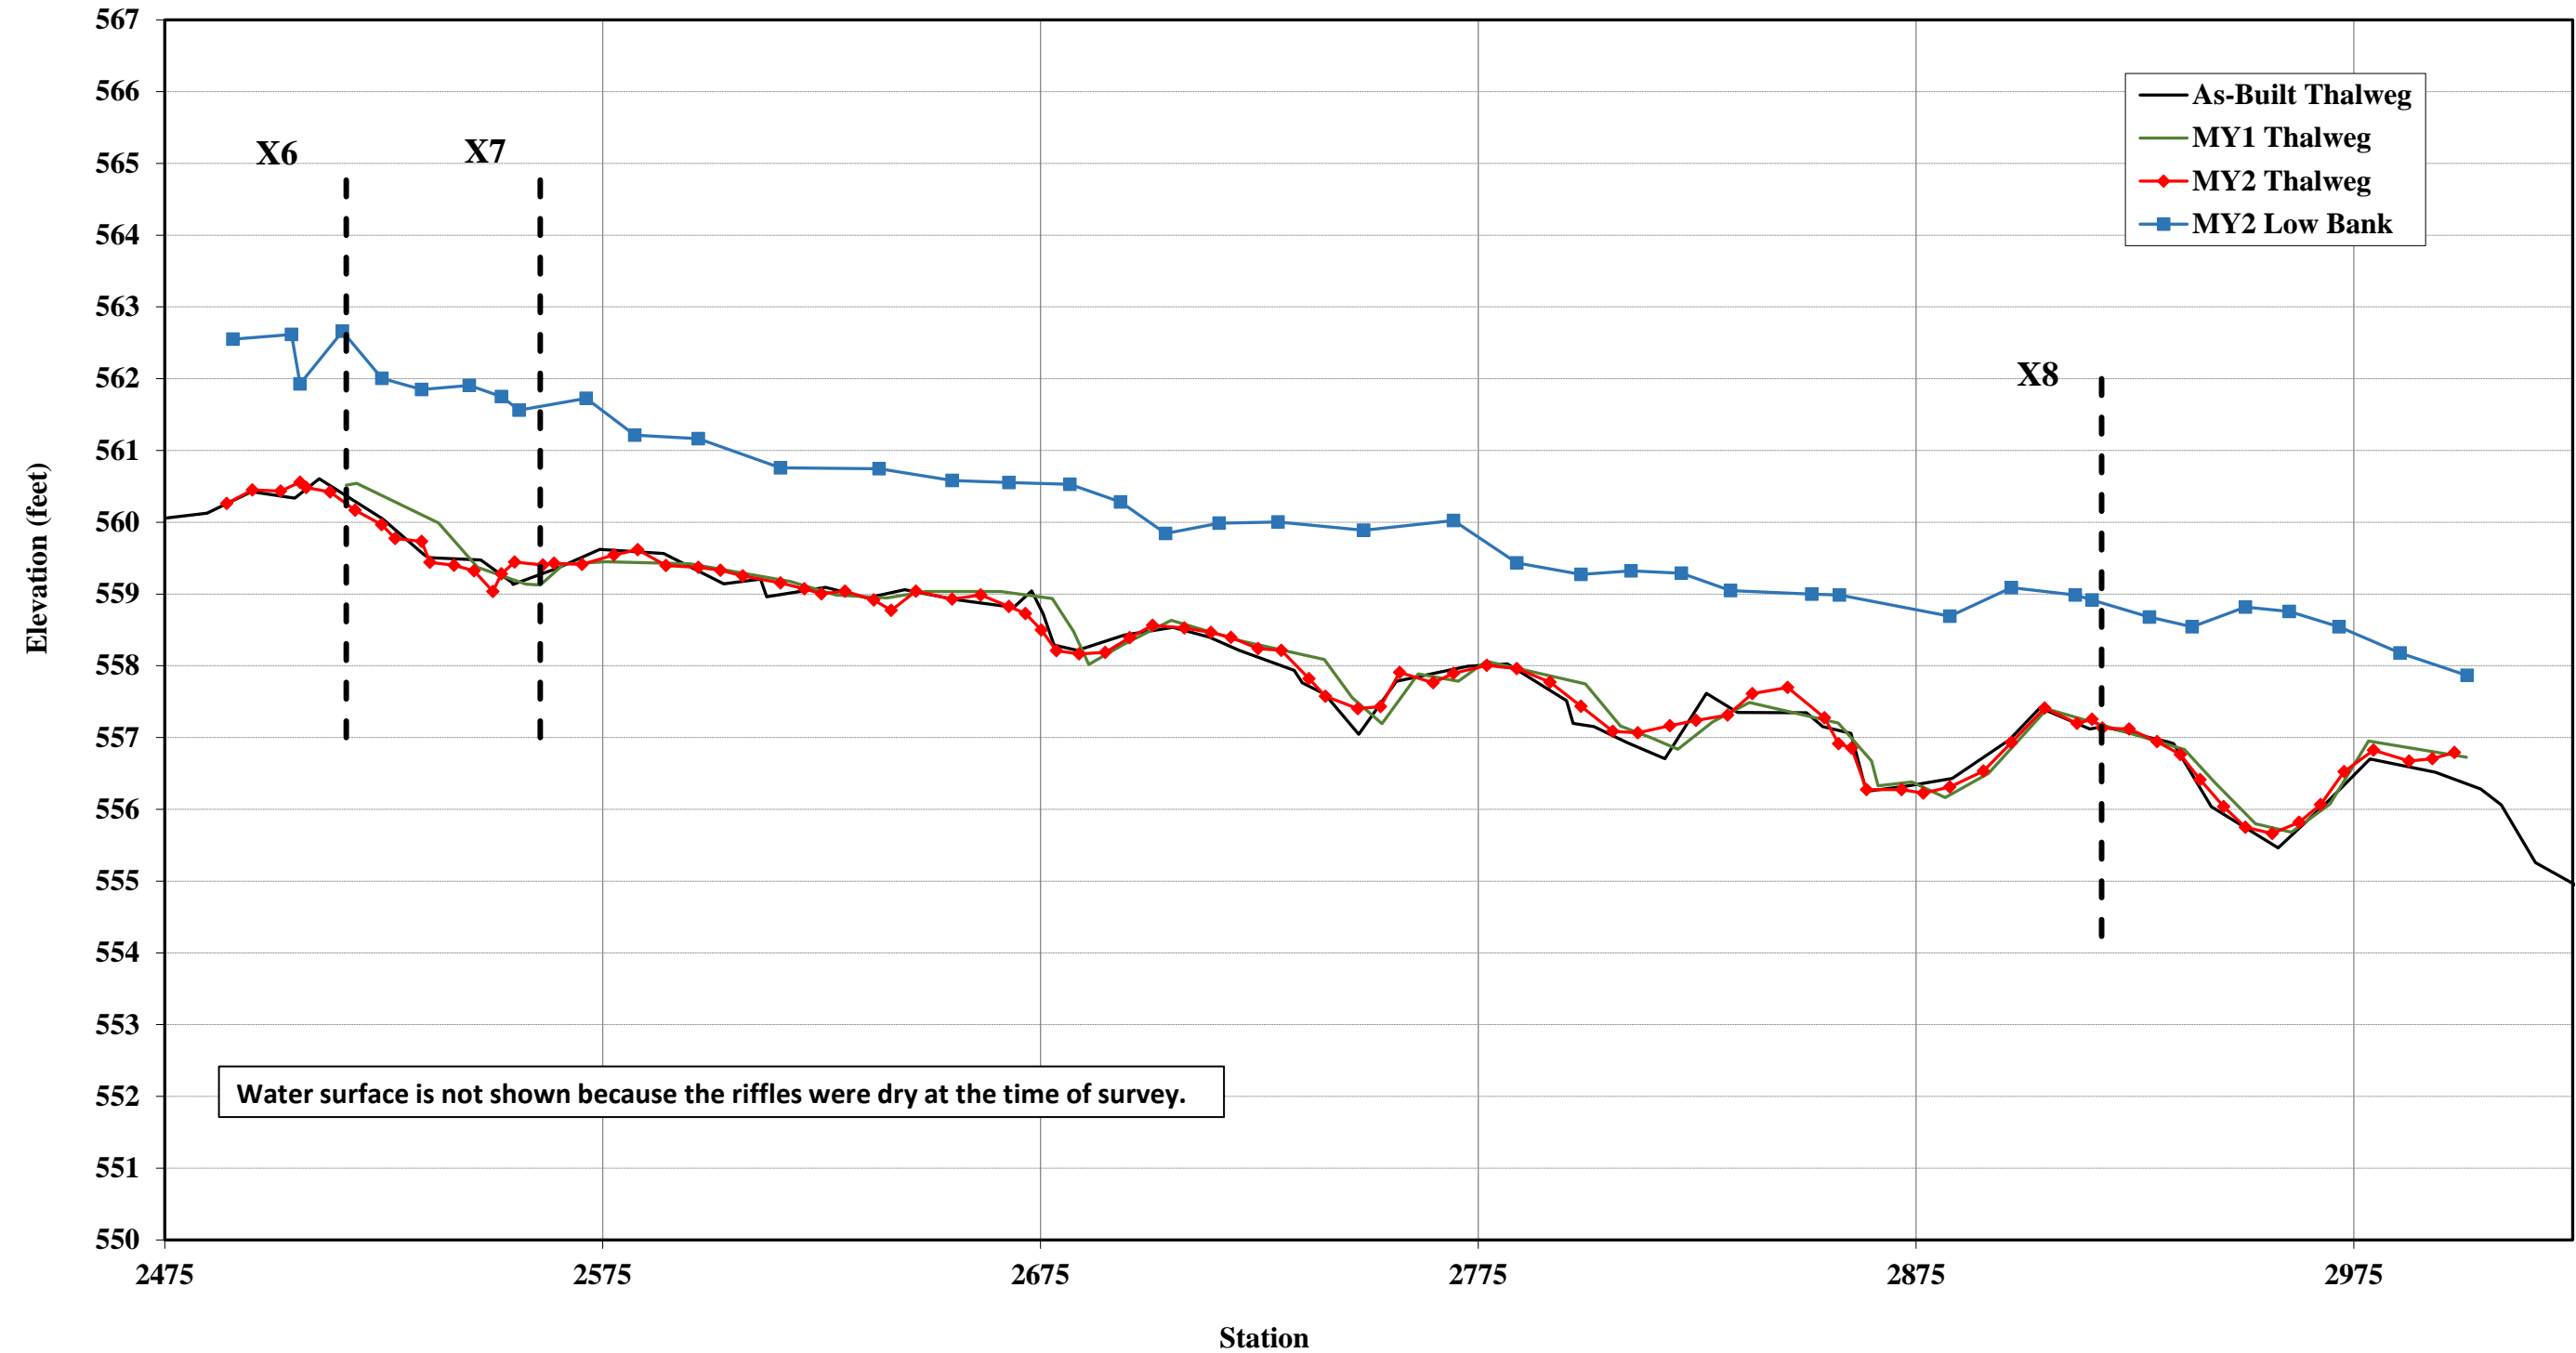
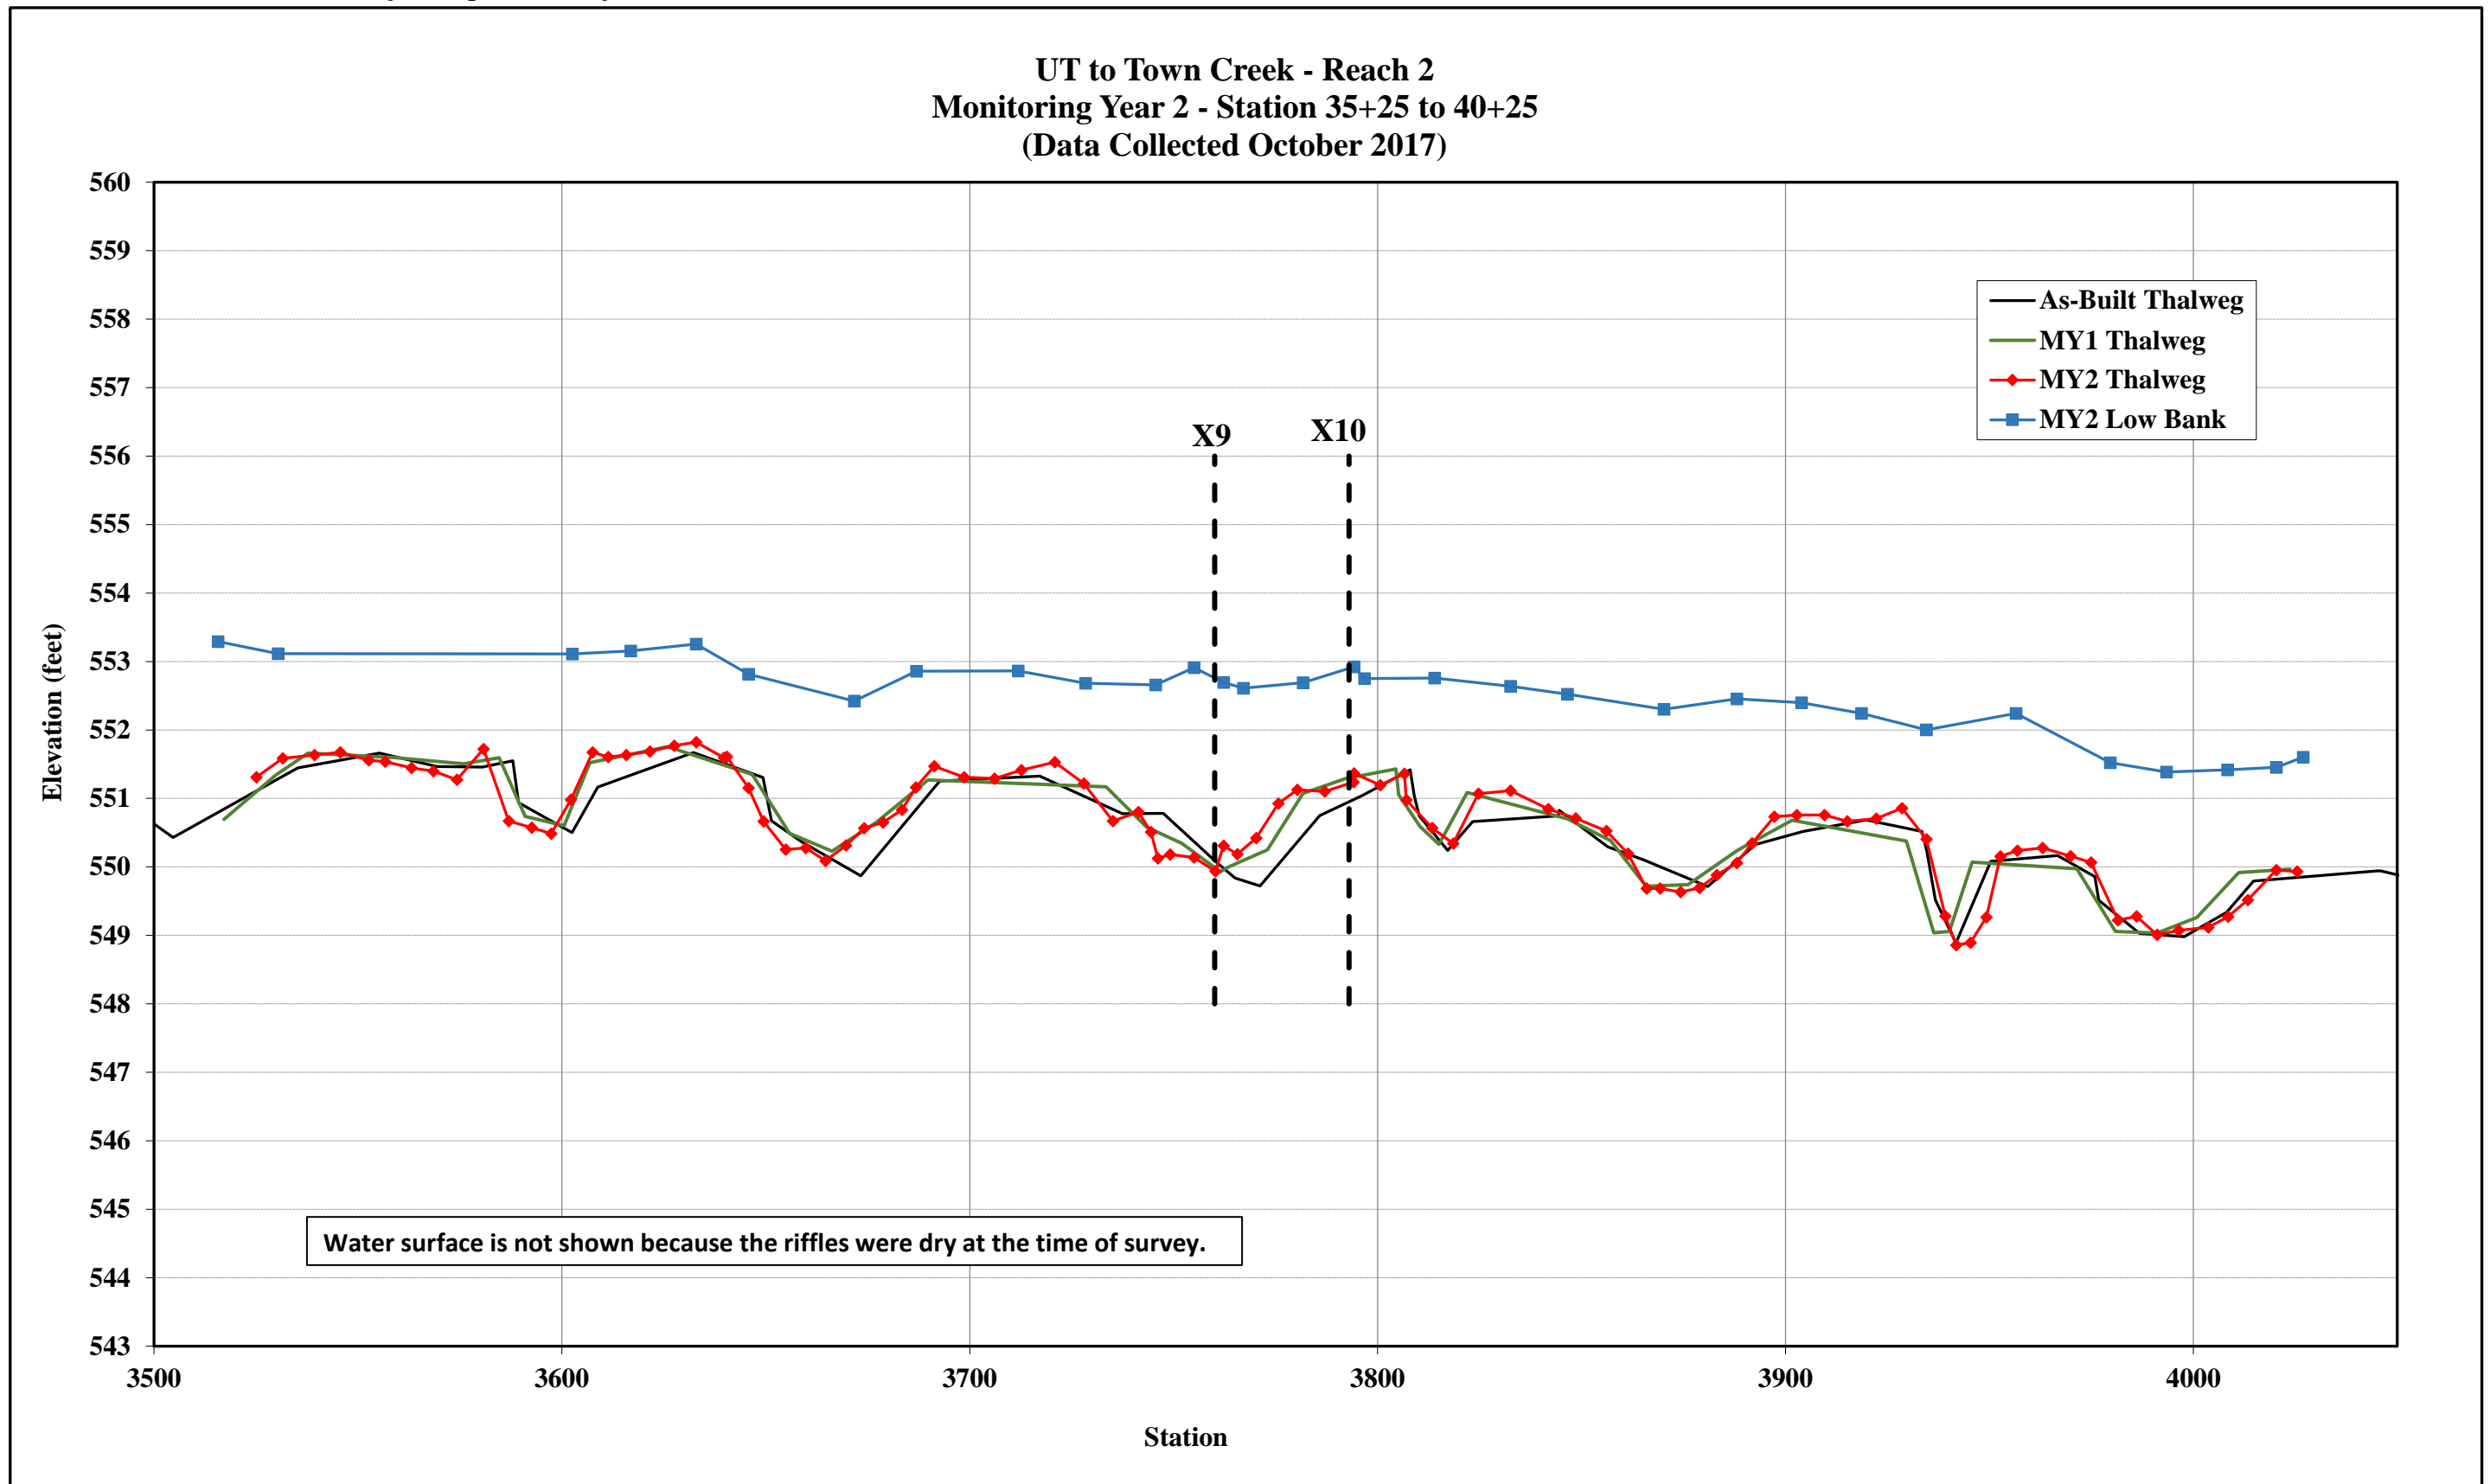
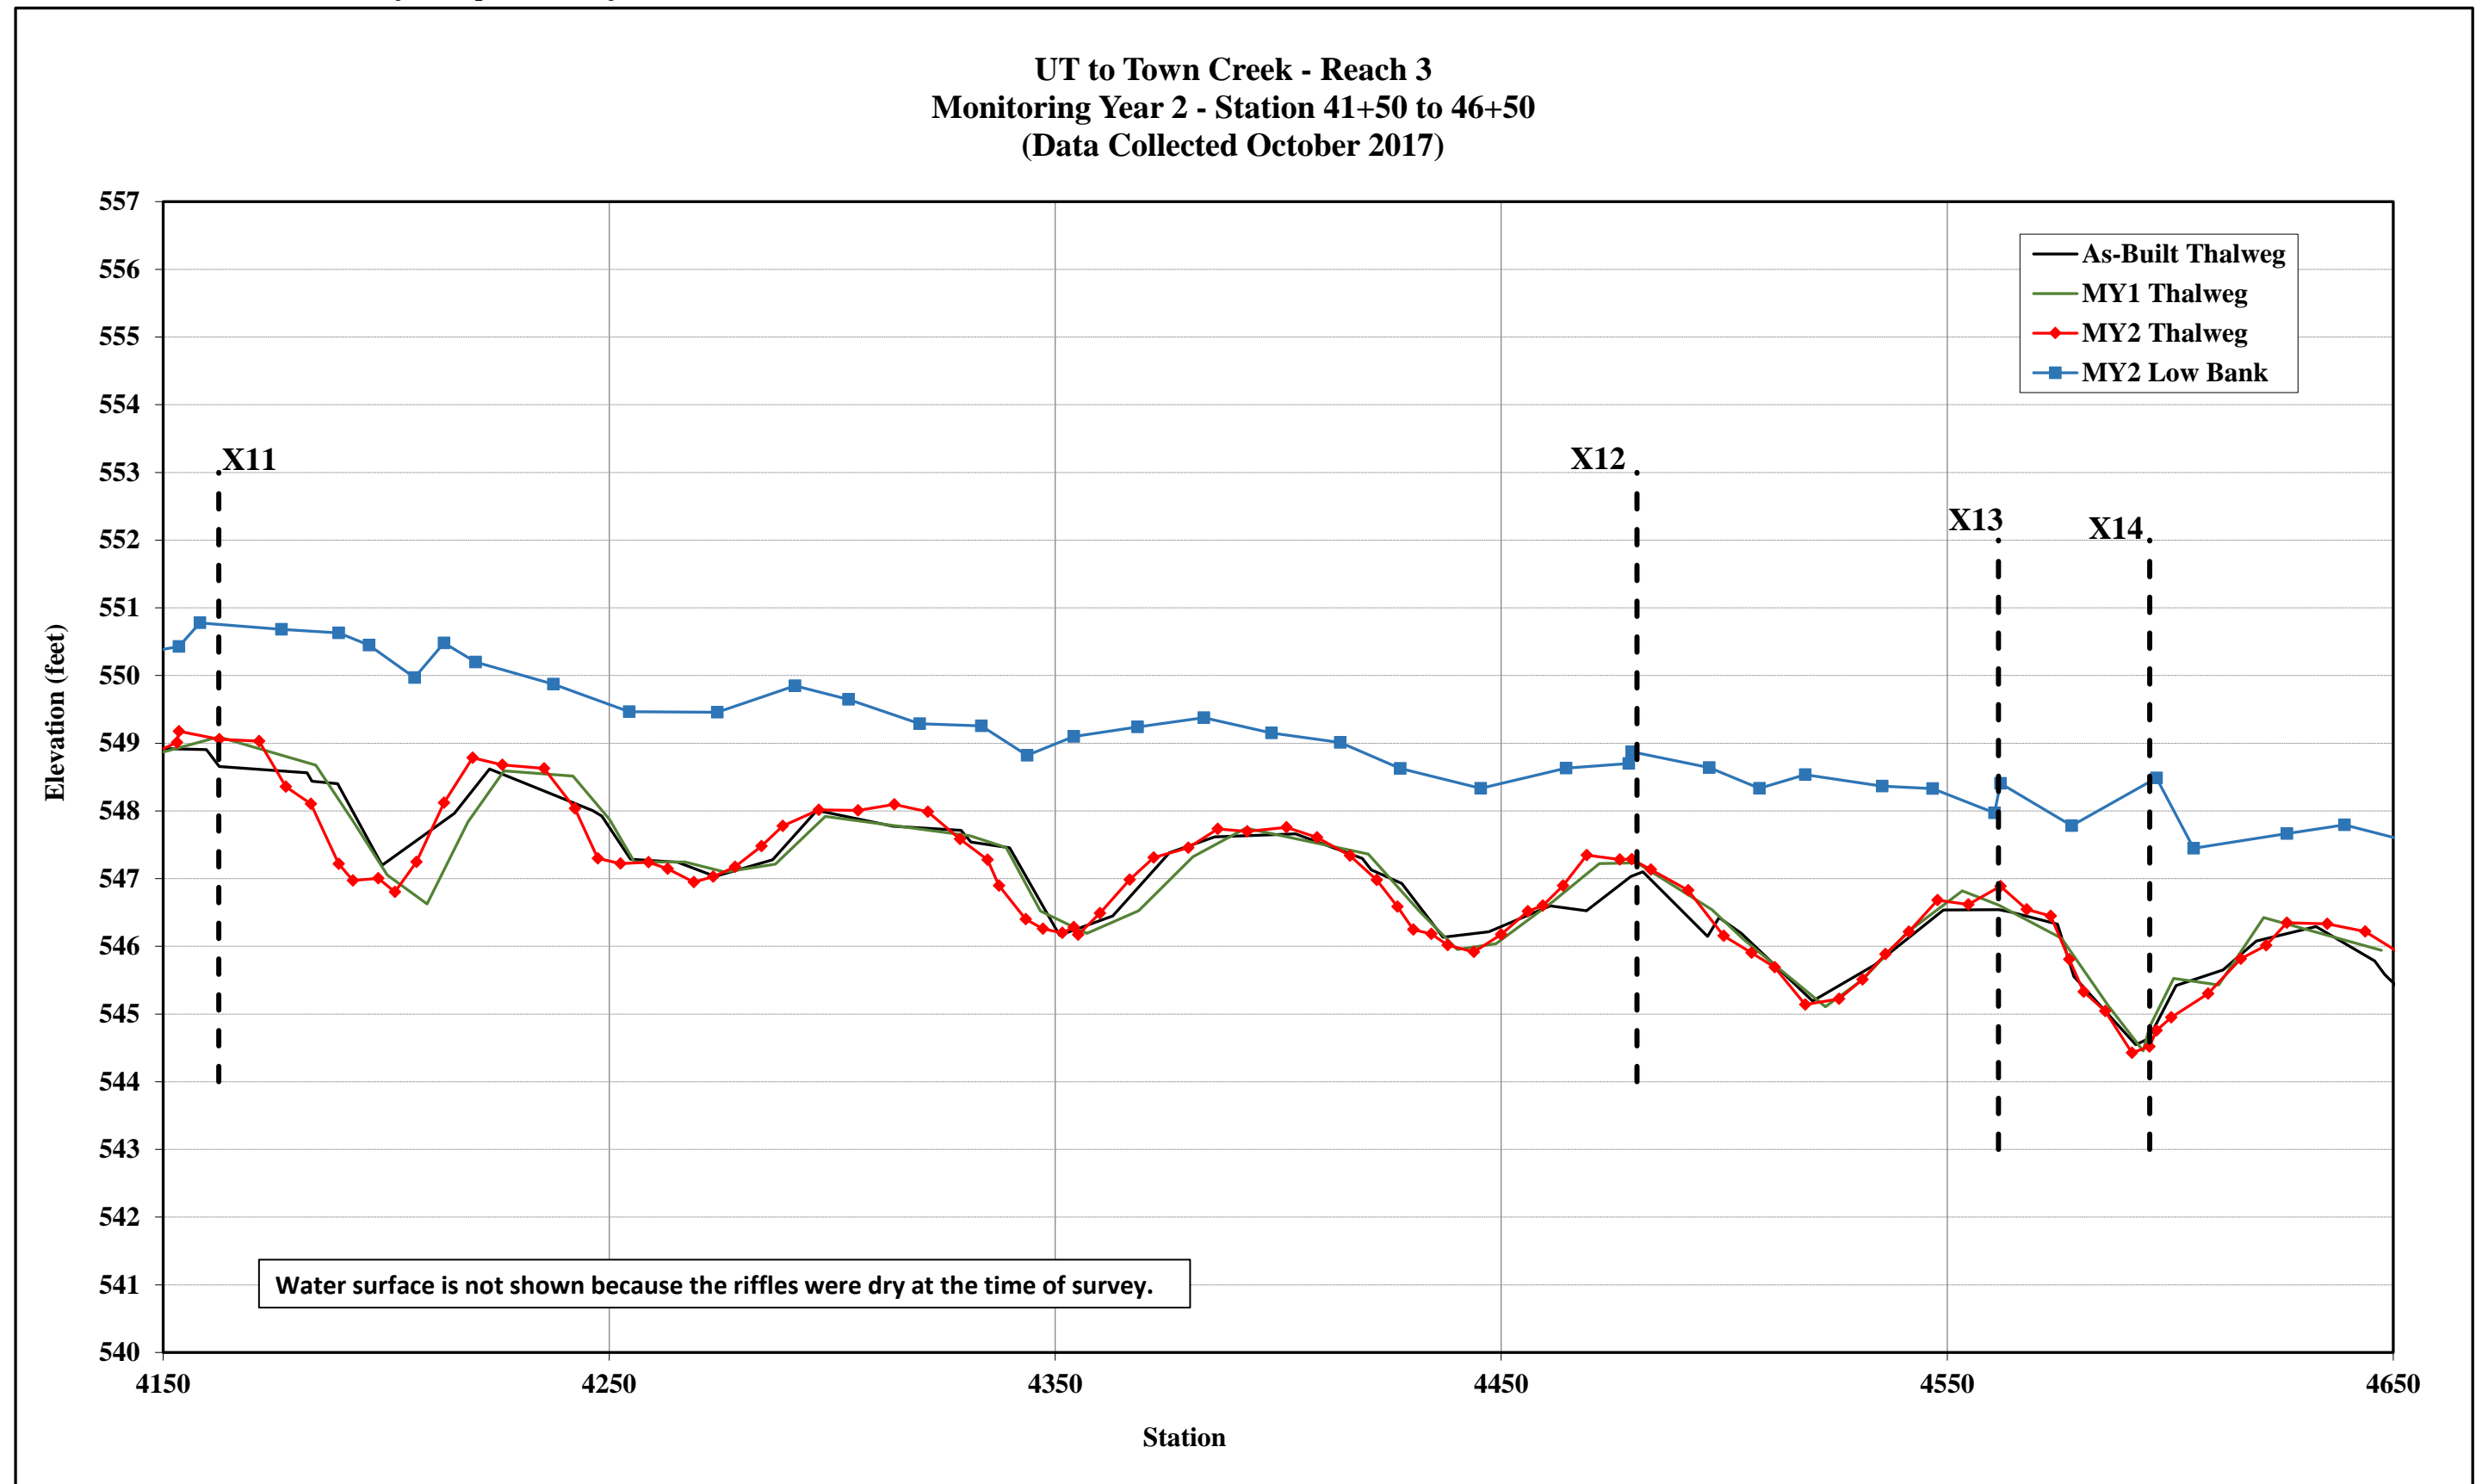
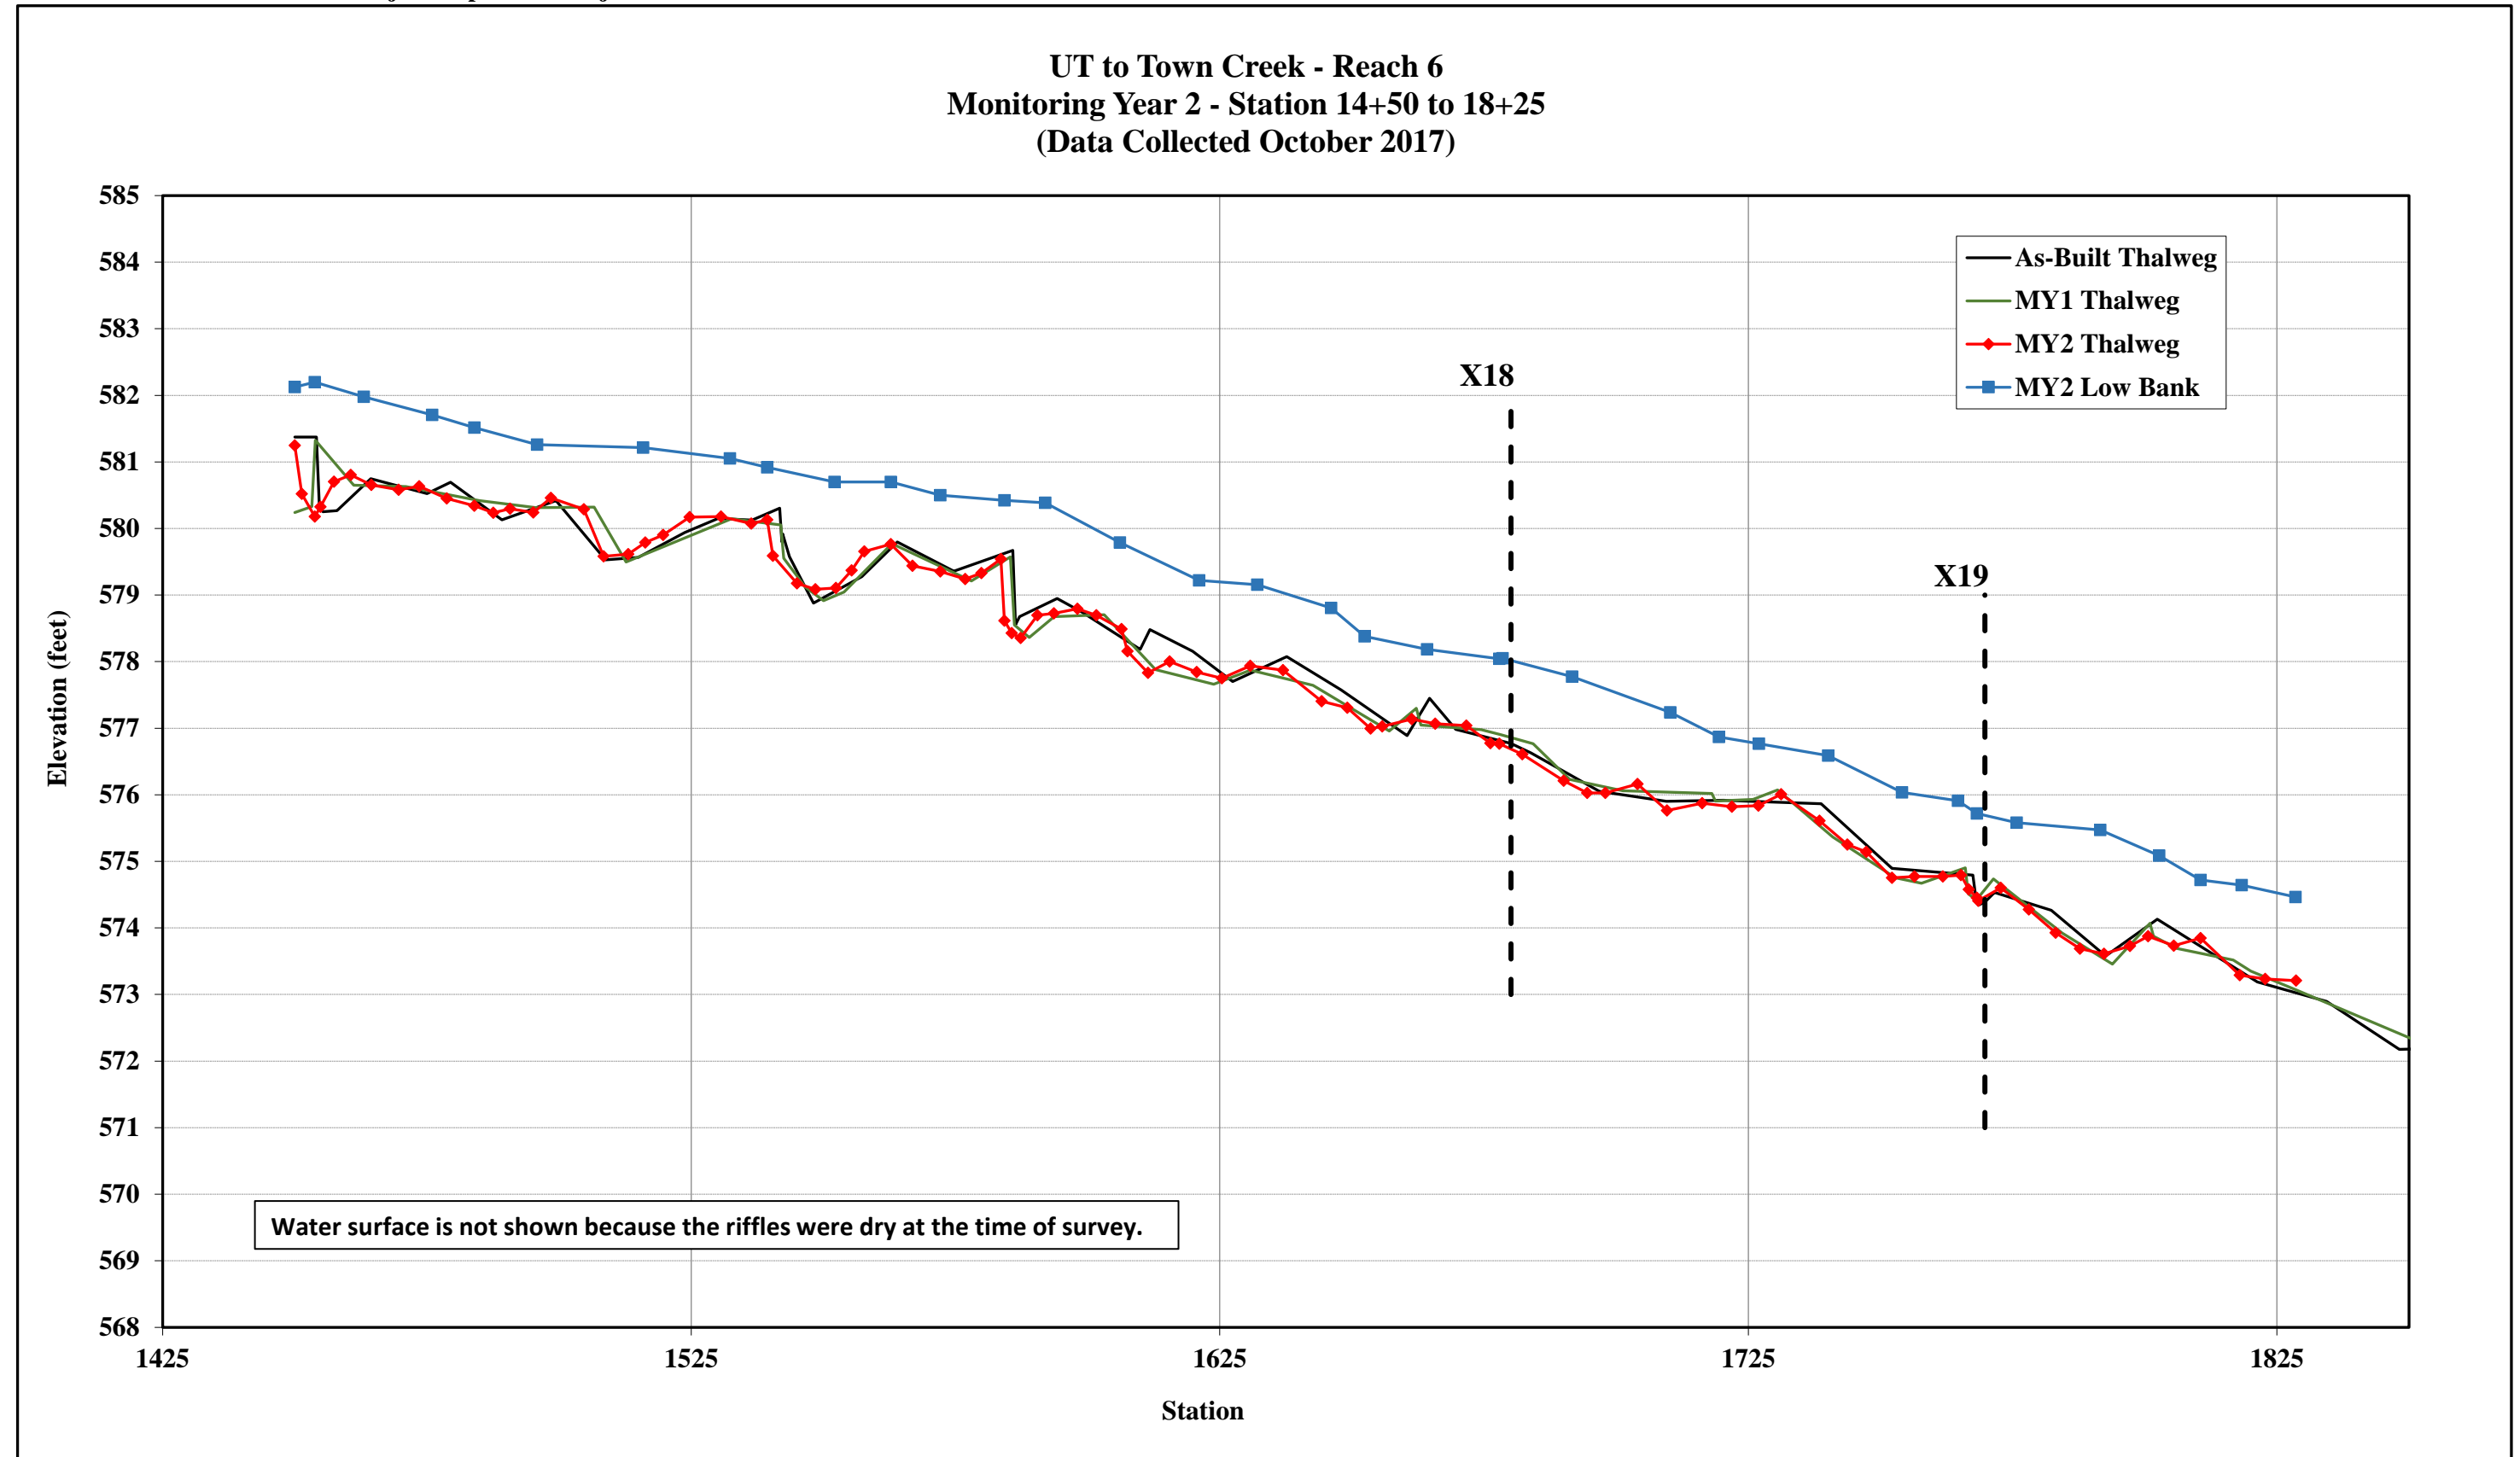
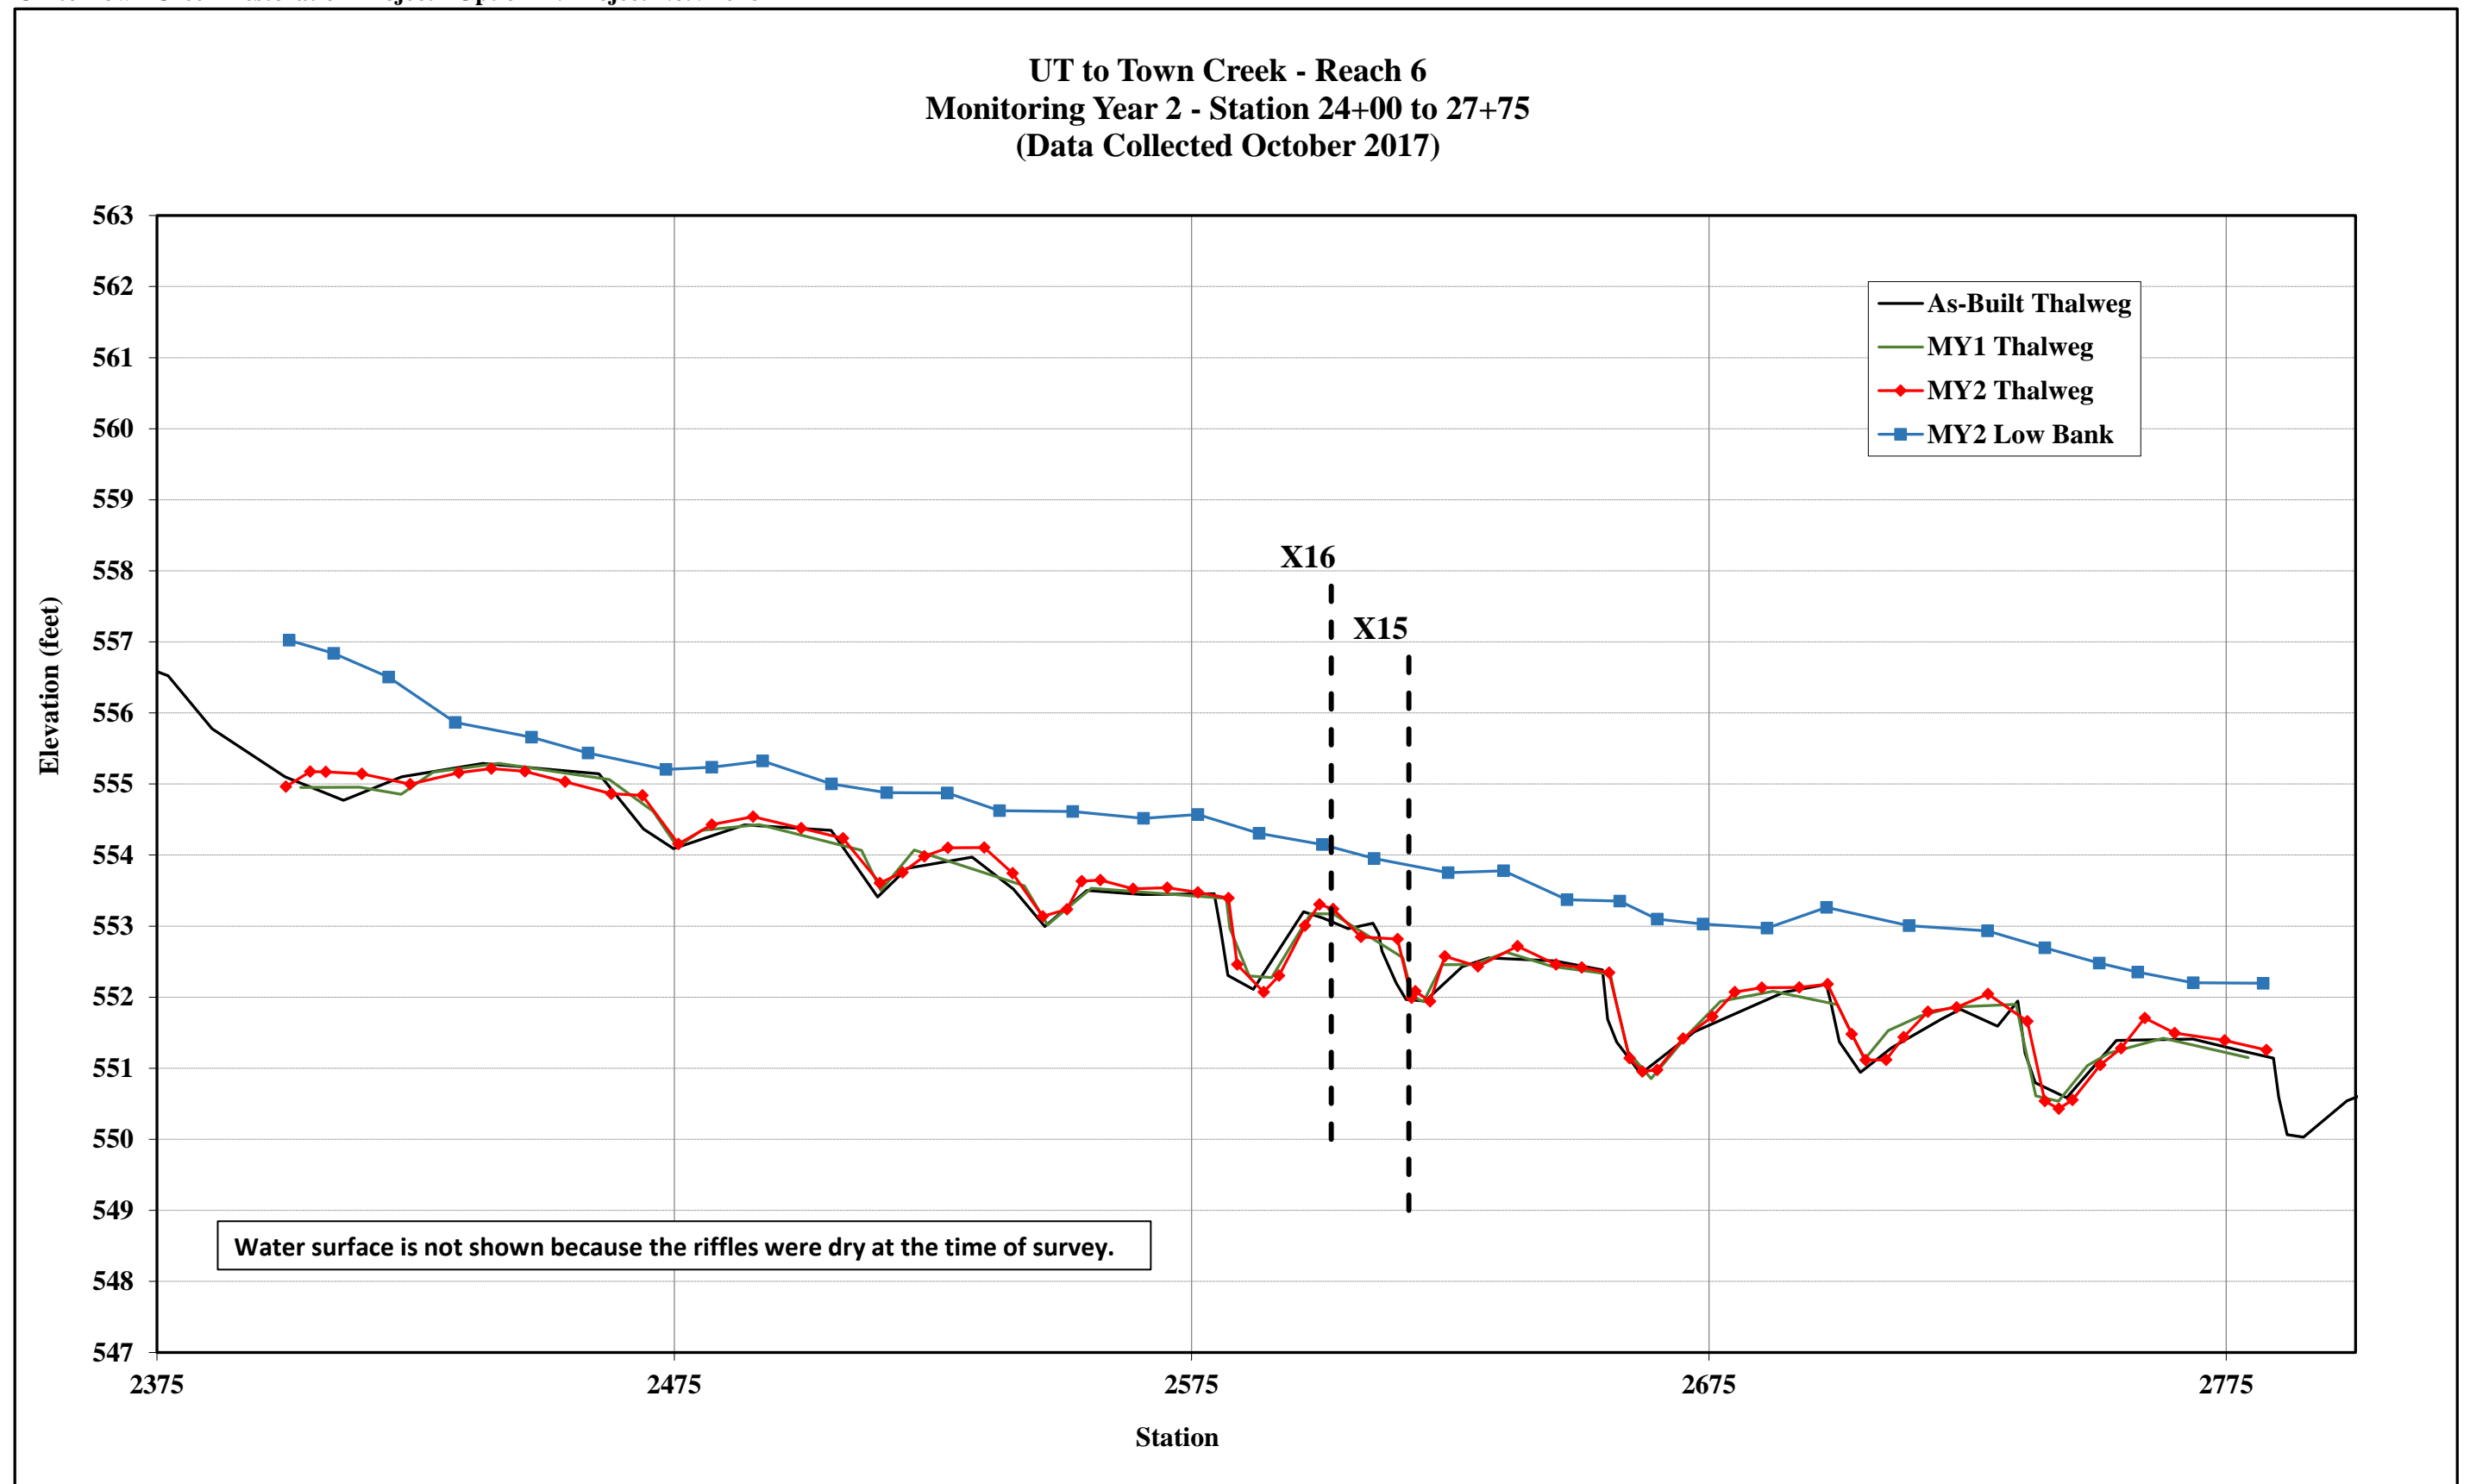
Figure 4. Year 2 Profile
 UT to Town Creek Restoration Project - Option A: Project No. 94648

Longitudinal profiles were surveyed for portions of the restored lengths of Reaches 1, 2, 3, and 6 and are provided in Figure 4 of Appendix D. Longitudinal profiles will be replicated annually during the five year monitoring period.
