**UT to Town Creek Restoration Project – Option A
Year 2 Monitoring Report**

Stanly County, North Carolina

DMS Project ID Number – 94648; NC DEQ Contract No. 003277

Monitoring Year: 2 of 7

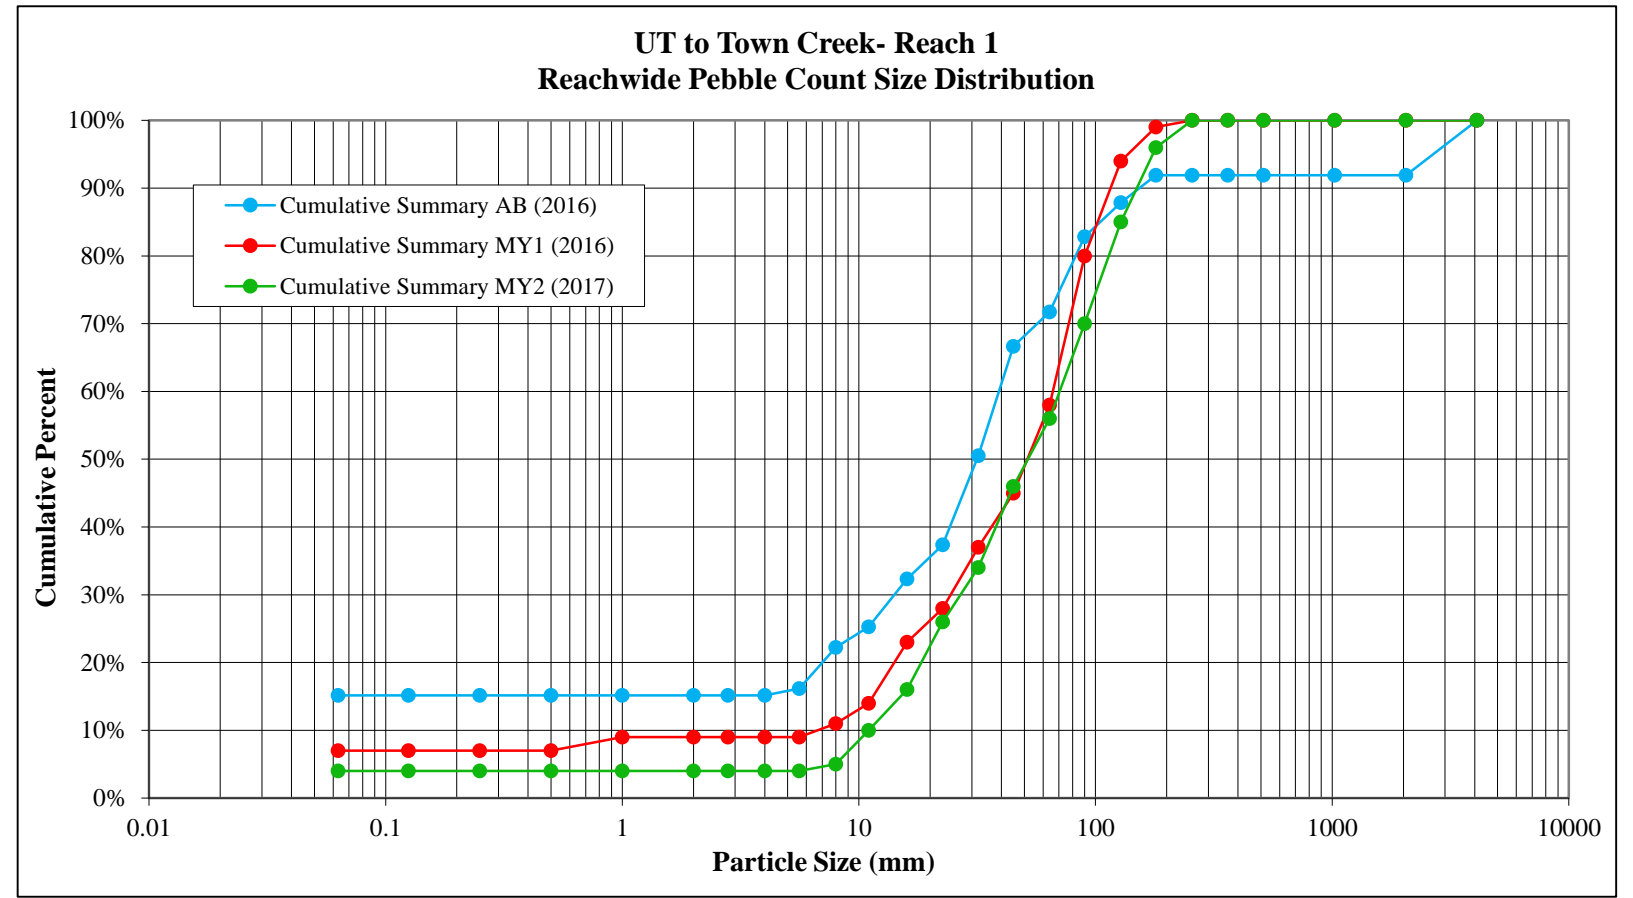
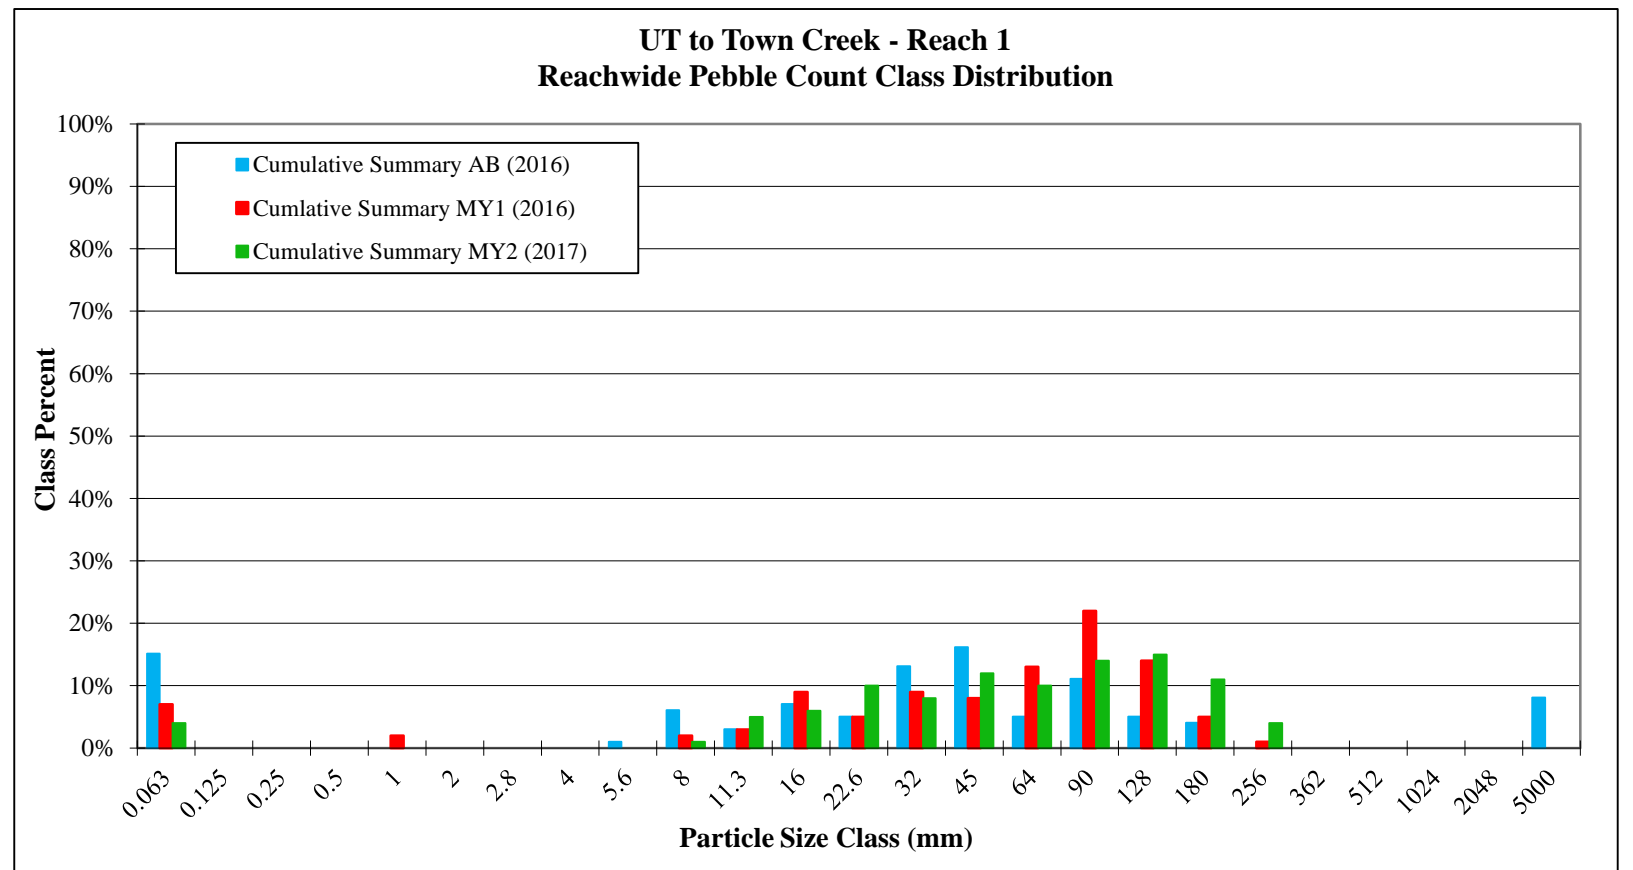
Figure 5a. Reachwide Pebble Count Distribution with Annual Overlays
UT to Town Creek Restoration Project: Project No. 94648

Cummulative Channel materials	
D16 =	16.00
D35 =	32.92
D50 =	51.81
D84 =	125.03
D95 =	174.51
D100 =	180 - 256

Riffle Channel materials	
D16 =	22.60
D35 =	58.61
D50 =	77.08
D84 =	145.46
D95 =	190.88
D100 =	180 - 256

Pool Channel materials	
D16 =	12.46
D35 =	22.12
D50 =	33.24
D84 =	101.21
D95 =	151.79
D100 =	180 - 256

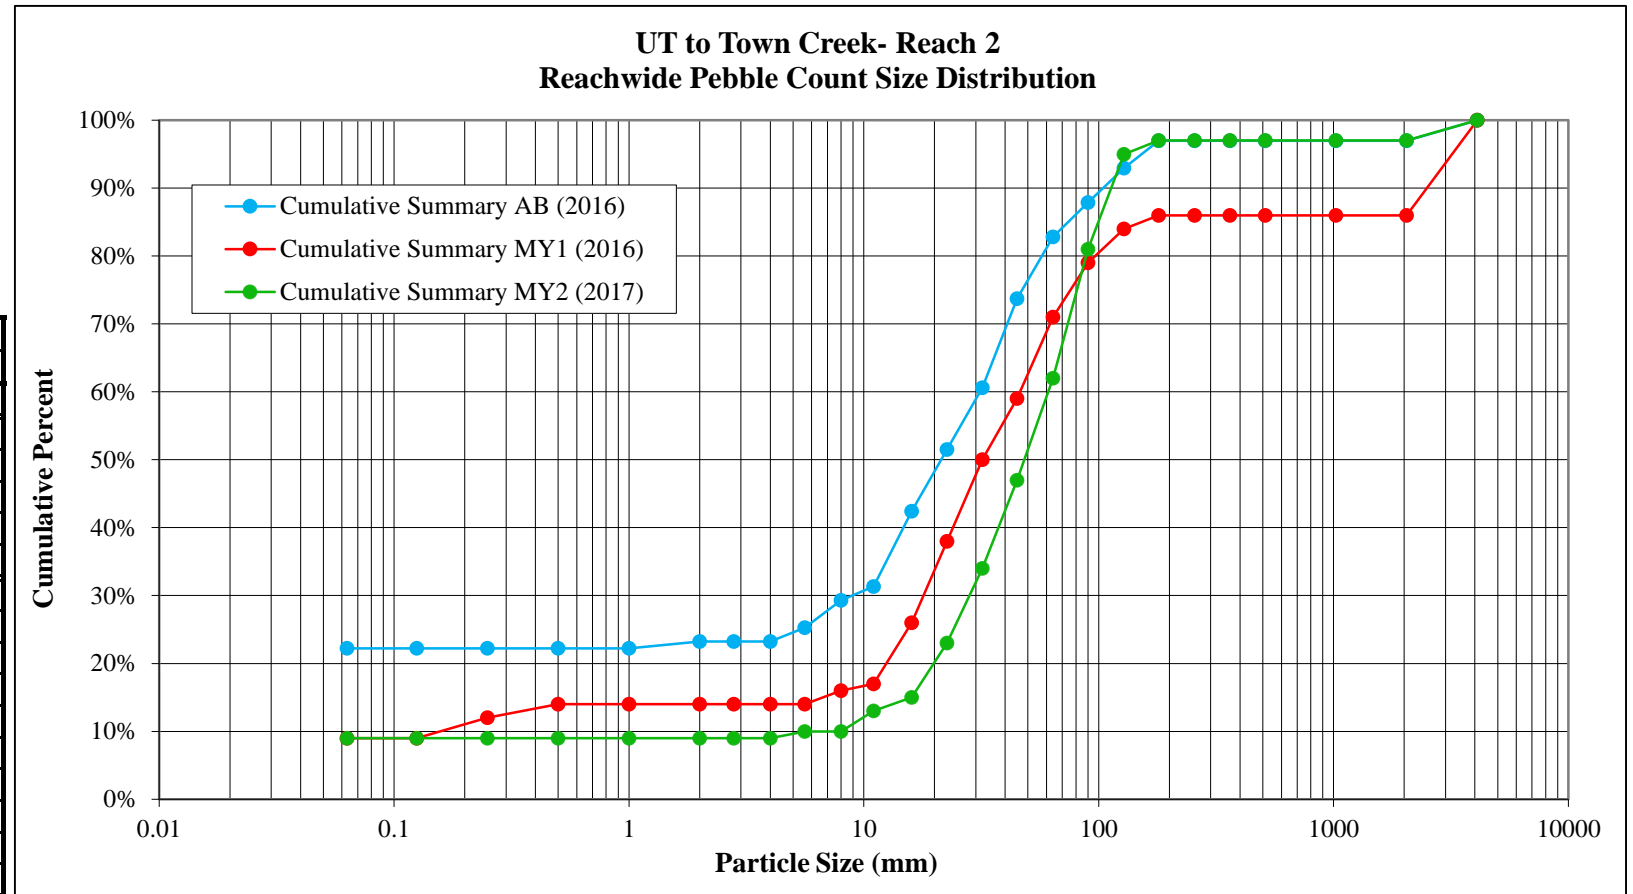
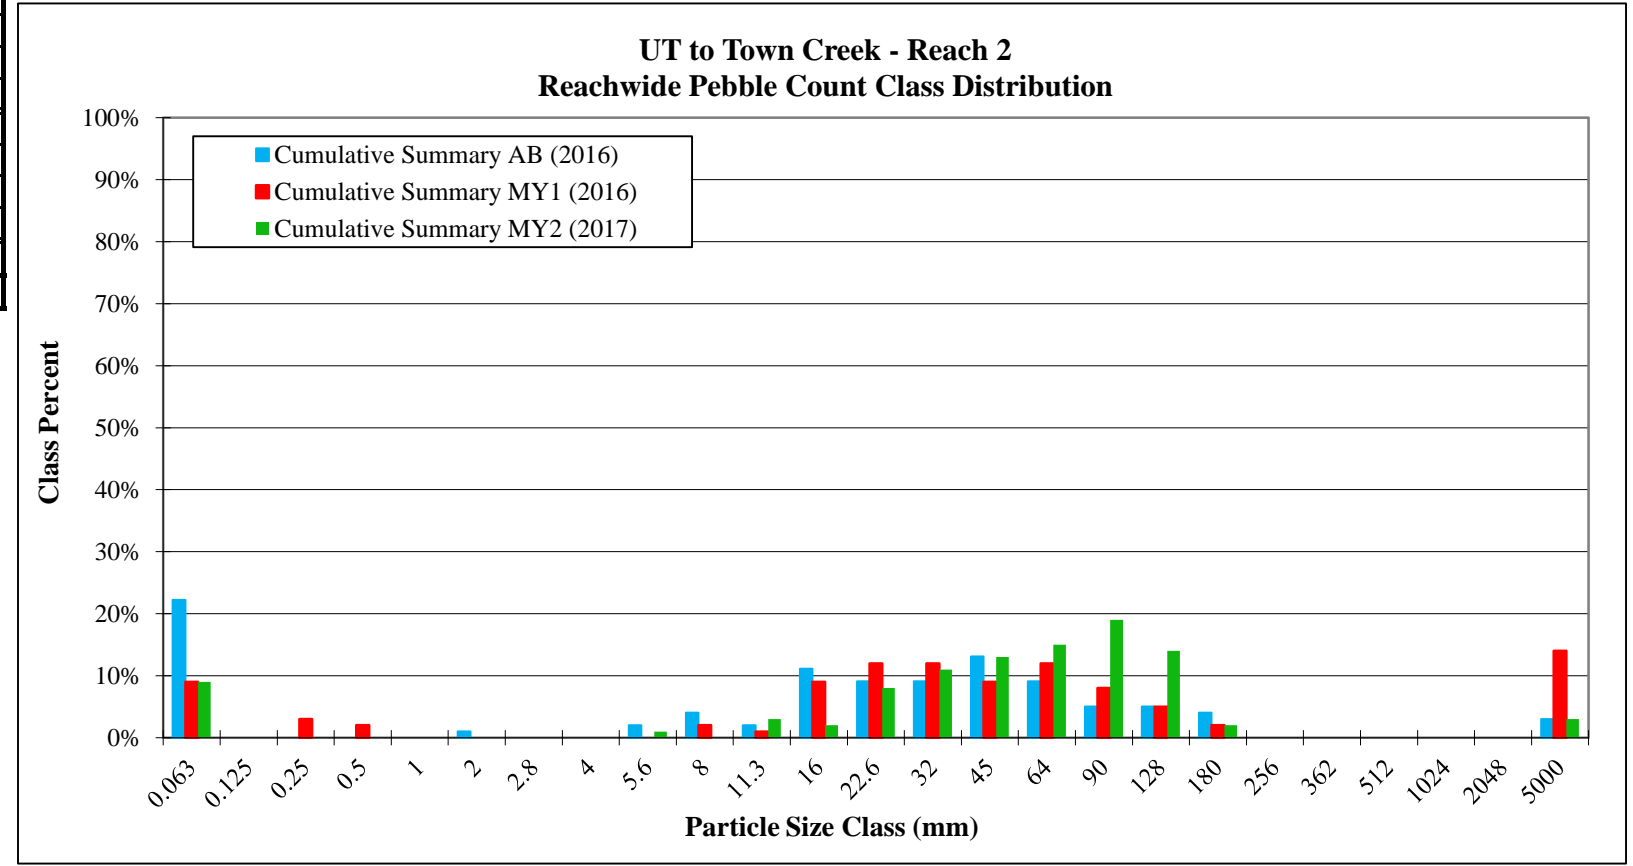
Figure 5b. Reachwide Pebble Count Distribution with Annual Overlays
UT to Town Creek Restoration Project: Project No. 94648

Cummulative Channel materials	
D16 =	16.71
D35 =	32.85
D50 =	48.28
D84 =	97.06
D95 =	128.00
D100 =	> 2048

Riffle Channel materials	
D16 =	22.60
D35 =	39.04
D50 =	54.73
D84 =	94.05
D95 =	119.82
D100 =	128 - 180

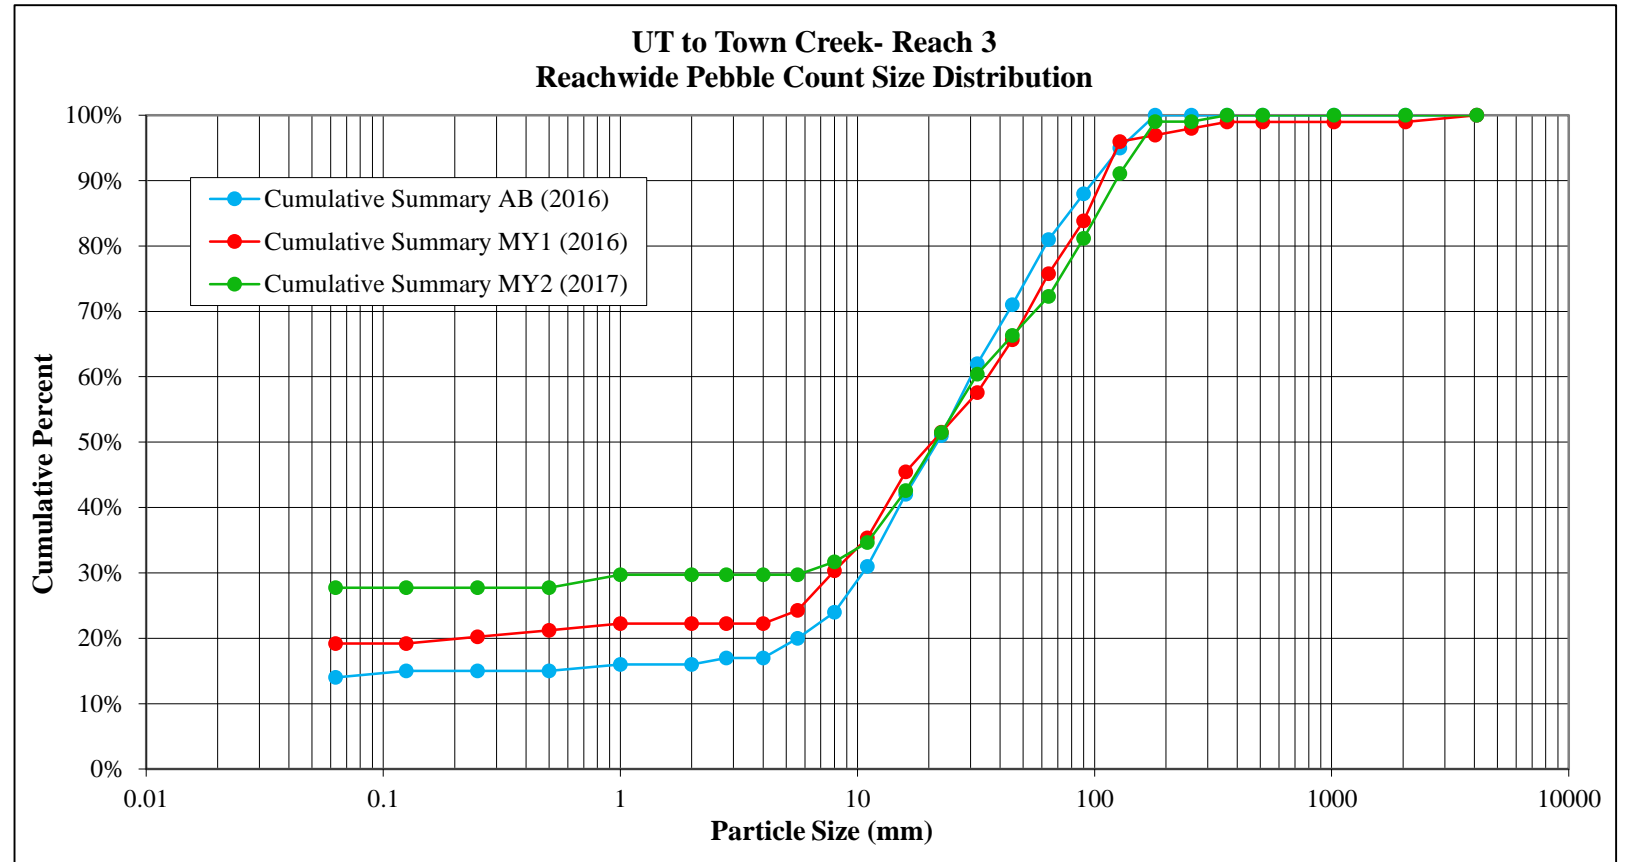
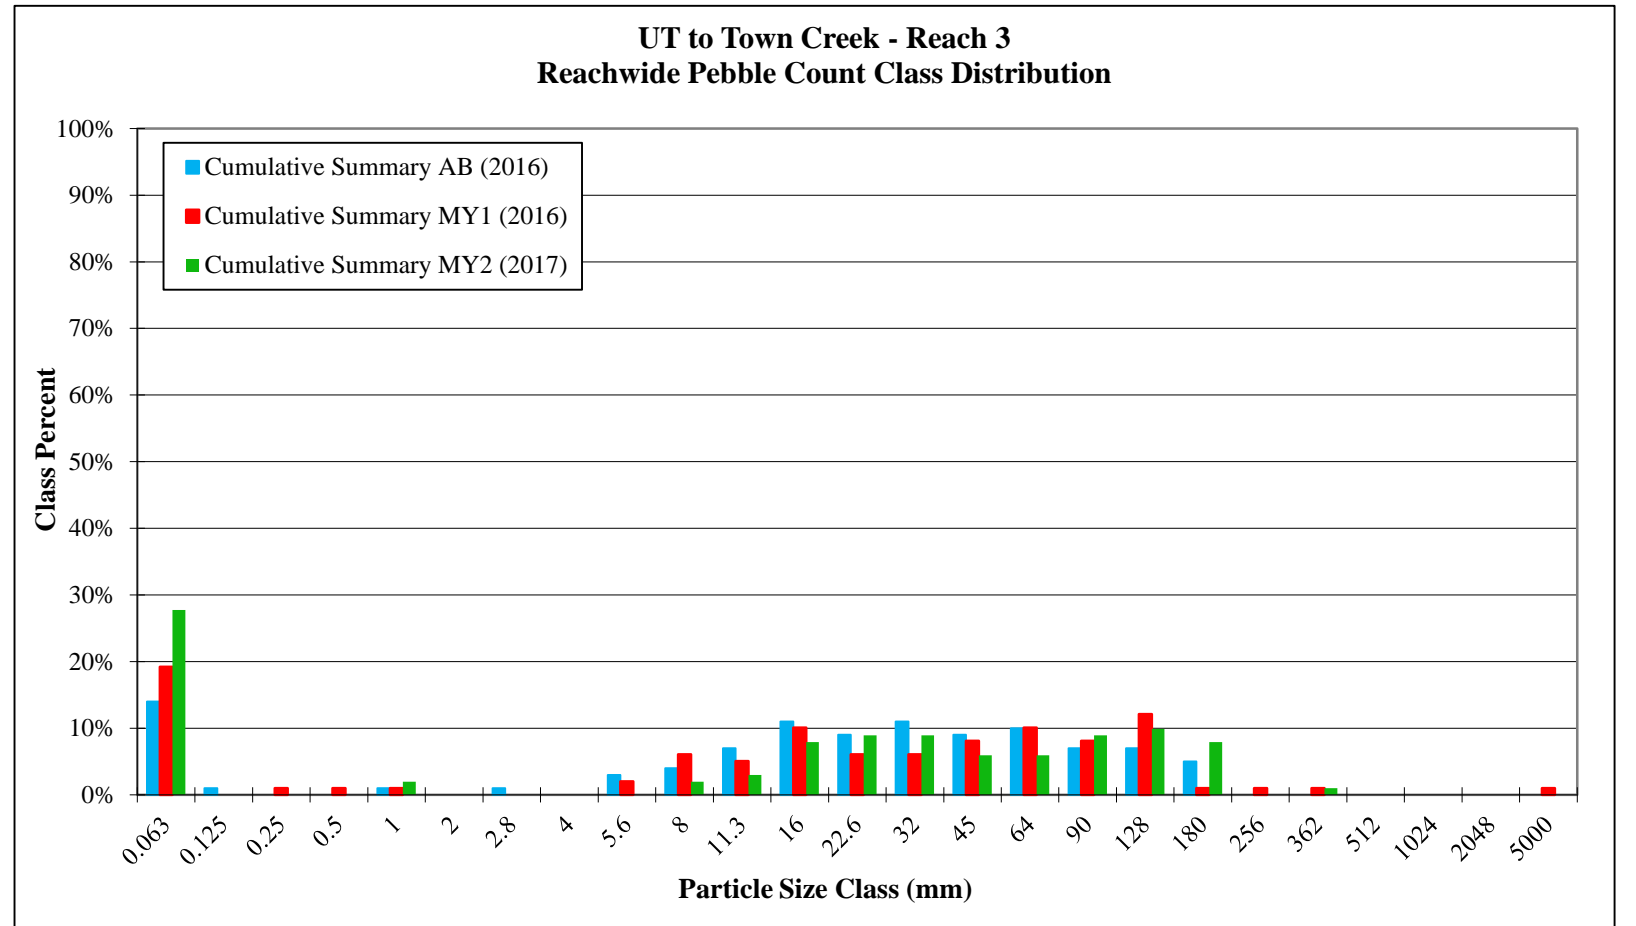
Figure 5c. Reachwide Pebble Count Distribution with Annual Overlays
UT to Town Creek Restoration Project: Project No. 94648

Riffle Channel materials	
D ₁₆ =	<0.063
D ₃₅ =	<0.063
D ₅₀ =	17.44
D ₈₄ =	119.29
D ₉₅ =	165.29
D ₁₀₀ =	256 - 362

Pool Channel materials	
D ₁₆ =	0.53
D ₃₅ =	14.68
D ₅₀ =	24.35
D ₈₄ =	83.16
D ₉₅ =	123.14
D ₁₀₀ =	128 - 180

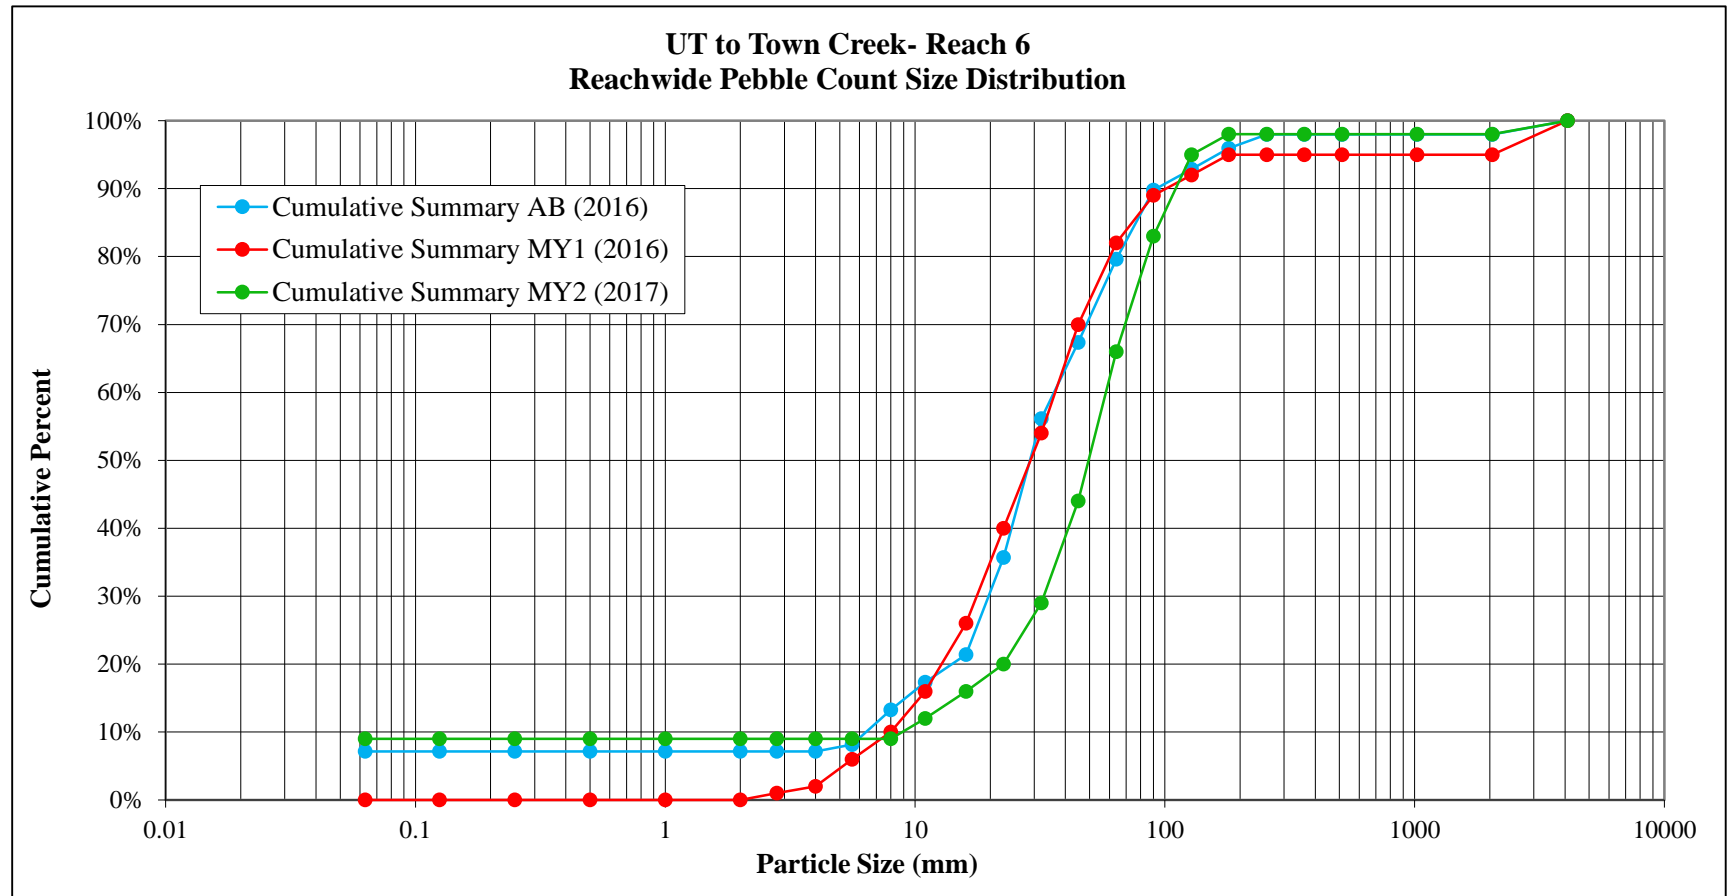
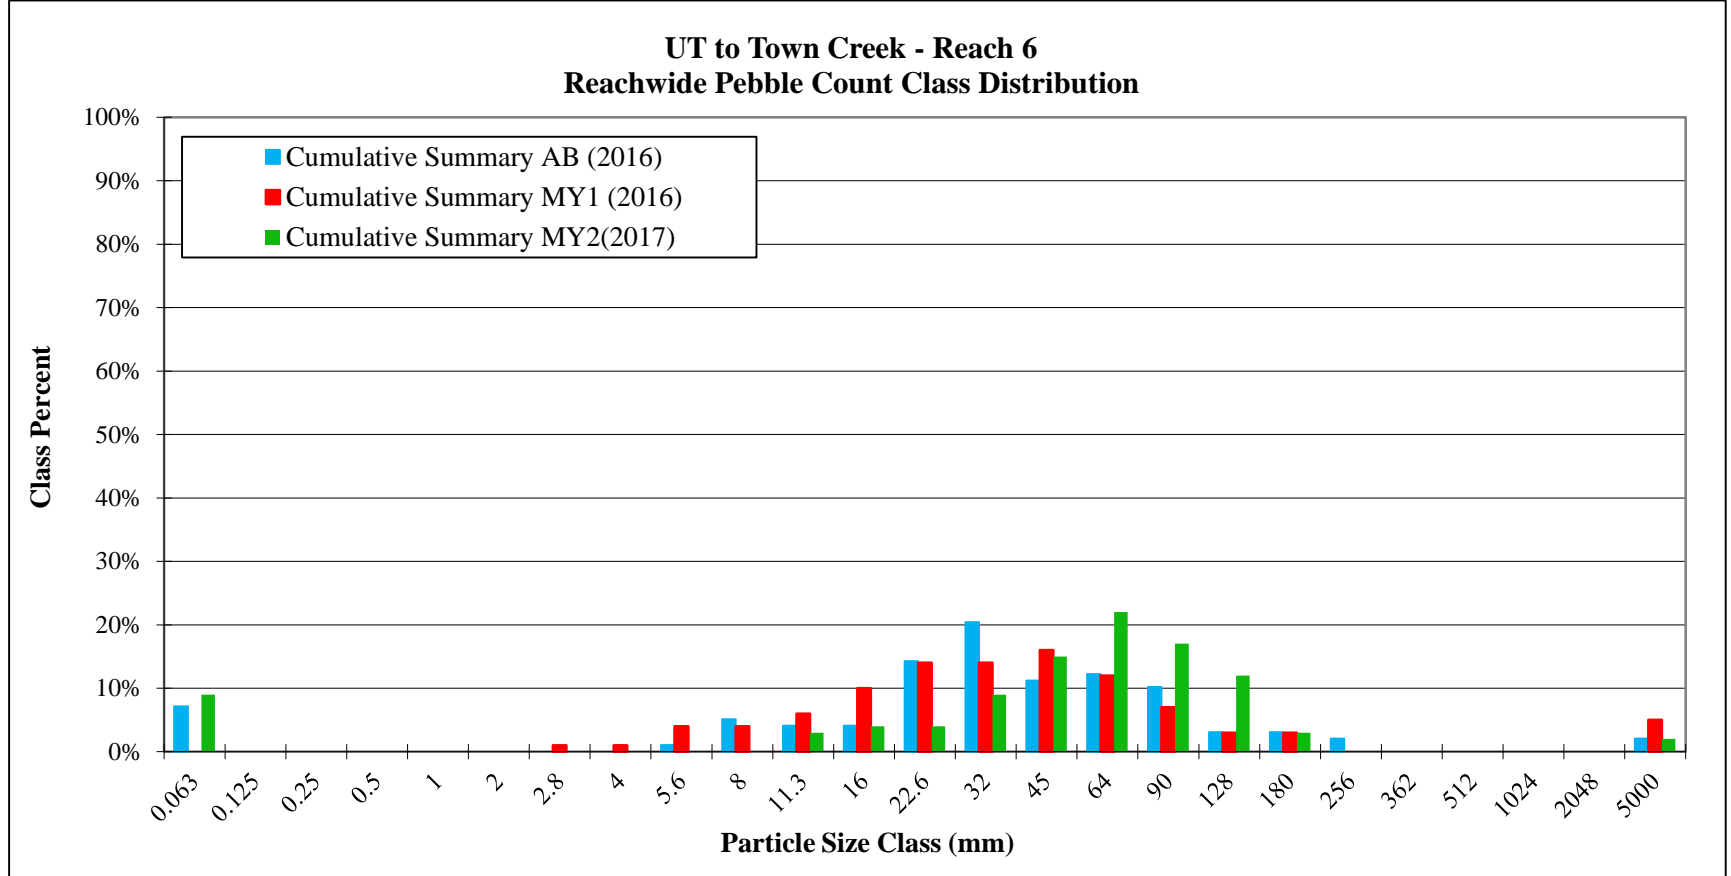
Figure 5d. Reachwide Pebble Count Distribution with Annual Overlays
UT to Town Creek Restoration Project: Project No. 94648

Riffle Channel materials	
D16 =	29.03
D35 =	45.00
D50 =	56.44
D84 =	108.85
D95 =	160.66
D100 =	> 2048

Pool Channel materials	
D16 =	9.09
D35 =	22.60
D50 =	36.68
D84 =	72.64
D95 =	90.00
D100 =	90 - 128
