**UT to Town Creek Restoration Project – Option A
Year 2 Monitoring Report**

Stanly County, North Carolina

DMS Project ID Number – 94648; NC DEQ Contract No. 003277

Monitoring Year: 2 of 7

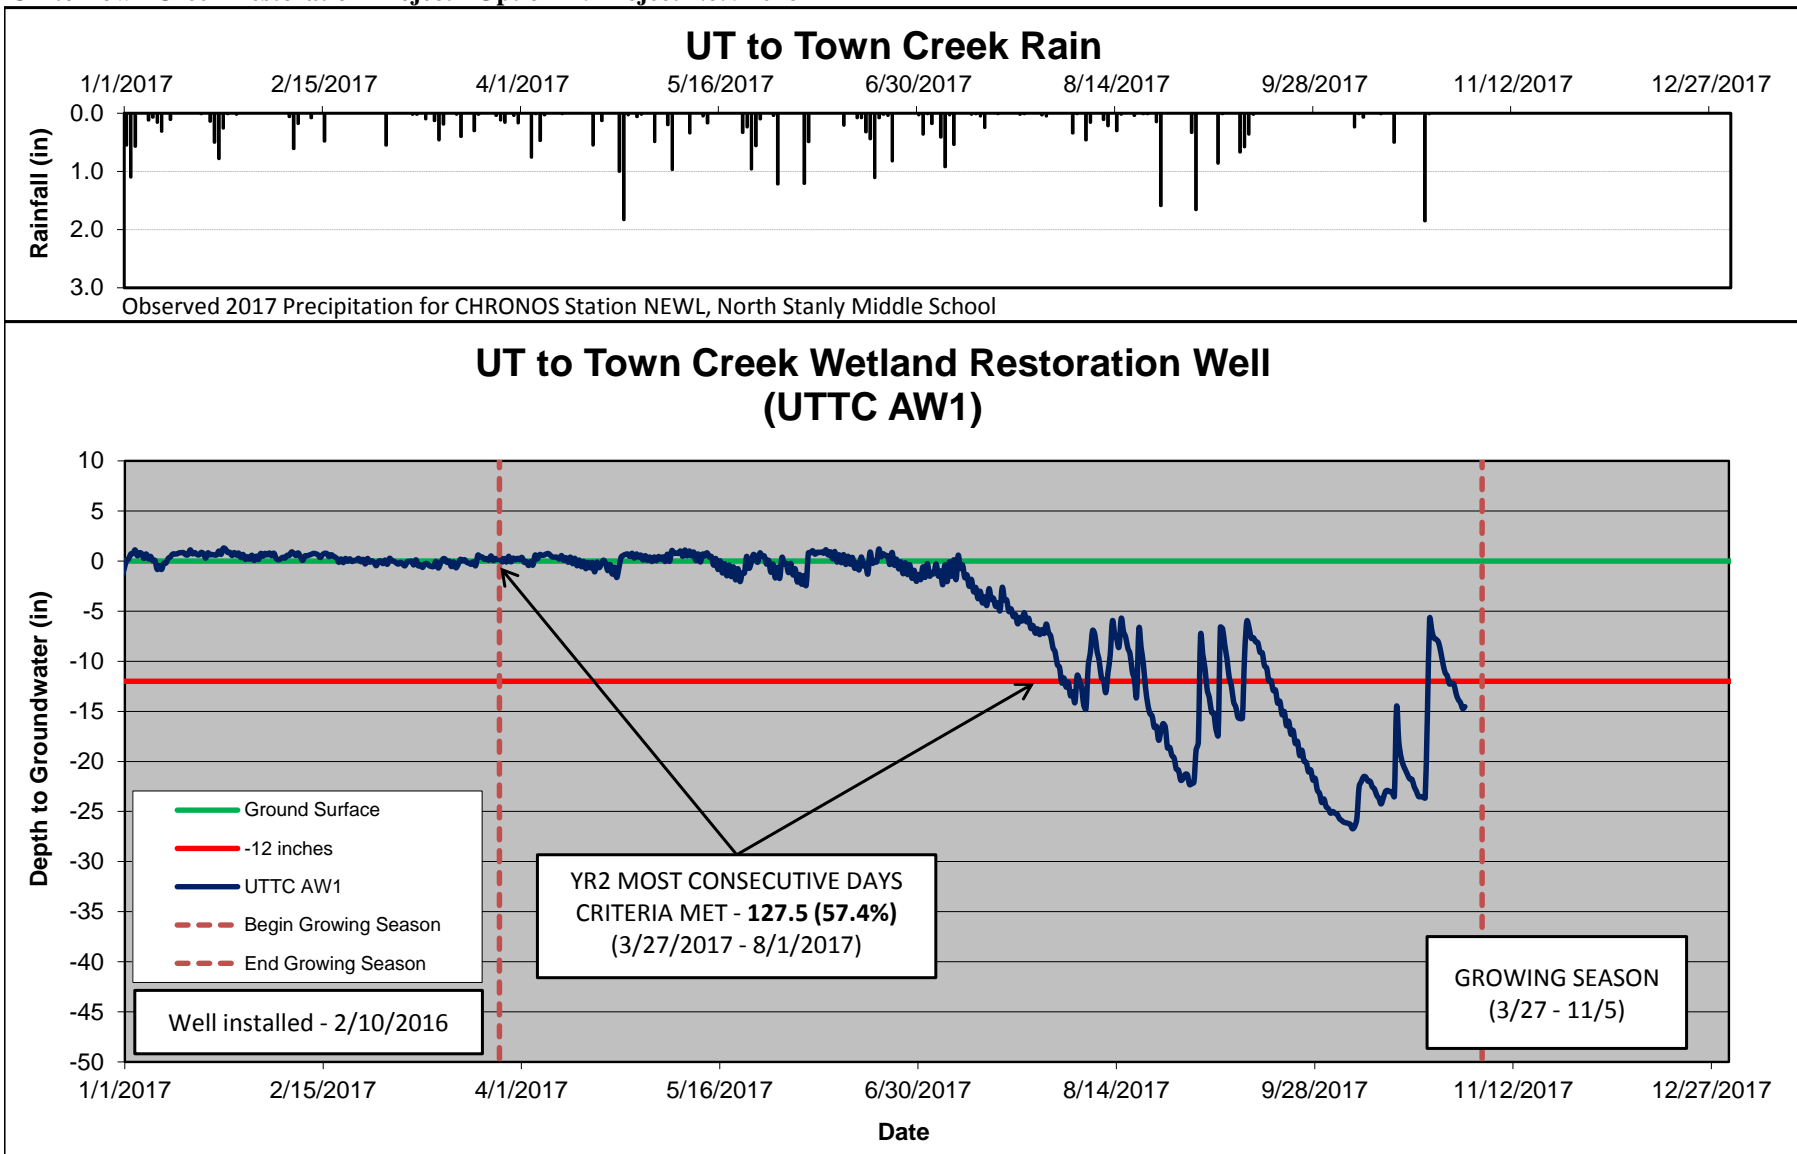
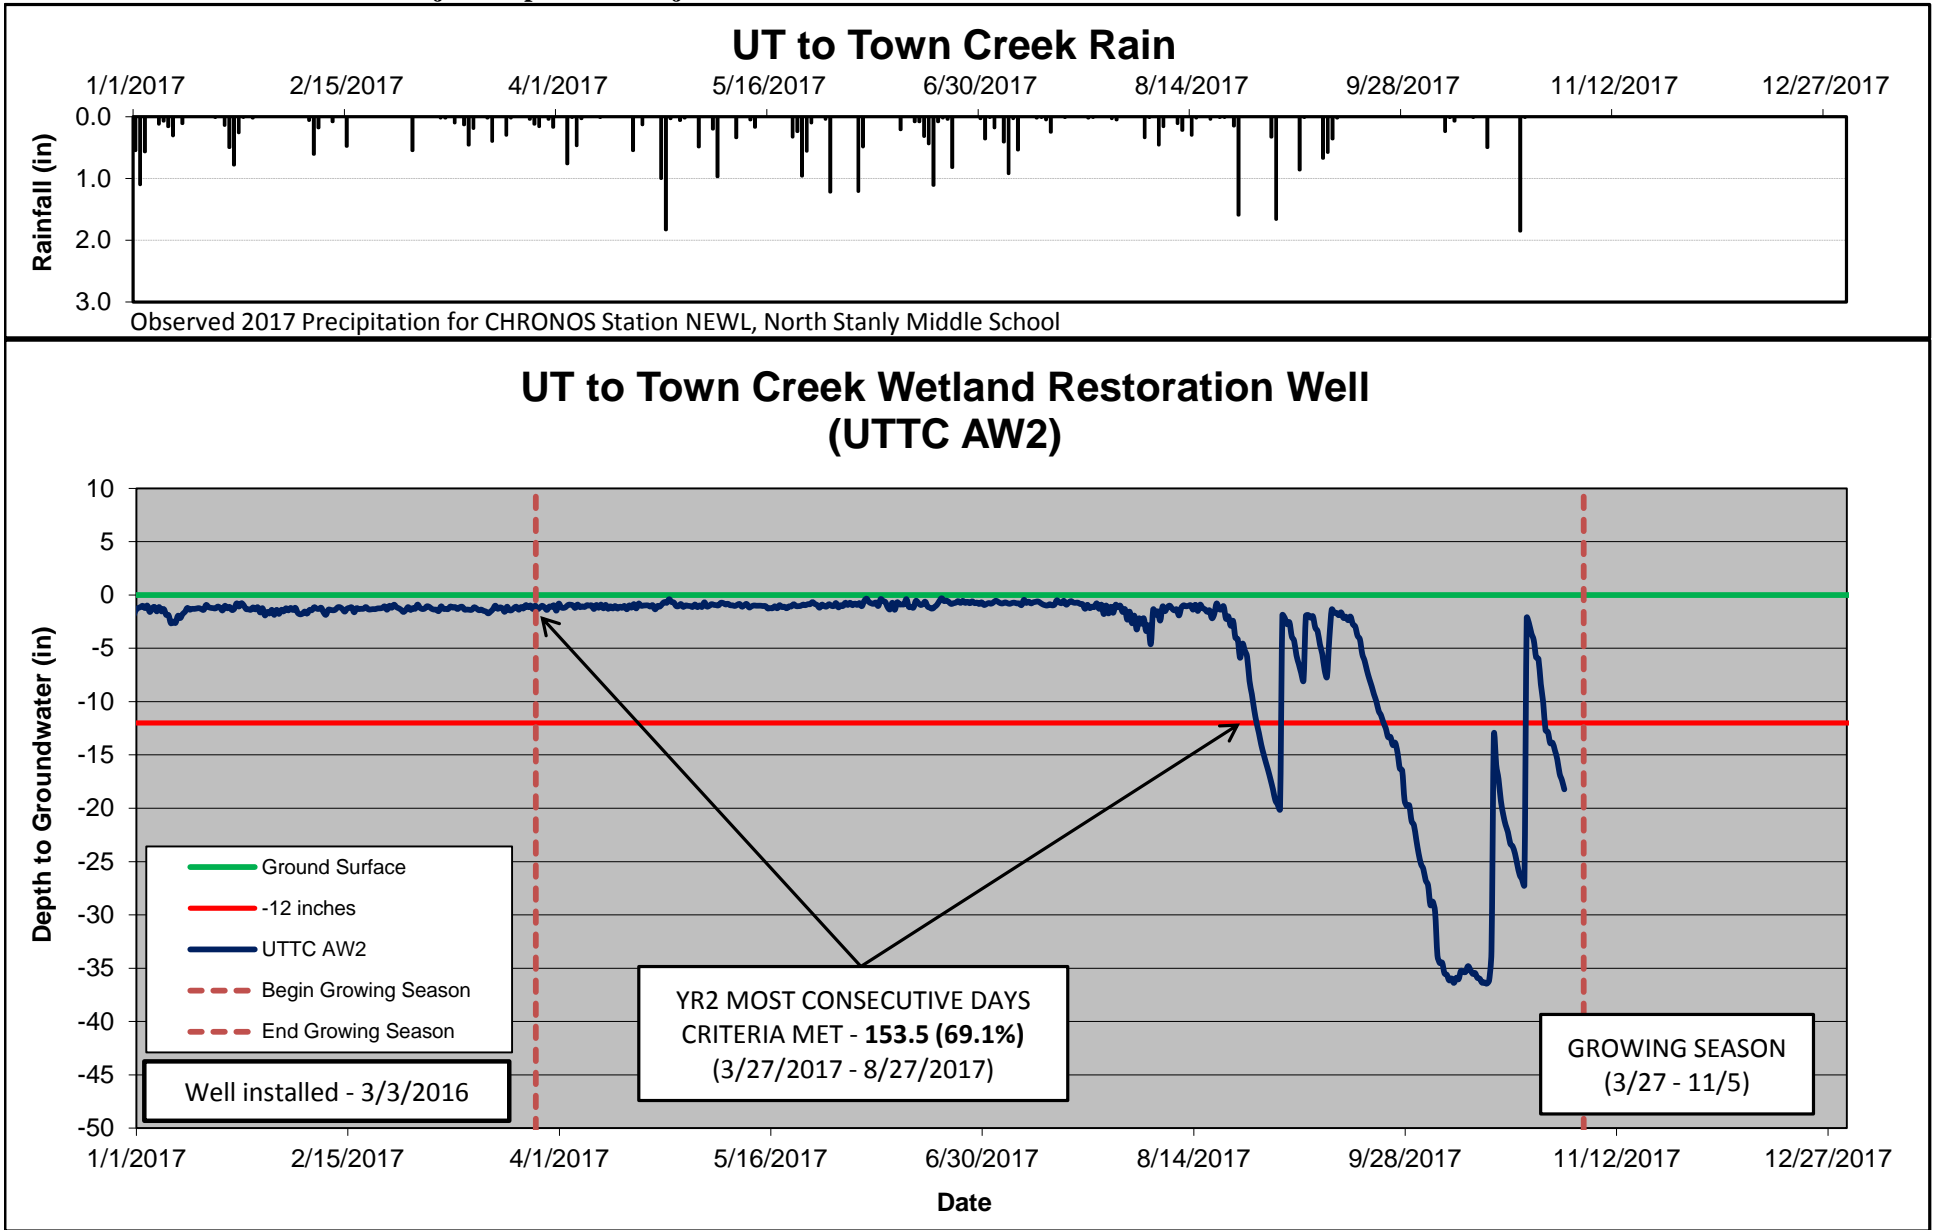
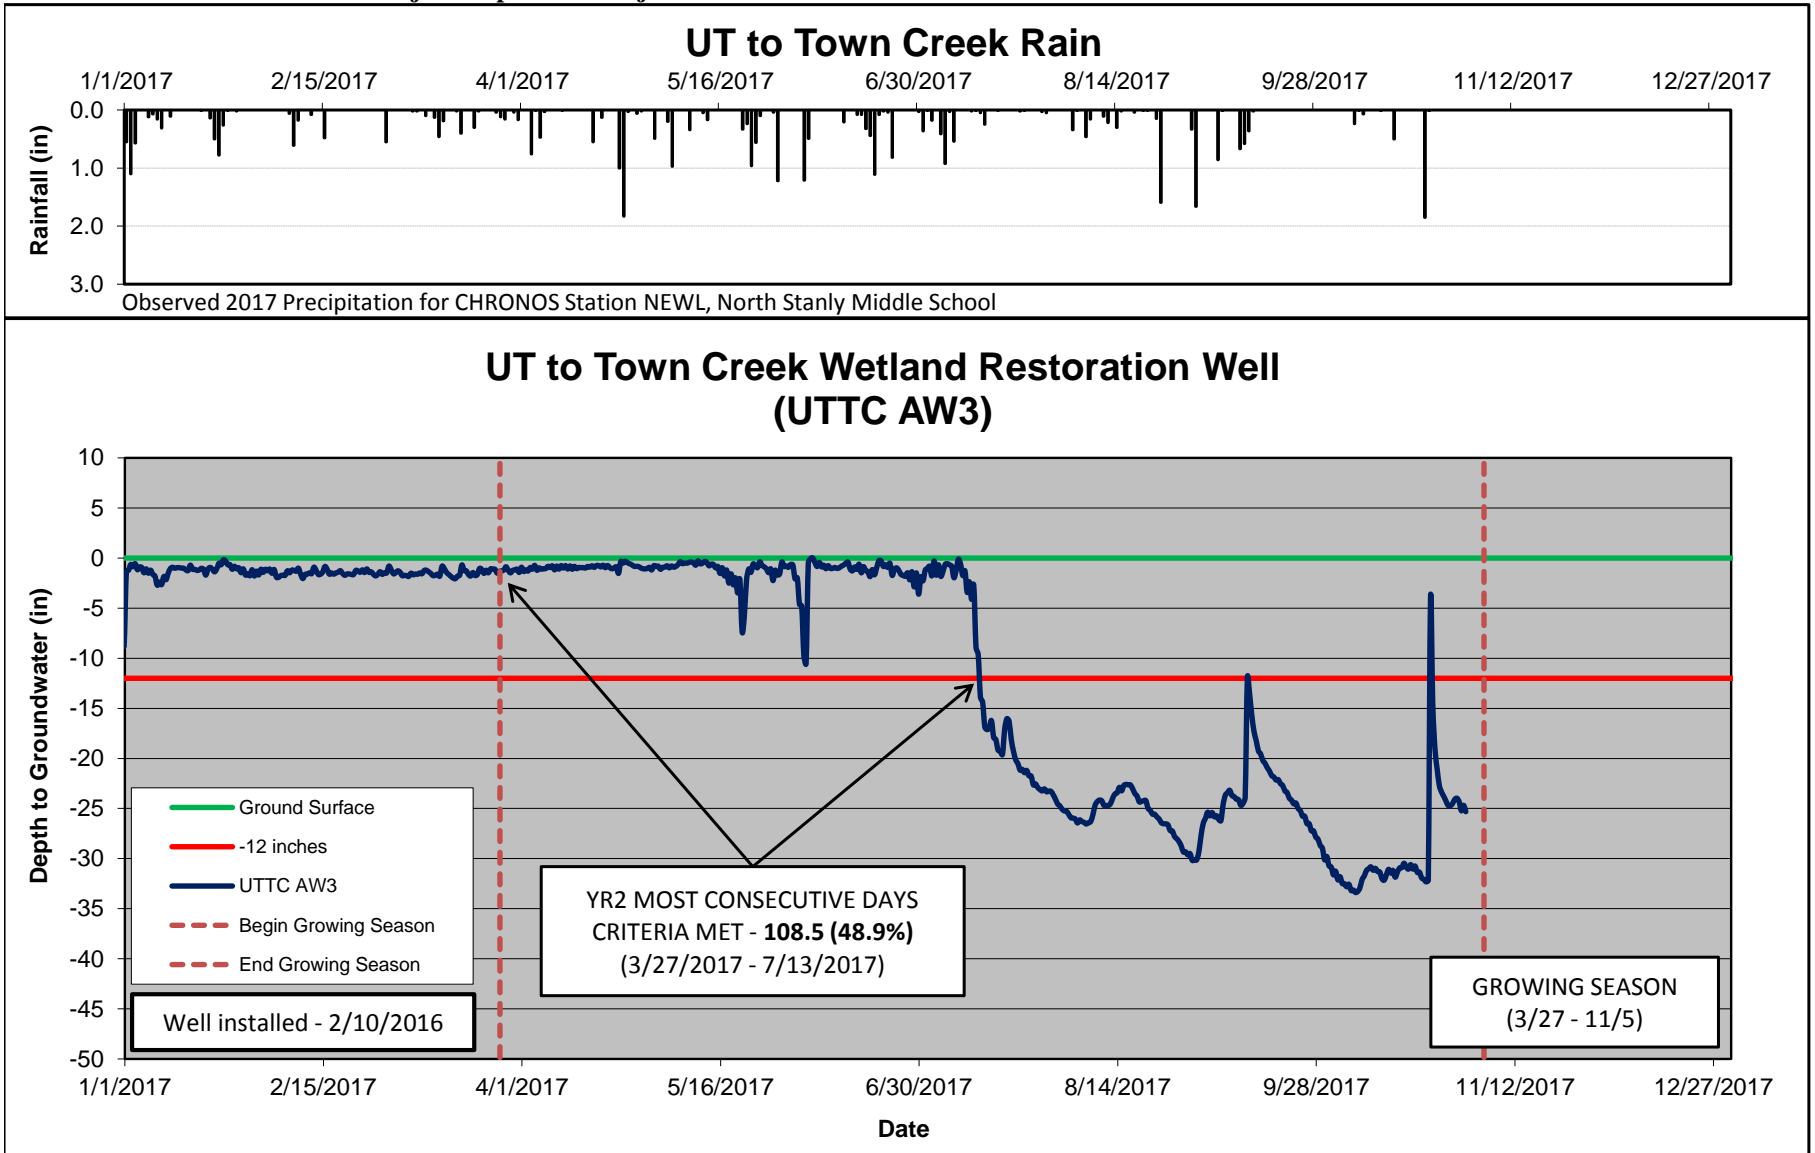
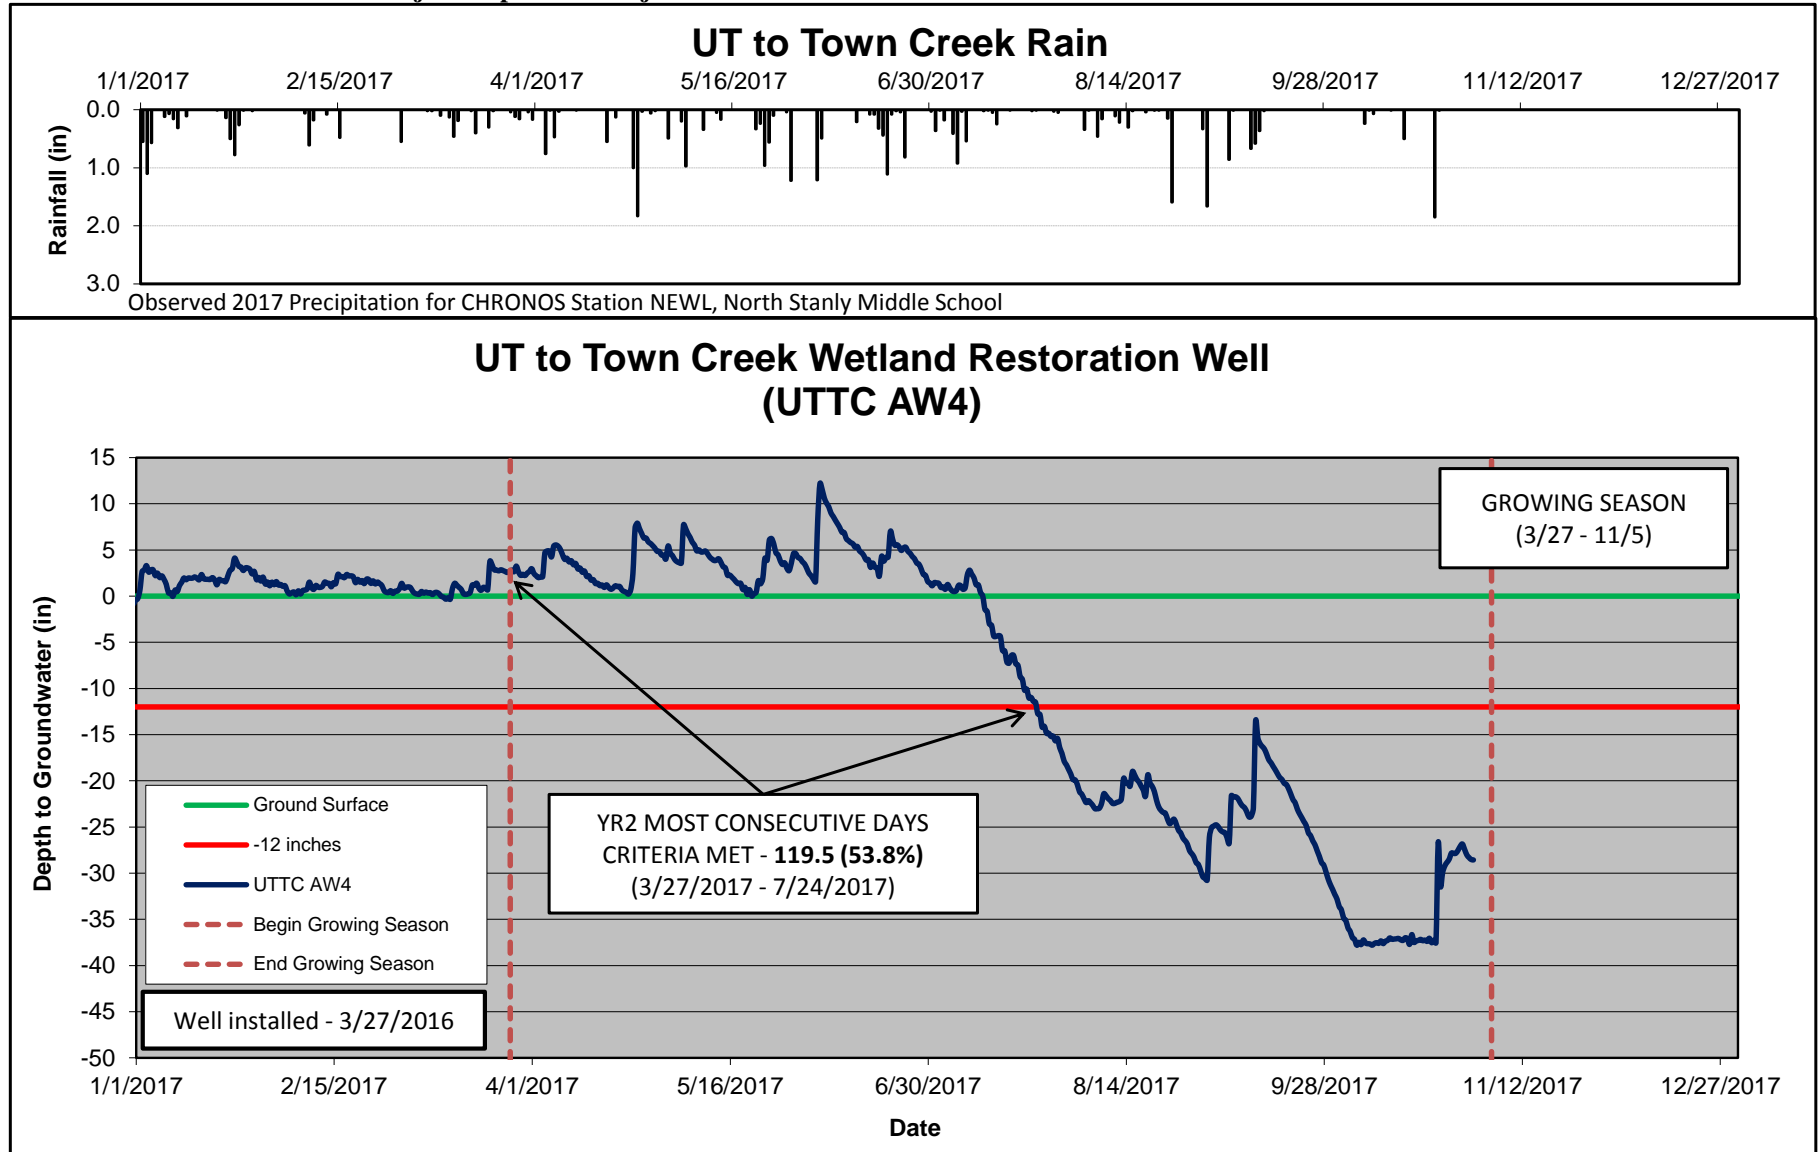
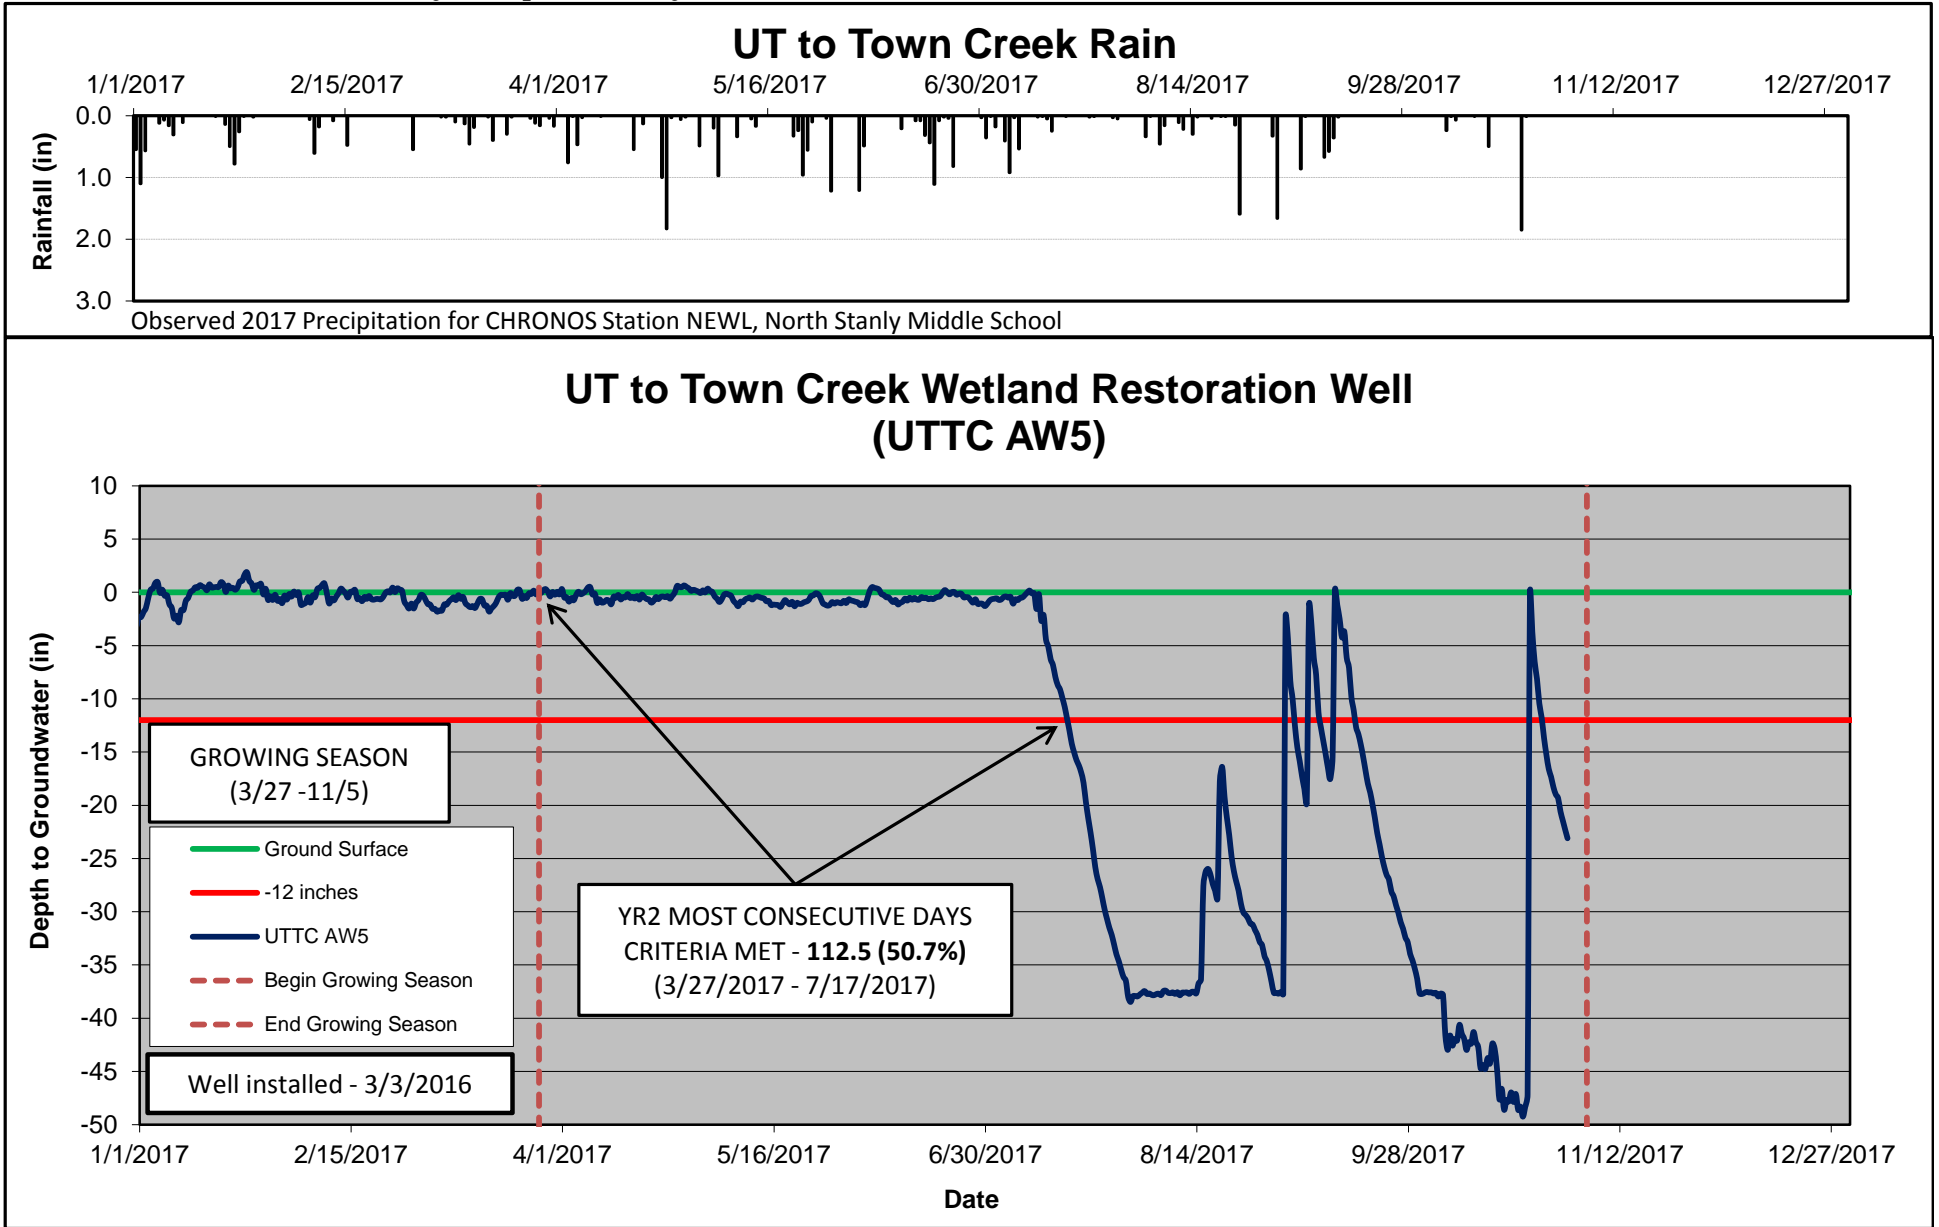
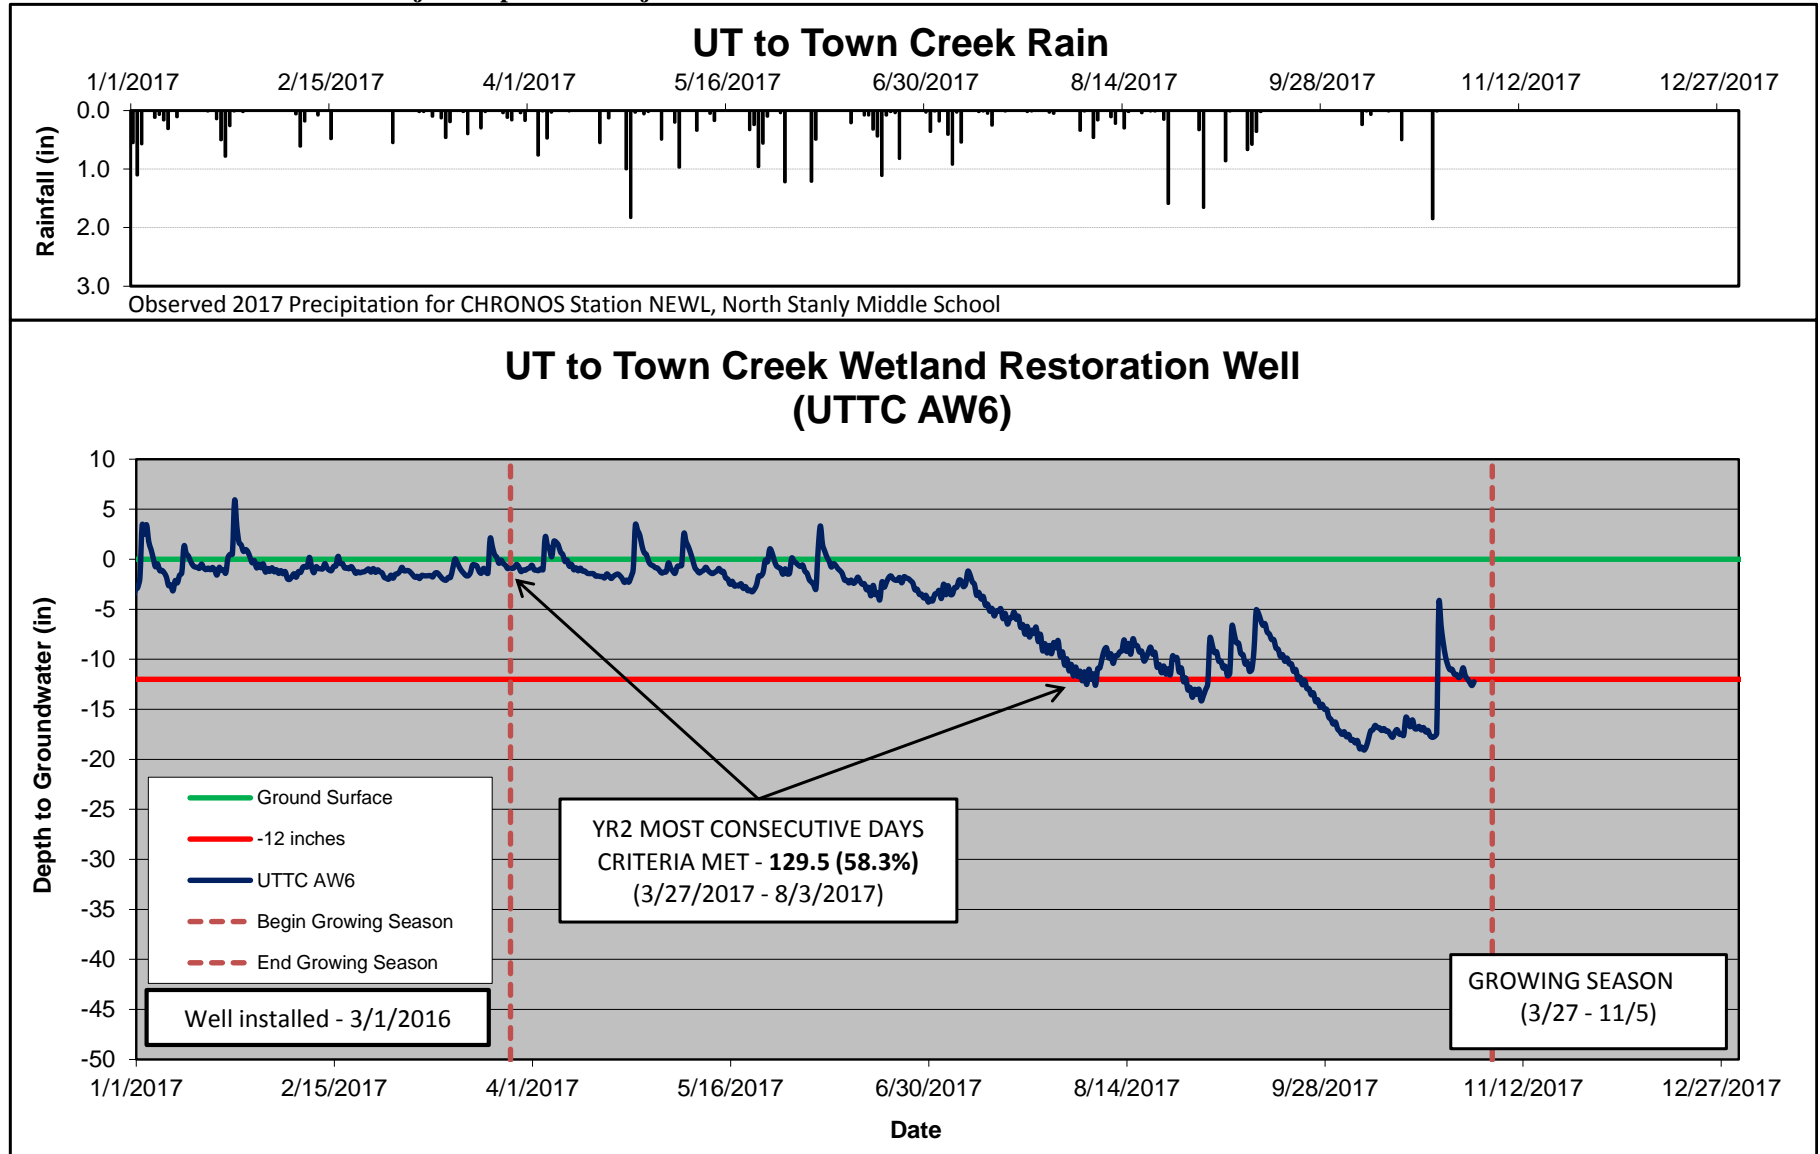
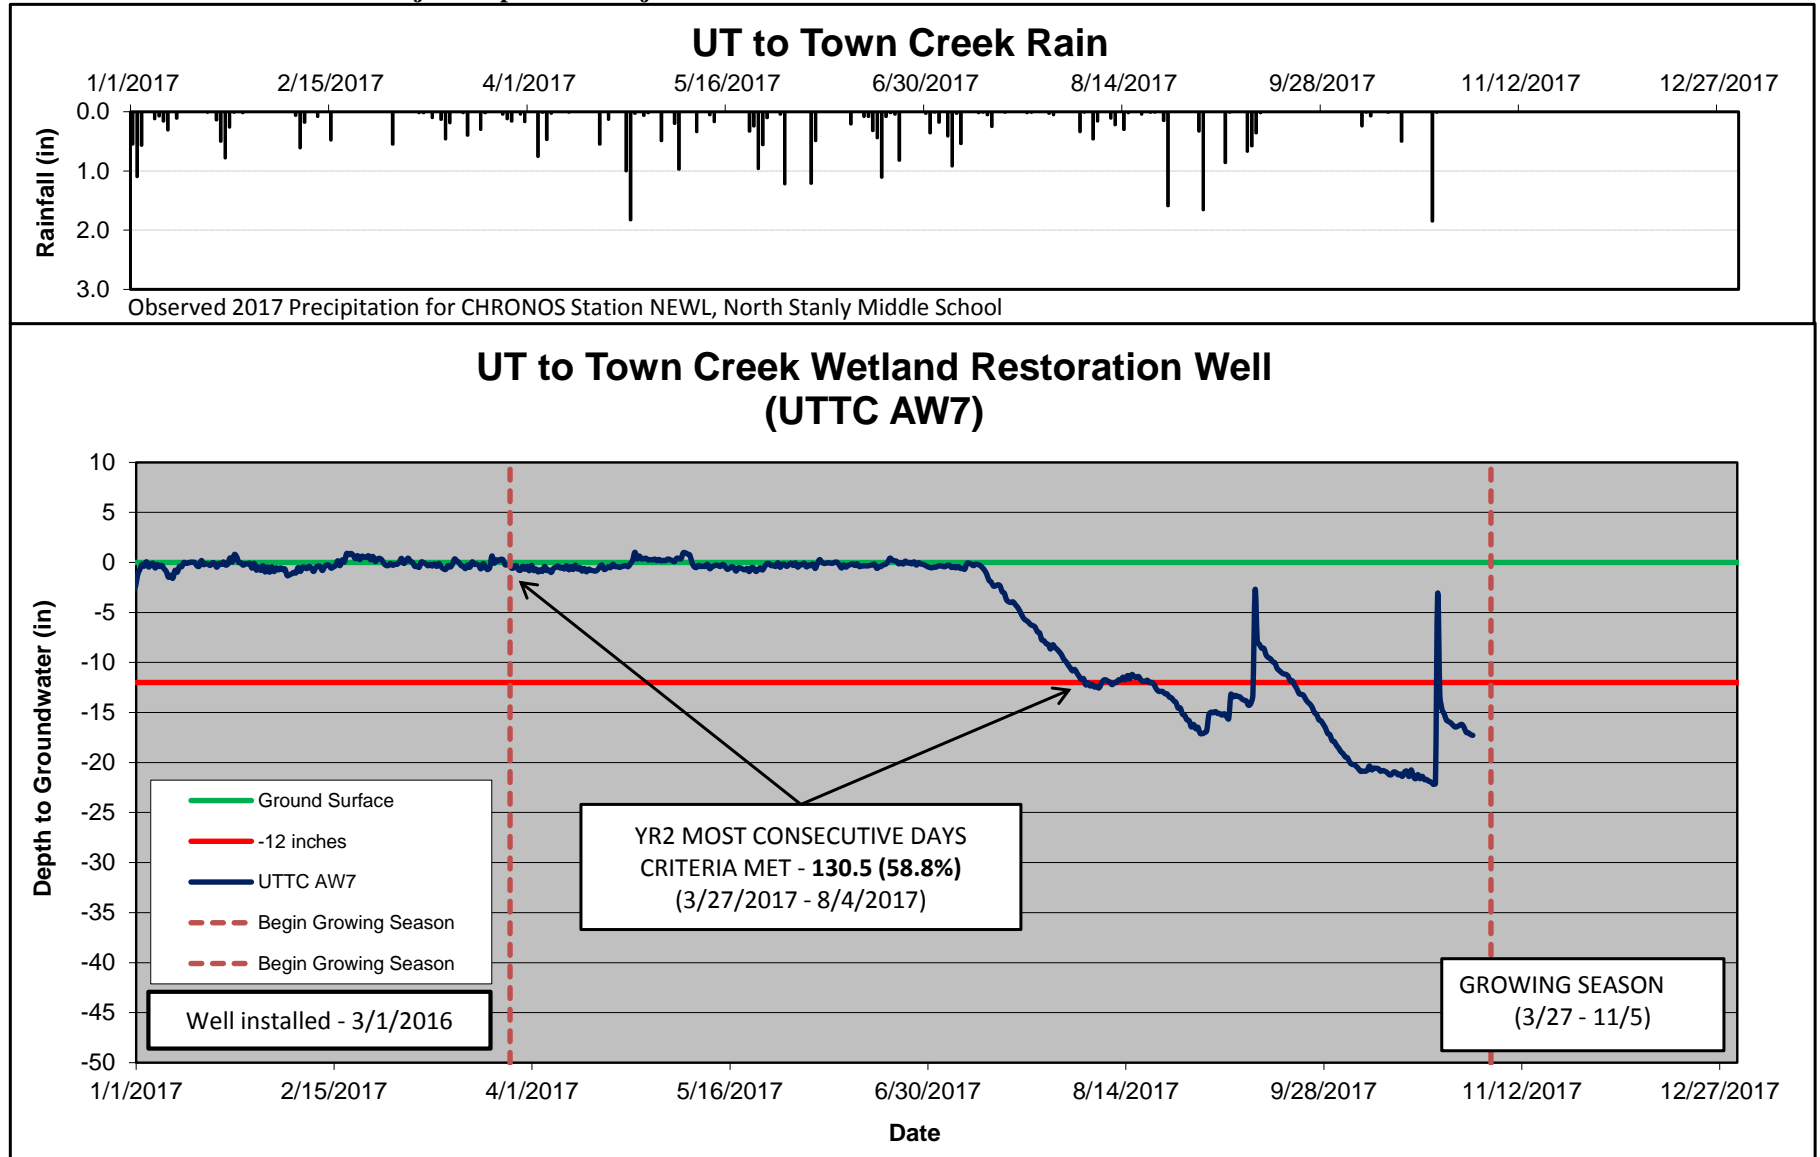
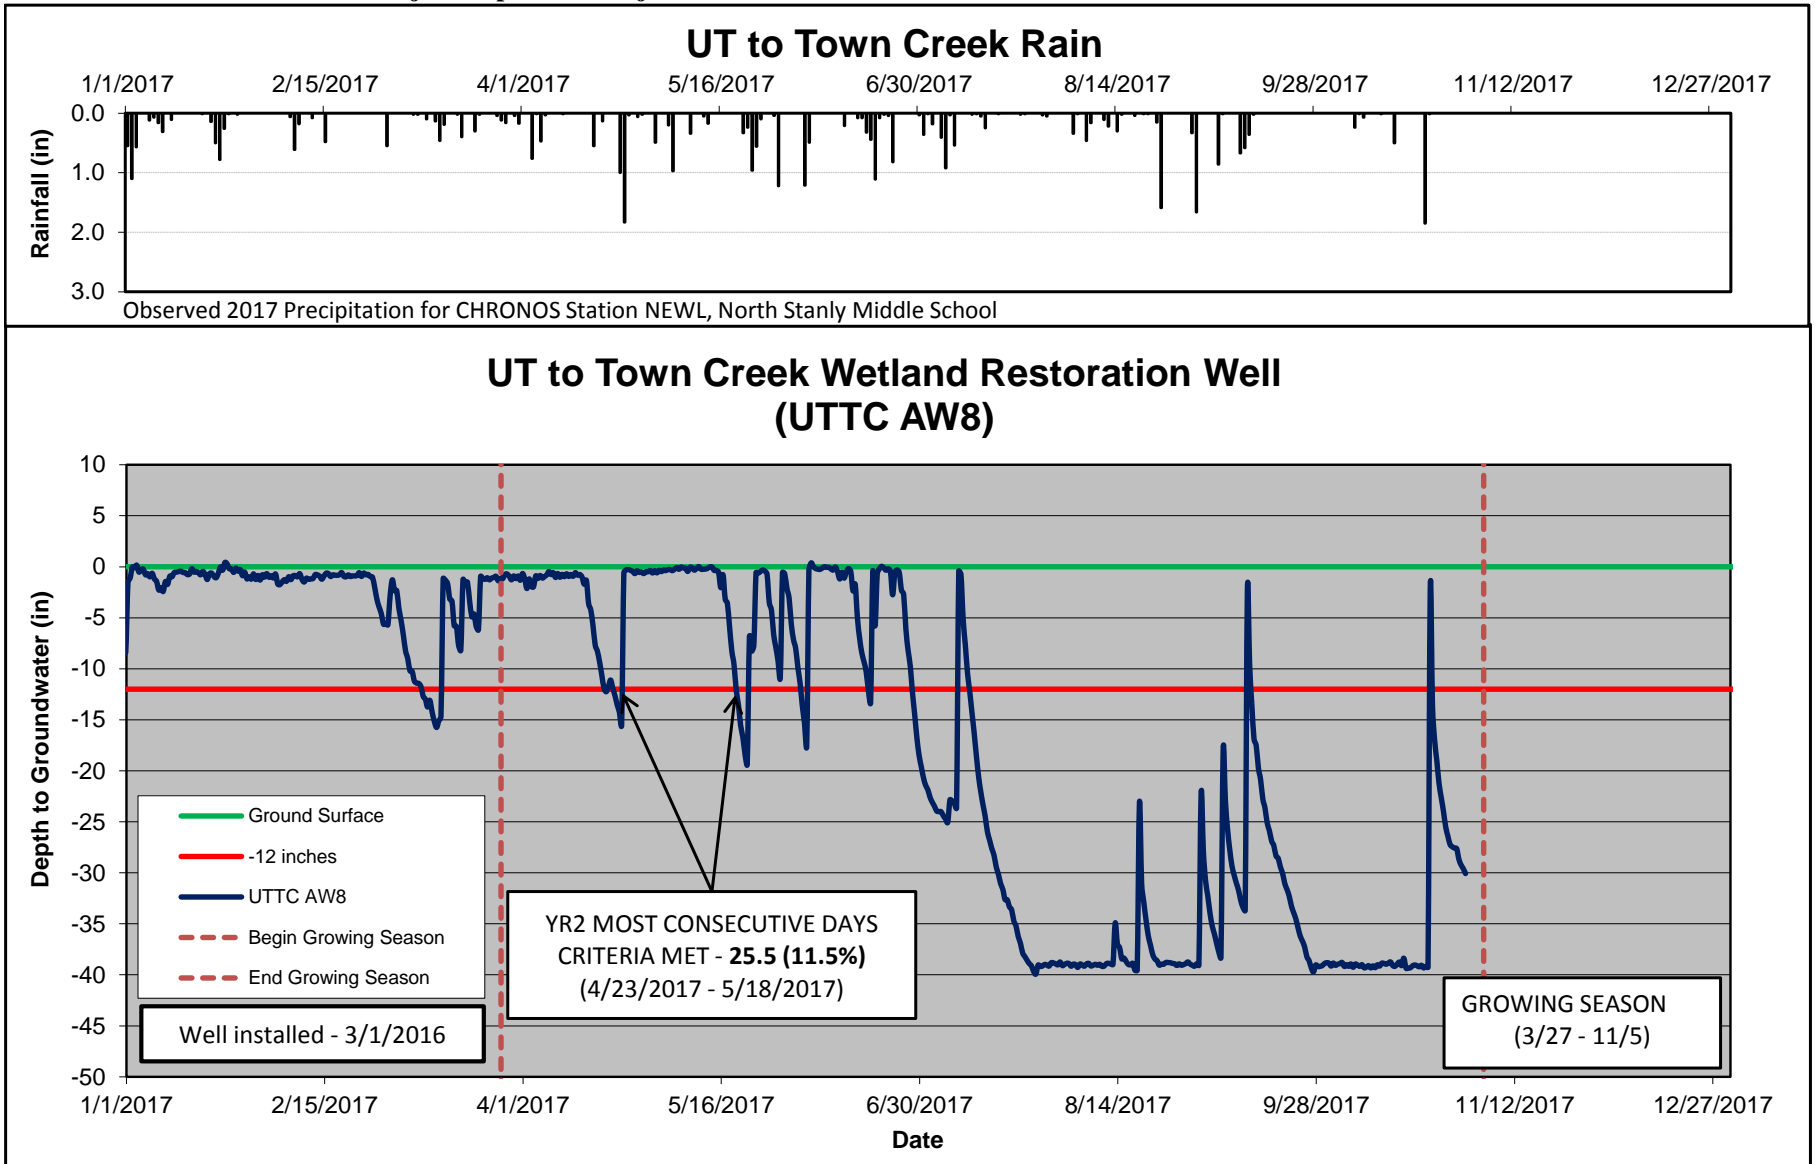
Figure 6. Wetland Gauge Graphs

Groundwater monitoring data collected during the growing season (March 27 through November 5) of the Year 2 monitoring period documented that all ten groundwater monitoring wells exhibited soil saturation within 12 inches of the ground surface for the minimum success criteria of nine percent (9%) or 20 consecutive days during the growing season. UTTC AW2 exhibited the highest percentage of consecutive days (69.1%) meeting saturated conditions, as well as, the having the highest number of cumulative days (179.5) meeting conditions. UTTC AW8 had the lowest percentage of consecutive days (11.5%) meeting saturated conditions, as well as, the having the lowest number of cumulative days (89.0) meeting conditions. It should also be noted that UTTC AW8 is located in a jurisdictional wetland and outside the boundary of the wetland areas where credit is being generated (See CCPV in Appendix B). See Appendix E for a plot of wetland gauge data as it relates to monthly precipitation for Monitoring Year 2 (Figure 6) and a summary of wetland attainment for all ten monitoring
