**UT to Town Creek Restoration Project – Option A
Year 2 Monitoring Report**

Stanly County, North Carolina

DMS Project ID Number – 94648; NC DEQ Contract No. 003277

Monitoring Year: 2 of 7

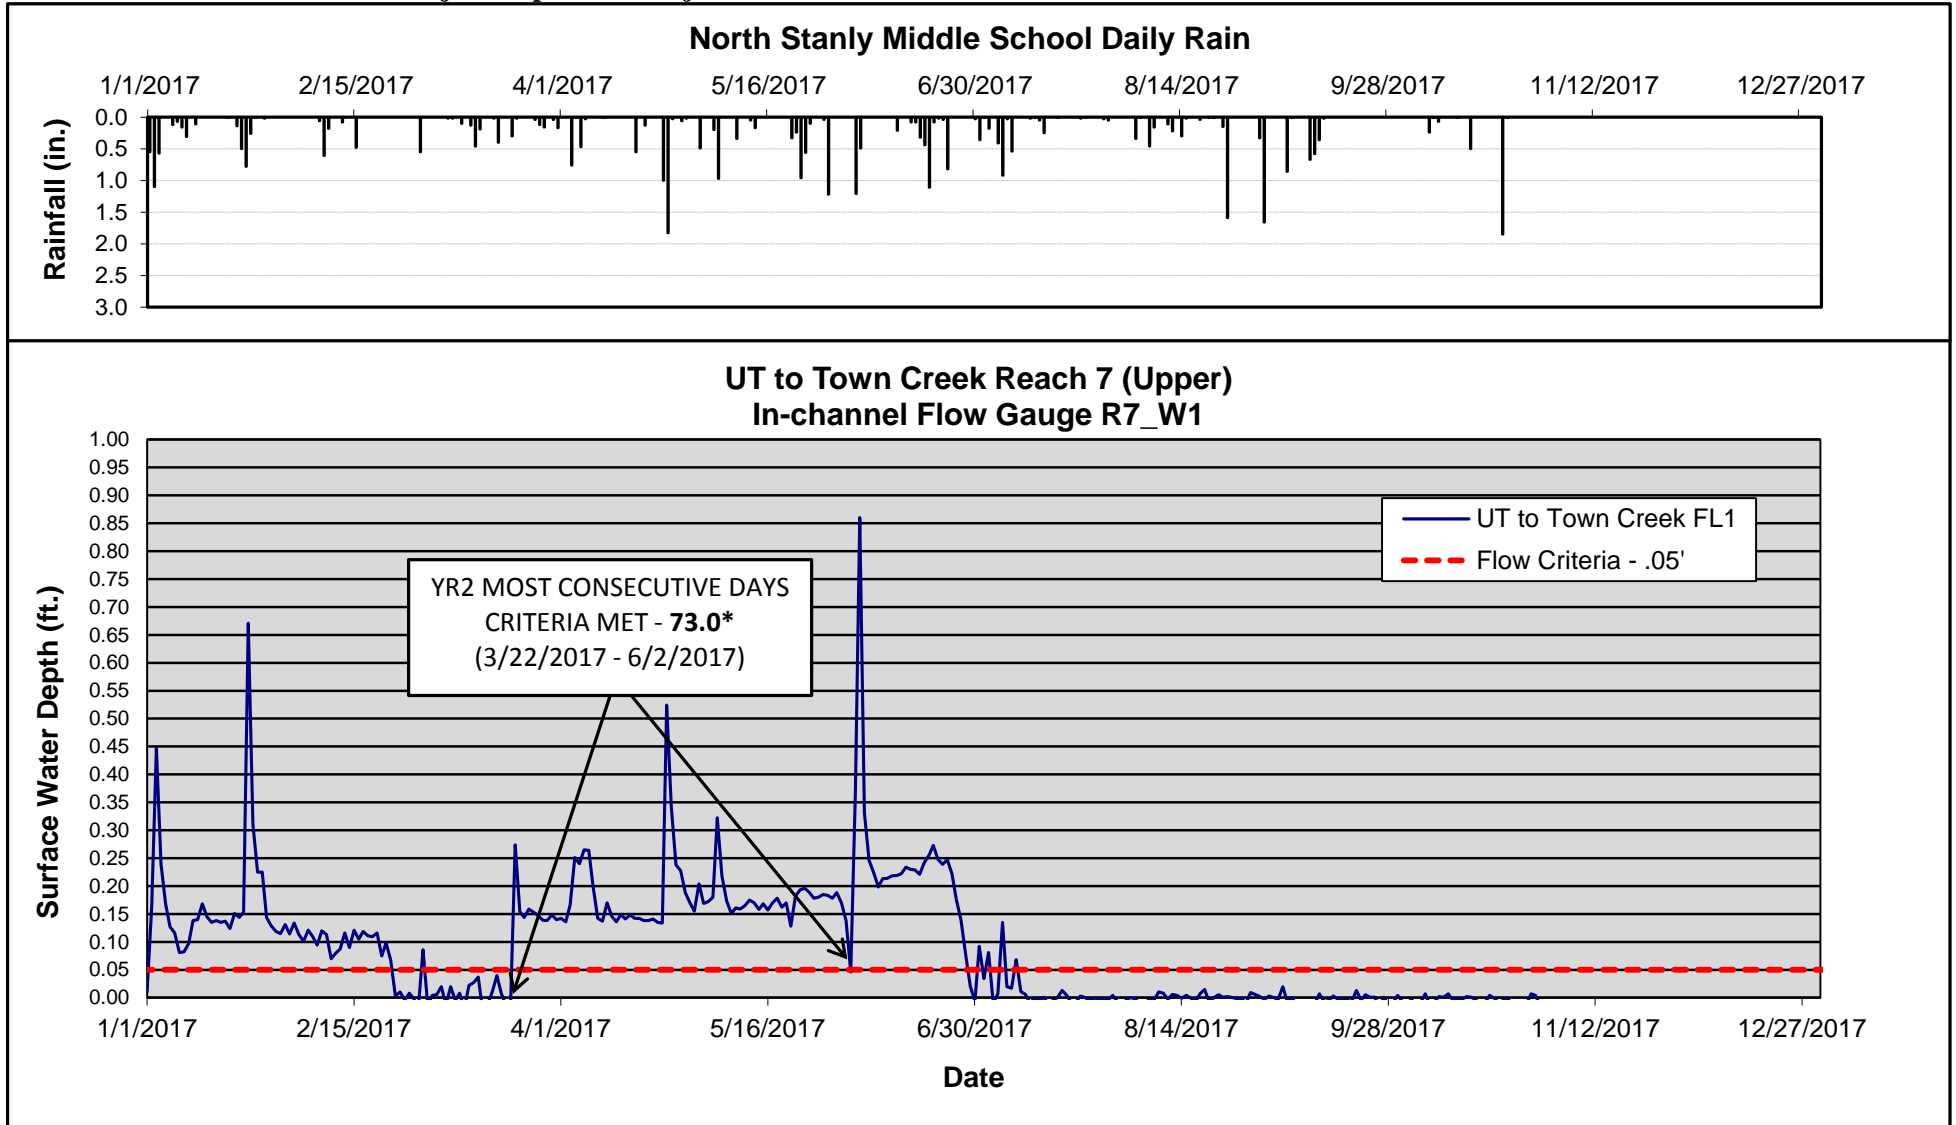
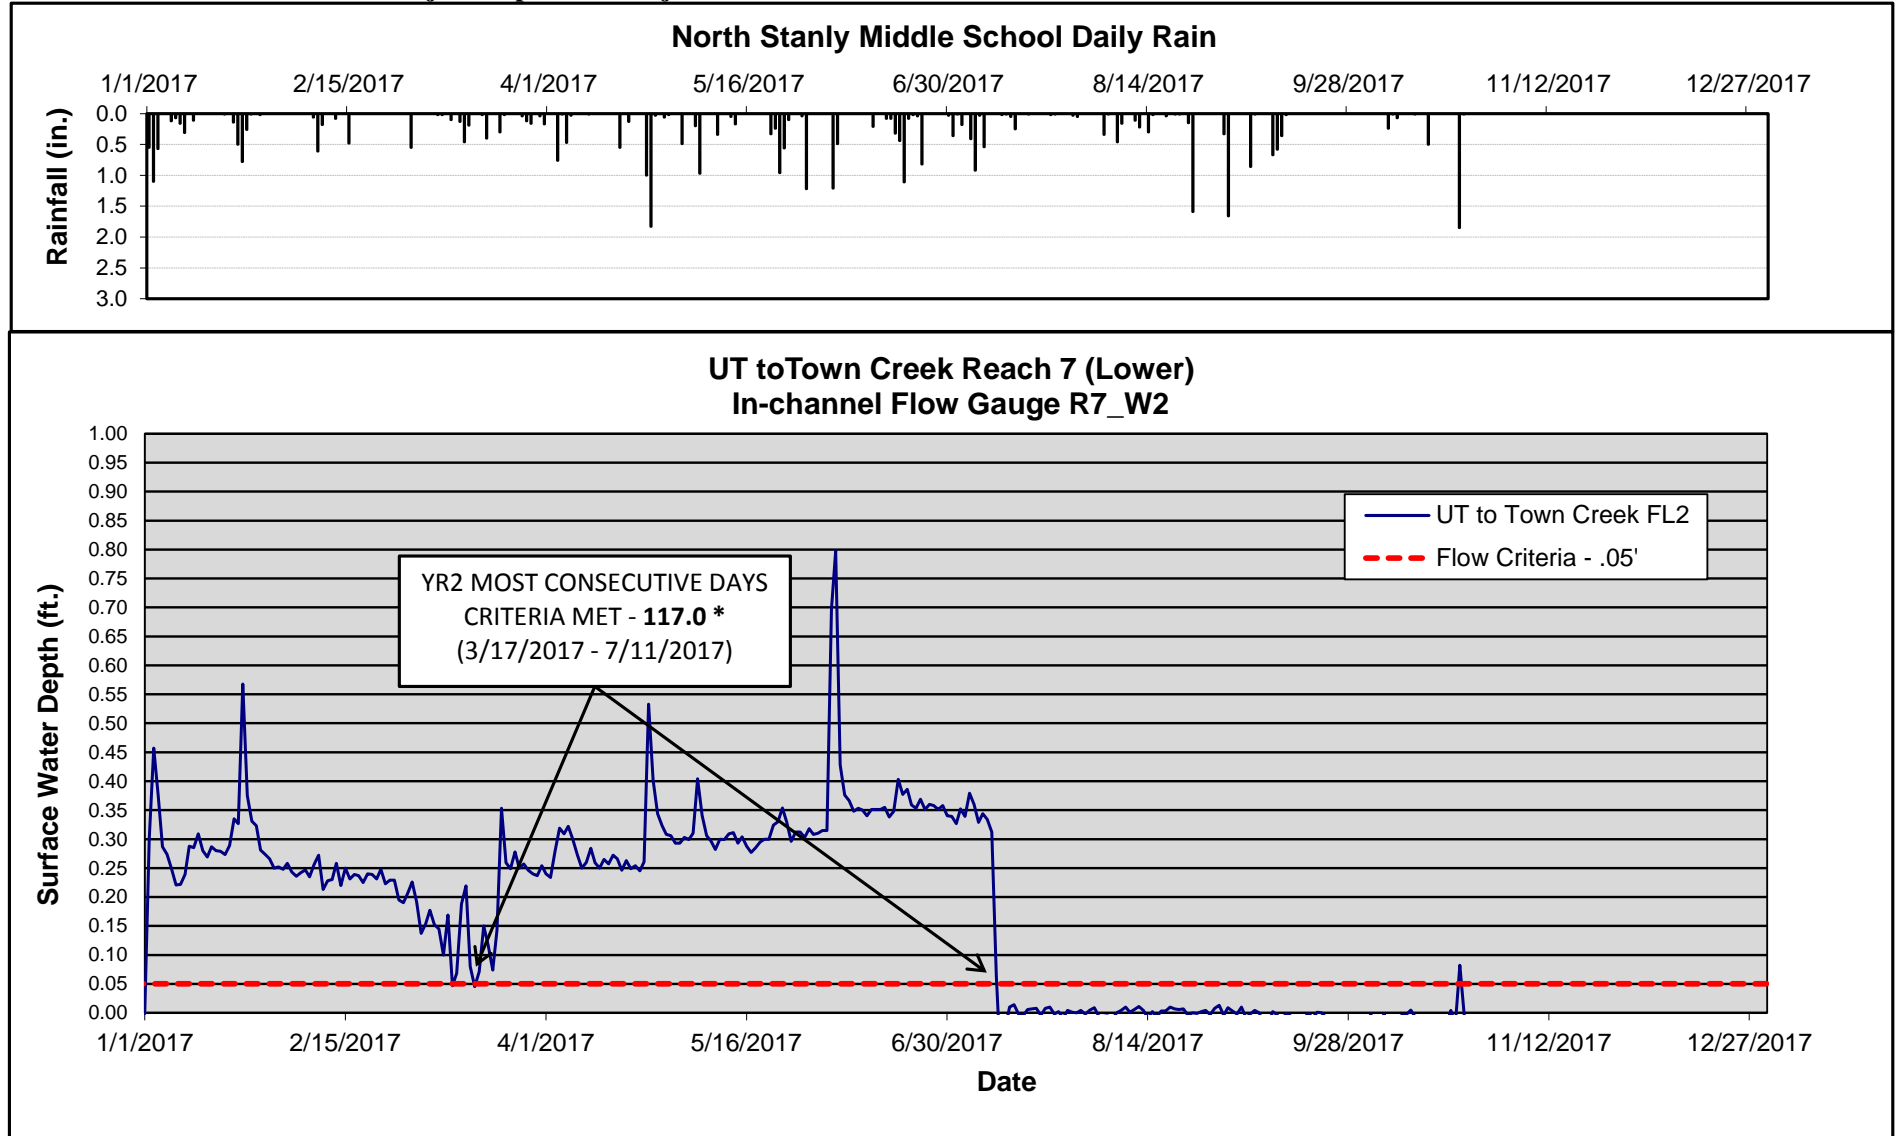
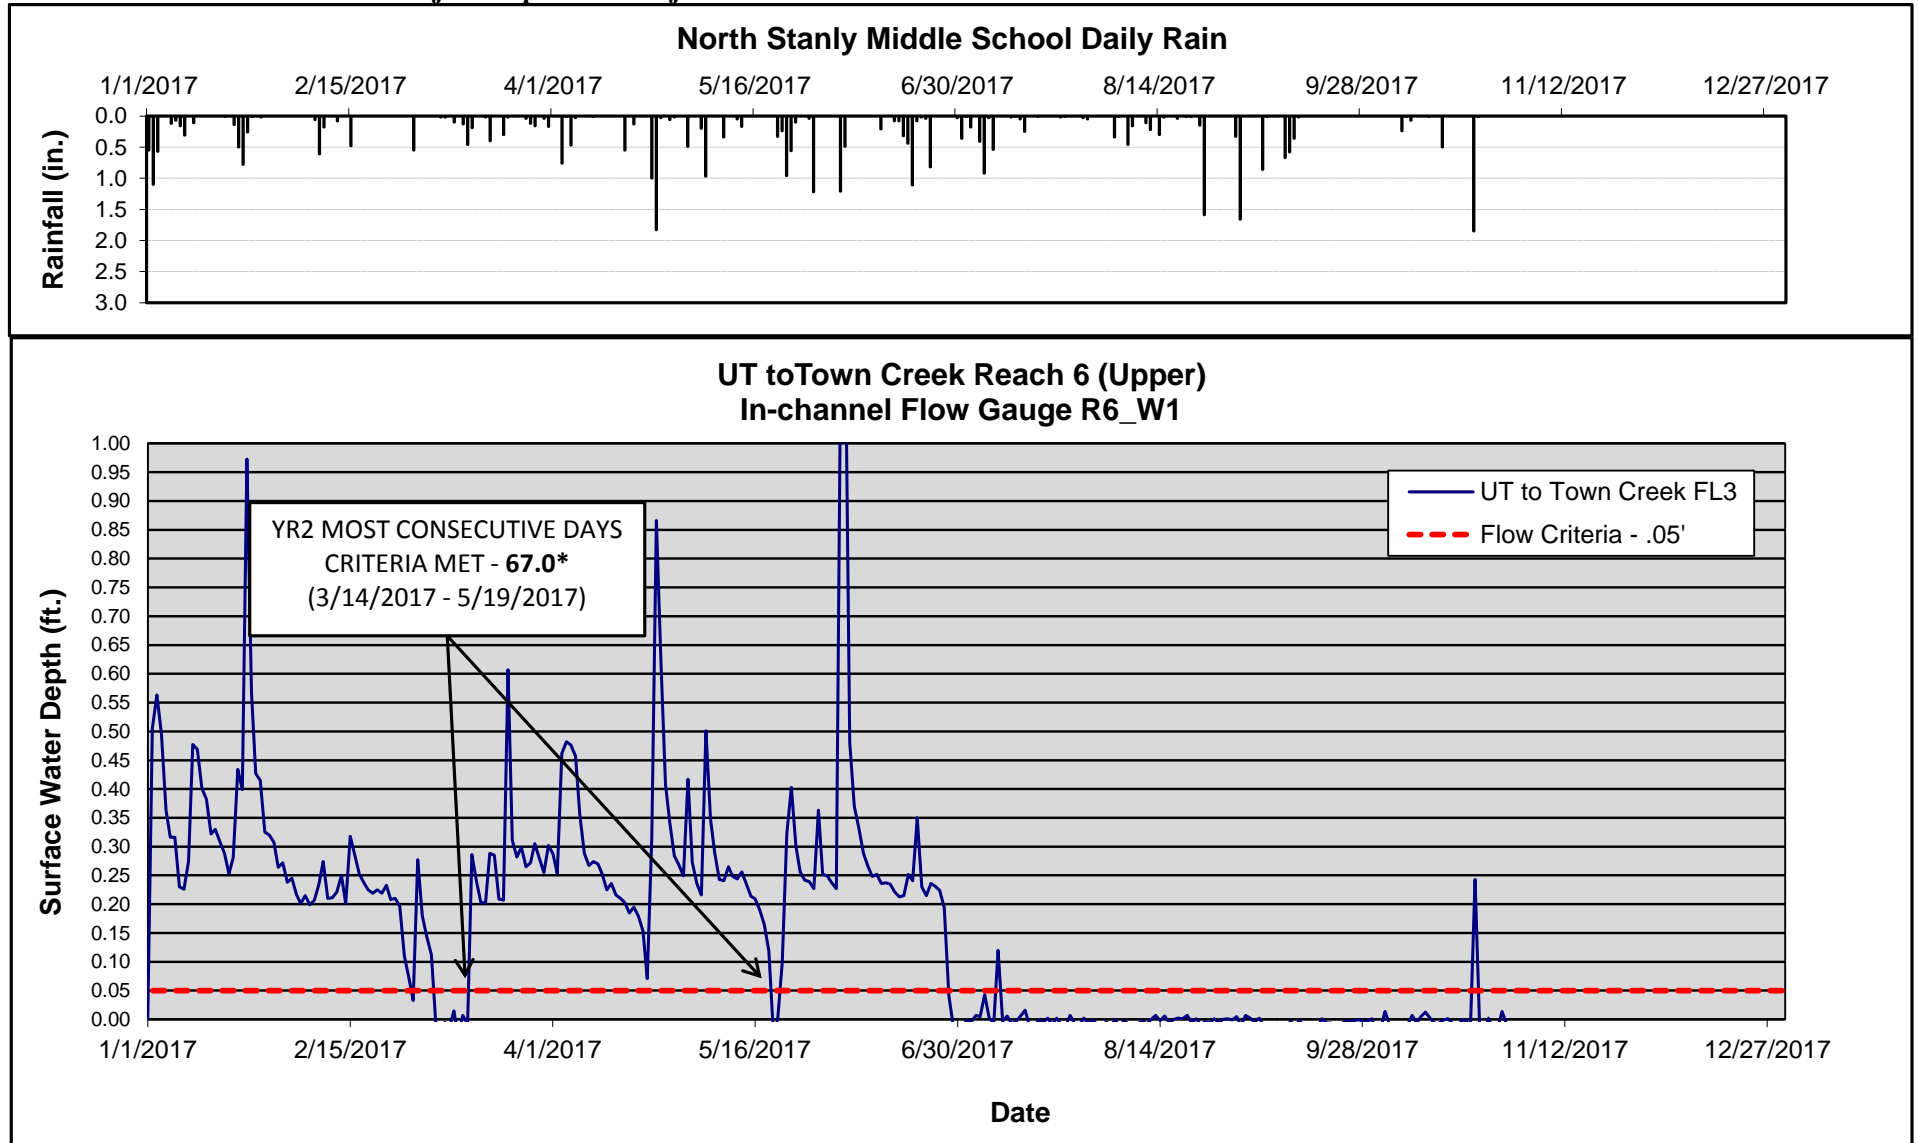
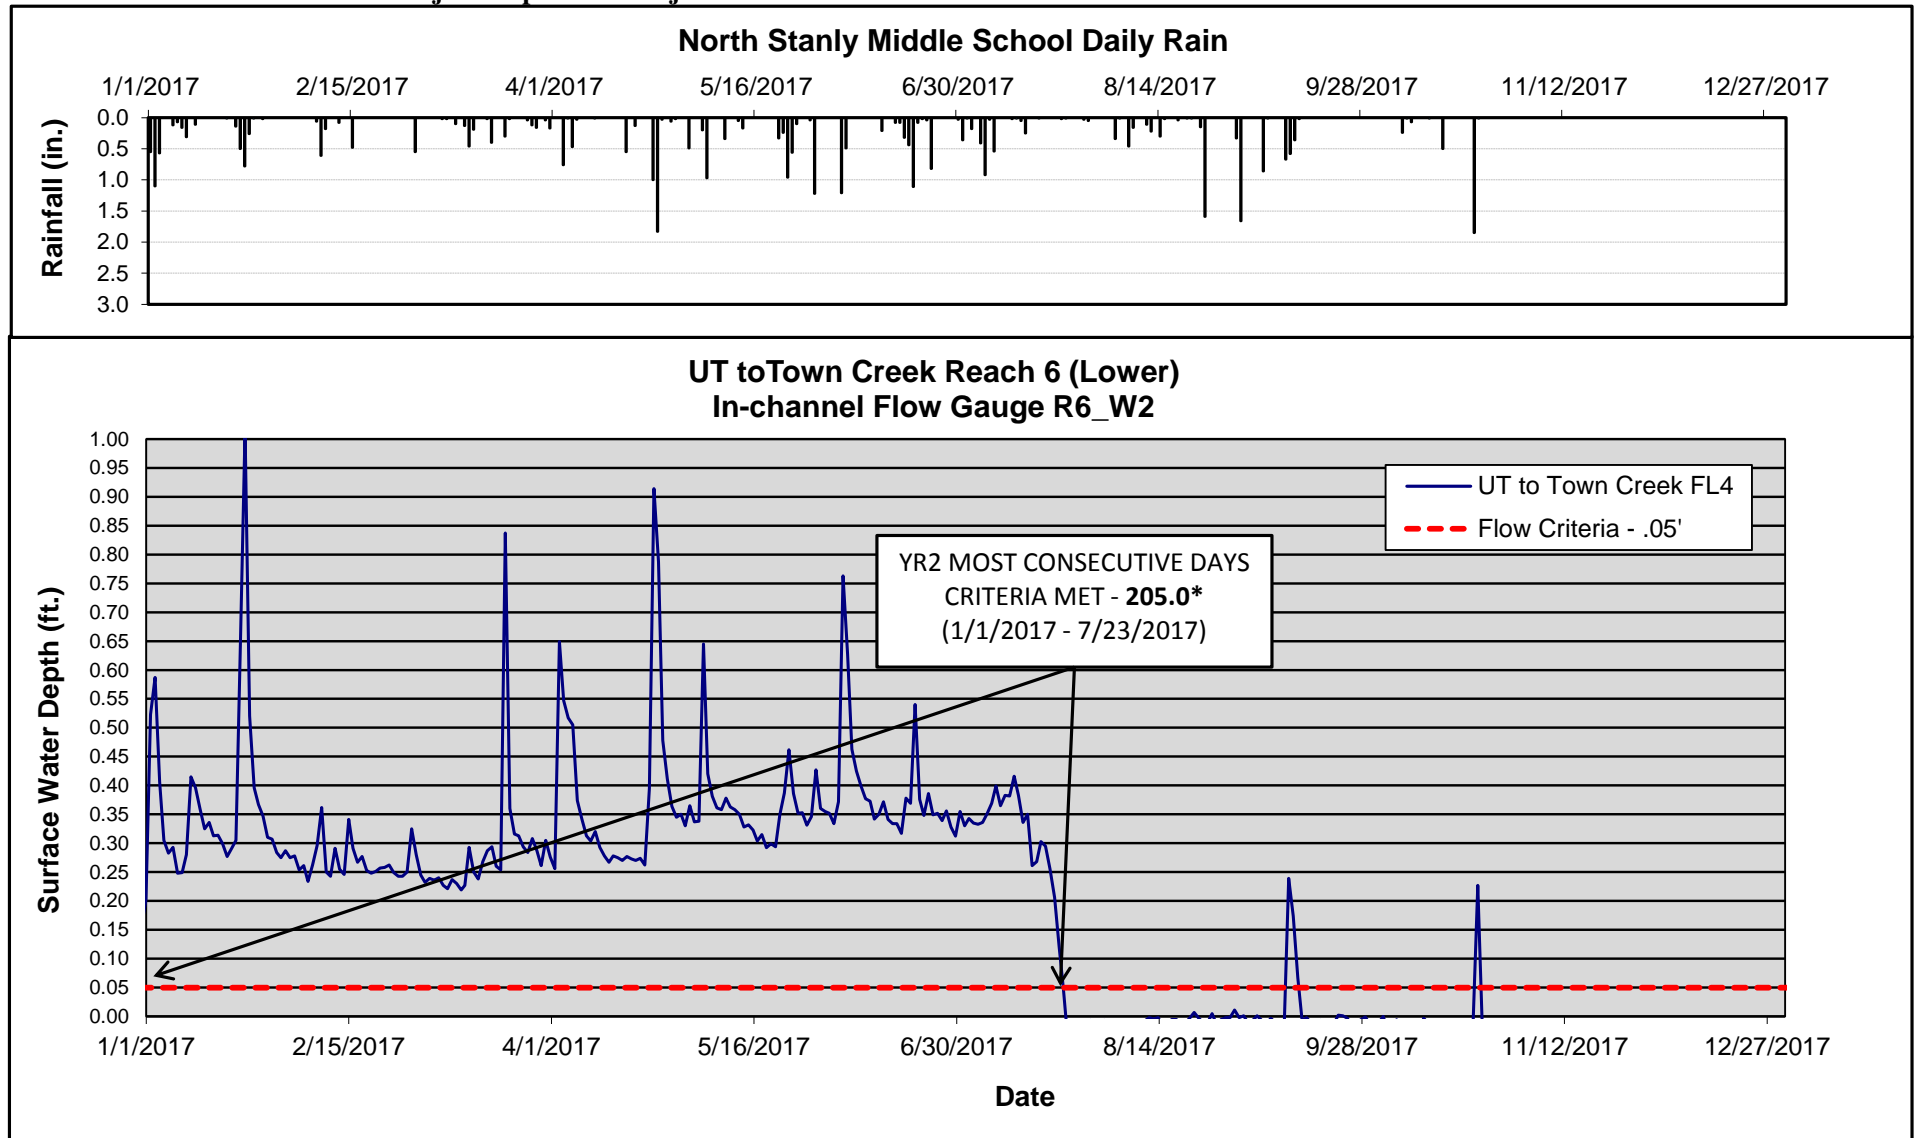
Figure 7. In-stream Flow Gauge Graphs

In-stream pressure transducers were installed on Reach 6 and 7 to document flow conditions throughout the monitoring year. During Monitoring Year 2, in-stream flow gauges on Reach 6 (R6_W1 and R6_W2) and on Reach 7 (R7_W1 and R7_W2) documented at least one period of consecutive stream flow for the required minimum of 30 days. R6_W1 experienced the longest period of consecutive stream flow with 205 days. Figure 7 in Appendix E, depict the documented flow conditions for each gauge through Monitoring Year 2 relative to local rainfall data, while Table 13 documents both the total cumulative days of flow and the maximum number of consecutive days of flow.

* Surface water flow is estimated to have occurred when the pressure transducer reading is equal to or above 0.05 feet in depth.

Table 13. Verification of In-stream Flow Conditions		
UT to Town Creek Restoration Project - Option A: DMS Project ID No. 94648		
Flow Gauge ID	Consecutive Days of Flow¹	Cumulative Days of Flow²
Reach 7 Flow Gauges		
R7_W1	73.0	156.0
R7_W2	117.0	190.0
Reach 6 Flow Gauges		
R6_W1	67.0	168.0
R6_W2	204.0	204.0

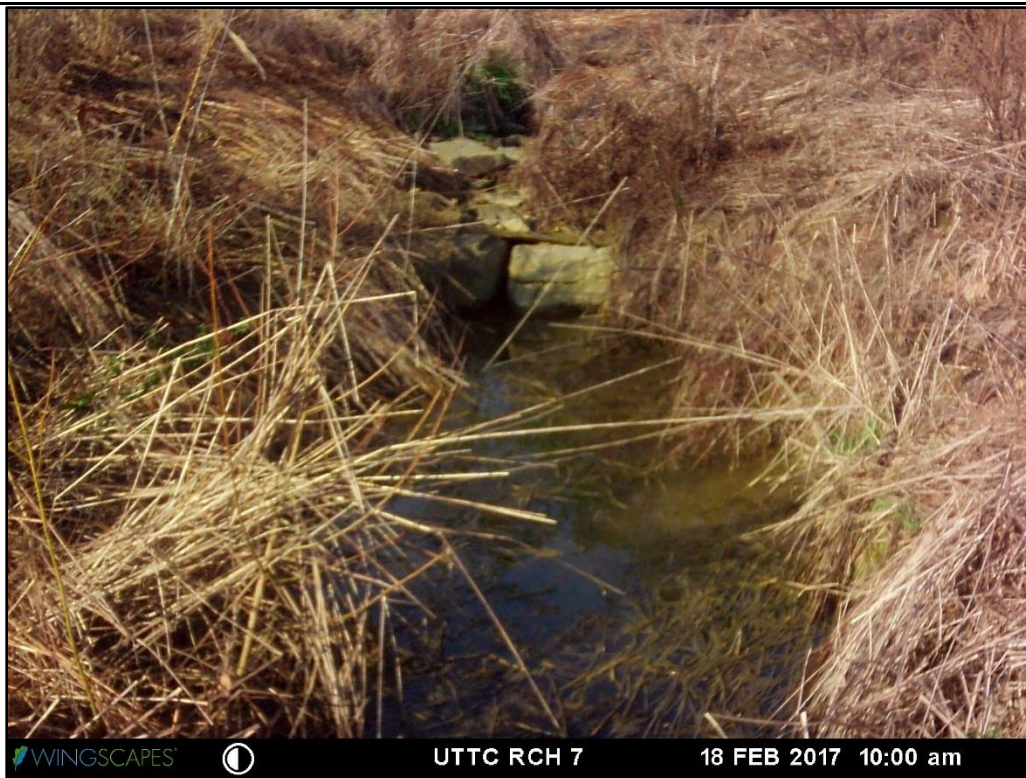
Flow Documentation Photo – R7_W2 (02/18/2017)

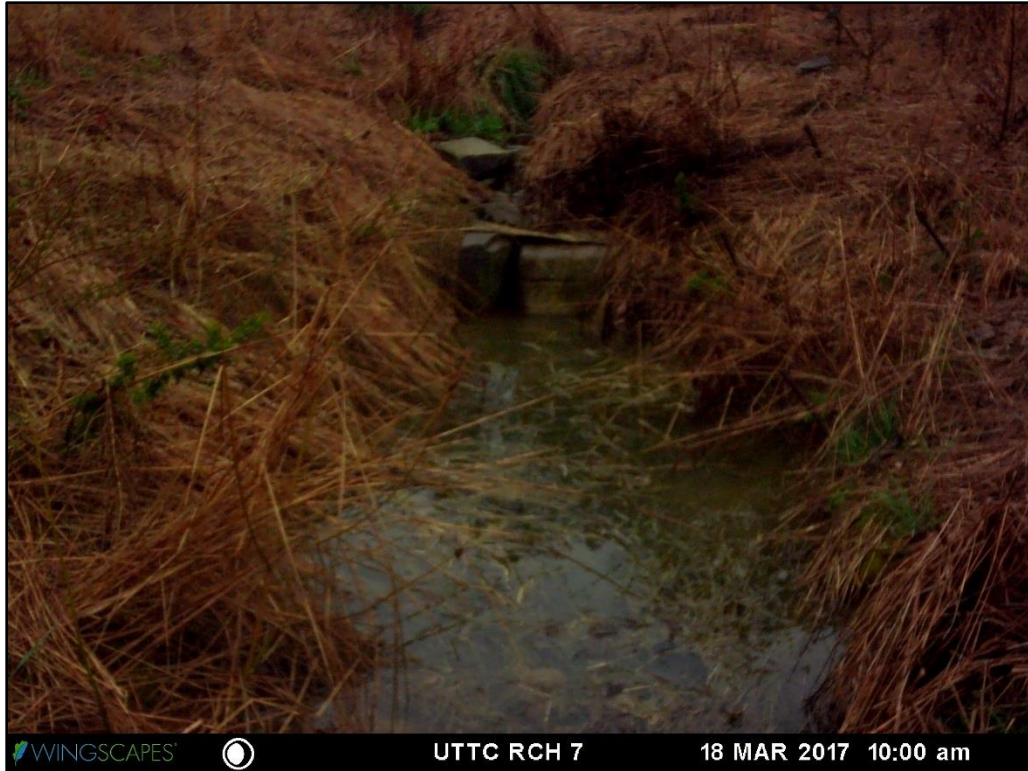
Flow Documentation Photo – R7_W2 (03/18/2017)

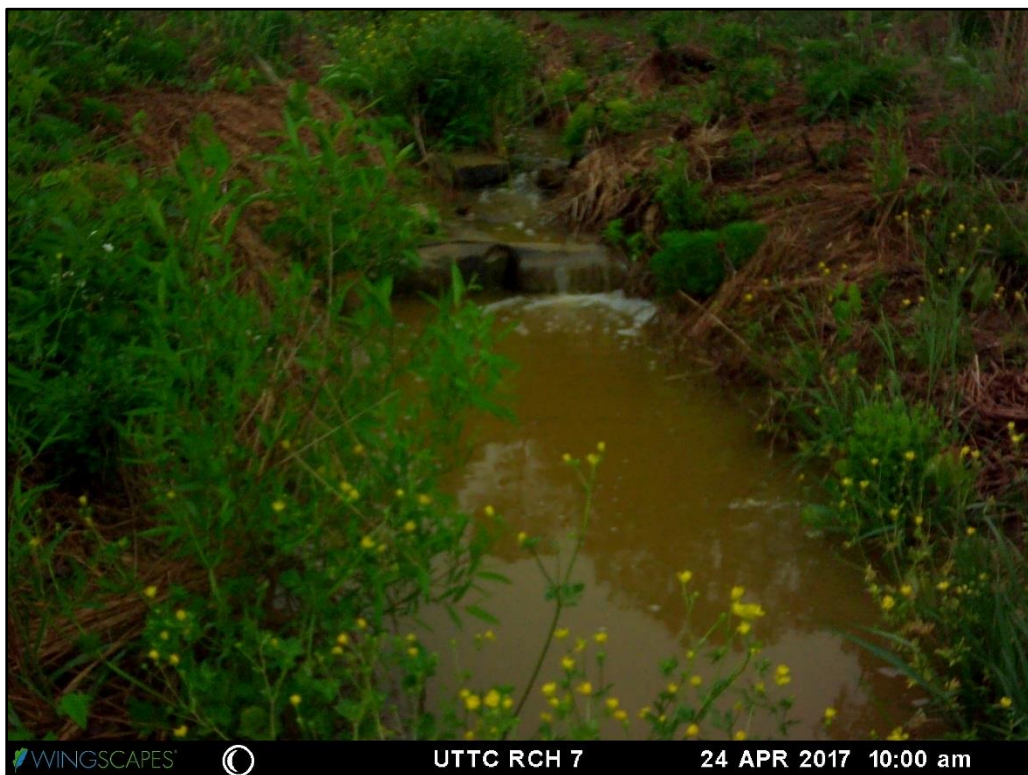
Flow Documentation Photo – R7_W2 (04/24/2017)

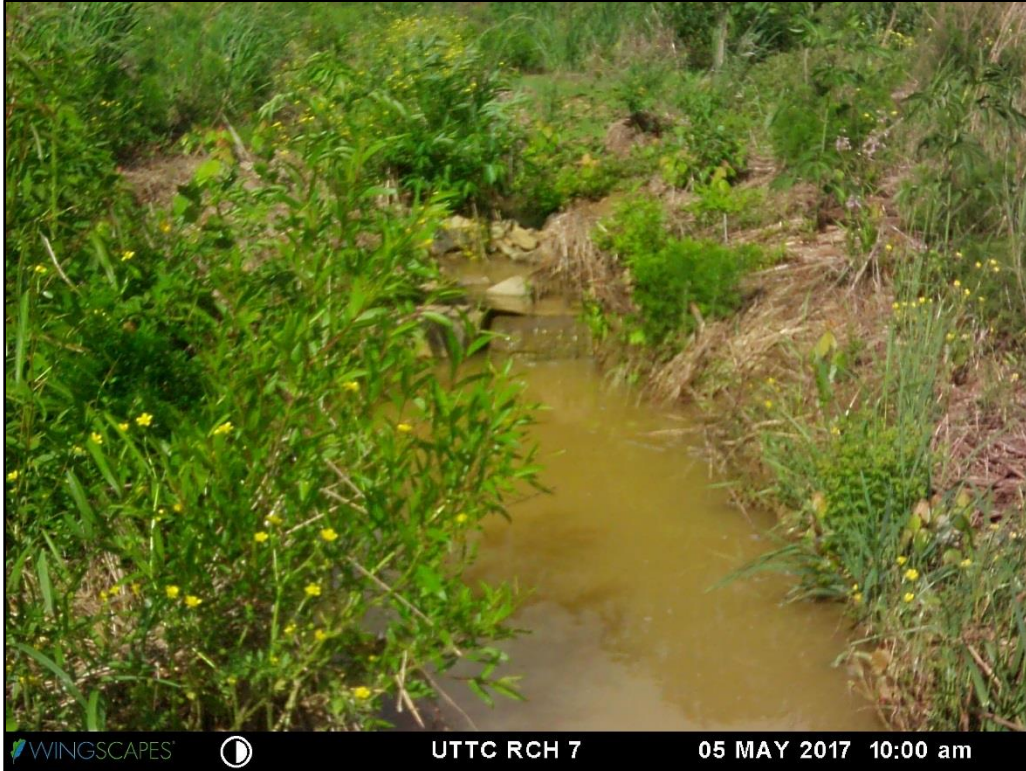
Flow Documentation Photo – R7_W2 (05/05/2017)

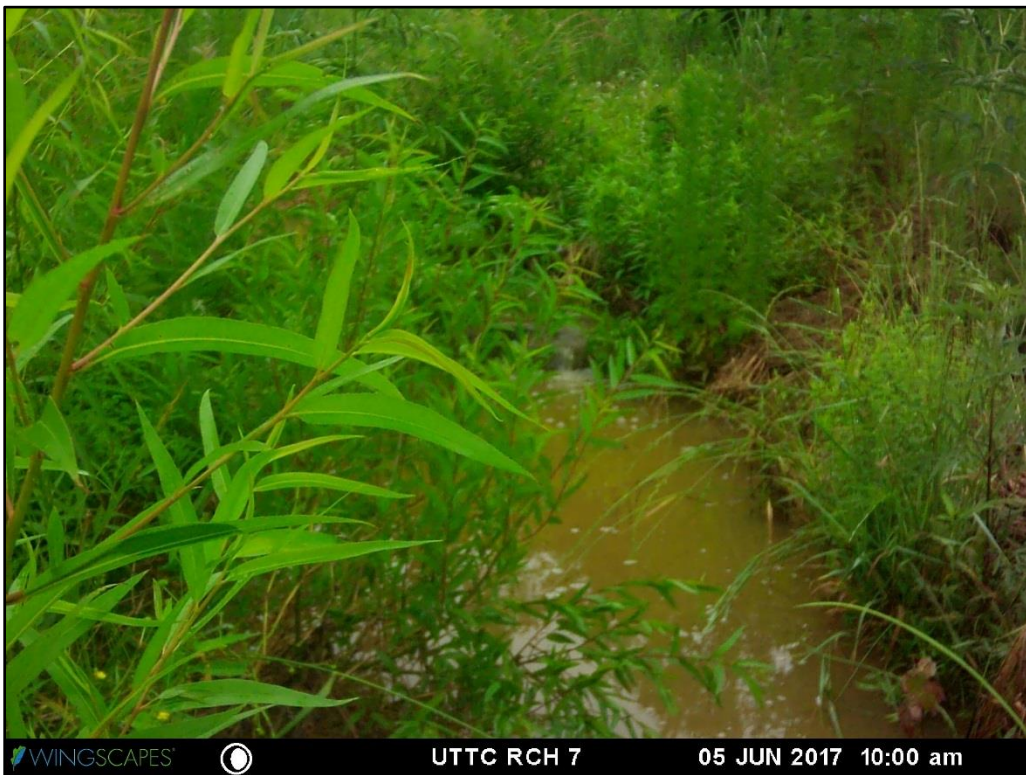
Flow Documentation Photo – R7_W2 (06/05/2017)
