Mitigation Project Name UT to Town Creek Stream and Wetland Restoration Site
 DMS ID 94648
 River Basin Yadkin
 Cataloging Unit 03040105

County Stanly
 Date Project Instituted 8/20/2010
 Date Prepared 8/27/2018

Stanly County, North Carolina

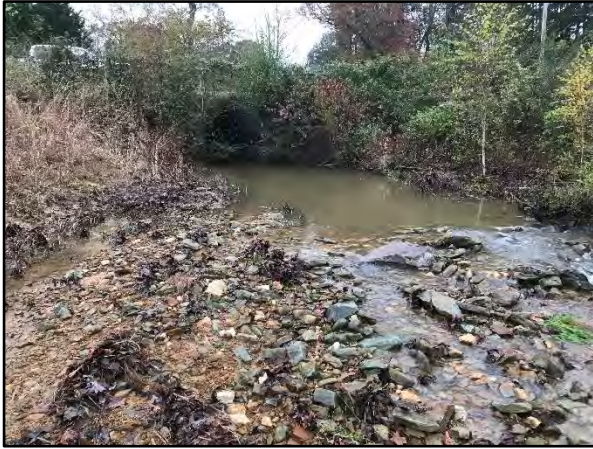
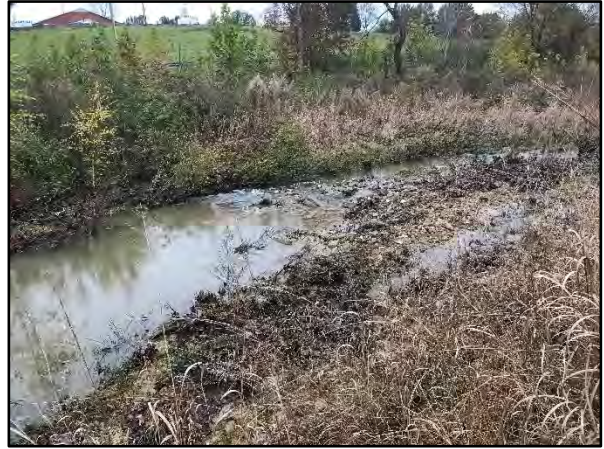
SPA 3-1 - Station 10+10 – Stream banks downstream of culvert have eroded and washed away during flooding in 2018 (11/14/18)

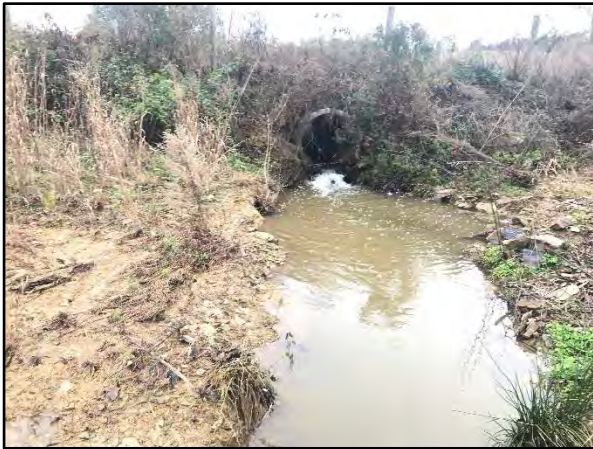
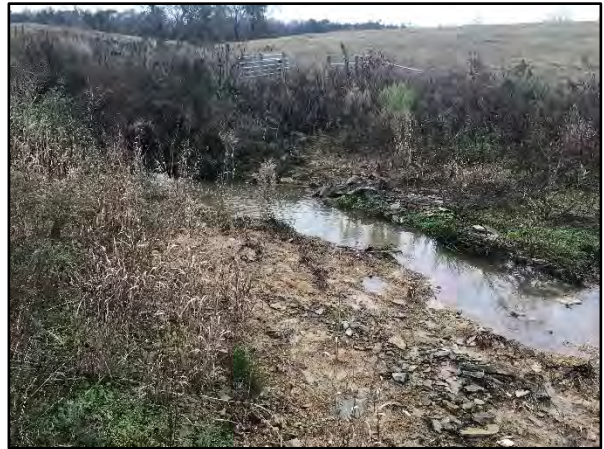
Reach 1			
Feature Issue	Station No.	Suspected Cause	Photo Number
Stream banks eroding downstream of the culvert	10+10	Flooding during 2018 eroded bank material from the area immediately downstream of the culvert at the beginning of the project. Vegetation is gone but area seems stable and will be monitored in MY4.	SPA 3-1
Reach 2			
Feature Issue	Station No.	Suspected Cause	Photo Number
No issues in Year 3	N/A	N/A	N/A
Reach 3			
Feature Issue	Station No.	Suspected Cause	Photo Number
No issues in Year 3	N/A	N/A	N/A
Reach 4			
Feature Issue	Station No.	Suspected Cause	Photo Number
No issues in Year 3	N/A	N/A	N/A
Reach 5			
Feature Issue	Station No.	Suspected Cause	Photo Number
No issues in Year 3	N/A	N/A	N/A
Reach 6			
Feature Issue	Station No.	Suspected Cause	Photo Number
Stream banks eroding downstream of the culvert	20+50	Flooding during 2018 eroded bank material from the area immediately downstream of the culvert. All soil material that was placed on bedrock has eroded away. Vegetation is gone but area seems stable since the banks are now primarily bedrock. This area will be monitored in MY4.	SPA 3-2

SPA 3-2 - Station 20+50 – Stream banks downstream of culvert have eroded and washed away during flooding in 2018 (11/14/18)

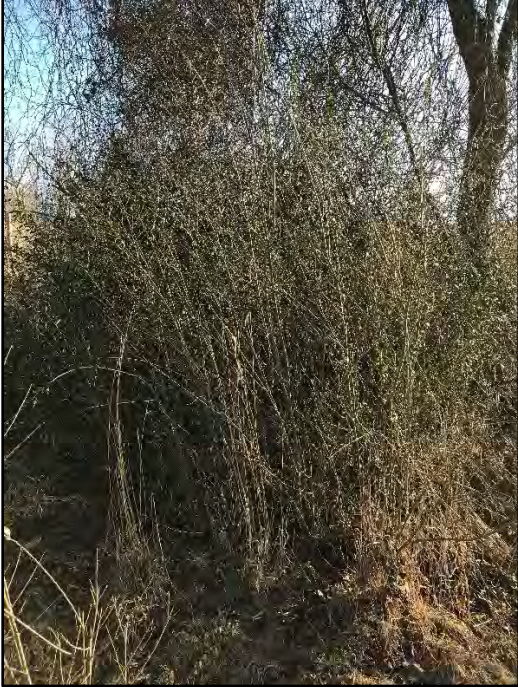
Poor growth rates*	22+15 - 26+60	Poor growth rates were noted in areas where supplemental bare root and gallon container plantings were installed during MY3.	VPA3-8
Reach 3			
Feature Issue	Station No.	Suspected Cause	Problem Area / Photo Number
Invasive/Exotic Populations	Reachwide in various locations	Myriophyllum aquaticum (parrot feather) growing in various locations along the channel reach due low flow conditions present during the monitoring assessment.	No VPA was associated with this problem area because it is a reachwide issue that is located in various sections along the Reach 3.
Bare Areas	46+50 - 48+60	Poor soils	VPA2-2
Poor growth rates*	44+50 - 48+60	Poor growth rates were noted in areas where supplemental bare root and gallon container plantings were installed during MY3.	VPA 3-7
Reach 4			
Feature Issue	Station No.	Suspected Cause	Problem Area / Photo Number
Invasive/Exotic Populations	N/A	<i>Ligustrum sinense</i> (Chinese privet) growing in along easement fence line at the upstream extent of Reach 4 (above BMP).	VPA3-1

Invasive/Exotic Populations	10+25 - 11+15	<i>Ligustrum sinense</i> (Chinese privet) growing in along easement fence line at the upstream extent of Reach 4 (above BMP).	VPA3-2
Reach 5			
Feature Issue	Station No.	Suspected Cause	Problem Area / Photo Number
Invasive/Exotic Populations	9+25 -10+00	<i>Ligustrum sinense</i> (Chinese privet) growing in along easement fence line at the upstream extent of Reach 5.	VPA 3-3
Reach 6			
Feature Issue	Station No.	Suspected Cause	Problem Area / Photo Number
Invasive/Exotic Populations	18+30 -18+75	<i>Ligustrum sinense</i> (Chinese privet) and <i>Paulownia tomentosa</i> (Princess tree) growing in along easement fence line.	VPA3-4
Invasive/Exotic	20+10 - 20+30	<i>Rosa multiflora</i> (multiflora rose) growing in along easement fence line .	VPA3-5
Poor growth rates*	14+50 - 26+25	Poor growth rates were noted in areas where supplemental bare root and gallon container plantings were installed during MY3.	VPA3-6

VPA3-1 through VPA3-5 - Representative photo of Chinese privet growing in VPAs along Reach 4, 5, and 6. (02/08/18)

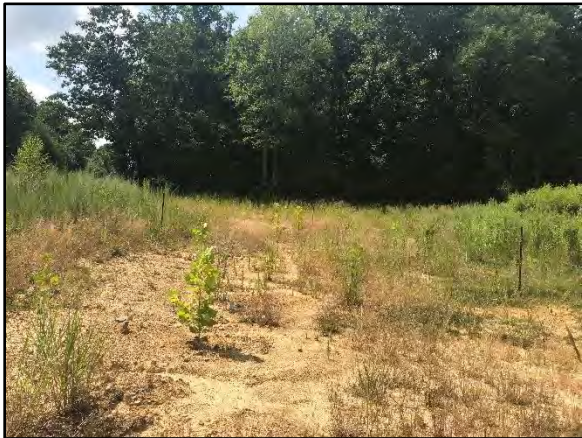
VPA 3-7 – Station 46+50 – Downstream photo of bare areas and areas of poor growth rates, as well as areas where supplemental plantings were installed. (07/17/18)

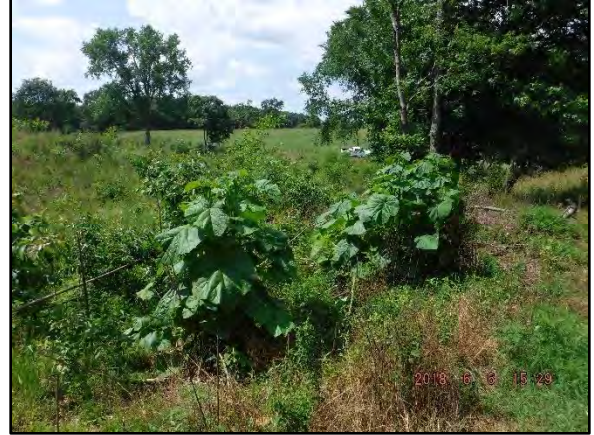
VPA3-4 – Regrowth of Princess tree (*Paulownia tomentosa*) growing in easement. (06/06/18)

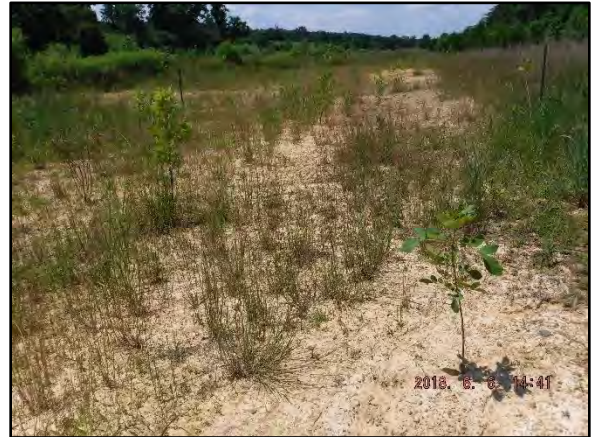
VPA 3-7 – Station 48+60 – Upstream photo of bare areas, areas of poor growth rates, and areas where supplemental plantings were installed. (06/06/18)

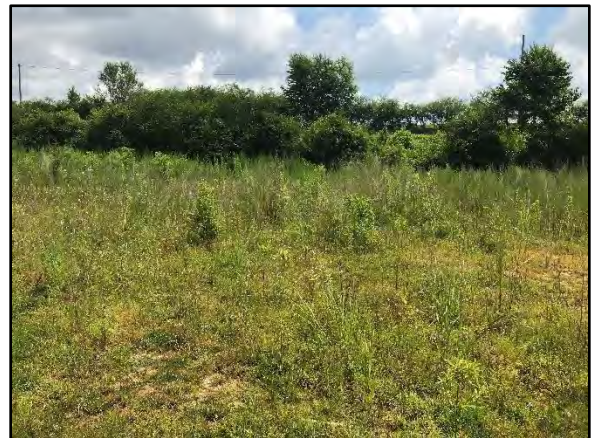
VPA 3-8 – Station 23+00 – Floodplain photo of areas of poor growth rates and where supplemental plantings were installed. (07/17/18)

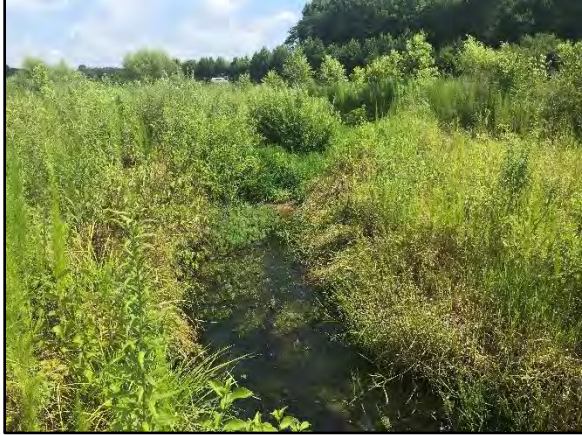
Table 6b. Vegetation Problem Areas			
UT to Town Creek Restoration Project: Project No. 94648			
Reach 1			
Feature Issue	Station No.	Suspected Cause	Problem Area / Photo Number
Invasive/Exotic Populations	Reachwide in various locations	Myriophyllum aquaticum (parrot feather) growing in various locations along the channel reach due low flow conditions present during the monitoring assessment.	No VPA was associated with this problem area because it is a reachwide issue that is located in various sections along the Reach 1.
Poor growth rates*	16+75 - 21+85	Poor growth rates were noted in areas where supplemental bare root and gallon container plantings were installed during MY3.	VPA3-9
Reach 2			
Feature Issue	Station No.	Suspected Cause	Problem Area / Photo Number
Invasive/Exotic Populations	Reachwide in various locations	Myriophyllum aquaticum (parrot feather) growing in various locations along the channel reach due low flow conditions present during the monitoring assessment.	No VPA was associated with this problem area because it is a reachwide issue that is located in various sections along the Reach 2.

**Parrot feather (*Myriophyllum aquaticum*)
growing in channel along Reach 2. (07/17/18)**

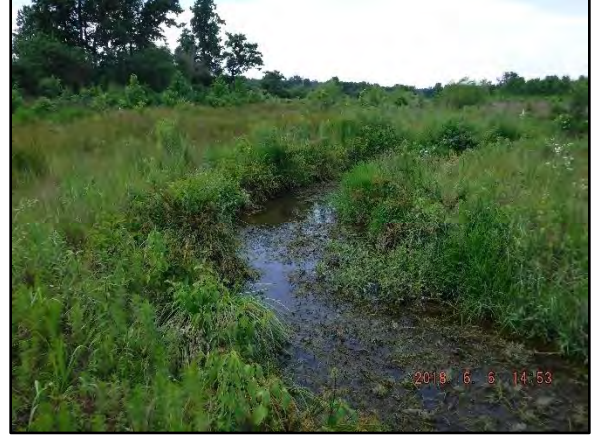
**Parrot feather (*Myriophyllum aquaticum*)
growing in channel along Reach 3. (06/06/18)**

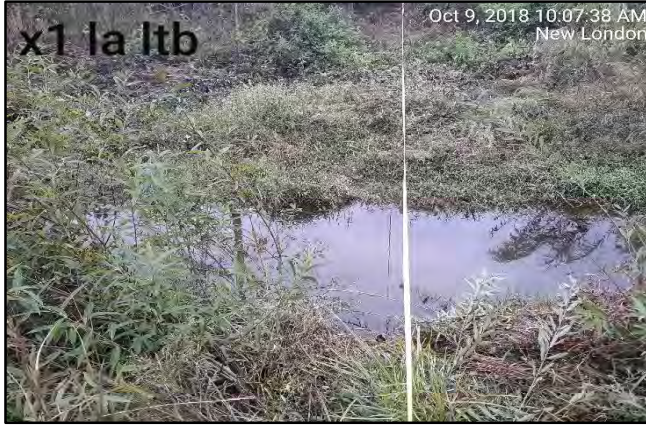
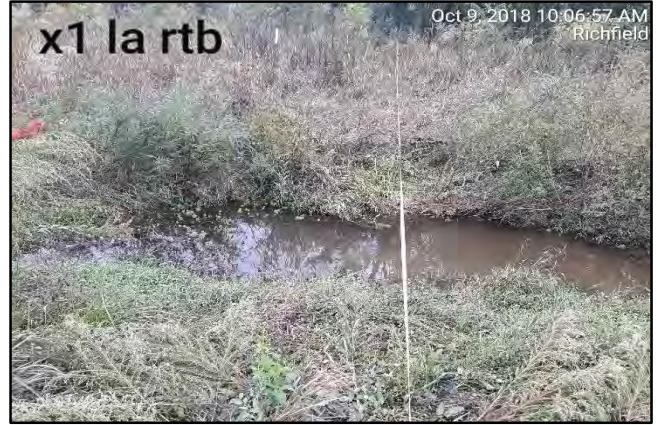
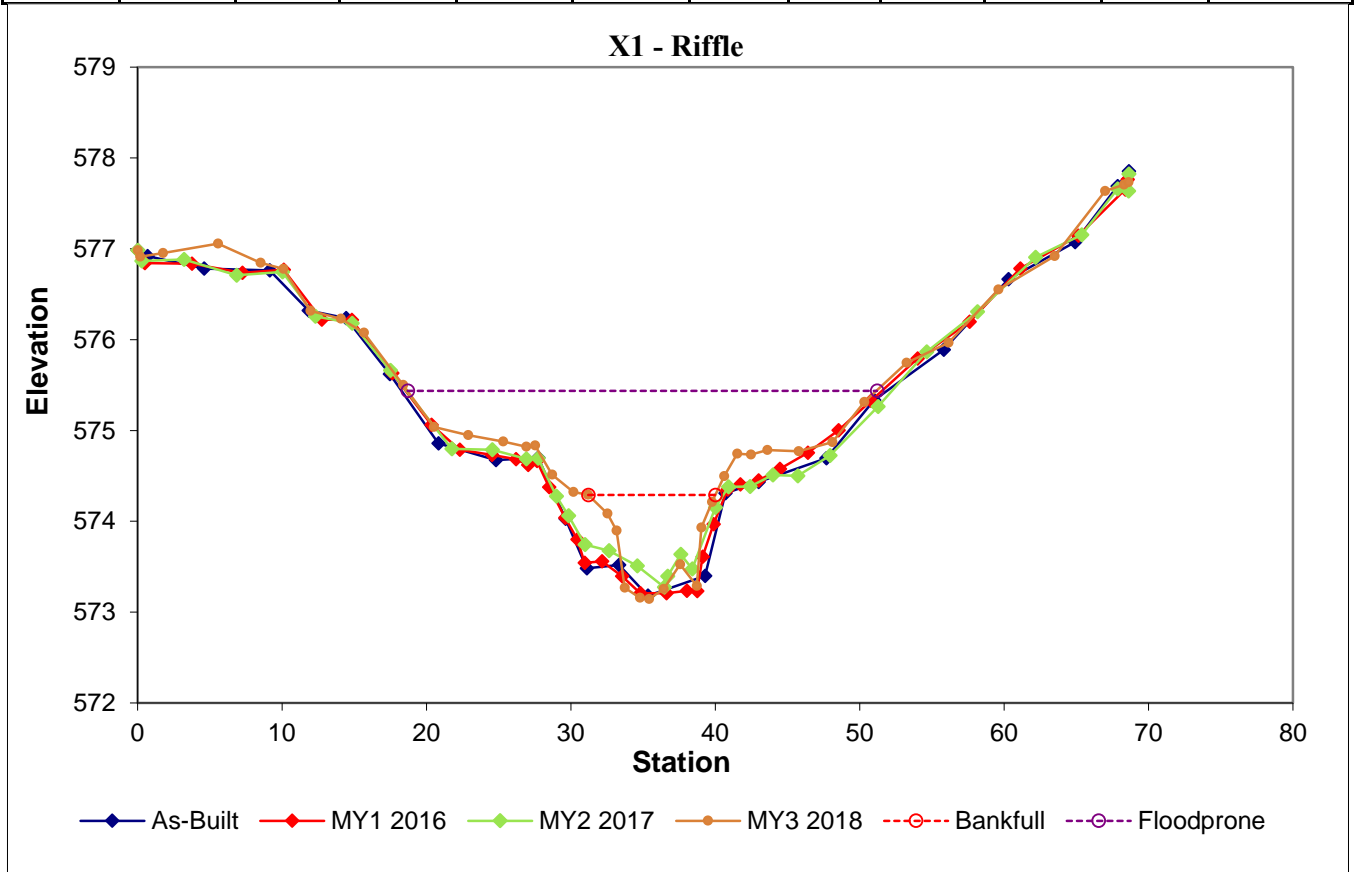
Permanent Cross-section
X1 Riffle - Reach 1 (Station 11+61)
Monitoring Year 3 - Collected October 2018

Feature	Stream Type	BKF Area	BKF Width	BKF Depth	Max BKF Depth	W/D	BH Ratio*	ER	BKF Elev**	TOB Elev	WFGPA
Riffle	C	6.1	8.8	0.7	1.1	12.7	1.1	3.7	574.3	574.7	32.5

*BHR = 1.1 is based on as-built bkf area of 9.1 at an elevation of 574.565. Remainder of data based on actual bankfull elevation from as-built which is 574.3.

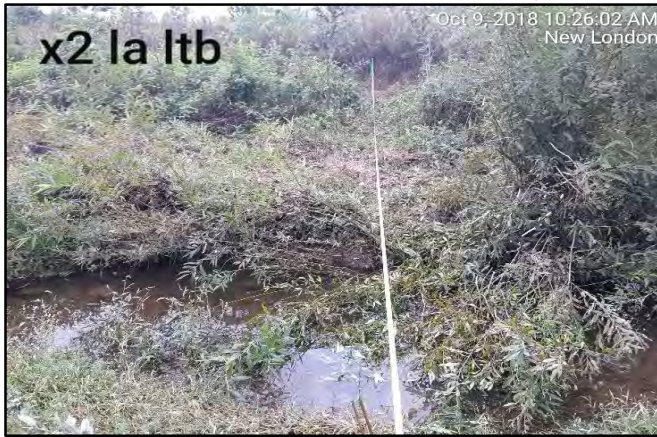
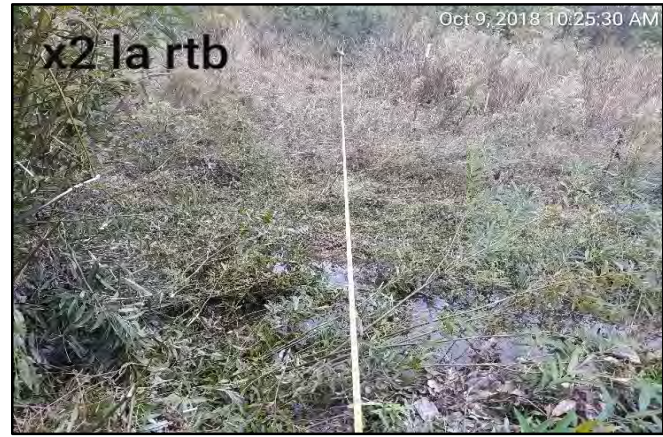
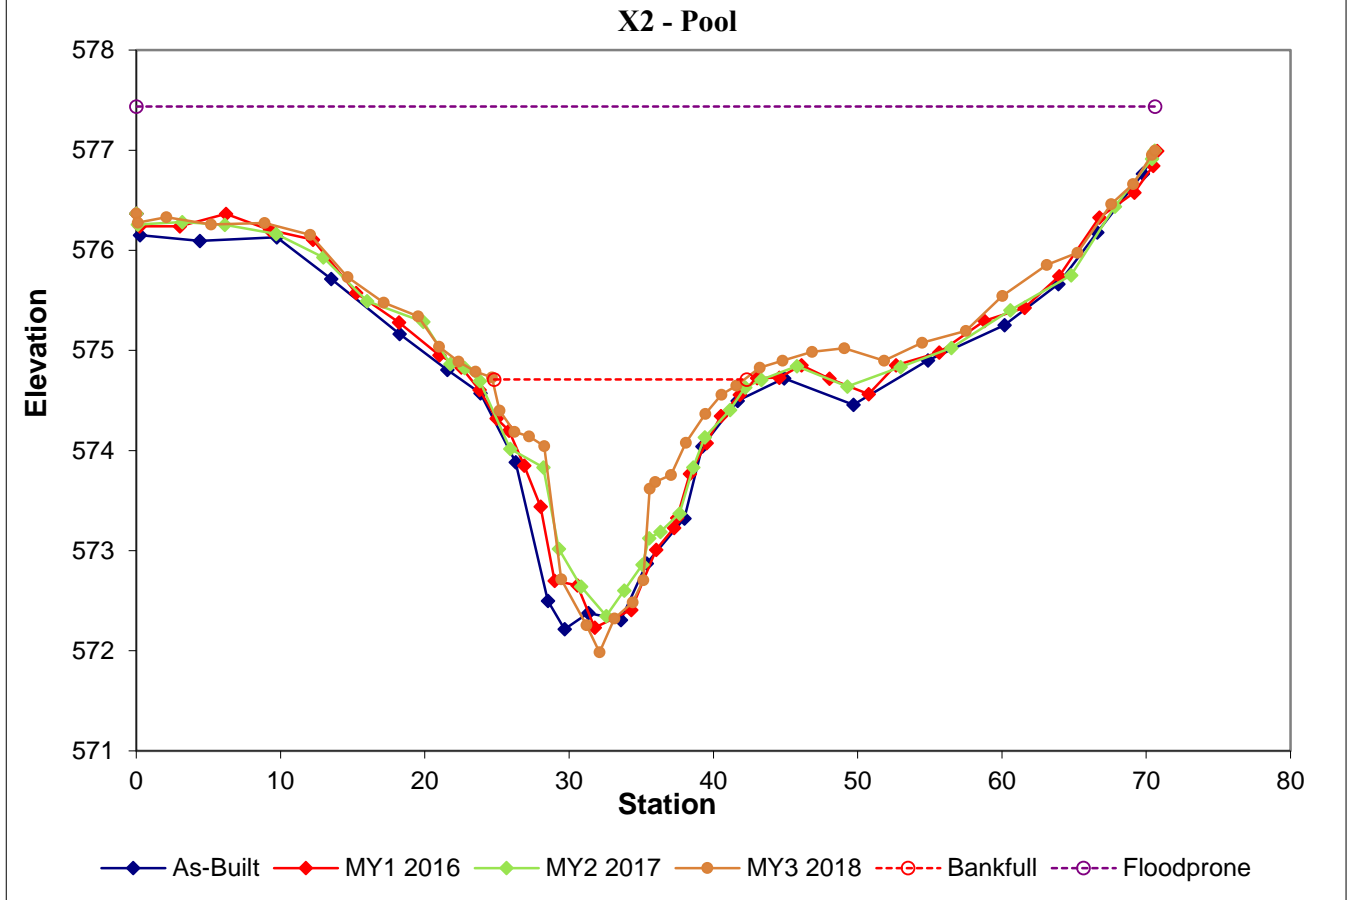
Permanent Cross-section
X2 Pool - Reach 1 (Station 12+00)
Monitoring Year 3 - Collected October 2018

Feature	Stream Type	BKF Area	BKF Width	BKF Depth	Max BKF Depth	W/D	BH Ratio*	ER	BKF Elev	TOB Elev	WFPA
Pool		20.7	17.5	1.2	2.7	14.7	-	-	574.7	574.6	70.6

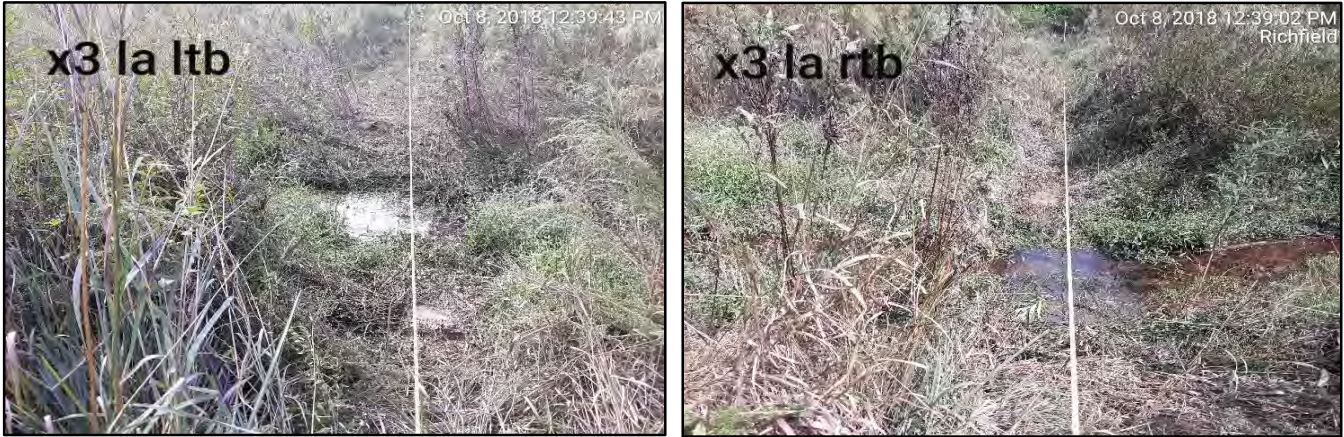
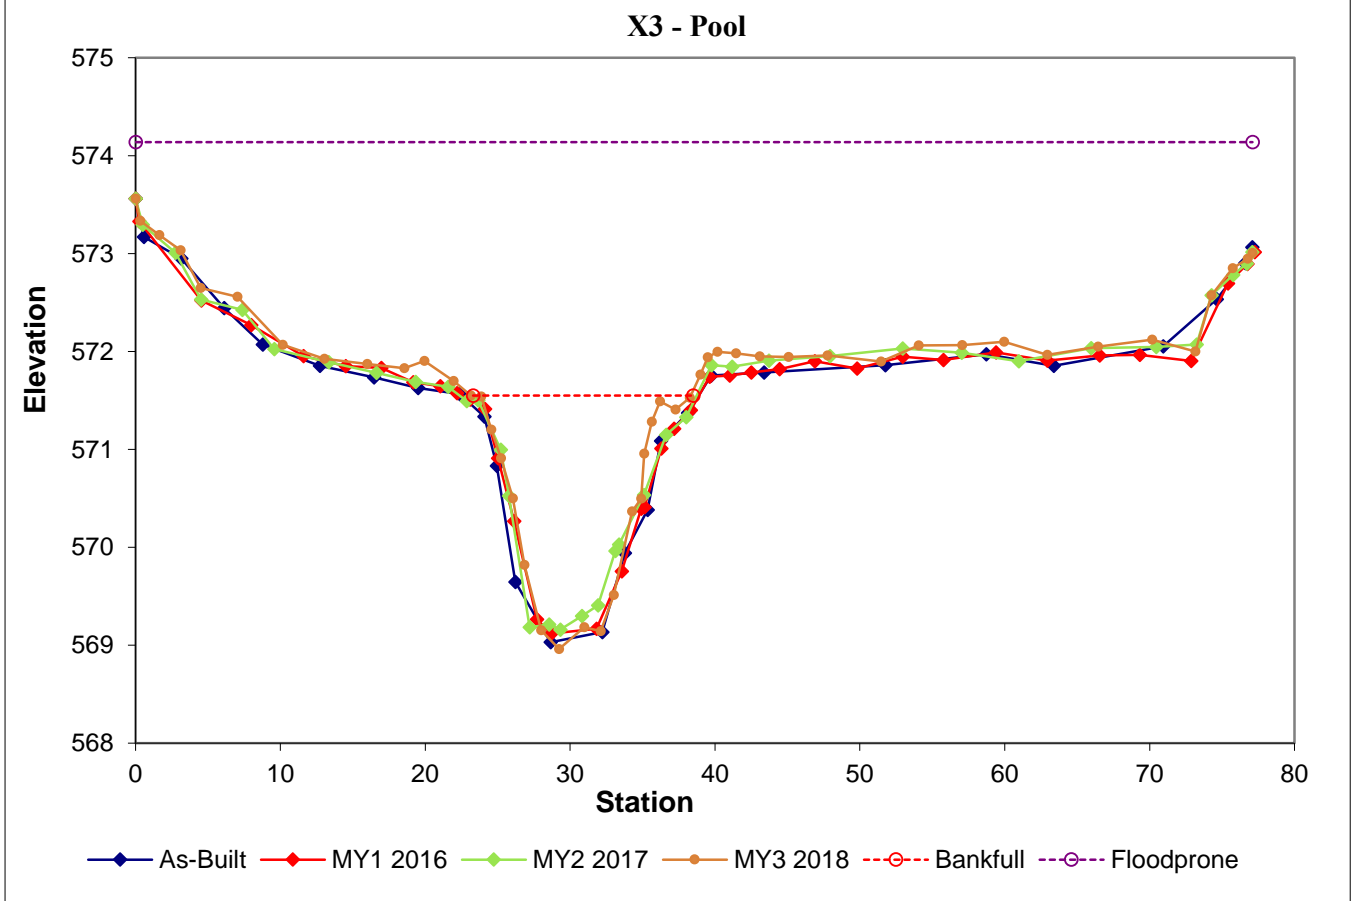
Permanent Cross-section
X3 Pool - Reach 1 (Station 15+99)
Monitoring Year 3 - Collected October 2018

Feature	Stream Type	BKF Area	BKF Width	BKF Depth	Max BKF Depth	W/D	BH Ratio	ER	BKF Elev*	TOB Elev	WFPA
Pool		20.2	15.2	1.3	2.6	11.4	-	-	571.6	571.5	77.1

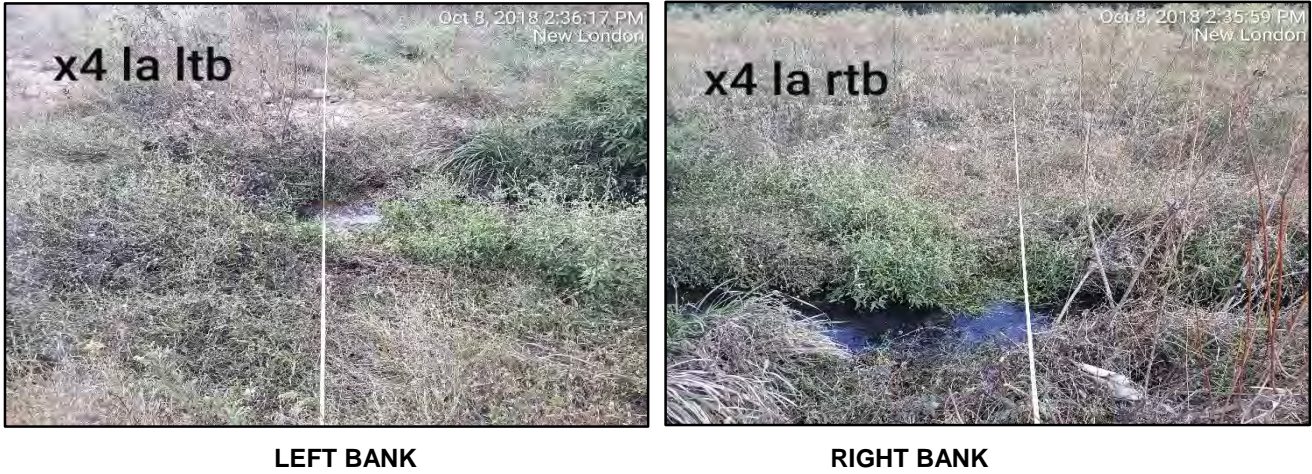
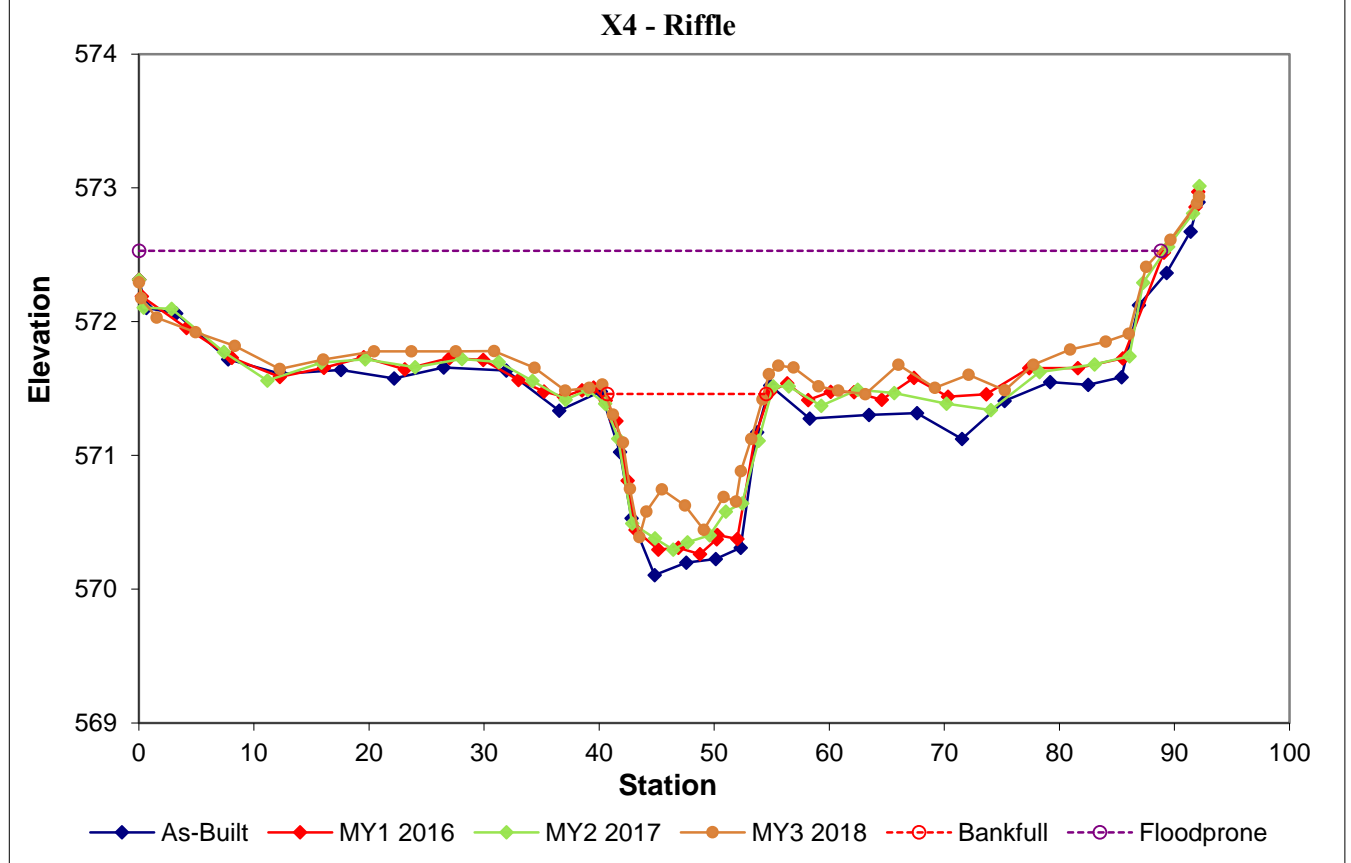
Permanent Cross-section
X4 Riffle - Reach 1 (Station 16+18)
Monitoring Year 3 - Collected October 2018

Feature	Stream Type	BKF Area	BKF Width	BKF Depth	Max BKF Depth	W/D	BH Ratio*	ER	BKF Elev	TOB Elev	WFPA
Riffle	C	9.3	13.8	0.7	1.1	20.2	0.9	6.7	571.5	571.5	88.8

*BHR = 0.9 is based on as-built bkf area of 13.9 at an elevation of 571.7. Remainder of data based on actual bankfull elevation from as-built which is 571.5.

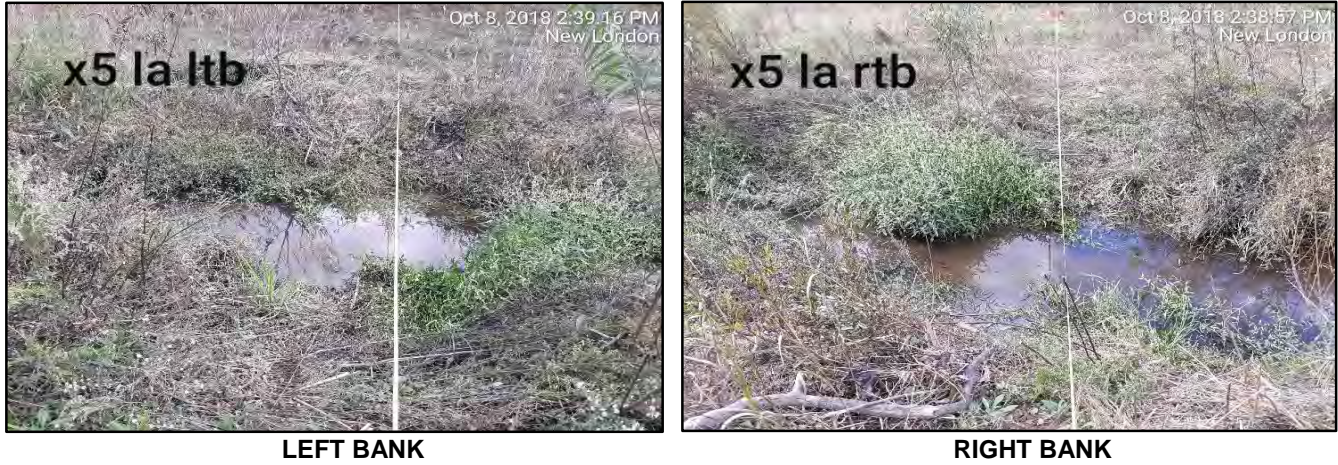
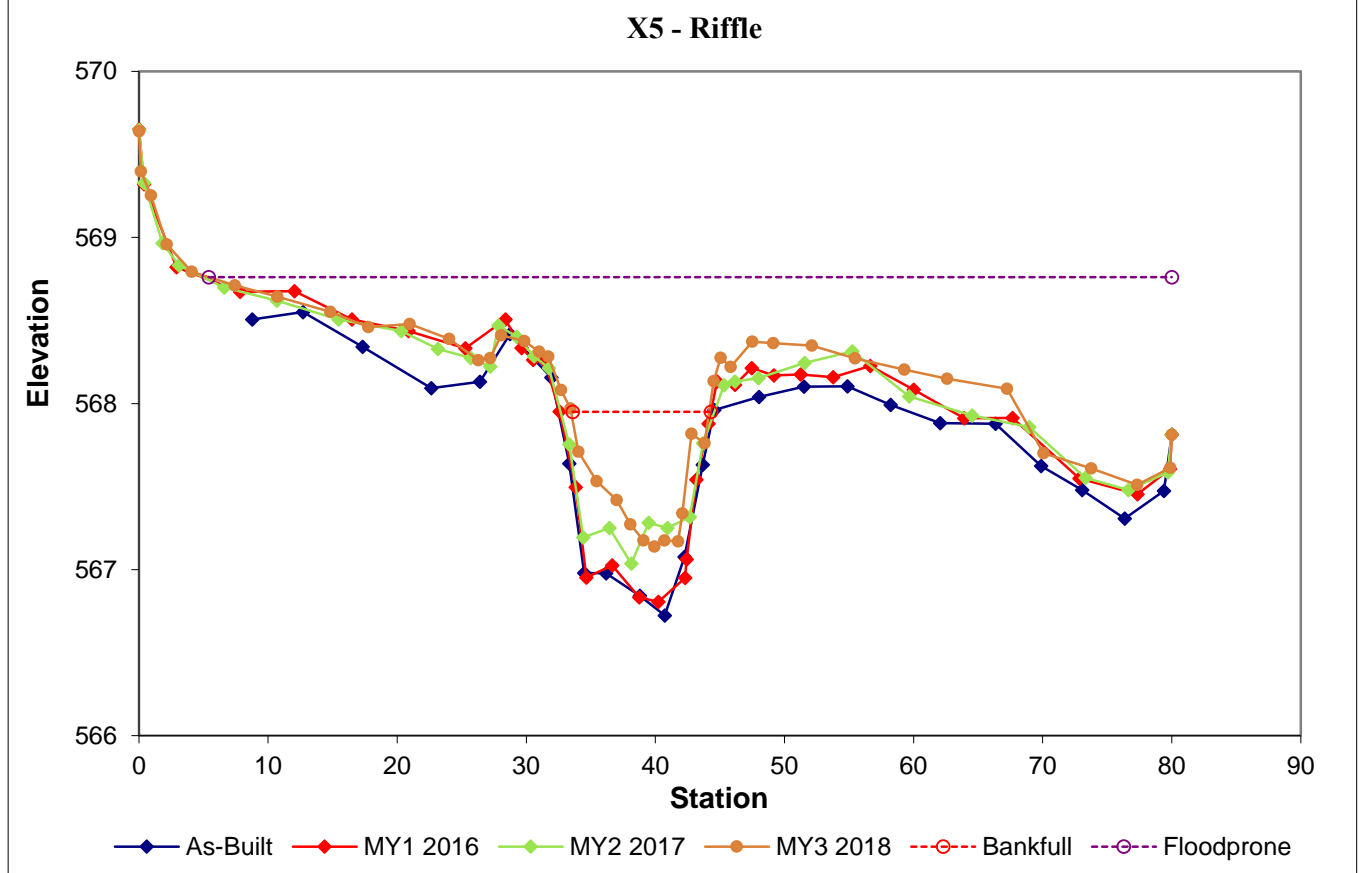
Permanent Cross-section
X5 Riffle - Reach 1 (Station 19+41)
Monitoring Year 3 - Collected October 2018

Feature	Stream Type	BKF Area	BKF Width	BKF Depth	Max BKF Depth	W/D	BH Ratio*	ER	BKF Elev	TOB Elev	WFGPA
Riffle	C	5.5	10.7	0.5	0.8	20.9	1.0	7.2	568.0	568.3	74.6

*BHR = 1.0 is based on as-built bkf area of 10.1 at an elevation of 568.257. Remainder of data based on actual bankfull elevation from as-built which is 568.0.

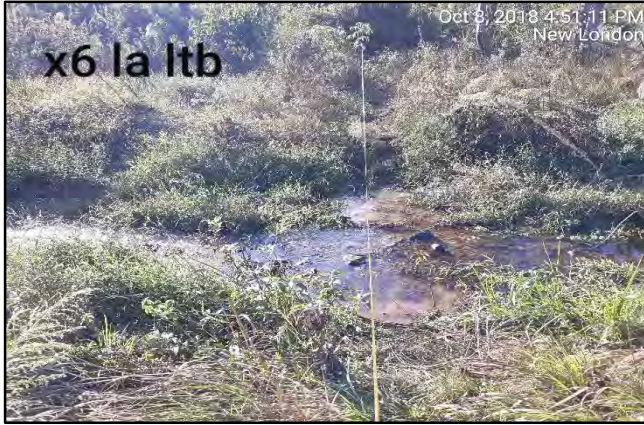
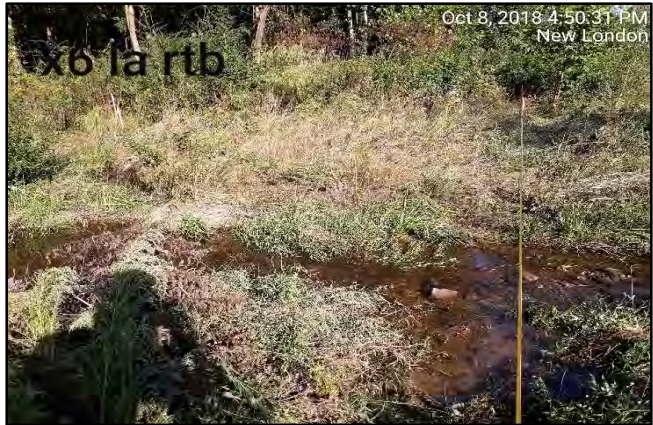
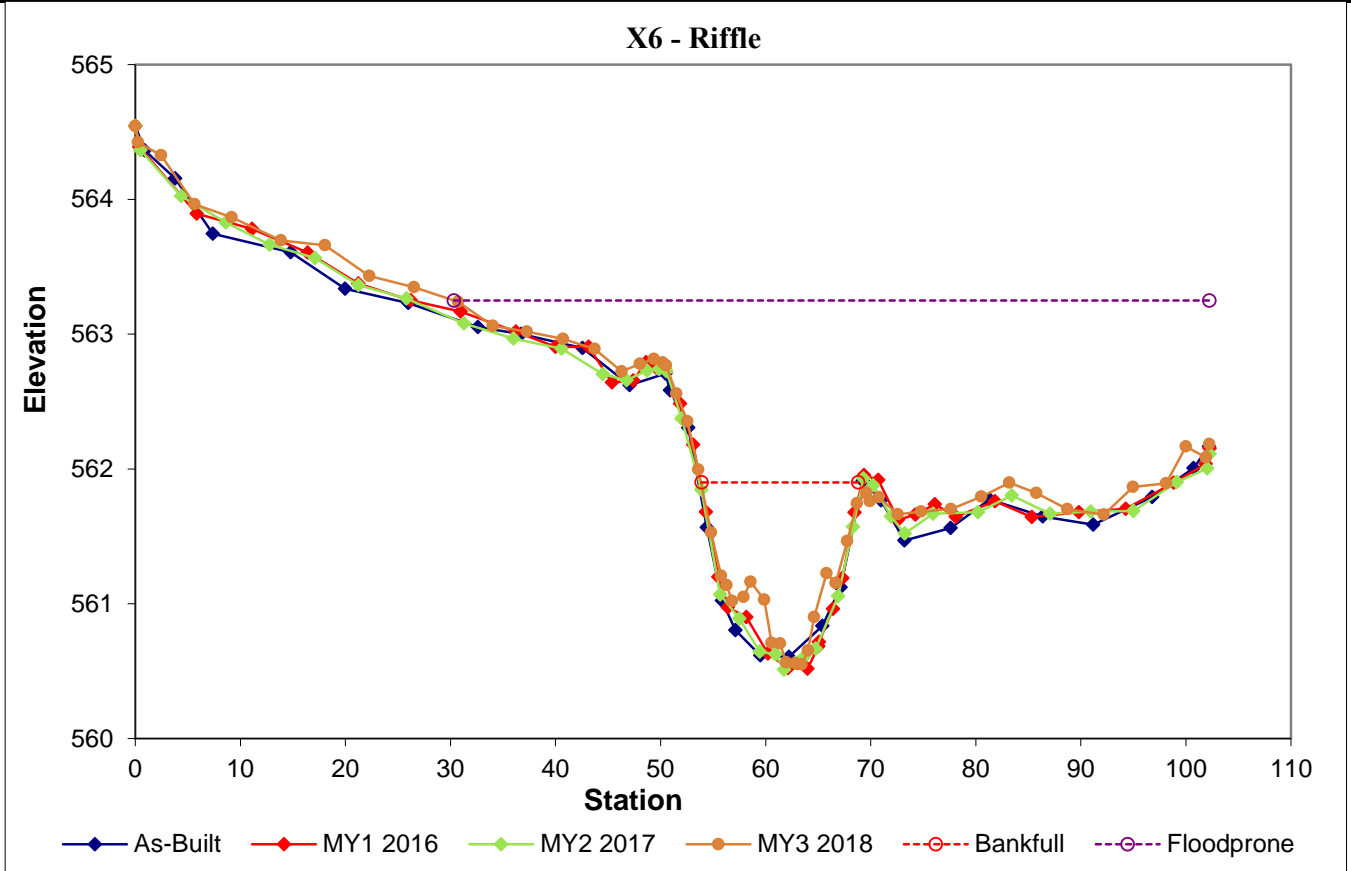
Permanent Cross-section
X6 Riffle - Reach 2 (Station 25+16)
Monitoring Year 3 - Collected October 2018

Feature	Stream Type	BKF Area	BKF Width	BKF Depth	Max BKF Depth	W/D	BH Ratio*	ER	BKF Elev	TOB Elev	WFGPA
Riffle	C	12.4	14.9	0.8	1.4	17.9	0.8	4.8	561.9	561.8	71.9

*BHR = 0.8 is based on as-built bkf area of 14.8 at an elevation of 562.059. Remainder of data based on actual bankfull elevation from as-built which is 561.9.

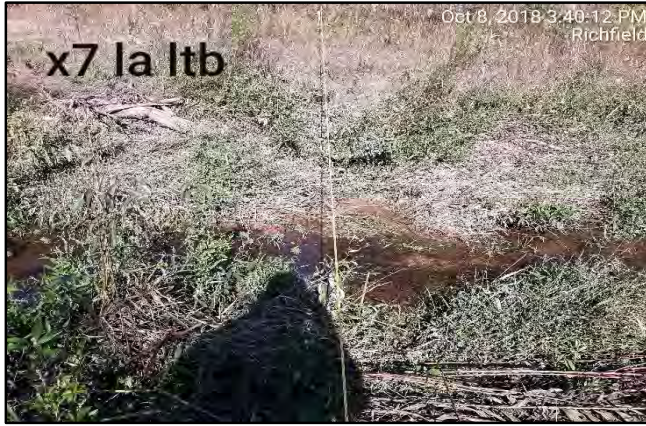
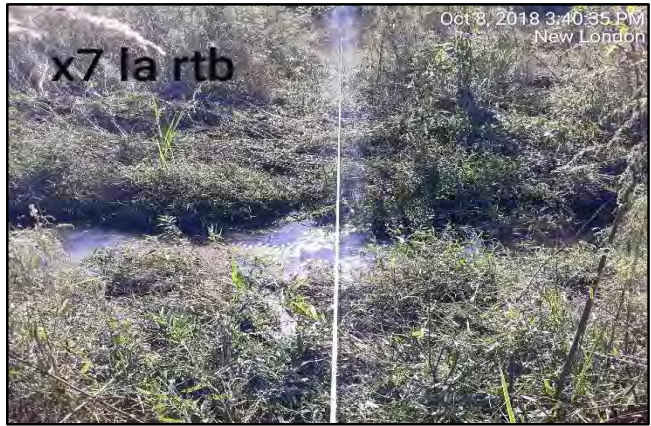
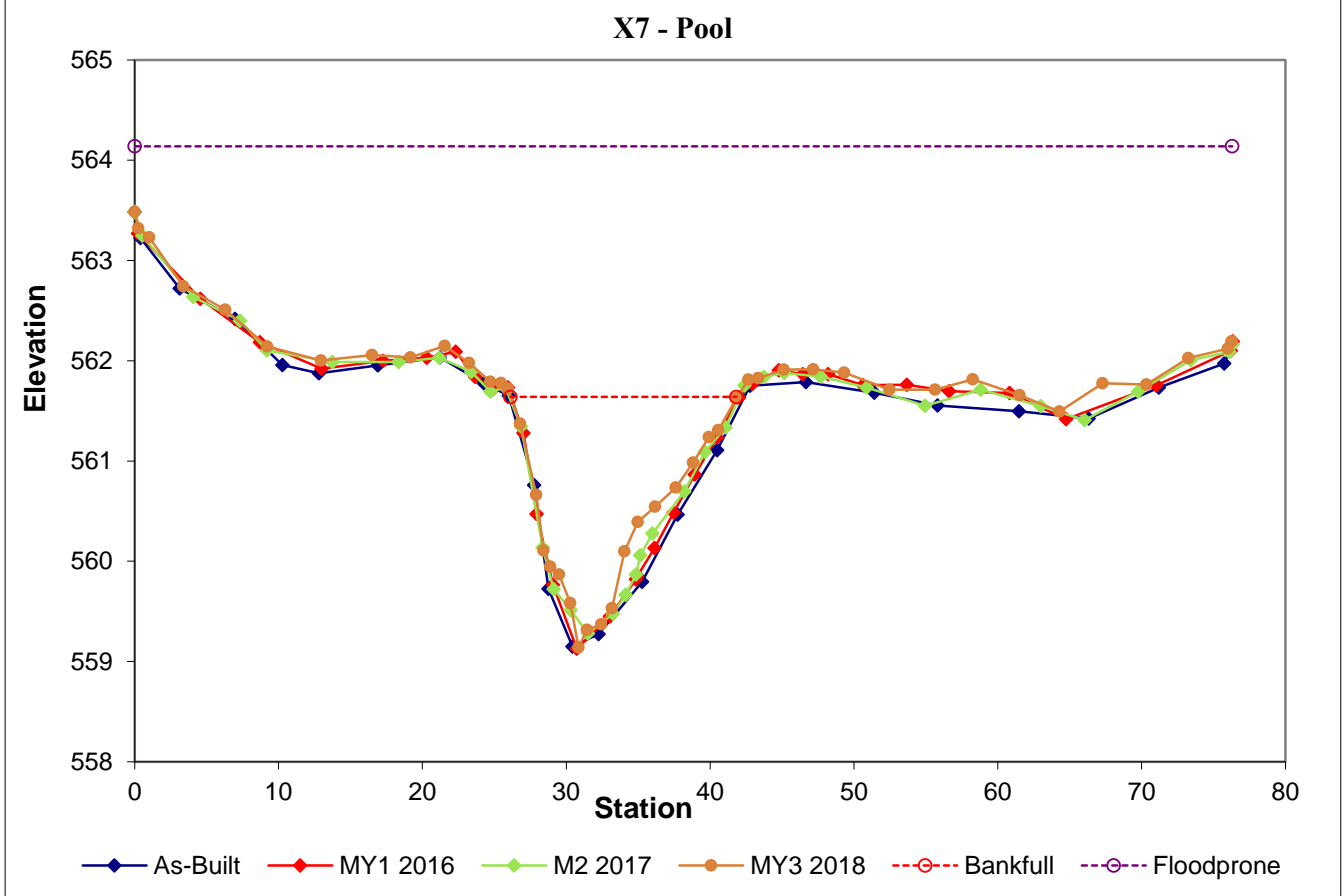
Permanent Cross-section
X7 Pool - Reach 2 (Station 25+60)
Monitoring Year 3 - Collected October 2018

Feature	Stream Type	BKF Area	BKF Width	BKF Depth	Max BKF Depth	W/D	BH Ratio*	ER	BKF Elev	TOB Elev	WFPA
Pool		19.1	15.7	1.2	2.5	13.0	-	-	561.6	561.7	76.3

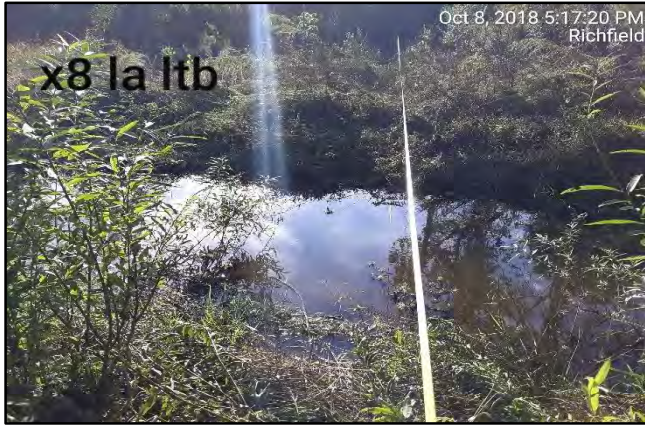
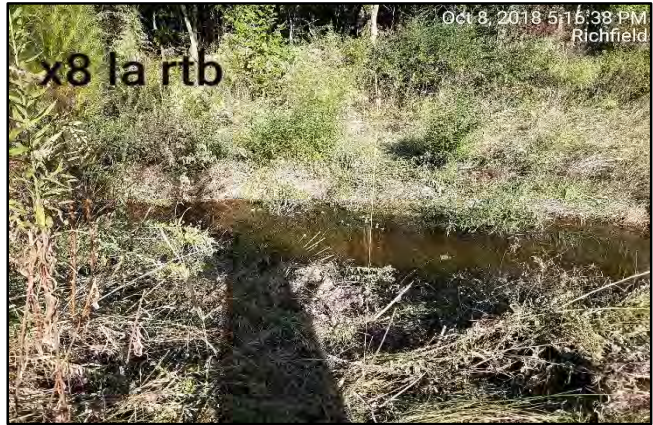
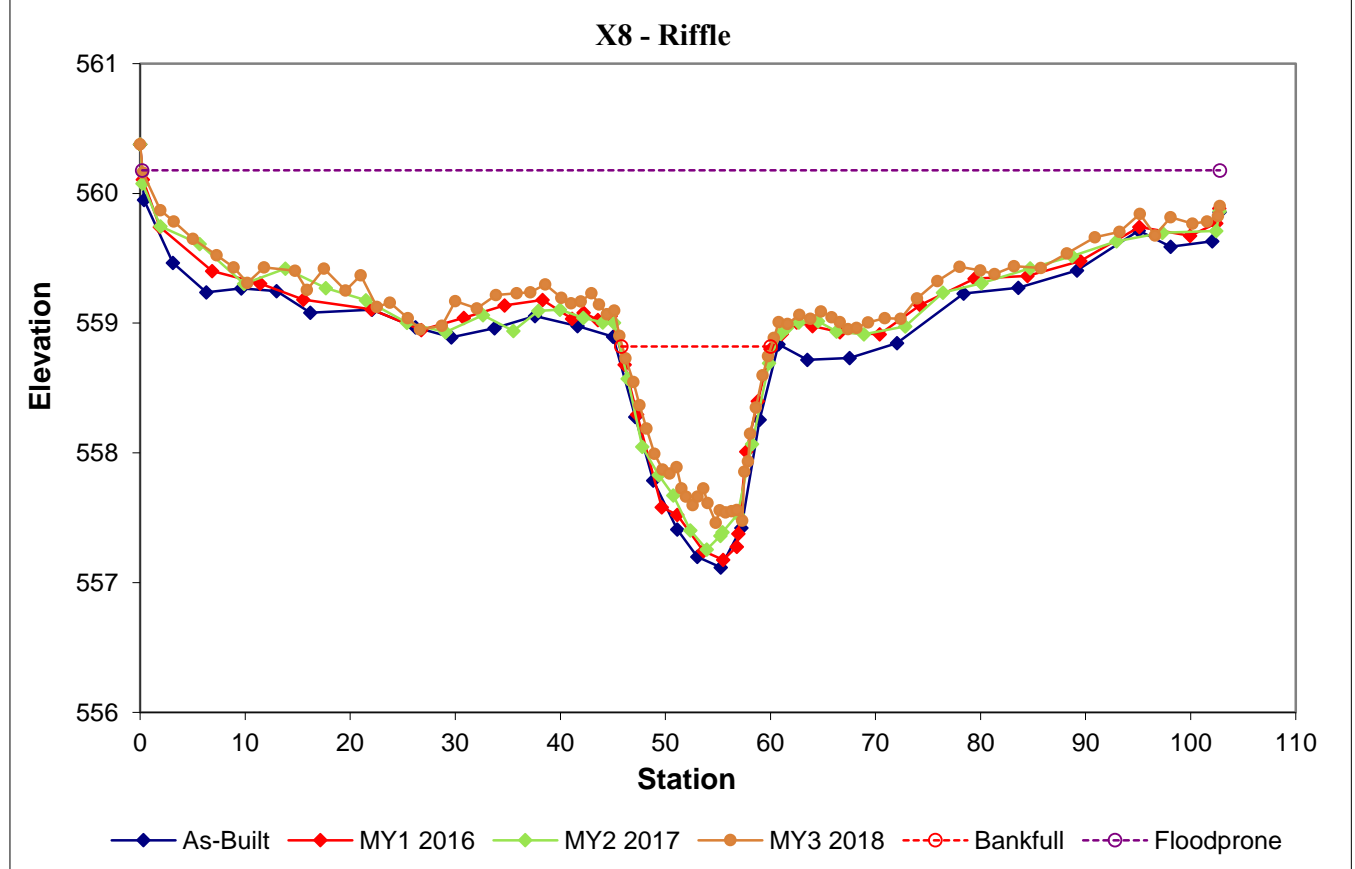
Permanent Cross-section
X8 Riffle - Reach 2 (Station 29+17)
Monitoring Year 3 - Collected October 2018

Feature	Stream Type	BKF Area	BKF Width	BKF Depth	Max BKF Depth	W/D	BH Ratio*	ER	BKF Elev	TOB Elev	WFPA
Riffle	C	12.2	14.2	0.9	1.4	16.5	0.9	7.3	558.8	559.0	102.6

*BHR = 0.9 is based on as-built bkf area of 16.5 at an elevation of 559.095. Remainder of data based on actual bankfull elevation from as-built which is 558.8.

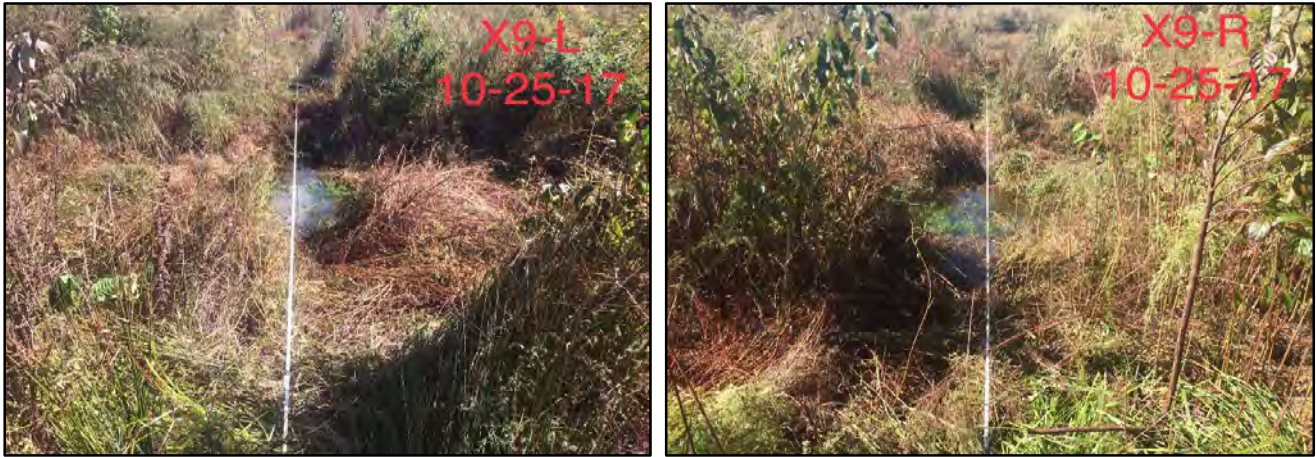
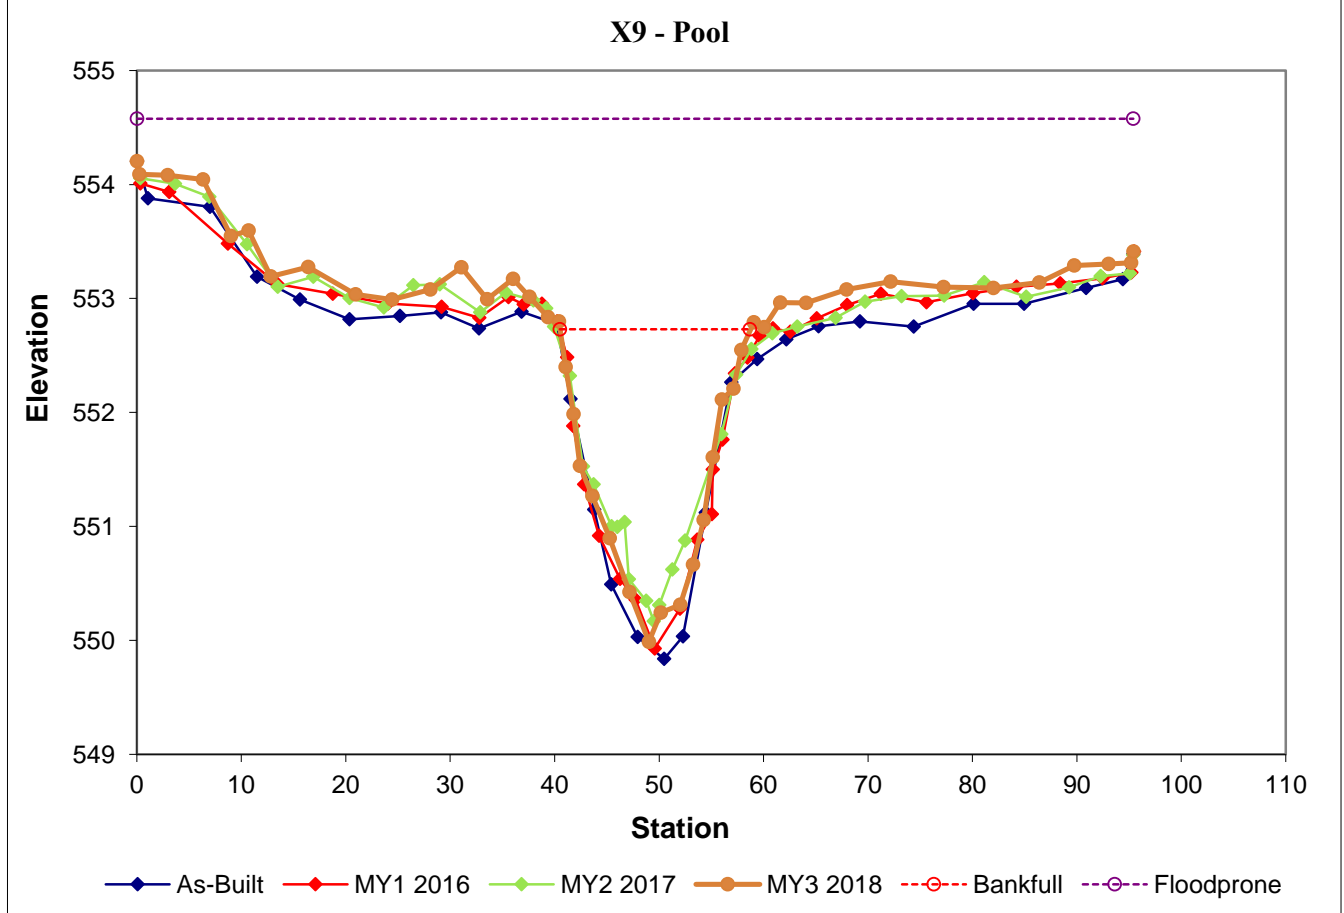
Permanent Cross-section
X9 Pool - Reach 2 (Station 37+60)
Monitoring Year 3 - Collected October 2018

Feature	Stream Type	BKF Area	BKF Width	BKF Depth	Max BKF Depth	W/D	BH Ratio*	ER	BKF Elev	TOB Elev	WFPA
Pool		29.2	18.2	1.6	2.7	11.4	-	-	552.7	552.8	95.4

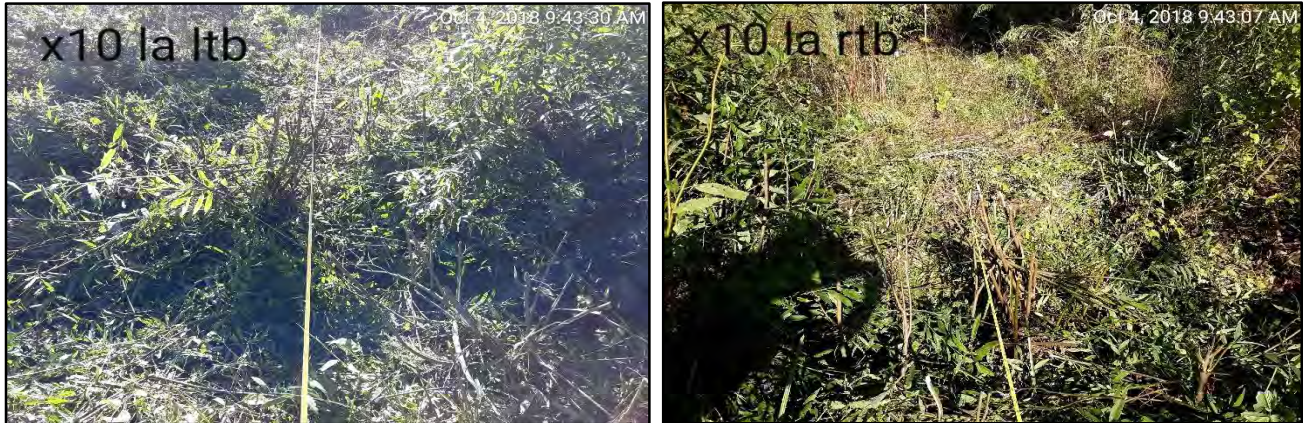
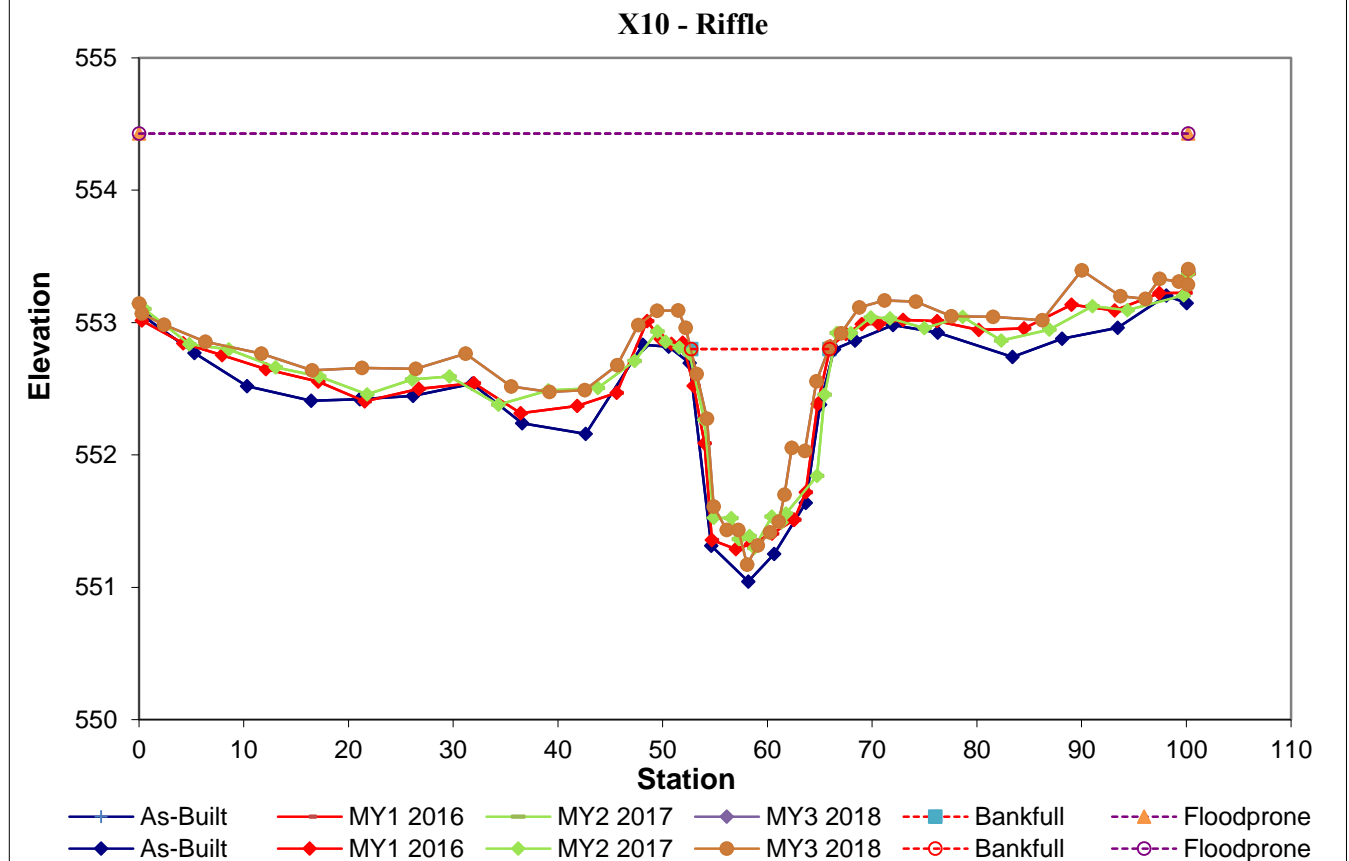
Permanent Cross-section
X10 Riffle - Reach 2 (Station 37+91)
Monitoring Year 3 - Collected October 2018

Feature	Stream Type	BKF Area	BKF Width	BKF Depth	Max BKF Depth	W/D	BH Ratio*	ER	BKF Elev	TOB Elev	WFPA
Riffle	C	12.7	13.2	1.0	1.6	13.7	0.9	7.6	552.8	552.8	100.2

*BHR = 0.9 is based on as-built bkf area of 17.0 at an elevation of 553.09. Remainder of data based on actual bankfull elevation from as-built which is 552.8.
