Mitigation Project Name UT to Town Creek Stream and Wetland Restoration Site
 DMS ID 94648
 River Basin Yadkin
 Cataloging Unit 03040105

County Stanly
 Date Project Instituted 8/20/2010
 Date Prepared 8/27/2018

Stanly County, North Carolina

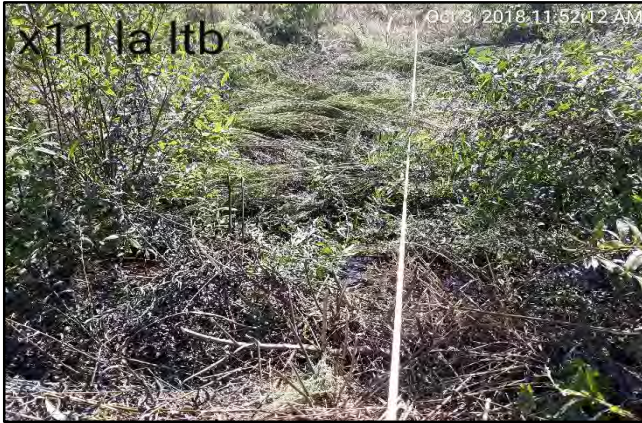
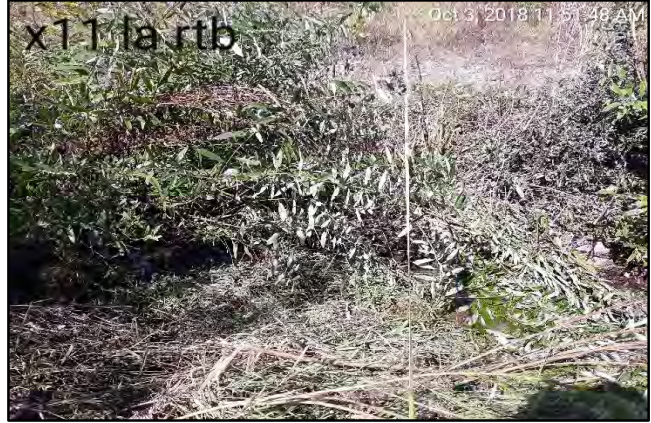
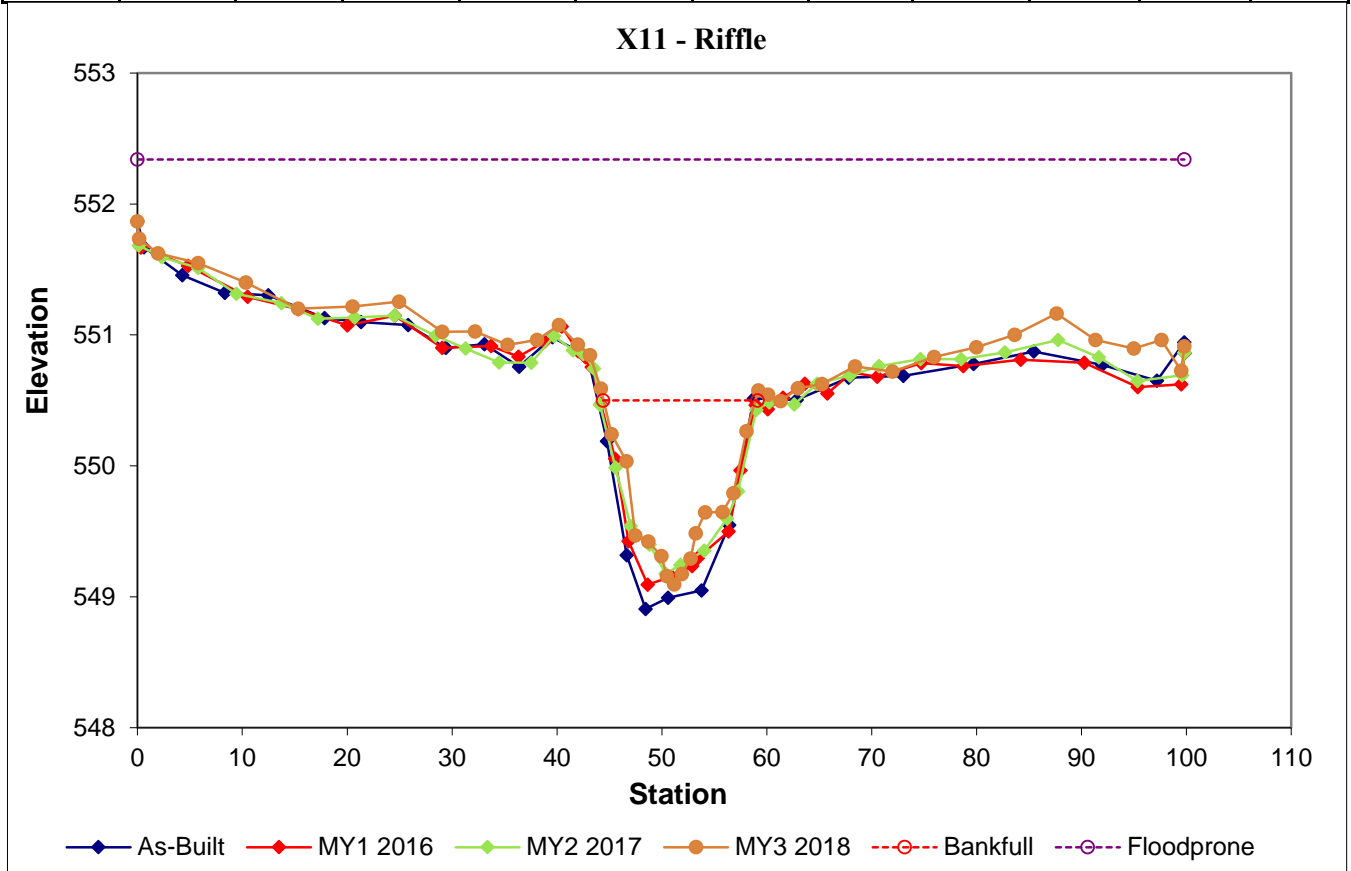
Permanent Cross-section
X11 Riffle - Reach 3 (Station 41+62)
Monitoring Year 3 Collected October 2018

Feature	Stream Type	BKF Area	BKF Width	BKF Depth	Max BKF Depth	W/D	BH Ratio*	ER	BKF Elev	TOB Elev	WFGA
Riffle	C	11.9	14.7	0.8	1.4	18.1	0.9	6.8	550.5	550.6	99.8

*BHR = 0.9 is based on as-built bkf area of 16.3 at an elevation of 550.72. Remainder of data based on actual bankfull elevation from as-built which is 550.5.

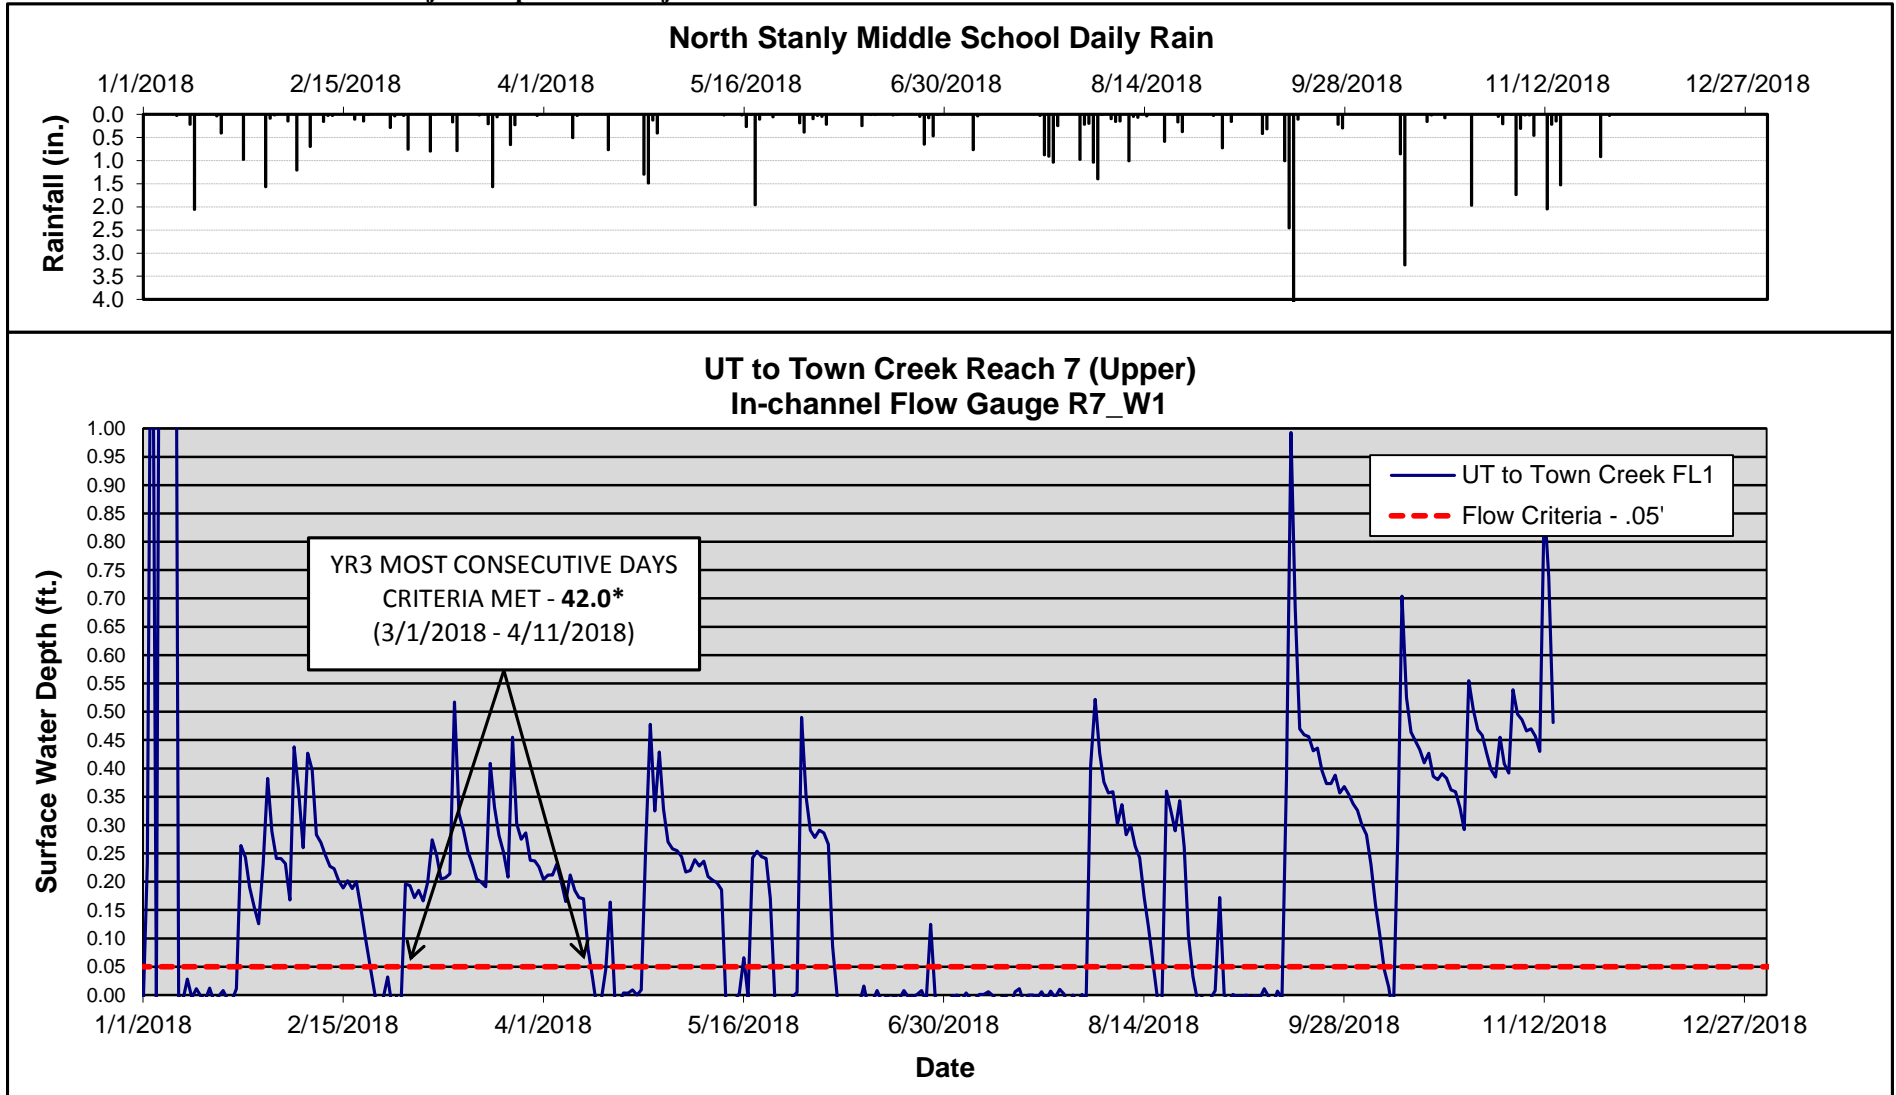
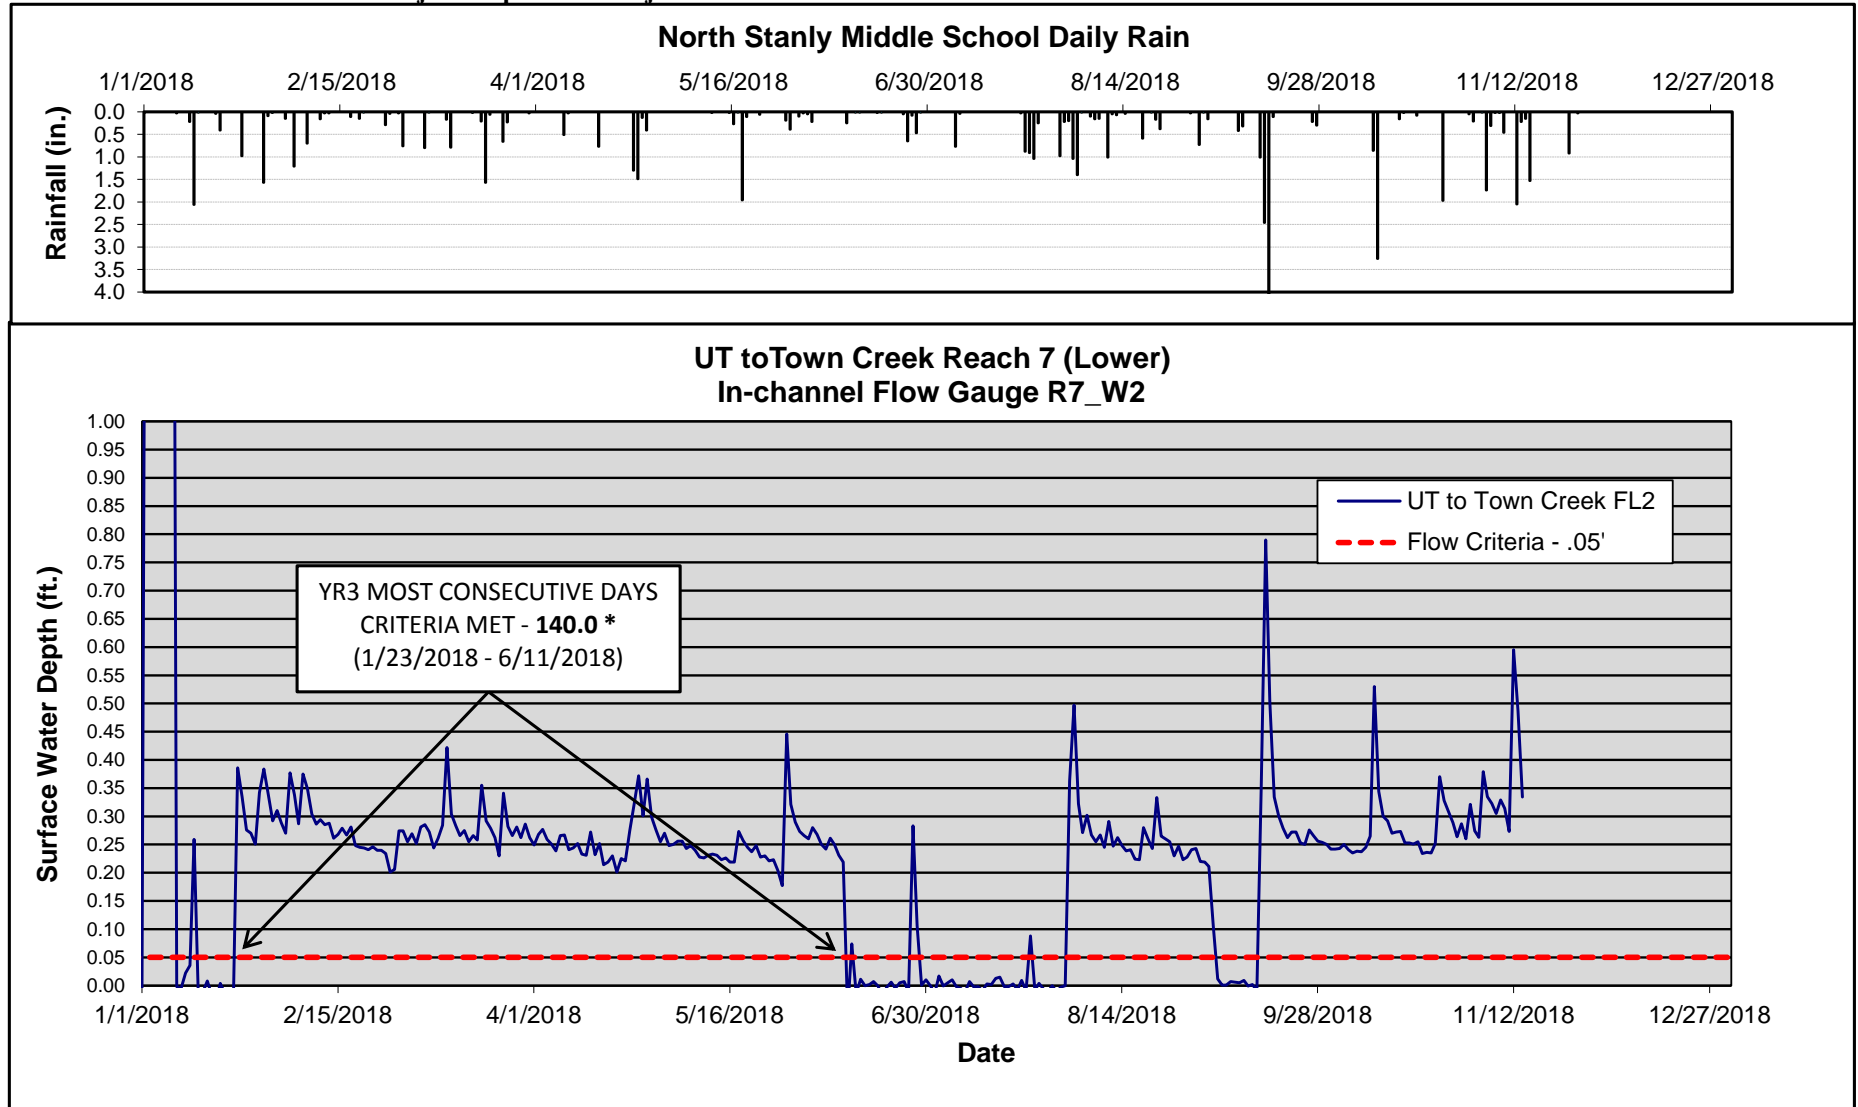
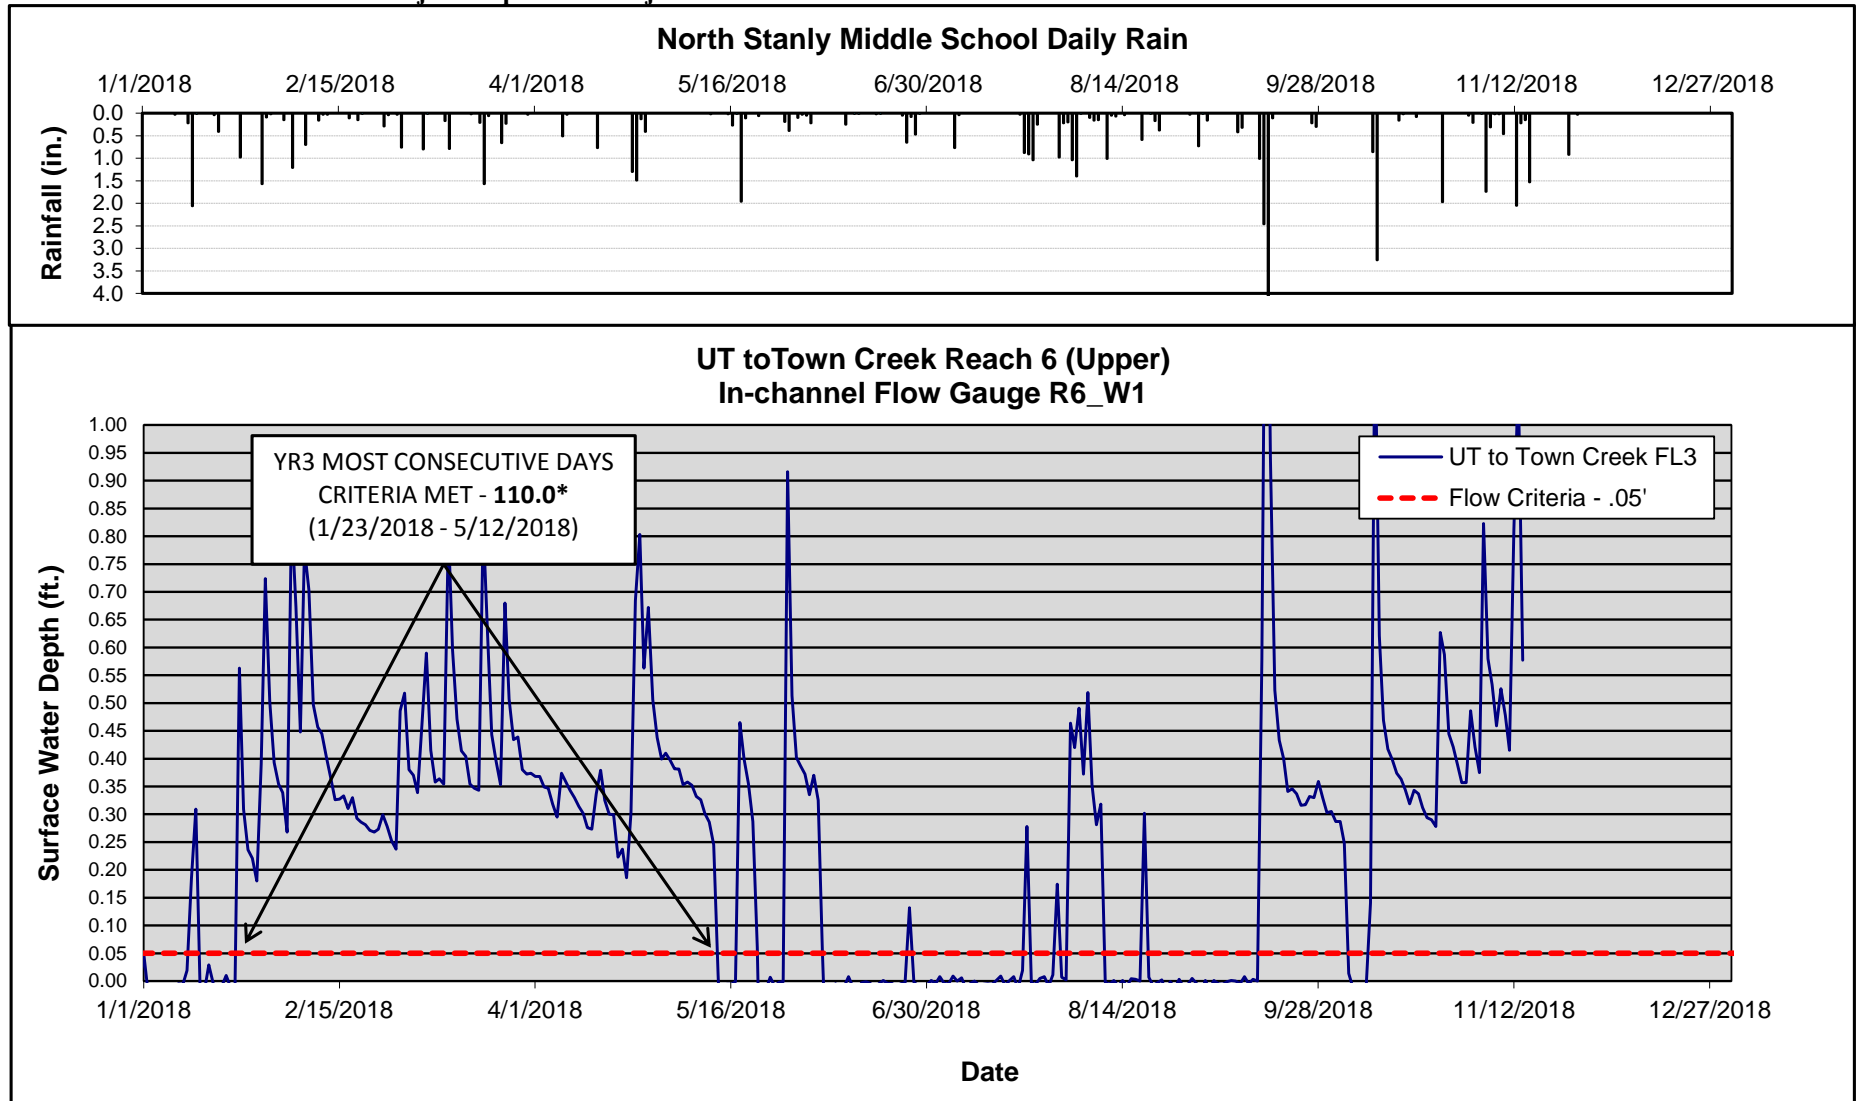
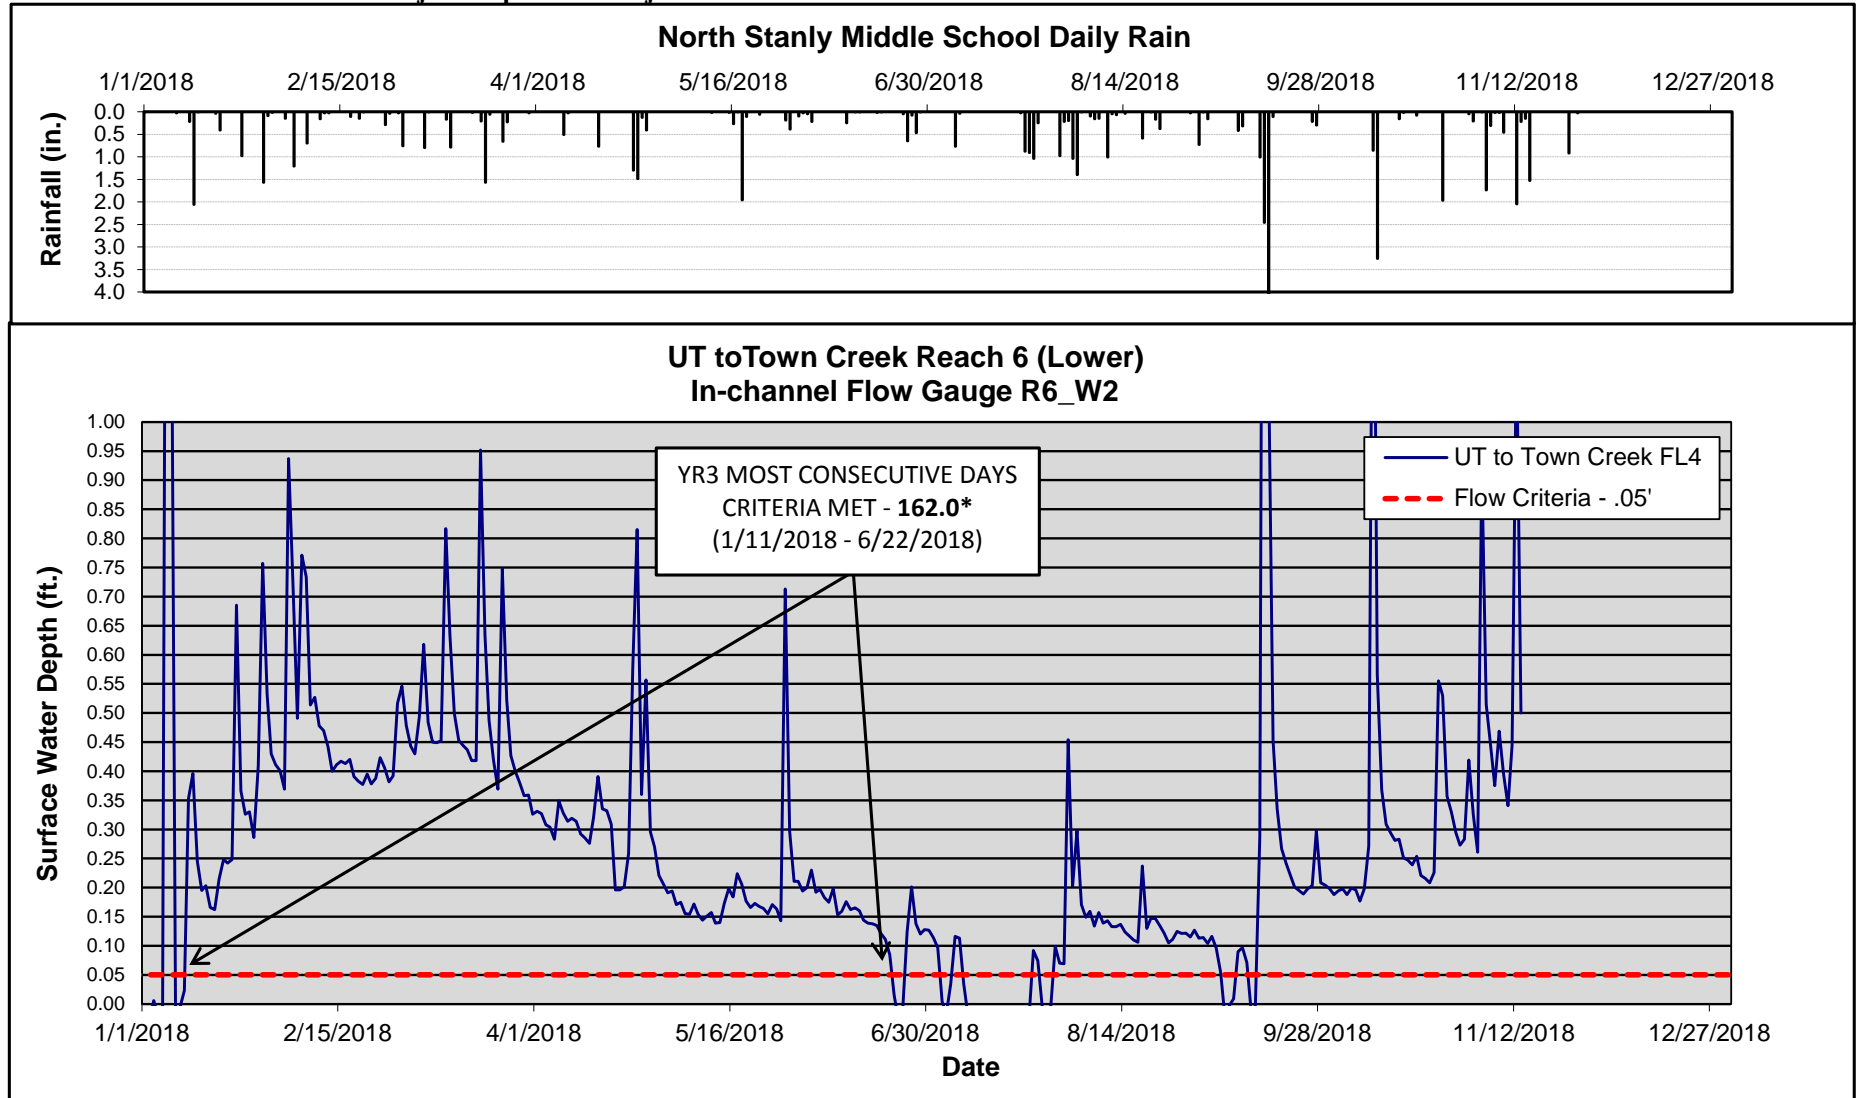
Figure 7. In-stream Flow Gauge Graphs

Since post-construction installation, each gauge has documented at least one period of consecutive stream flow for the required minimum of 30 days for all three monitoring years. In MY3, R6_W2 experienced the longest period of consecutive stream flow with 162 days. Figure 7 depicts the documented flow conditions for each gauge through Monitoring Year 3 relative to local rainfall data, while Table 13 documents both the total cumulative days of flow and the maximum number of consecutive days of flow. Flow data and photographic documentation collected during Year 3 monitoring are located in Appendix E.

* Surface water flow is estimated to have occurred when the pressure transducer reading is equal to or above 0.05 feet in depth.

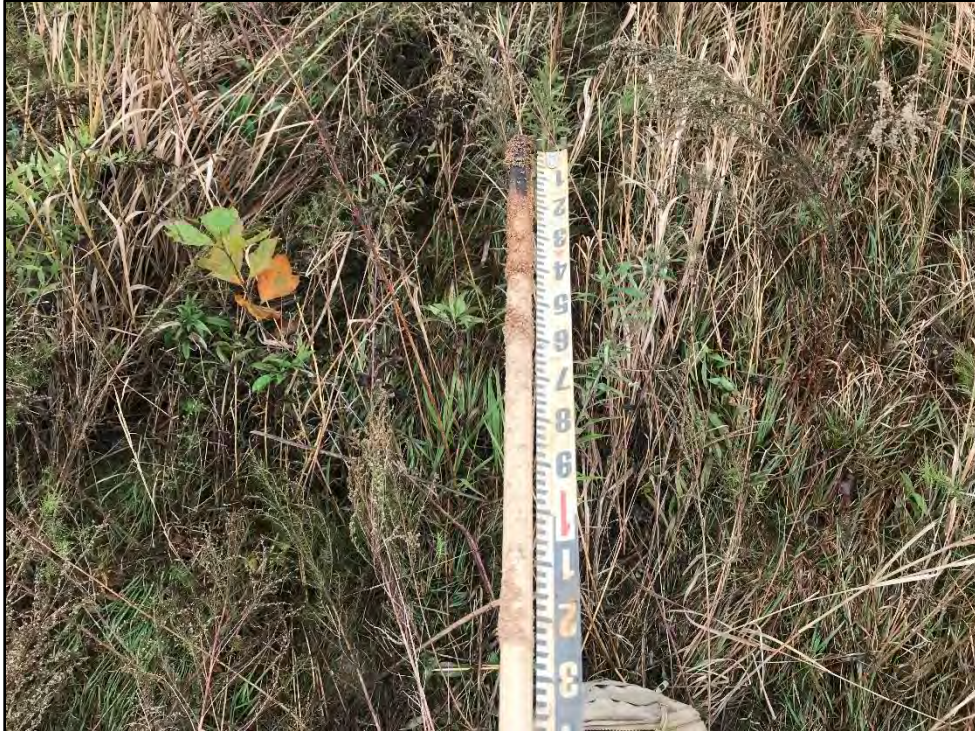
Crest Gauge Photo MY3-7 (11/14/2018)

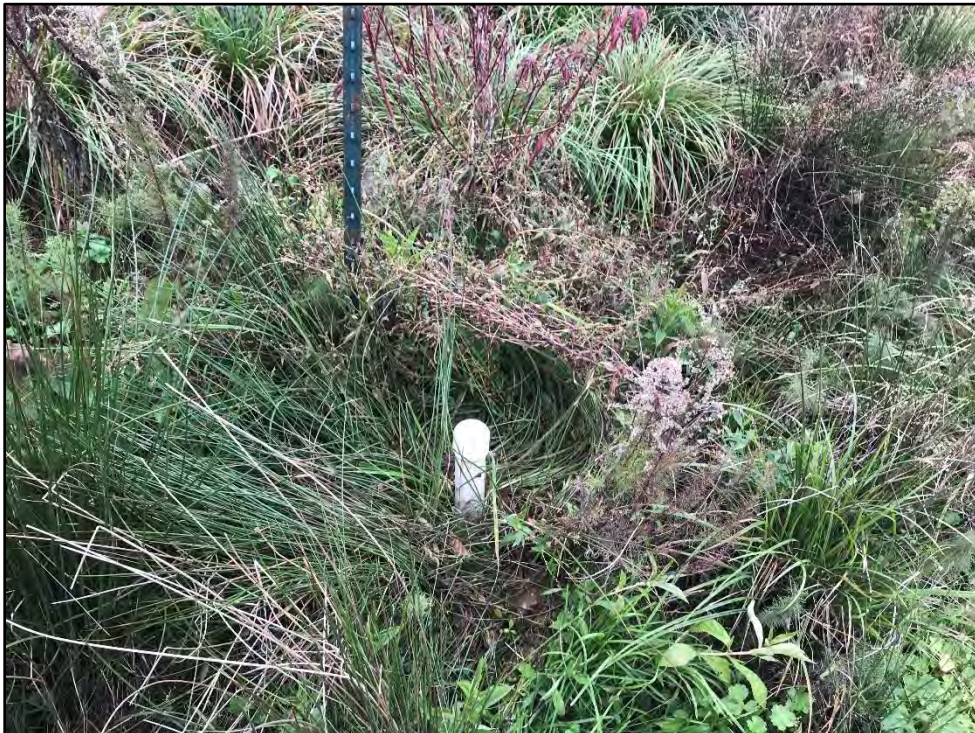
UTTC AW8 – 11/14/2018

Table 12. Wetland Restoration Area Well Success							
UT to Town Creek Restoration Project - Option A: Project No. 94648							
Well ID	Automated Well Type	Wetland Mitigation Type	*Percentage of Consecutive Days <12 inches from Ground Surface ¹	Most Consecutive Days Meeting Criteria ²	*Percentage of Cumulative Days <12 inches from Ground Surface ¹	Cumulative Days Meeting Criteria ³	Number of Instances where Water Table rose to <12 inches from Ground Surface ⁴
Cross-sectional Well Arrays							
UTTC AW1	Reference	Jurisdictional	49.5	110.0	97.5	216.5	2
UTTC AW2	Groundwater	Restoration	52.0	115.5	100.2	222.5	2
UTTC AW3	Groundwater	Restoration	33.1	73.5	81.3	180.5	8
UTTC AW4	Groundwater	Restoration	43.9	97.5	88.7	197.0	4
UTTC AW5	Groundwater	Creation	35.8	79.5	79.7	177.0	8
UTTC AW6	Reference	Jurisdictional	48.9	108.5	96.6	214.5	2
UTTC AW7	Groundwater	Restoration	100.0	222.0	100.0	222.0	1
UTTC AW8	Groundwater	Restoration	23.4	52.0	59.2	131.5	9

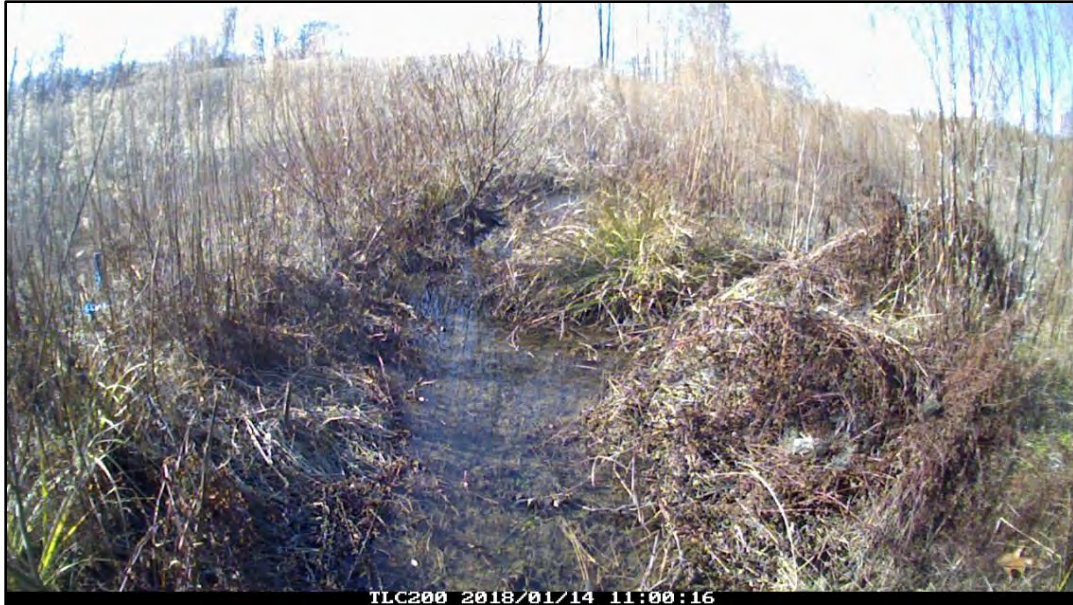
Flow Documentation Photo – R6 (1/14/2018)

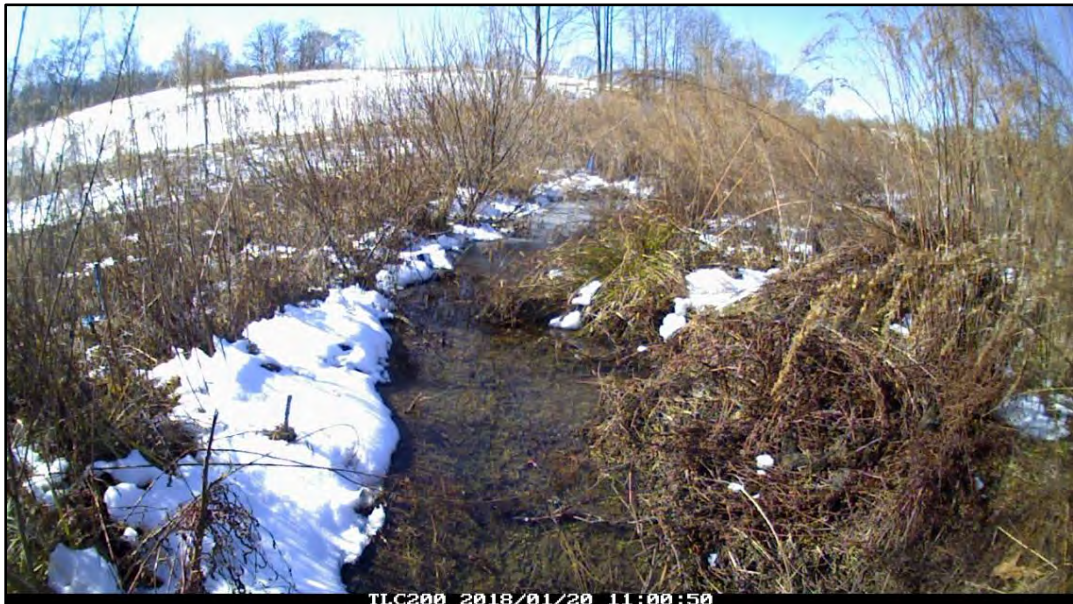
Flow Documentation Photo – R6 (1/20/2018)

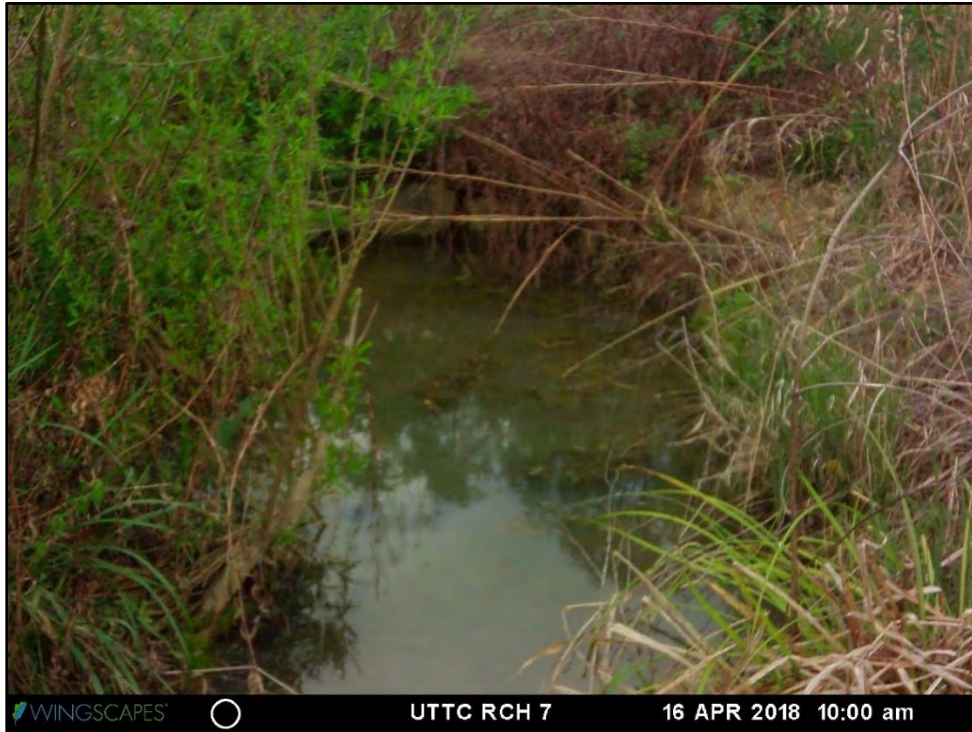
Flow Documentation Photo – R7 (4/16/2018)

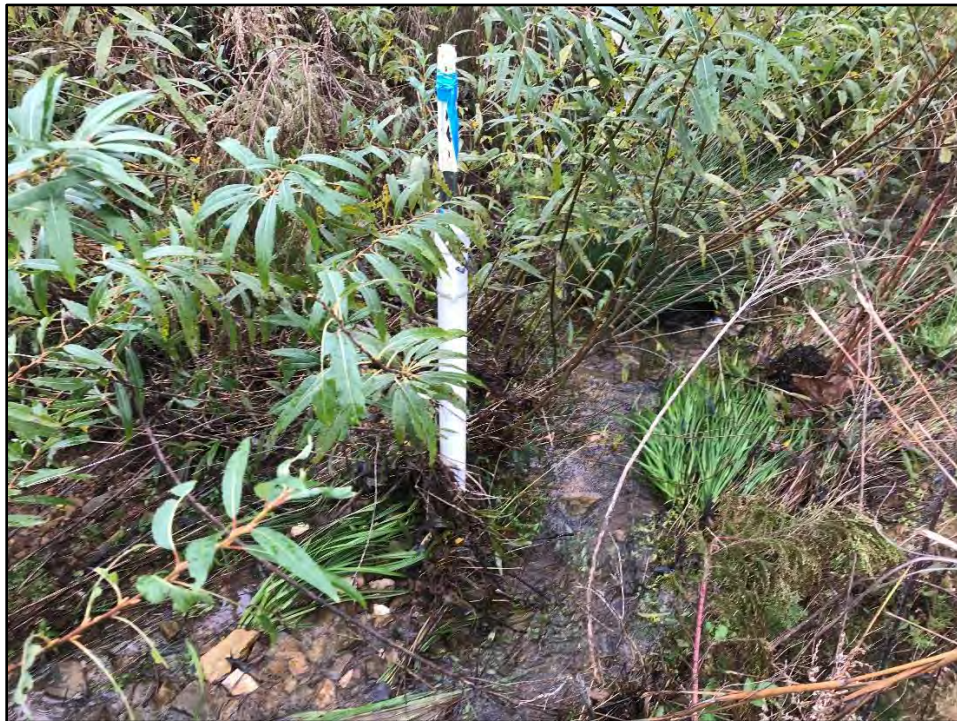
Flow Documentation Photo – R7 (11/14/2018)

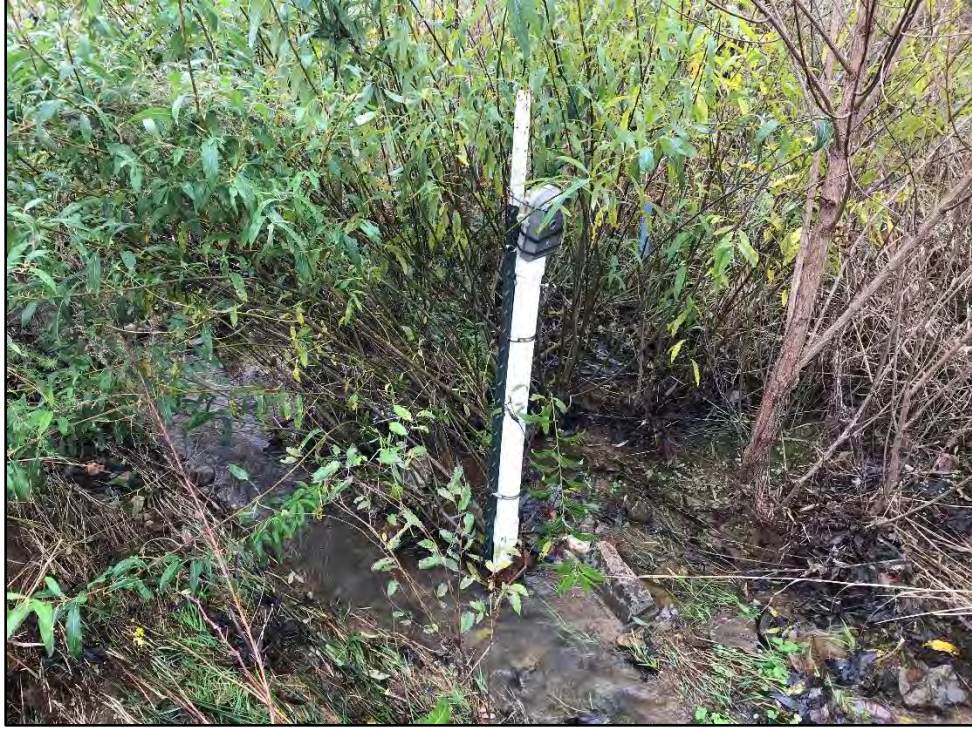
Flow Documentation Photo – R7 (11/14/2018)
