UT to Town Creek Restoration Project – Option A Final Monitoring Report/Closeout Report

Stanly County, North Carolina

DMS Project ID Number – 94648; NC DEQ Contract No. 003277

Monitoring Year: 5

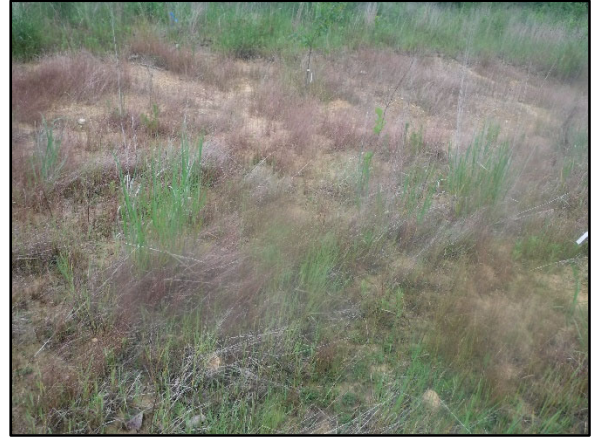
Bare Areas	46+50 - 48+60	Poor soils noted in an area where supplemental seeding and grass plugs were installed during MY5.	VPA 5-1
Poor growth rates	46+50 - 48+60	Poor growth rates were noted in areas where supplemental bare root and gallon container plantings were installed during MY5.	VPA 5-1
Reach 4			
Feature Issue	Station No.	Suspected Cause	Problem Area / Photo Number
Invasive/Exotic Populations	N/A	<i>Ligustrum sinense</i> (Chinese privet)	No VPA was associated with this problem area because very minimal amounts are scattered throughout the reach.
Reach 5			
Feature Issue	Station No.	Suspected Cause	Problem Area / Photo Number
Invasive/Exotic Populations	N/A	<i>Ligustrum sinense</i> (Chinese privet)	No VPA was associated with this problem area because very minimal amounts are scattered throughout the reach.
Reach 6			
Feature Issue	Station No.	Suspected Cause	Problem Area / Photo Number
Invasive/Exotic Populations	N/A	<i>Ligustrum sinense</i> (Chinese privet)	No VPA was associated with this problem area because very minimal amounts are scattered throughout the reach.

VPA 5-1 – Photo of bare areas, areas of poor growth rates, and areas where supplemental plantings were installed. (5/26/2020)

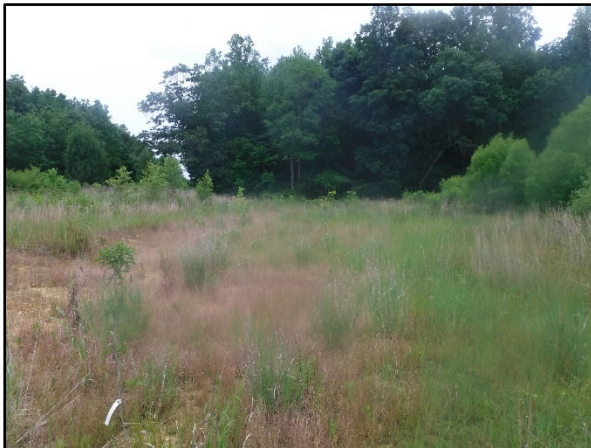
VPA 5-1 – Photo of bare areas and areas of poor growth rates, as well as areas where supplemental plantings were installed. (5/26/20)

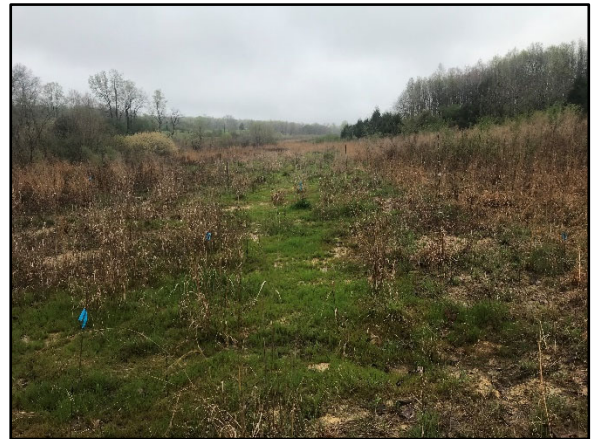
VPA 5-1 -- Photo of bare areas, areas of poor growth rates, and areas where supplemental plantings were installed. (3/25/20)
