*Final*  
**Year 4 Monitoring Report**

**UT to Uwharrie River Stream Restoration Project  
Randolph County, North Carolina  
DMS Project No. 847**

Construction Completed: March 2011  
Vegetation Data Collected: August 2015  
Morphology Data Collected: November 2015  
Submission Date: March 2016

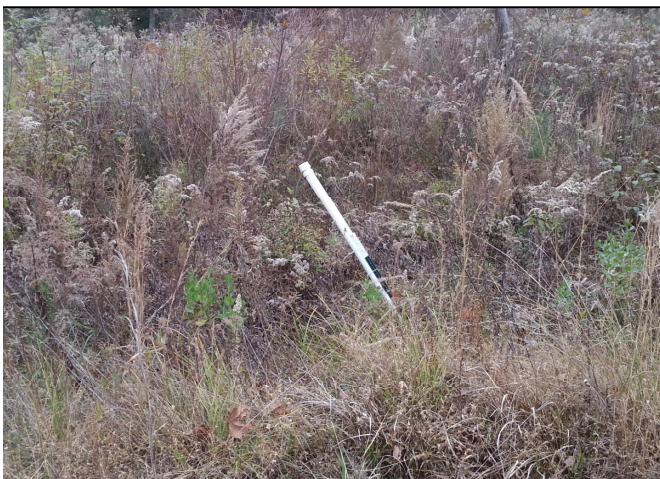
Photo 3: Crest Gauge (Main East) Leaning Over Following Bankfull Event - Fall 2013
