**Final
Year 5 Monitoring Report**

**UT to Uwharrie River Stream Restoration Project
Randolph County, North Carolina
DMS Project No. 847**

Construction Completed: March 2011
Vegetation Data Collected: September 2016
Morphology Data Collected: November 2016
Submission Date: January 2017

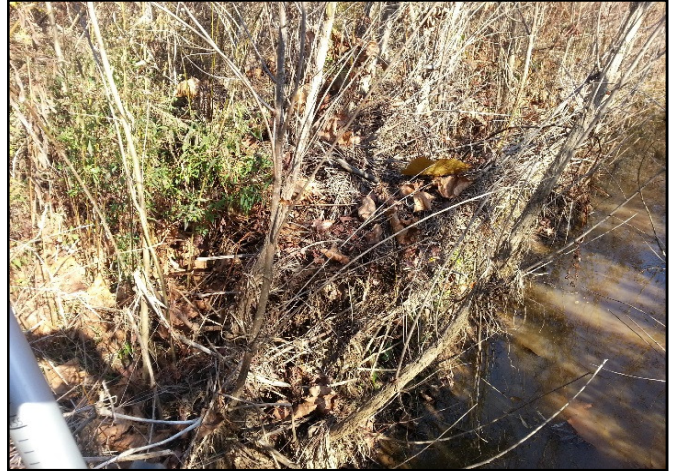
Photo 6: Wrack Lines on Main Center
Following Bankfull Event - Fall 2014
