Year 2 Monitoring Report

**UT WEST BRANCH ROCKY RIVER
RESTORATION SITE**

NCDMS Project #92684 (Contract # WBRR010521)
USACE Action ID: SAW-2017-00342 | NCDWR Project #18-1696

RE: UT West Branch Rocky River Project: Year 2 Monitoring Report

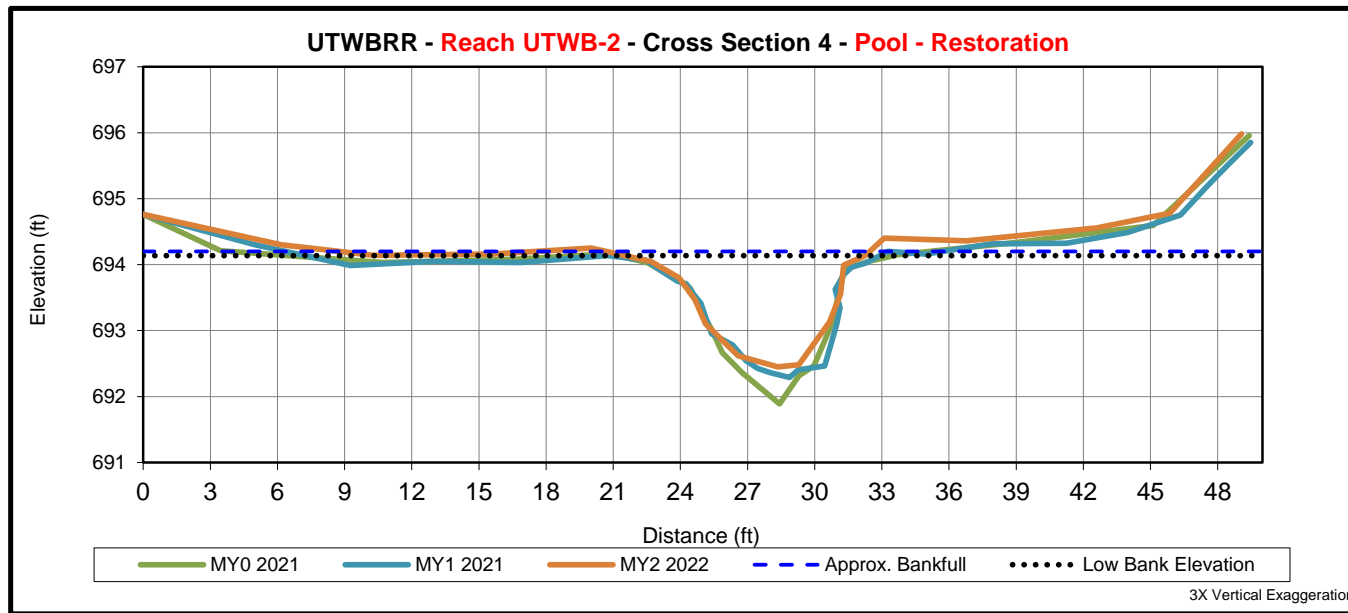
Cross Section 4 (Pool)						
	MY0	MY1	MY2	MY3	MY5	MY7	MY+
Bankfull Elevation (ft) - Based on AB-XSA¹	694.05	694.1	694.2				
Bankfull Width (ft) ¹	NA	NA	NA				
Floodprone Width (ft) ¹	NA	NA	NA				
Bankfull Max Depth (ft) ²	2.2	1.8	1.7				
Low Bank Elevation (ft)	694.05	694.1	694.1				
Bankfull Cross Sectional Area (ft ²) ²	10.4	10.2	9.7				
Bankfull Entrenchment Ratio ¹	NA	NA	NA				
Bankfull Bank Height Ratio ¹	NA	NA	NA

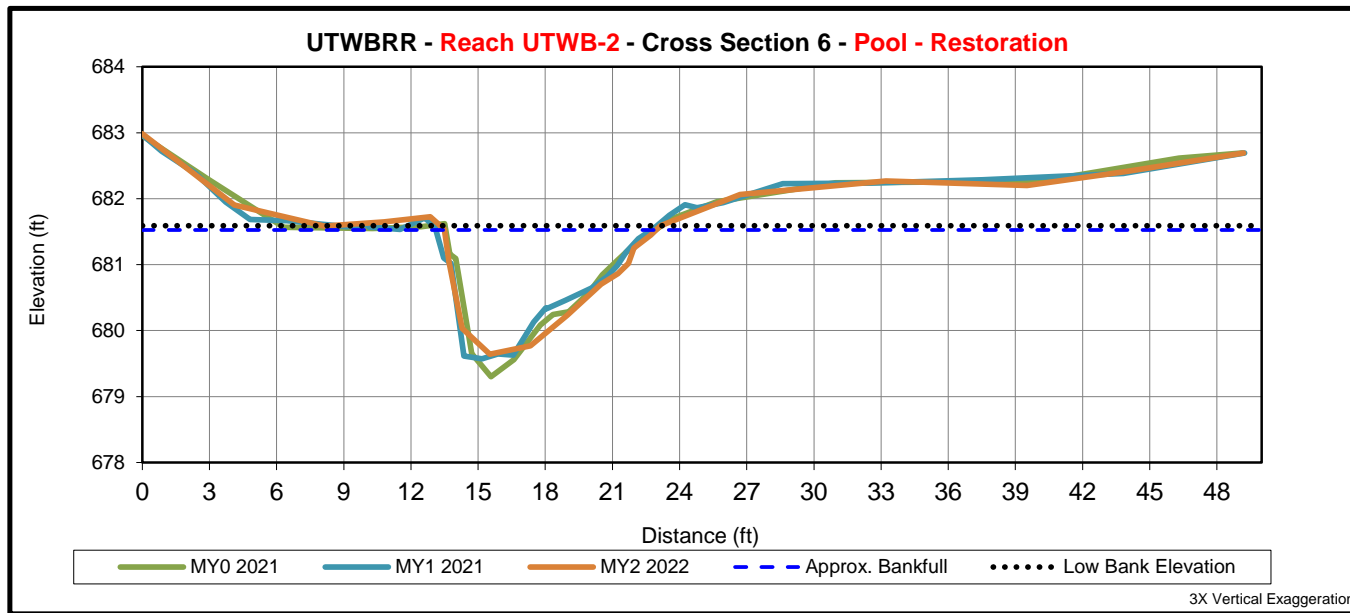
Cross Section 6 (Pool)						
	MY0	MY1	MY2	MY3	MY5	MY7	MY+
Bankfull Elevation (ft) - Based on AB-XSA¹	681.58	681.6	681.5				
Bankfull Width (ft) ¹	NA	NA	NA				
Floodprone Width (ft) ¹	NA	NA	NA				
Bankfull Max Depth (ft) ²	2.3	2.1	1.9				
Low Bank Elevation (ft)	681.58	681.7	681.6				
Bankfull Cross Sectional Area (ft ²) ²	11.2	12.5	11.8				
Bankfull Entrenchment Ratio ¹	NA	NA	NA				
Bankfull Bank Height Ratio ¹	NA	NA	NA

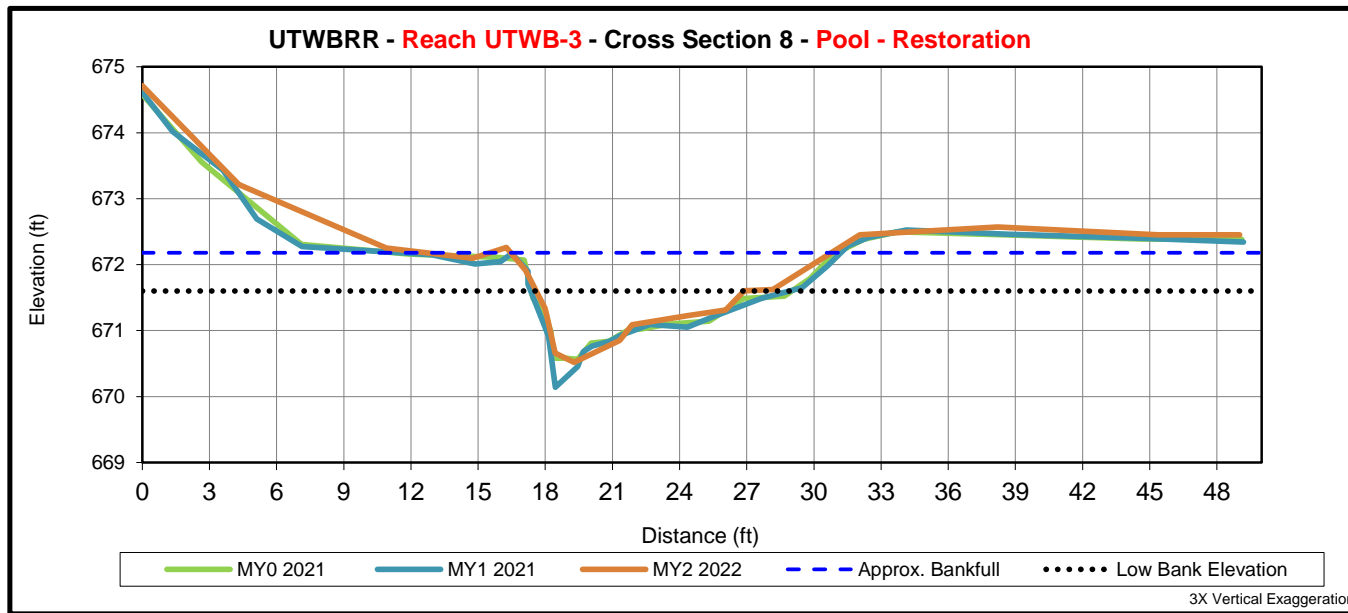
Cross Section 8 (Pool)						
	MY0	MY1	MY2	MY3	MY5	MY7	MY+
Bankfull Elevation (ft) - Based on AB-XSA¹	672.11	672.1	672.2				
Bankfull Width (ft) ¹	NA	NA	NA				
Floodprone Width (ft) ¹	NA	NA	NA				
Bankfull Max Depth (ft) ²	1.5	2.0	1.7				
Low Bank Elevation (ft)	672.11	672.2	672.3				
Bankfull Cross Sectional Area (ft ²) ²	12.3	13.8	13.5				
Bankfull Entrenchment Ratio ¹	NA	NA	NA				
Bankfull Bank Height Ratio ¹	NA	NA	NA

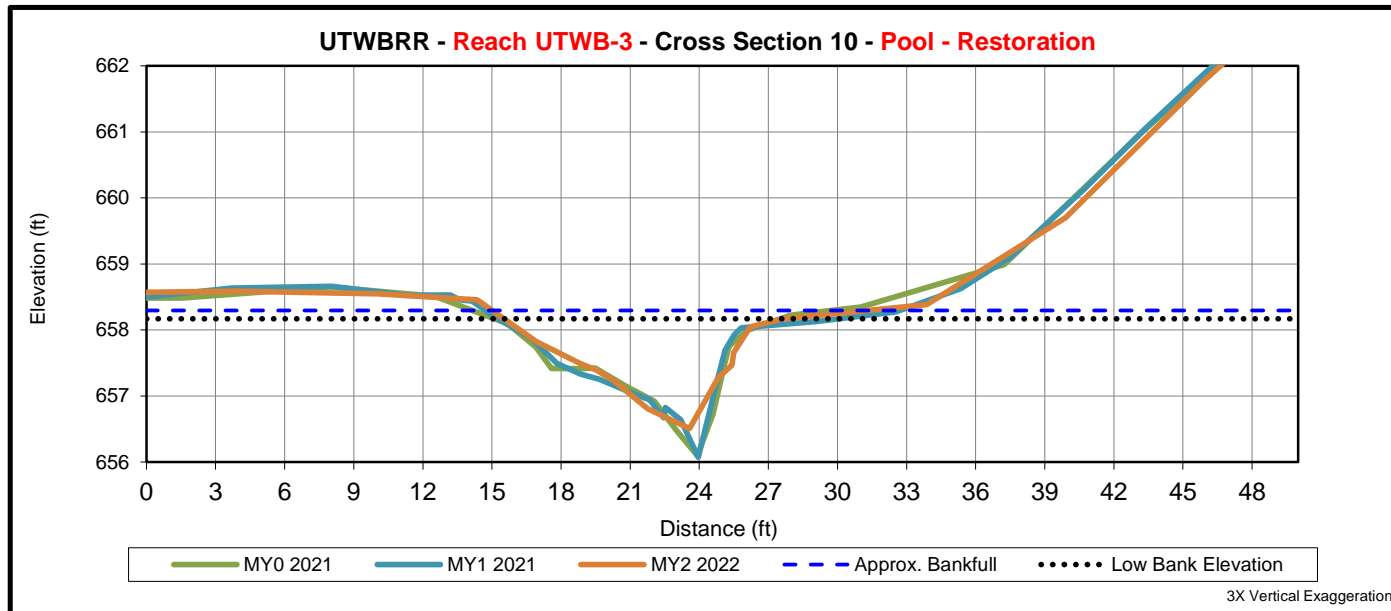
Cross Section 10 (Pool)						
	MY0	MY1	MY2	MY3	MY5	MY7	MY+
Bankfull Elevation (ft) - Based on AB-XSA¹	658.23	658.3	658.3				
Bankfull Width (ft) ¹	NA	NA	NA				
Floodprone Width (ft) ¹	NA	NA	NA				
Bankfull Max Depth (ft) ²	2.1	2.0	1.7				
Low Bank Elevation (ft)	658.23	658.0	658.2				
Bankfull Cross Sectional Area (ft ²) ²	10.8	8.1	9.2				
Bankfull Entrenchment Ratio ¹	NA	NA	NA				
Bankfull Bank Height Ratio ¹	NA	NA	NA

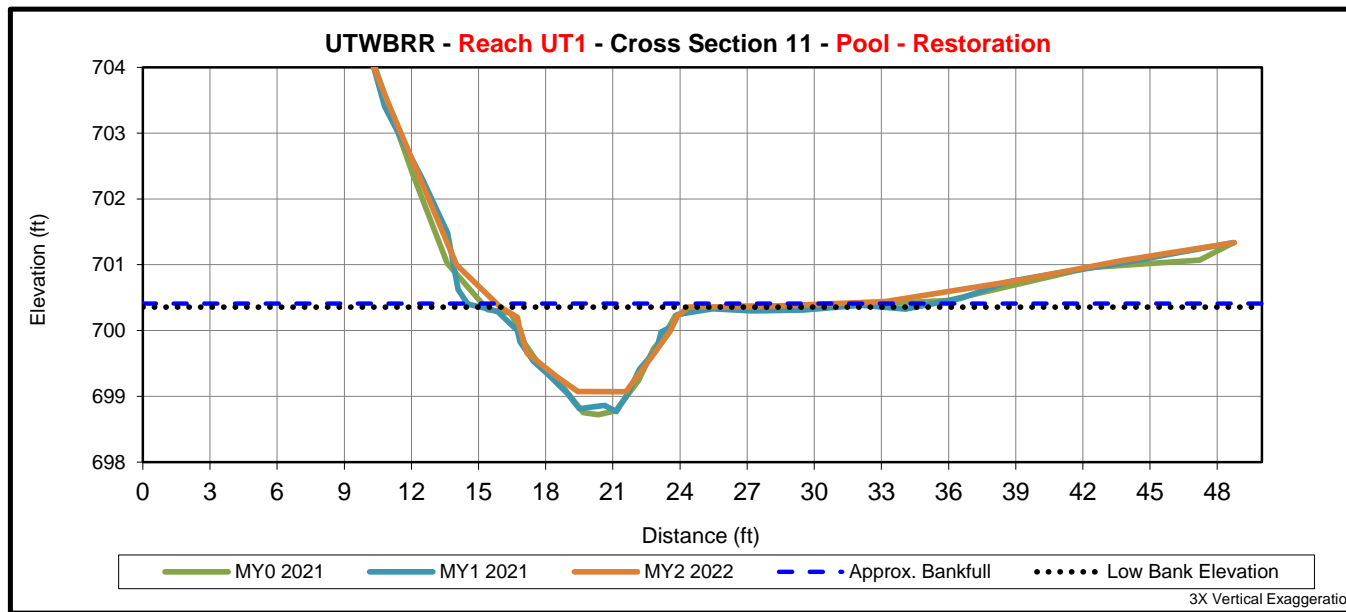
Cross Section 11 (Pool)						
	MY0	MY1	MY2	MY3	MY5	MY7	MY+
Bankfull Elevation (ft) - Based on AB-XSA¹	700.32	700.3	700.4				
Bankfull Width (ft) ¹	NA	NA	NA				
Floodprone Width (ft) ¹	NA	NA	NA				
Bankfull Max Depth (ft) ²	1.6	1.5	1.3				
Low Bank Elevation (ft)	700.32	700.2	700.4				
Bankfull Cross Sectional Area (ft ²) ²	7.5	6.9	7.0				
Bankfull Entrenchment Ratio ¹	NA	NA	NA				
Bankfull Bank Height Ratio ¹	NA	NA	NA

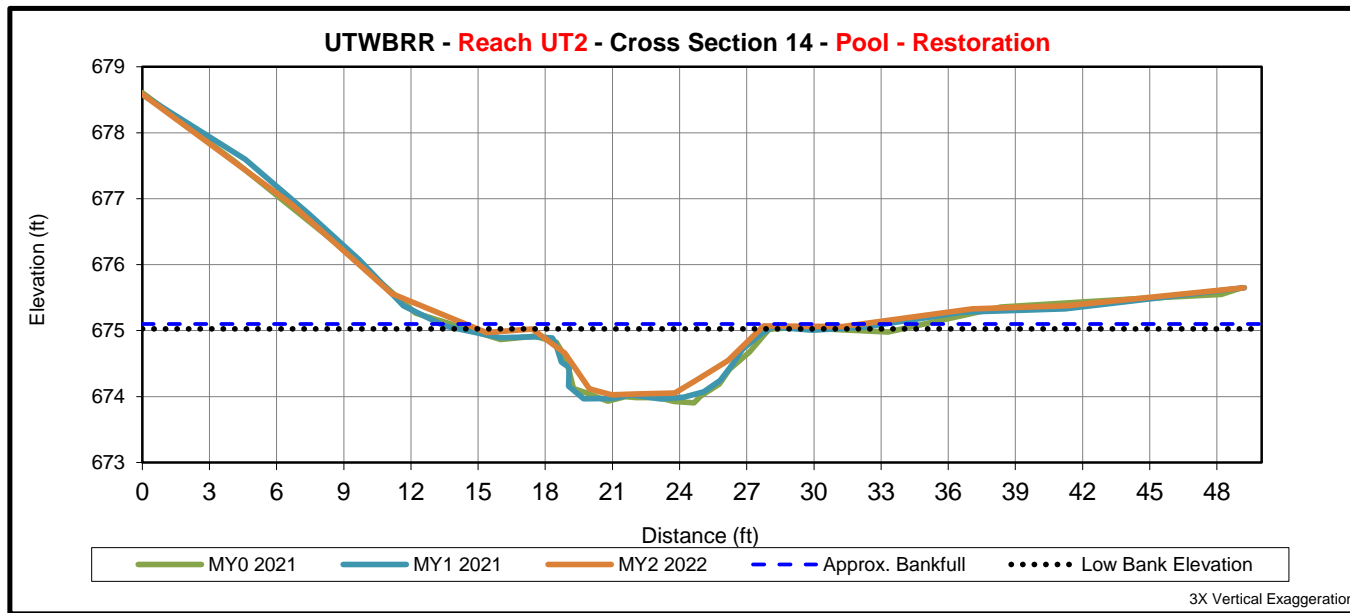
Cross Section 14 (Pool)						
	MY0	MY1	MY2	MY3	MY5	MY7	MY+
Bankfull Elevation (ft) - Based on AB-XSA¹	674.91	674.9	675.1				
Bankfull Width (ft) ¹	NA	NA	NA				
Floodprone Width (ft) ¹	NA	NA	NA				
Bankfull Max Depth (ft) ²	1.0	0.9	1.0				
Low Bank Elevation (ft)	674.91	674.9	675.0				
Bankfull Cross Sectional Area (ft ²) ²	7.0	6.6	6.8				
Bankfull Entrenchment Ratio ¹	NA	NA	NA				
Bankfull Bank Height Ratio ¹	NA	NA	NA

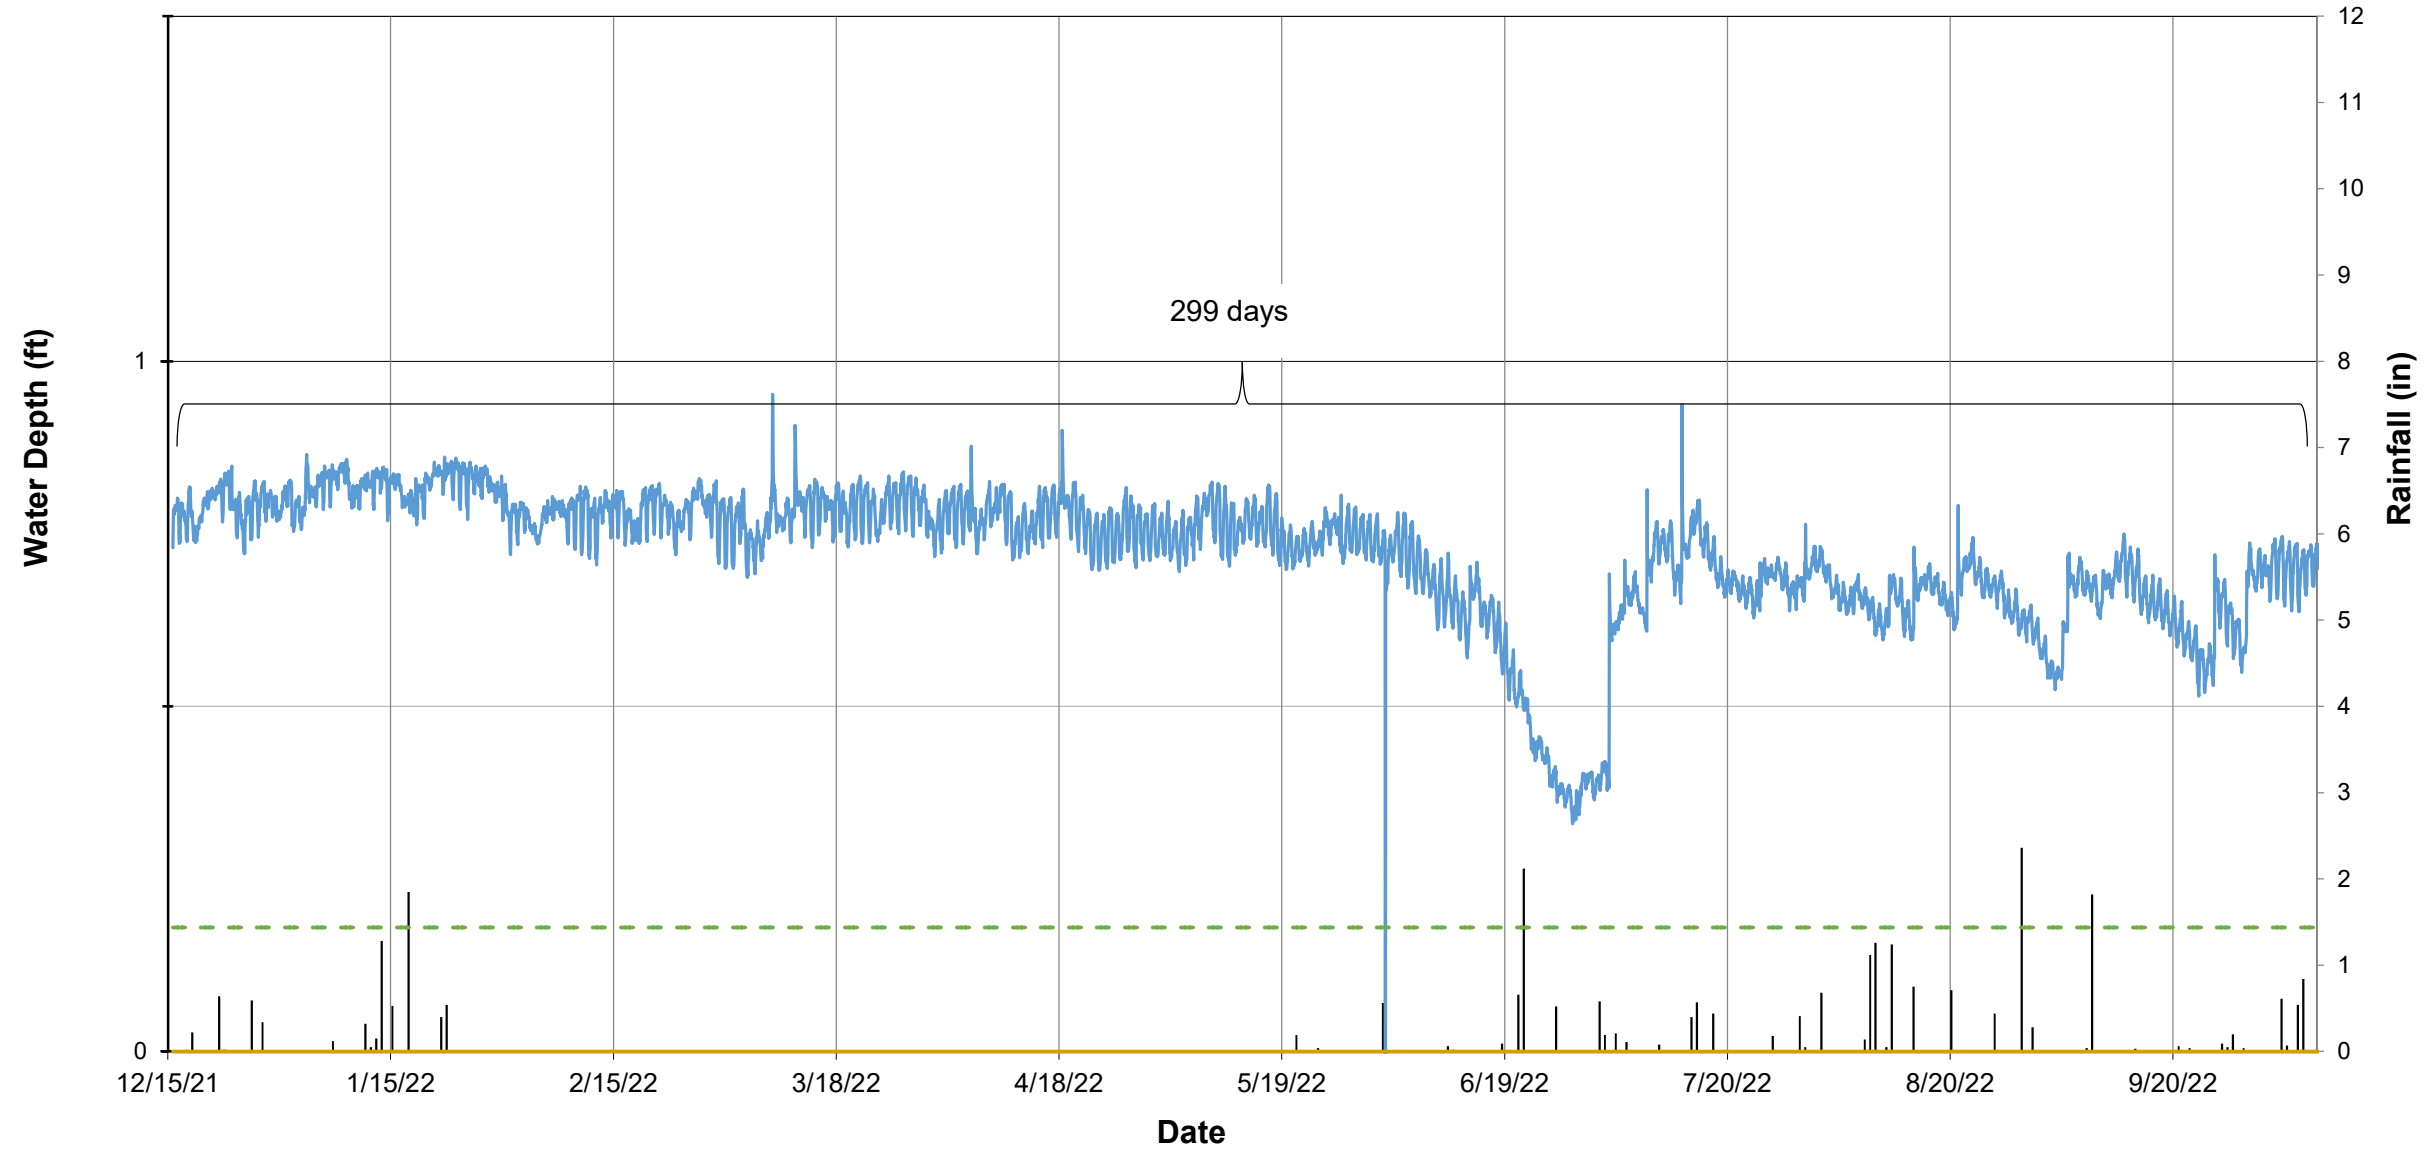
MY2 2022 UTWBRR UT1 Flow Gauge

Year	Number of Bankfull Events	Maximum Bankfull Height (ft)	Date of Maximum Bankfull Event	
Stage Recorder UTWB-3				
MY1 2021	0	N/A	N/A	
MY2 2022	1	0.14	7/13/2022	
Year	Number of Flow Events	Maximum Consecutive Flow Days	Maximum Cumulative Flow Days	Maximum Consecutive Flow Date Range
Flow Gauge UT1				
MY1 2021	1	243	243	4/16/2021 - 12/15/2021
MY2 2022	1	299	299	12/15/2021 - 10/10/2022
Flow Gauge UT2				
MY1 2021	1	243	243	4/16/2021 - 12/15/2021
MY2 2022	1	299	299	12/15/2021 - 10/10/2022
