**Year 3 Monitoring Report**

**UT WEST BRANCH ROCKY RIVER  
RESTORATION SITE**

NCDMS Project #92684 (Contract # WBRR010521)  
USACE Action ID: SAW-2017-00342 | NCDWR Project #18-1696

Mecklenburg County, North Carolina  
Yadkin River Basin | HUC 03040105

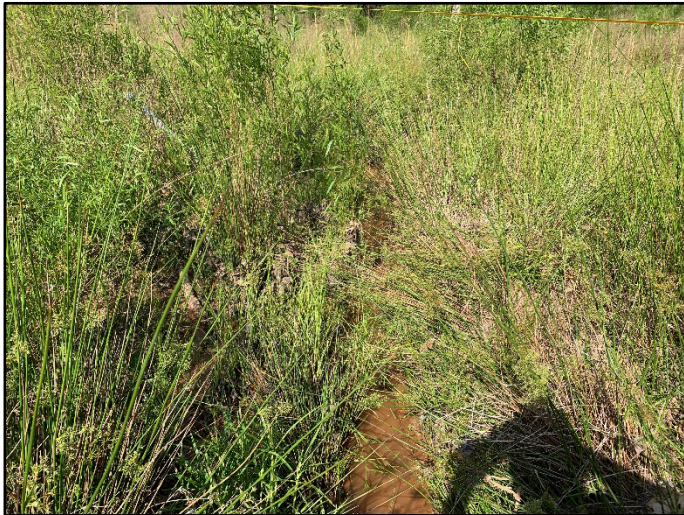
Along UT1-2 there is approximately 20 feet of aggradation and on UT2-2 there is approximately 40 feet of aggradation that has been noted. In-stream vegetation throughout may contribute to this aggradation, removal of the excessive vegetation could help the aggradation in these channels. Four structures were found to be piping with two on UTWB-1 and two on UTWB-2. Structures #2 and #4 have been hand repaired and are now functioning properly. Structures #1 and #3 will be repaired in January 2024. The aggradation and structures will continue to be monitored in the future. Pictures of the aggradation area, piping structures can be found in **Appendix B** and locations of these areas can be found on **Figure 2**.

Aggradation on UT2-2 (5/11/2023)

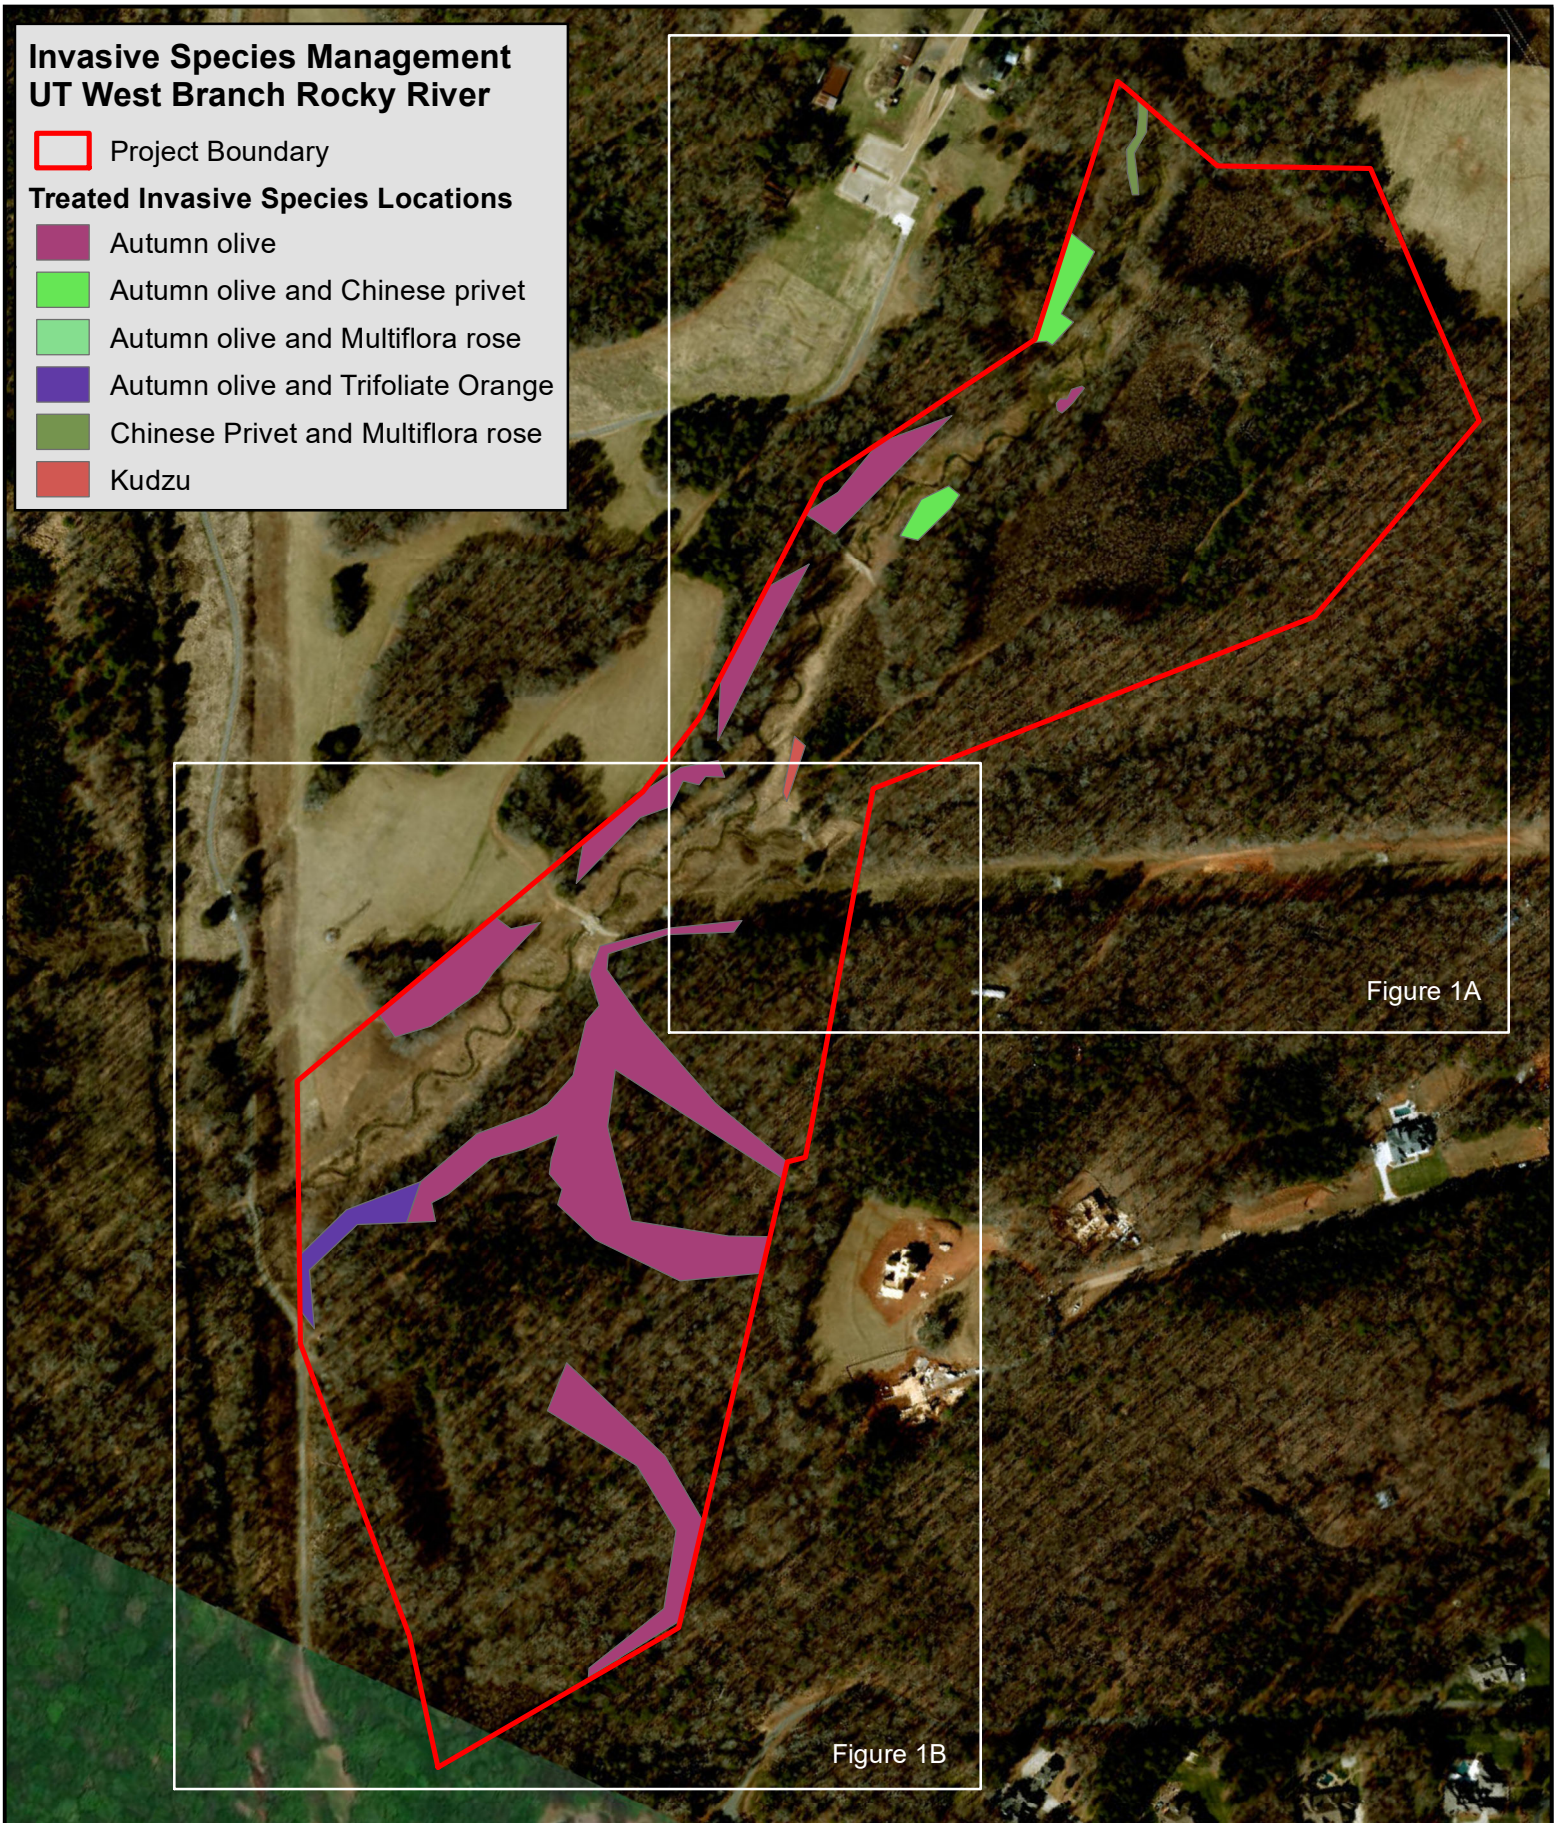
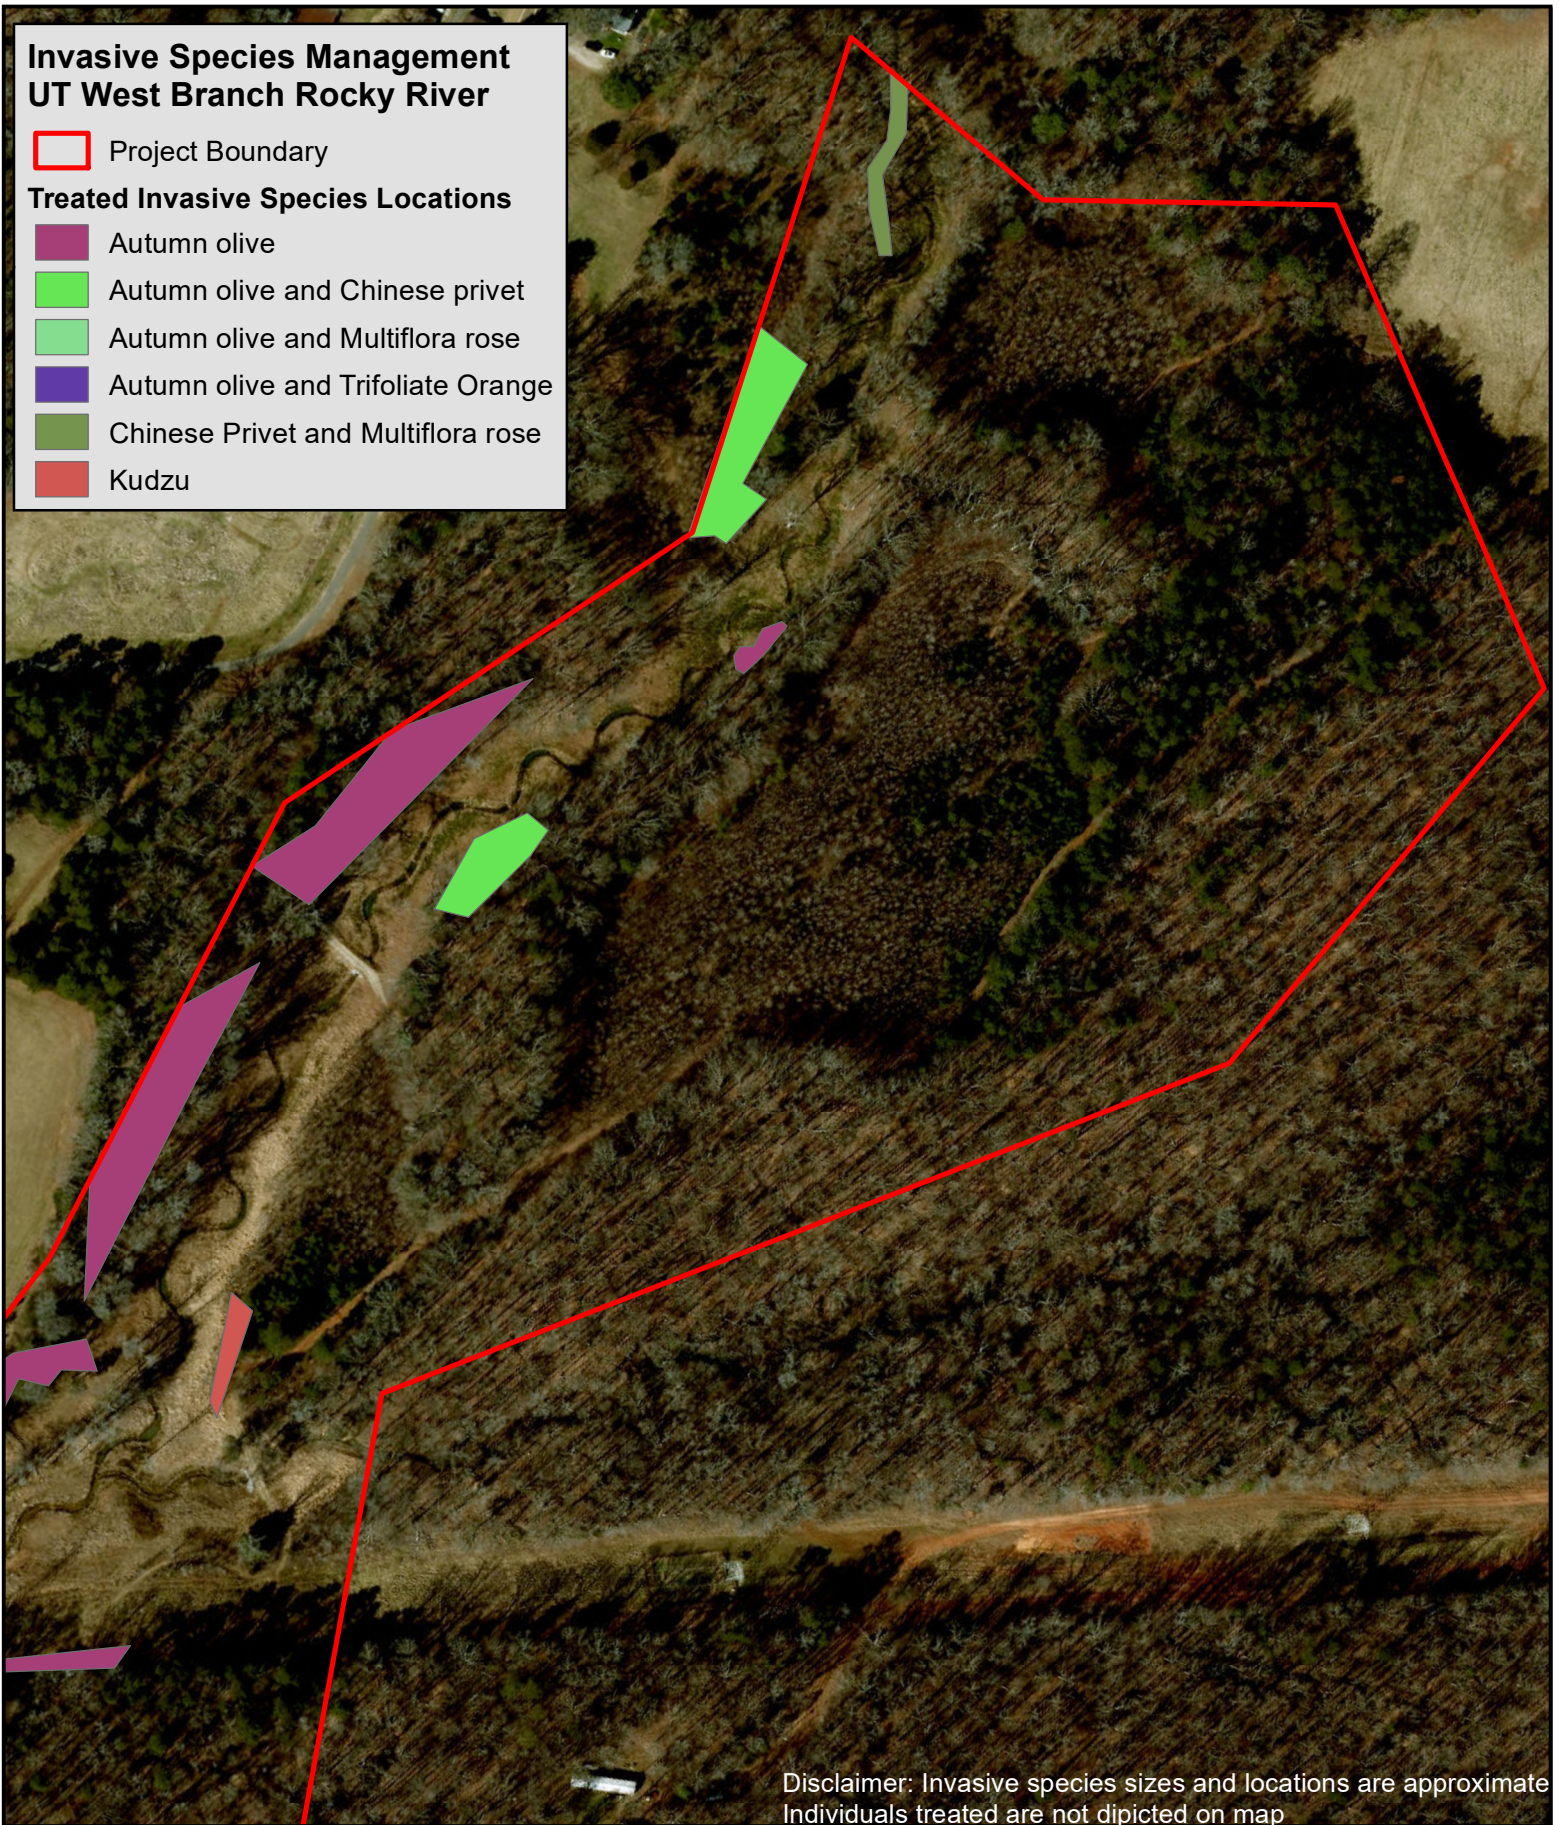
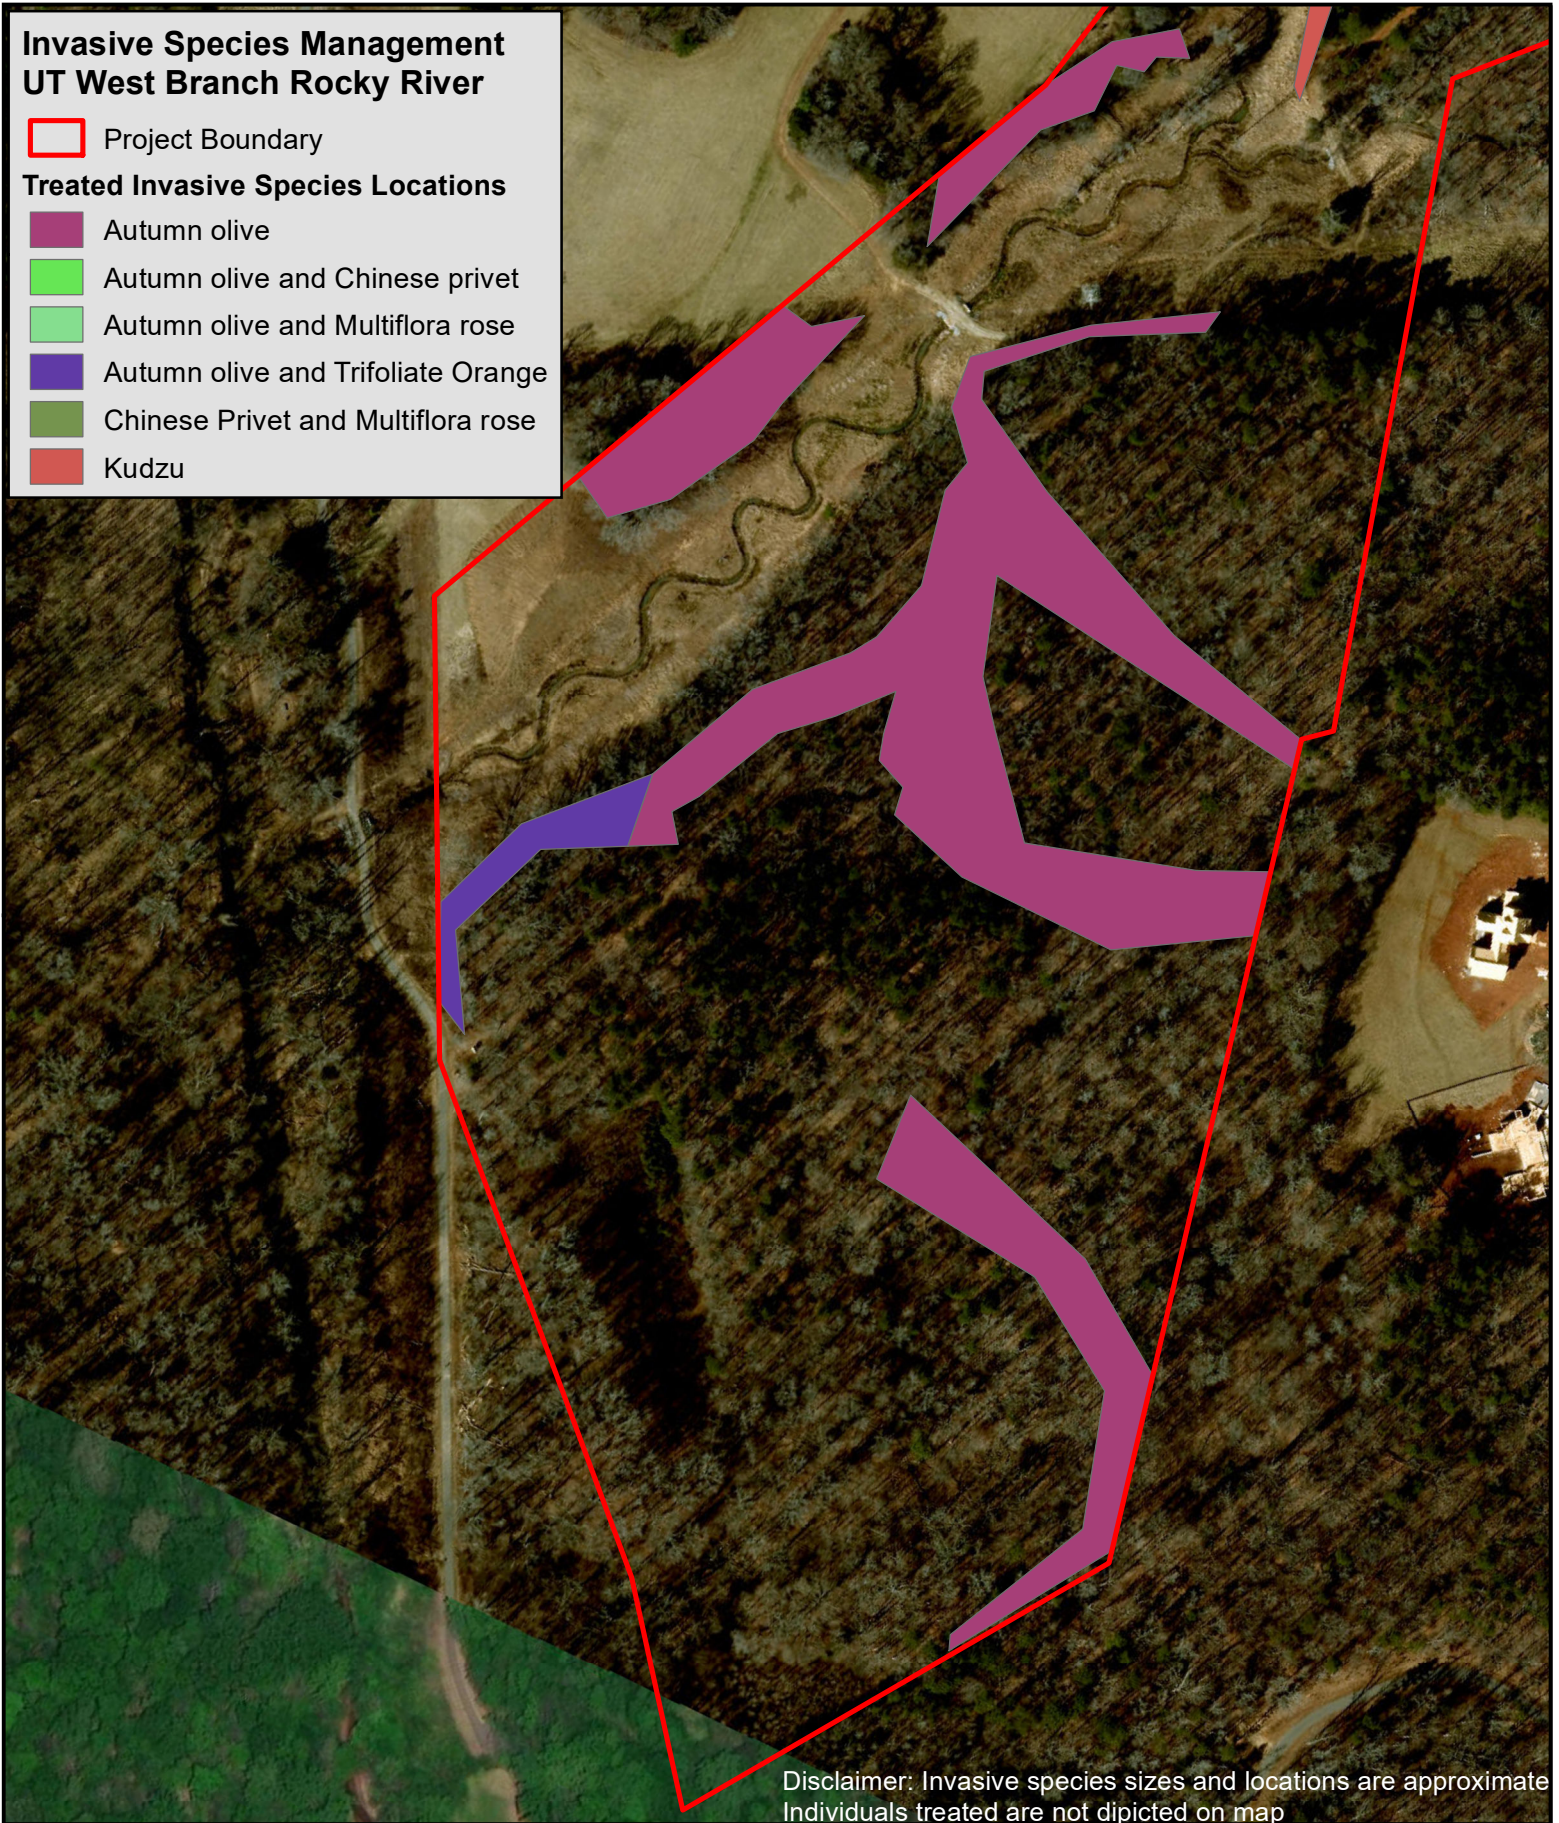
Approximately 6.0 acres of invasive species were treated. Primary species treated on-site included Chinese privet, autumn olive, and multiflora rose. Several individuals of trifoliolate orange were observed and treated within the easement boundary. DRG also observed and treated two areas of kudzu on-site. Both trifoliolate orange and kudzu were treated with the same 6% solution used to treat other invasive species on-site. Locations of invasive species treated can be seen in Figures 1A and 1B.
