Valley Fields Farm Monitoring Report FINAL Year 2 (2011)

Davidson County, North Carolina

EEP Project ID #407

Submitted December 2011

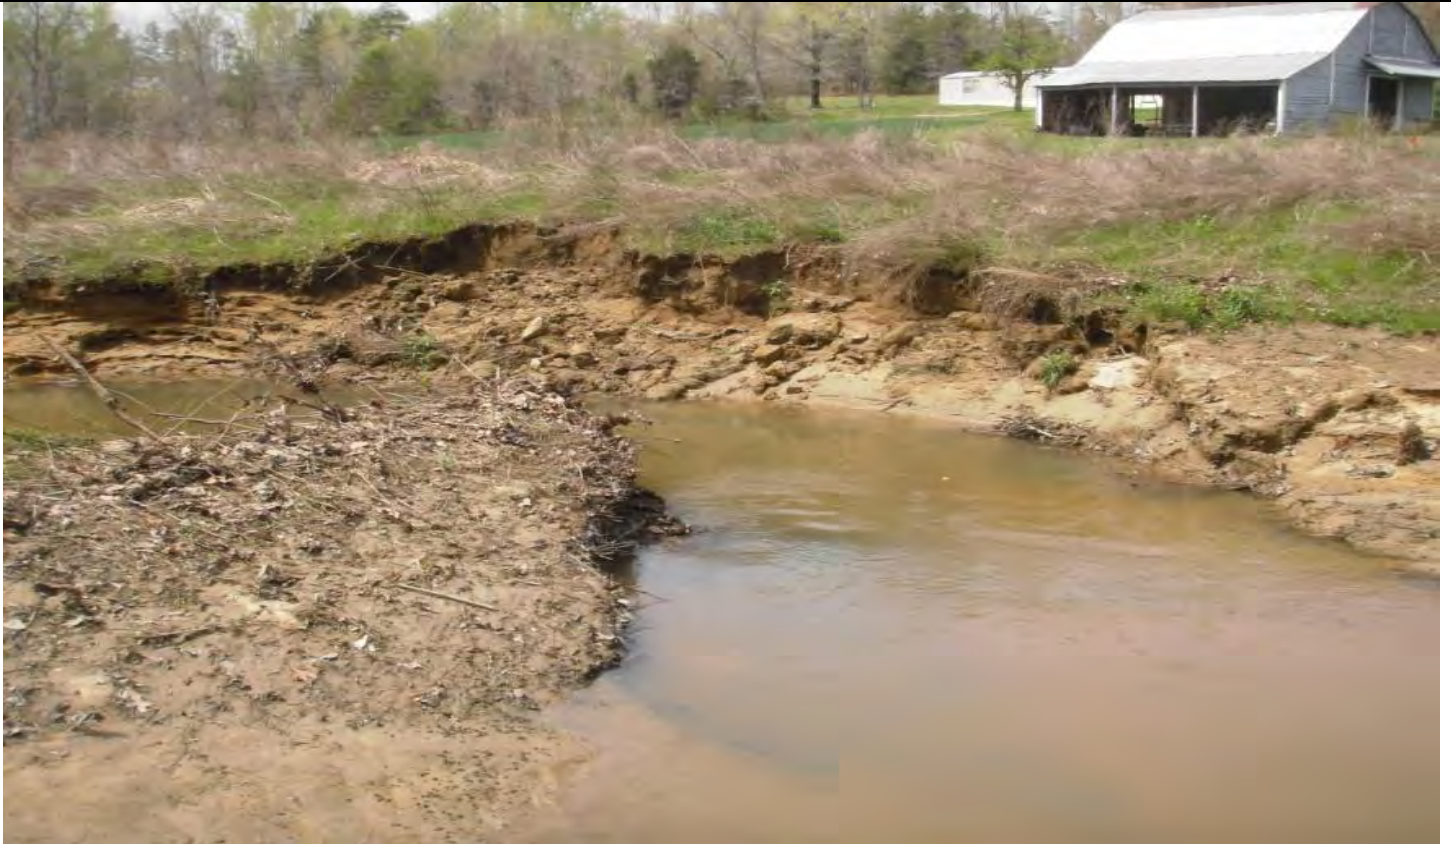
SP03 (2011) - Bank scour on left bank of Reach B (STA 151+475)

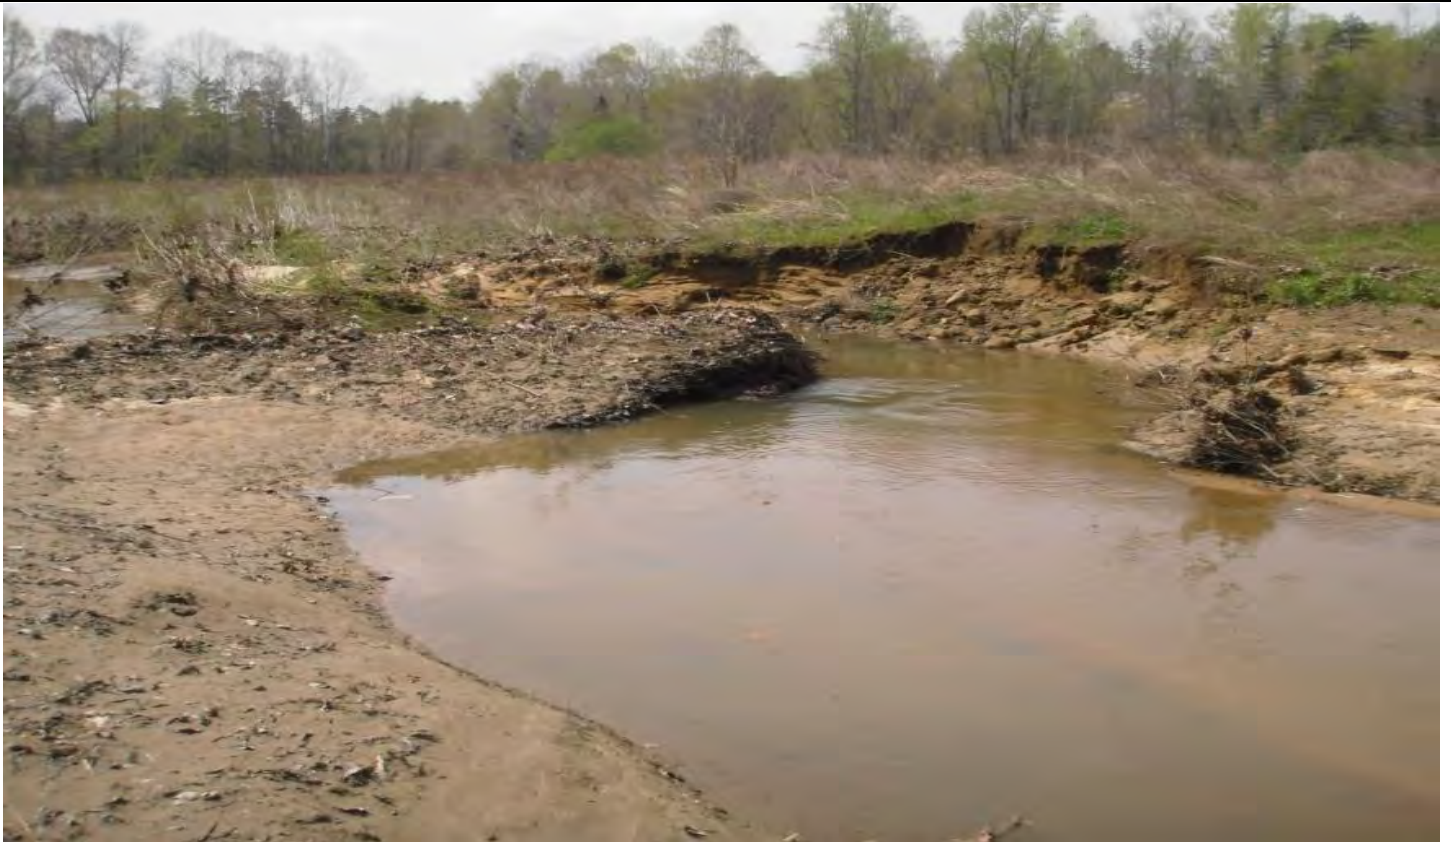
SP04 (2011) - Bank scour on right bank of Reach Lower A (STA 95+50)

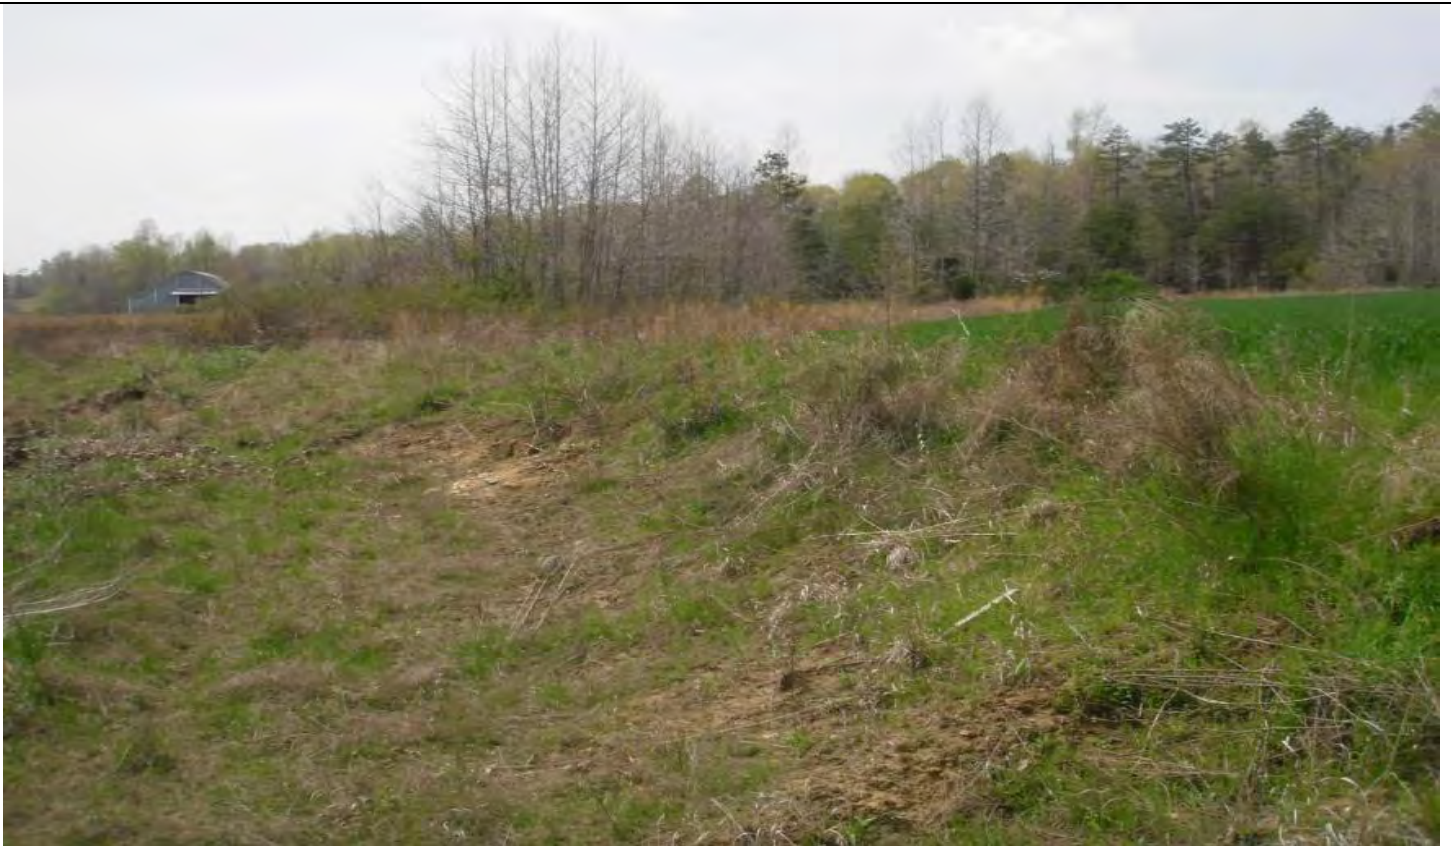
VP01 (2011) - Potential encroachment along Reach Lower A (STA: 87+50)

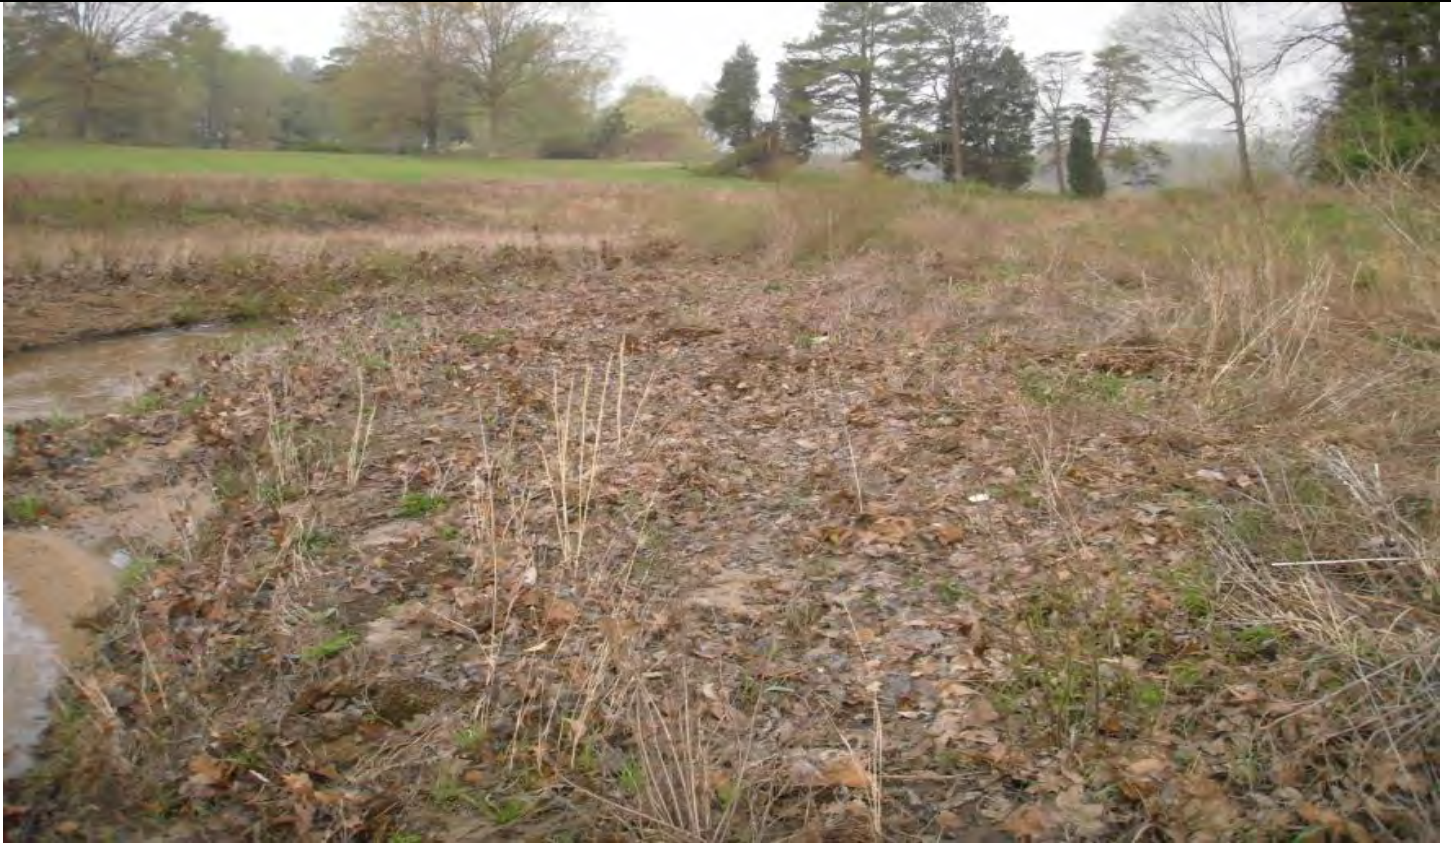
VP02 (2011) - Potential encroachment along Reach Lower A (STA: 87+50)

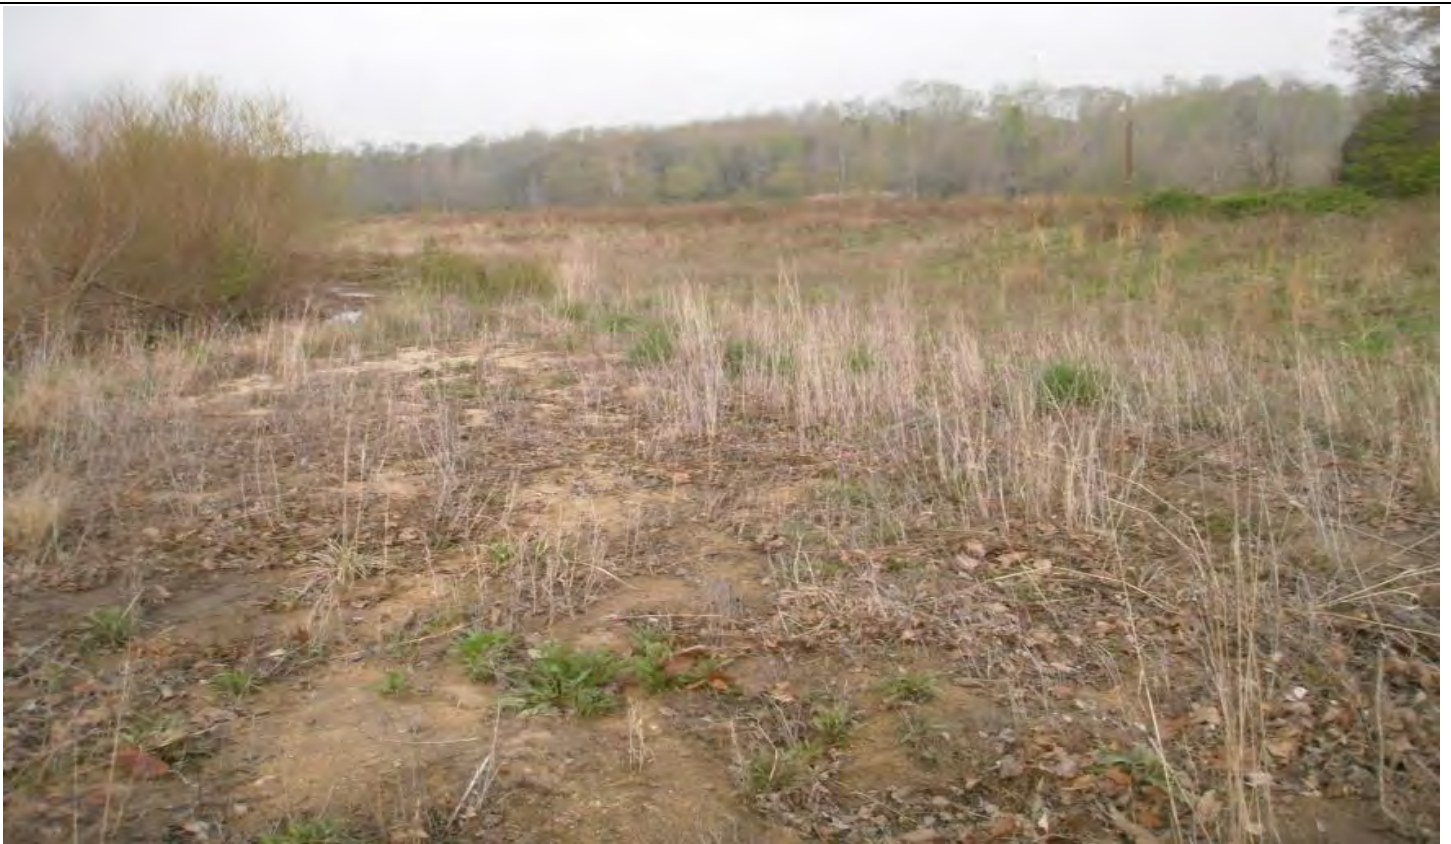
VP03 (2011) - Weak growth on right bank of Reach B (STA 150+700)

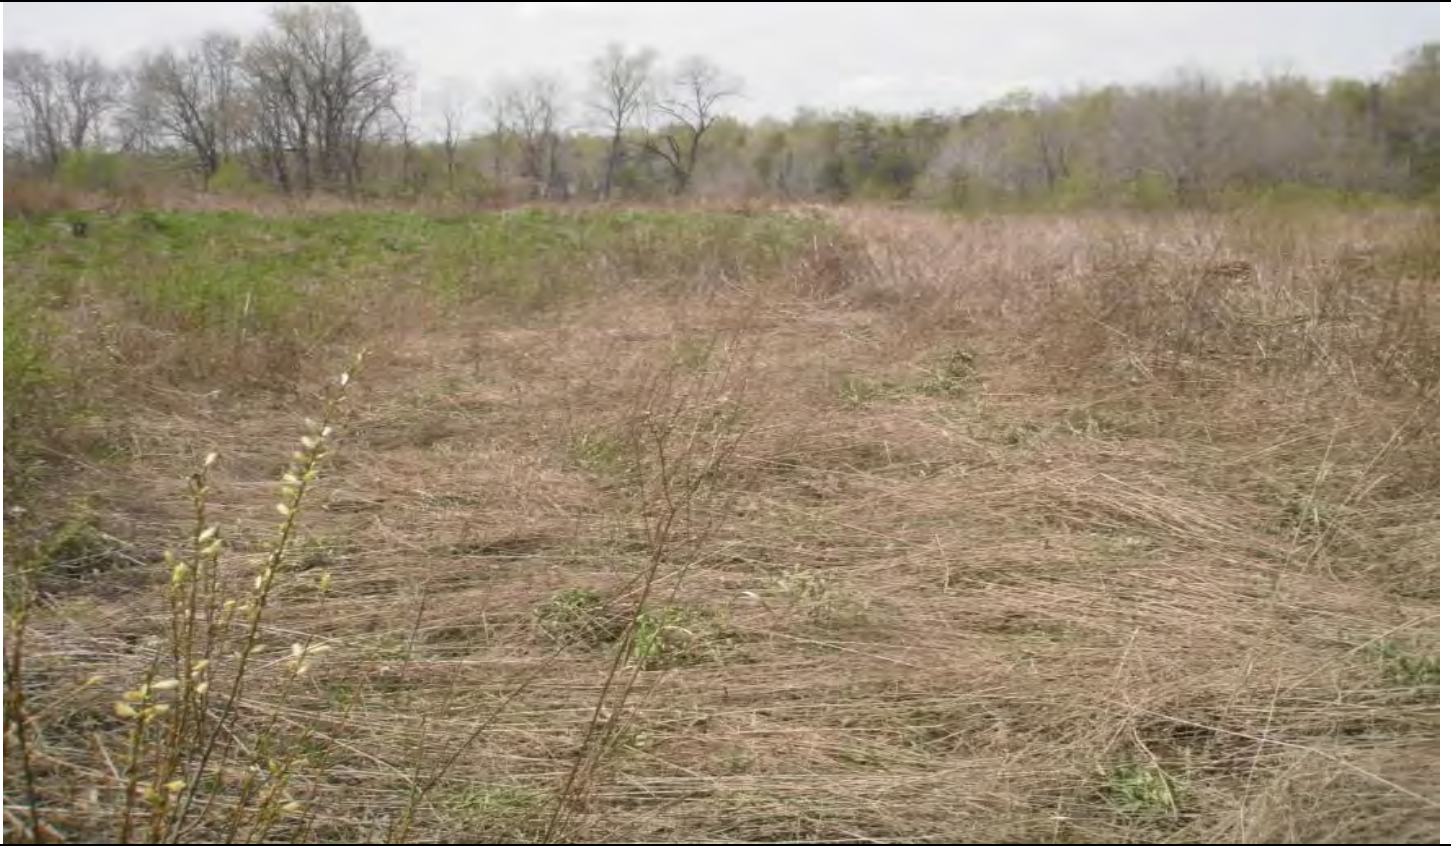
VP04 (2011) - Weak growth on right bank of Reach B (STA 151+650)

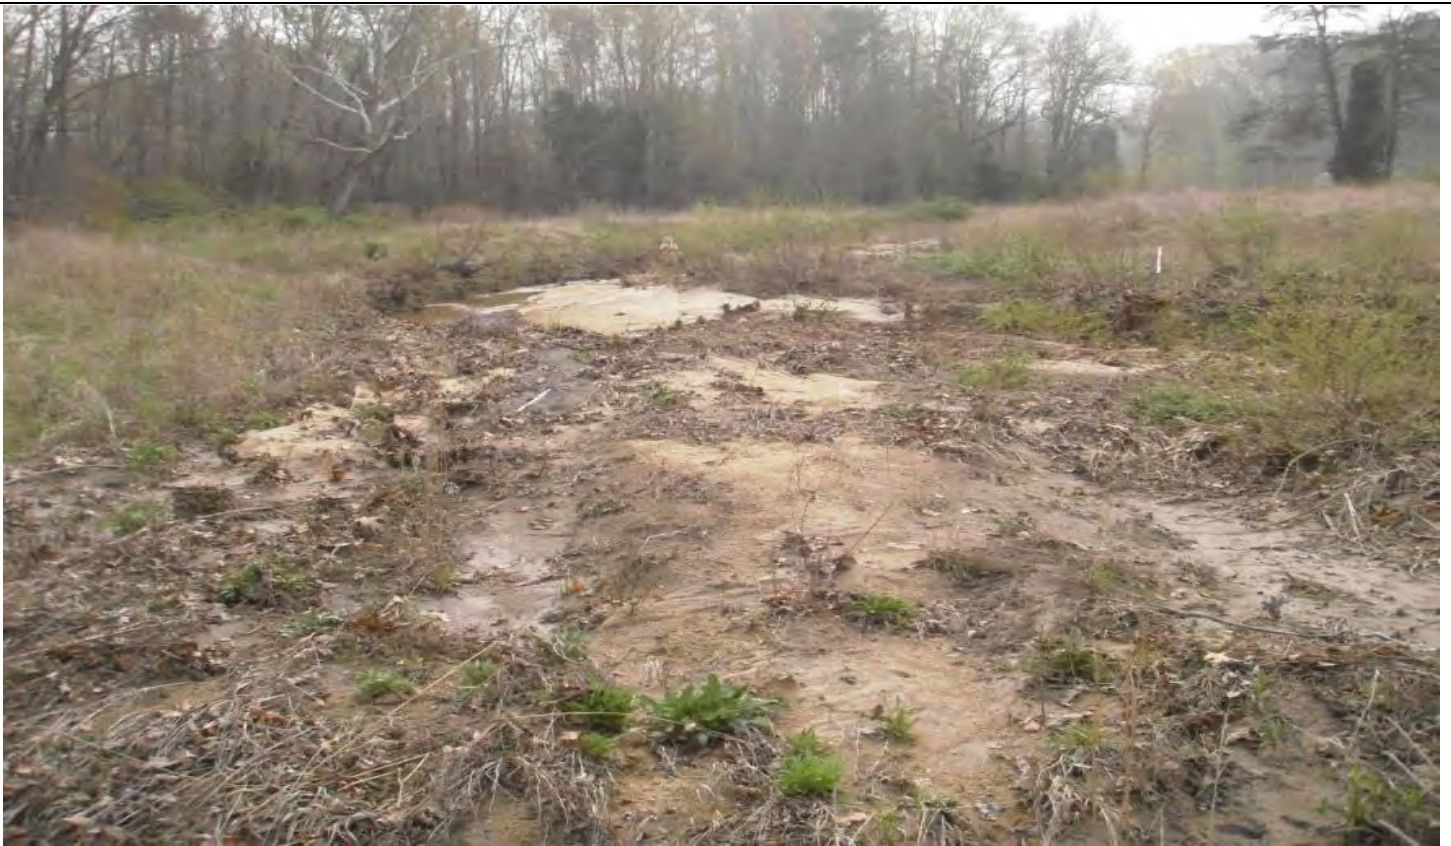
VP05 (2011) - Weak growth on left bank of Reach B (STA 152+450)

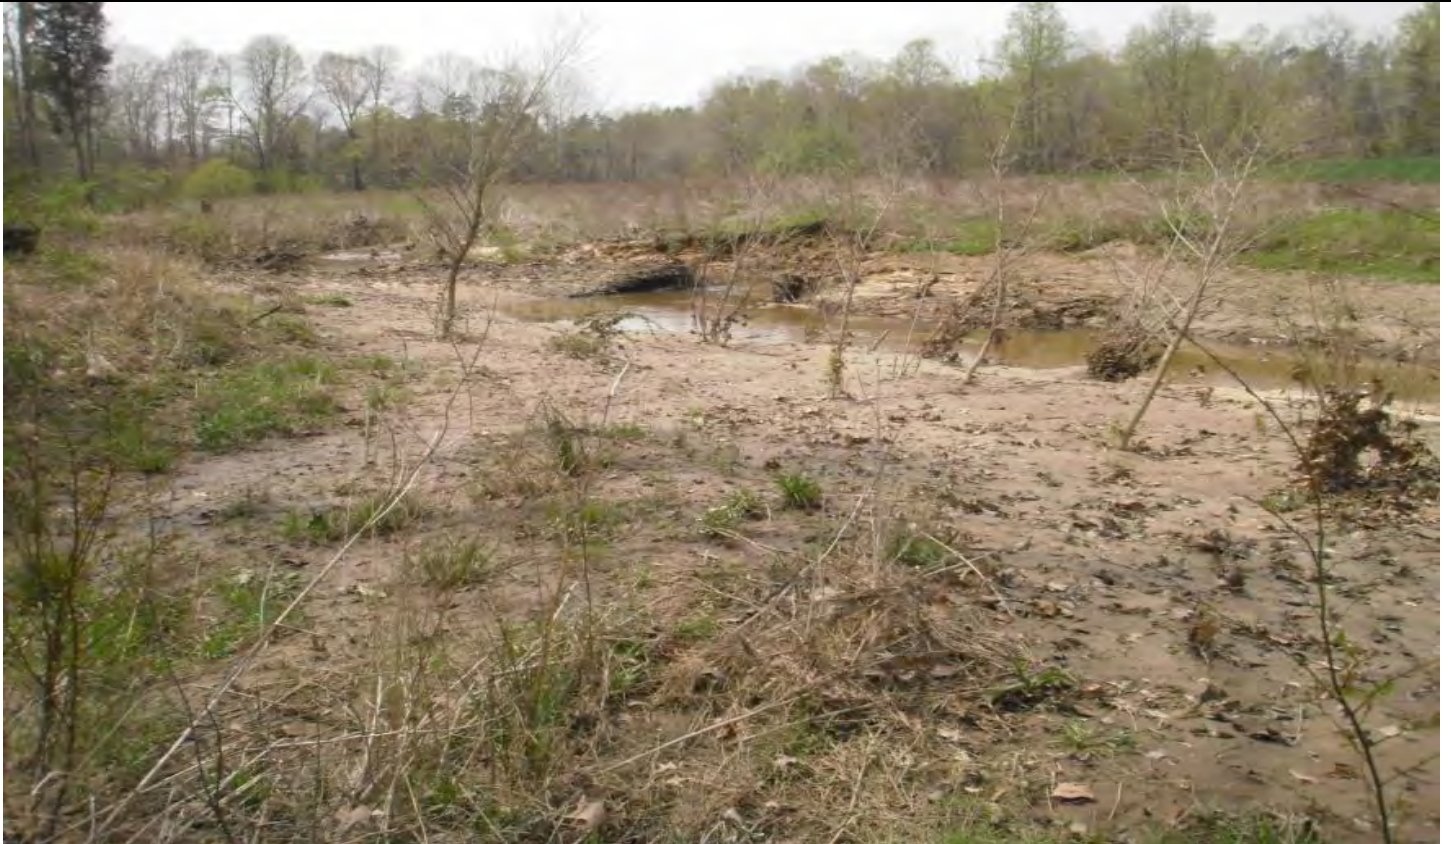
VP06 (2011) - Bare bench on right bank of Reach B (STA 151+575)
