# Valley Fields Farm Stream Restoration Project

## Monitoring Report: Year 03

Davidson County, North Carolina  
Upper Yadkin River Basin  
Cataloging Unit 030401030  
EEP Project ID #407

January 2014

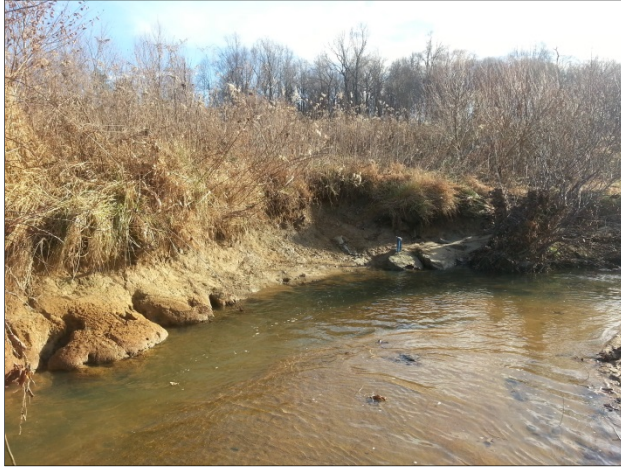
Bank erosion (Station 79+00) – 12/18/2013

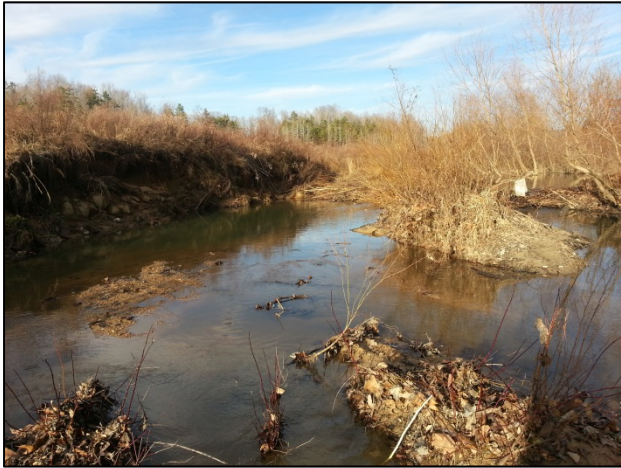
Beaver dam (Station 95+75) – 12/18/2013

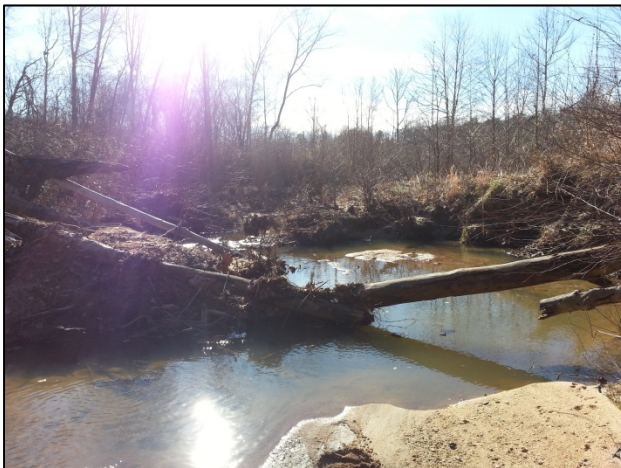
Bank erosion (Station 50+00) – 12/18/2013

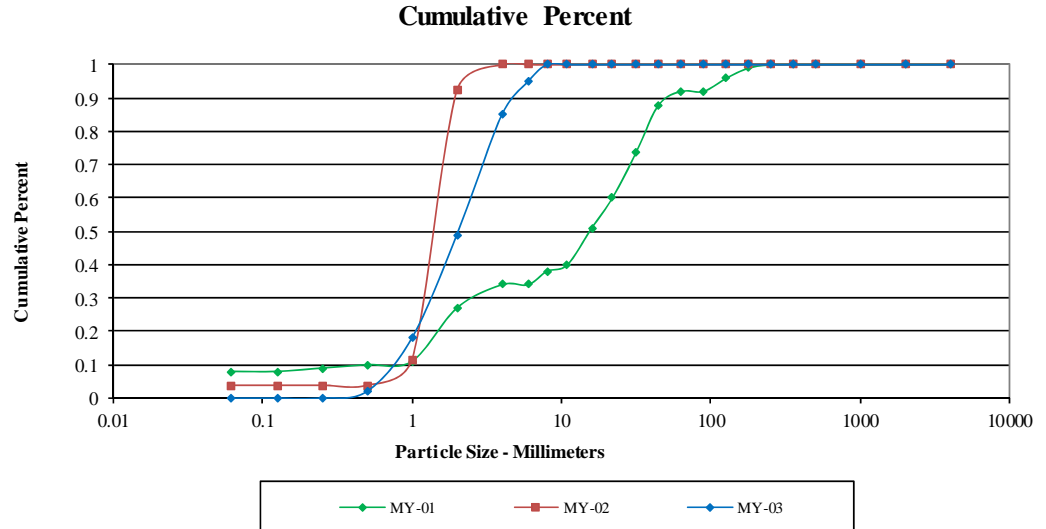
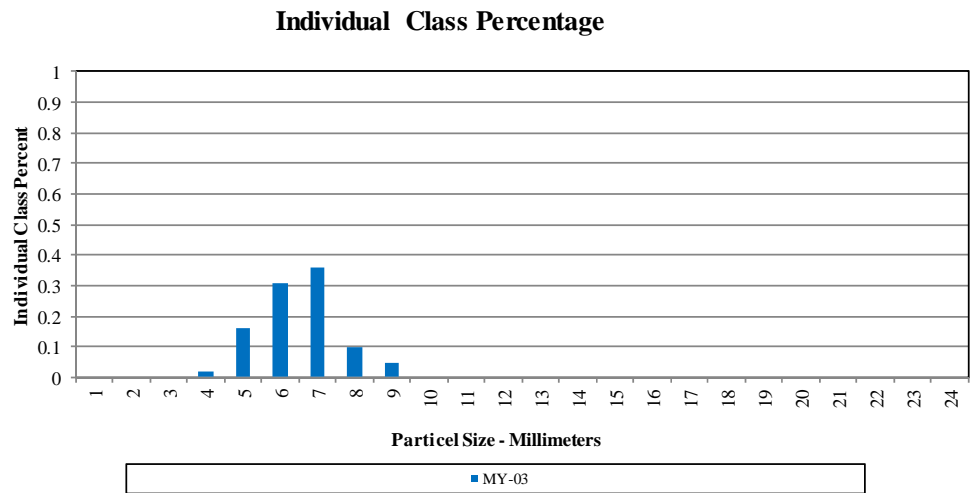
Cross-Section A3 Riffle - VFF MY-03					
Particle	Millimeter	Material	Count	Item %	Cum %
Silt/Clay	< 0.062	S/C		0%	0%
Very Fine	.062 - .125	S		0%	0%
Fine	.125 - .25	A		0%	0%
Medium	.25 - .50	N	2	2%	2%
Coarse	.50 - 1	D	16	16%	18%
Very Coarse	1 - 2	S	31	31%	49%
Very Fine	2 - 4		36	36%	85%
Fine	4 - 5.7	G	10	10%	95%
Fine	5.7 - 8	R	5	5%	100%
Medium	8 - 11.3	A		0%	100%
Medium	11.3 - 16	V		0%	100%
Coarse	16 - 22.6	E		0%	100%
Coarse	22.6 - 32	L		0%	100%
Very Coarse	32 - 45	S		0%	100%
Very Coarse	45 - 64			0%	100%
Small	64 - 90	C		0%	100%
Small	90 - 128	O		0%	100%
Large	128 - 180	B		0%	100%
Large	180 - 256	L		0%	100%
Small	256 - 362	B		0%	100%
Small	362 - 512	L		0%	100%
Medium	512 - 1024	D		0%	100%
Lrg- Very Lrg	1024 - 2048	R		0%	100%
Bedrock	>2048	BDRK		0%	100%
<b>Total</b>			100	100%	100%
Size (mm)		Type			
D50	2	silt/clay	0%		
D84	3.9	sand	49%		
D95	6	gravel	51%		
		cobble	0%

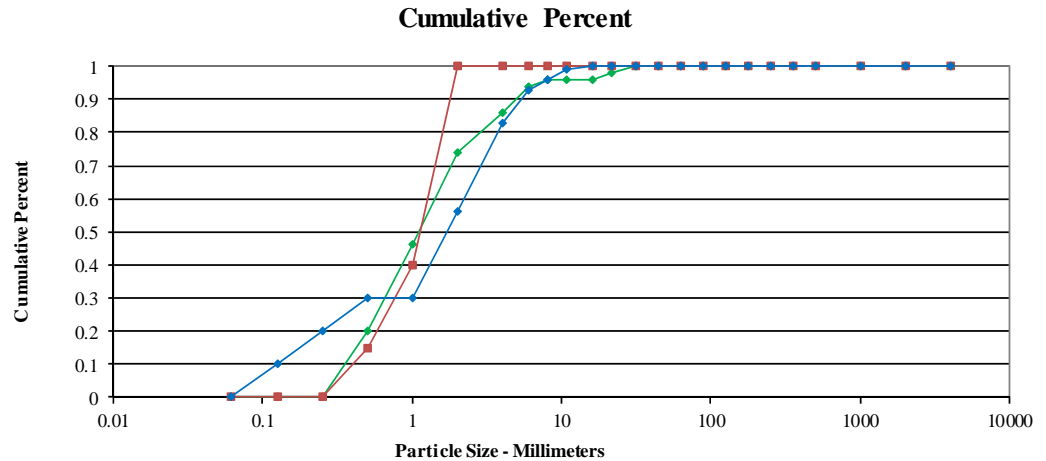
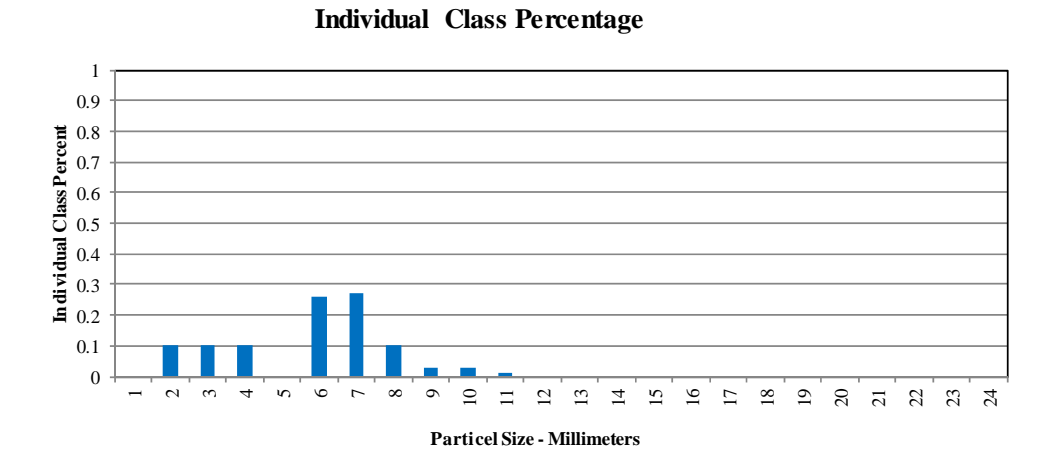
Cross-Section A10 Riffle - VFF MY-03					
Particle	Millimeter	Material	Count	Item %	Cum %
Silt/Clay	< 0.062	S/C		0%	0%
Very Fine	.062 - .125	S	10	10%	10%
Fine	.125 - .25	A	10	10%	20%
Medium	.25 - .50	N	10	10%	30%
Coarse	.50 - 1	D		0%	30%
Very Coarse	1 - 2	S	26	26%	56%
Very Fine	2 - 4		27	27%	83%
Fine	4 - 5.7	G	10	10%	93%
Fine	5.7 - 8	R	3	3%	96%
Medium	8 - 11.3	A	3	3%	99%
Medium	11.3 - 16	V	1	1%	100%
Coarse	16 - 22.6	E		0%	100%
Coarse	22.6 - 32	L		0%	100%
Very Coarse	32 - 45	S		0%	100%
Very Coarse	45 - 64			0%	100%
Small	64 - 90	C		0%	100%
Small	90 - 128	O		0%	100%
Large	128 - 180	B		0%	100%
Large	180 - 256	L		0%	100%
Small	256 - 362	B		0%	100%
Small	362 - 512	L		0%	100%
Medium	512 - 1024	D		0%	100%
Lrg- Very Lrg	1024 - 2048	R		0%	100%
Bedrock	>2048	BDRK		0%	100%
<b>Total</b>			100	100%	100%
Size (mm)		Type			
D50	1.7	silt/clay	0%		
D84	4.2	sand	56%		
D95	7.3	gravel	44%		
		cobble	0%

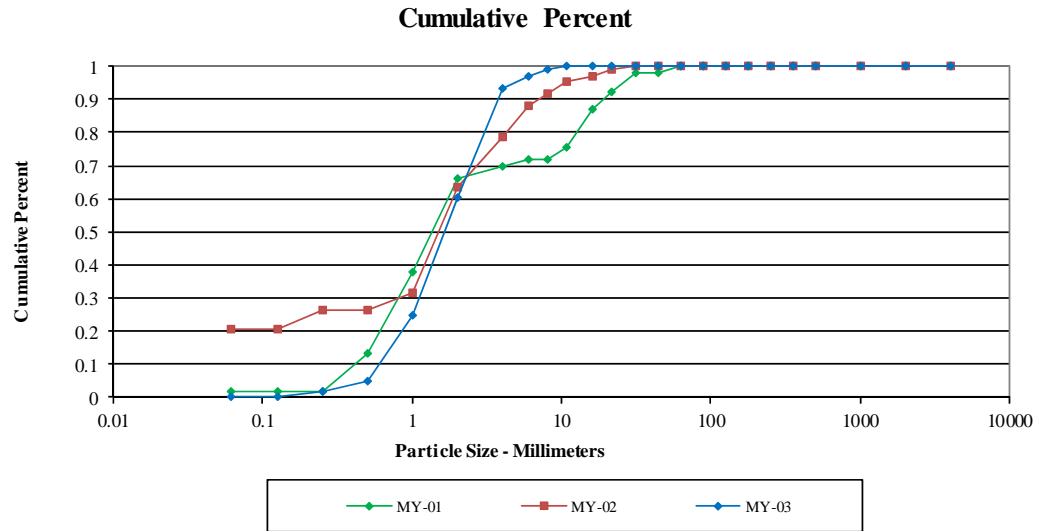
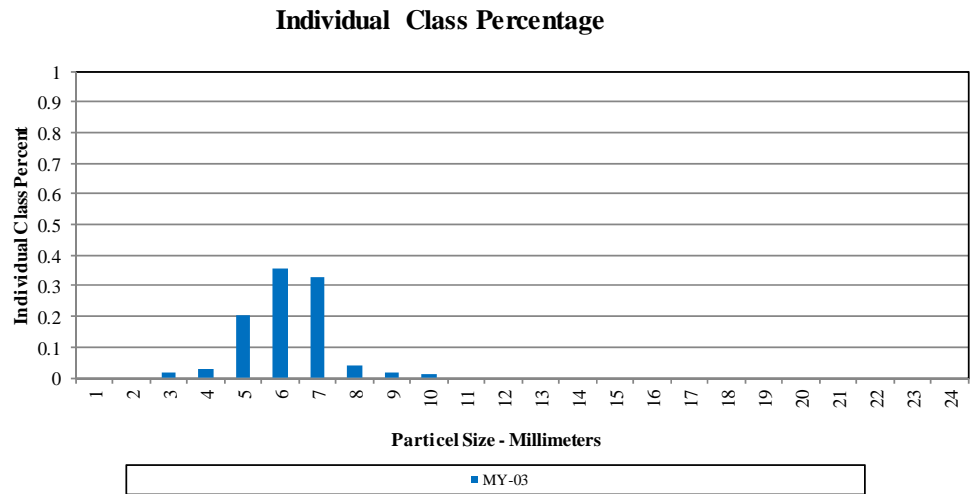
Cross-Section B1 Riffle - VFF MY-03					
Particle	Millimeter	Material	Count	Item %	Cum %
Silt/Clay	< 0.062	S/C		0%	0%
Very Fine	.062 - .125	S		0%	0%
Fine	.125 - .25	A	2	2%	2%
Medium	.25 - .50	N	3	3%	5%
Coarse	.50 - 1	D	21	20%	25%
Very Coarse	1 - 2	S	37	36%	61%
Very Fine	2 - 4		34	33%	93%
Fine	4 - 5.7	G	4	4%	97%
Fine	5.7 - 8	R	2	2%	99%
Medium	8 - 11.3	A	1	1%	100%
Medium	11.3 - 16	V		0%	100%
Coarse	16 - 22.6	E		0%	100%
Coarse	22.6 - 32	L		0%	100%
Very Coarse	32 - 45	S		0%	100%
Very Coarse	45 - 64			0%	100%
Small	64 - 90	C		0%	100%
Small	90 - 128	O		0%	100%
Large	128 - 180	B		0%	100%
Large	180 - 256	L		0%	100%
Small	256 - 362	B		0%	100%
Small	362 - 512	L		0%	100%
Medium	512 - 1024	D		0%	100%
Lrg- Very Lrg	1024 - 2048	R		0%	100%
Bedrock	>2048	BDRK		0%	100%
<b>Total</b>			104	100%	100%
Size (mm)		Type			
D50	1.6	silt/clay	0%		
D84	3.3	sand	61%		
D95	4.8	gravel	39%		
		cobble	0%

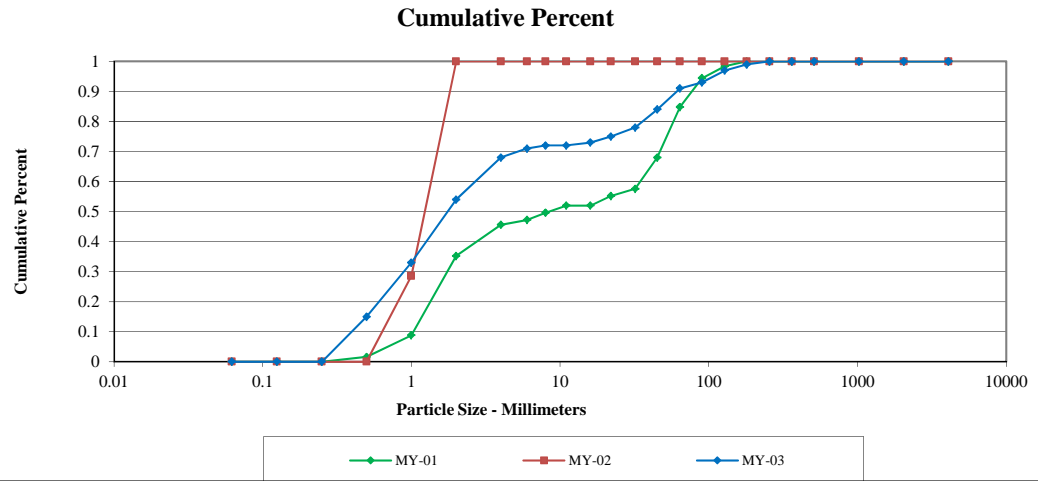
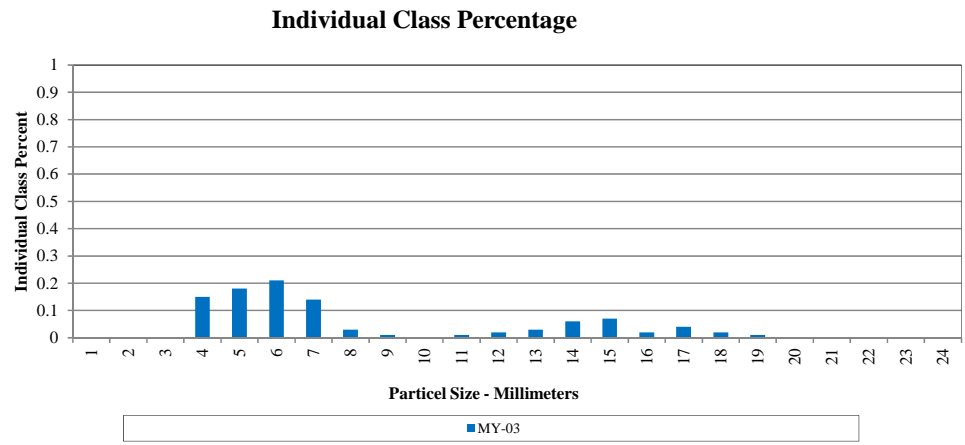
Cross-Section C3 Riffle - VFF MY-03					
Particle	Millimeter	Material	Count	Item %	Cum %
Silt/Clay	< .062	S/C		0%	0%
Very Fine	.062 - .125	S		0%	0%
Fine	.125 - .25	A		0%	0%
Medium	.25 - .50	N	15	15%	15%
Coarse	.50 - 1	D	18	18%	33%
Very Coarse	1 - 2	S	21	21%	54%
Very Fine	2 - 4	G	14	14%	68%
Fine	4 - 5.7		3	3%	71%
Fine	5.7 - 8	R	1	1%	72%
Medium	8 - 11.3	A		0%	72%
Medium	11.3 - 16	V	1	1%	73%
Coarse	16 - 22.6	E	2	2%	75%
Coarse	22.6 - 32	L	3	3%	78%
Very Coarse	32 - 45	S	6	6%	84%
Very Coarse	45 - 64		7	7%	91%
Small	64 - 90	C	2	2%	93%
Small	90 - 128	O	4	4%	97%
Large	128 - 180	B	2	2%	99%
Large	180 - 256	L	1	1%	100%
Small	256 - 362	B		0%	100%
Small	362 - 512	L		0%	100%
Medium	512 - 1024	D		0%	100%
Lrg- Very Lrg	1024 - 2048	R		0%	100%
Bedrock	>2048	BDRK		0%	100%
<b>Total</b>			100	100%	100%
Size (mm)		Type			
D50	1.8	silt/clay	0%		
D84	45	sand	54%		
D95	110	gravel	30%		
		cobble	9%

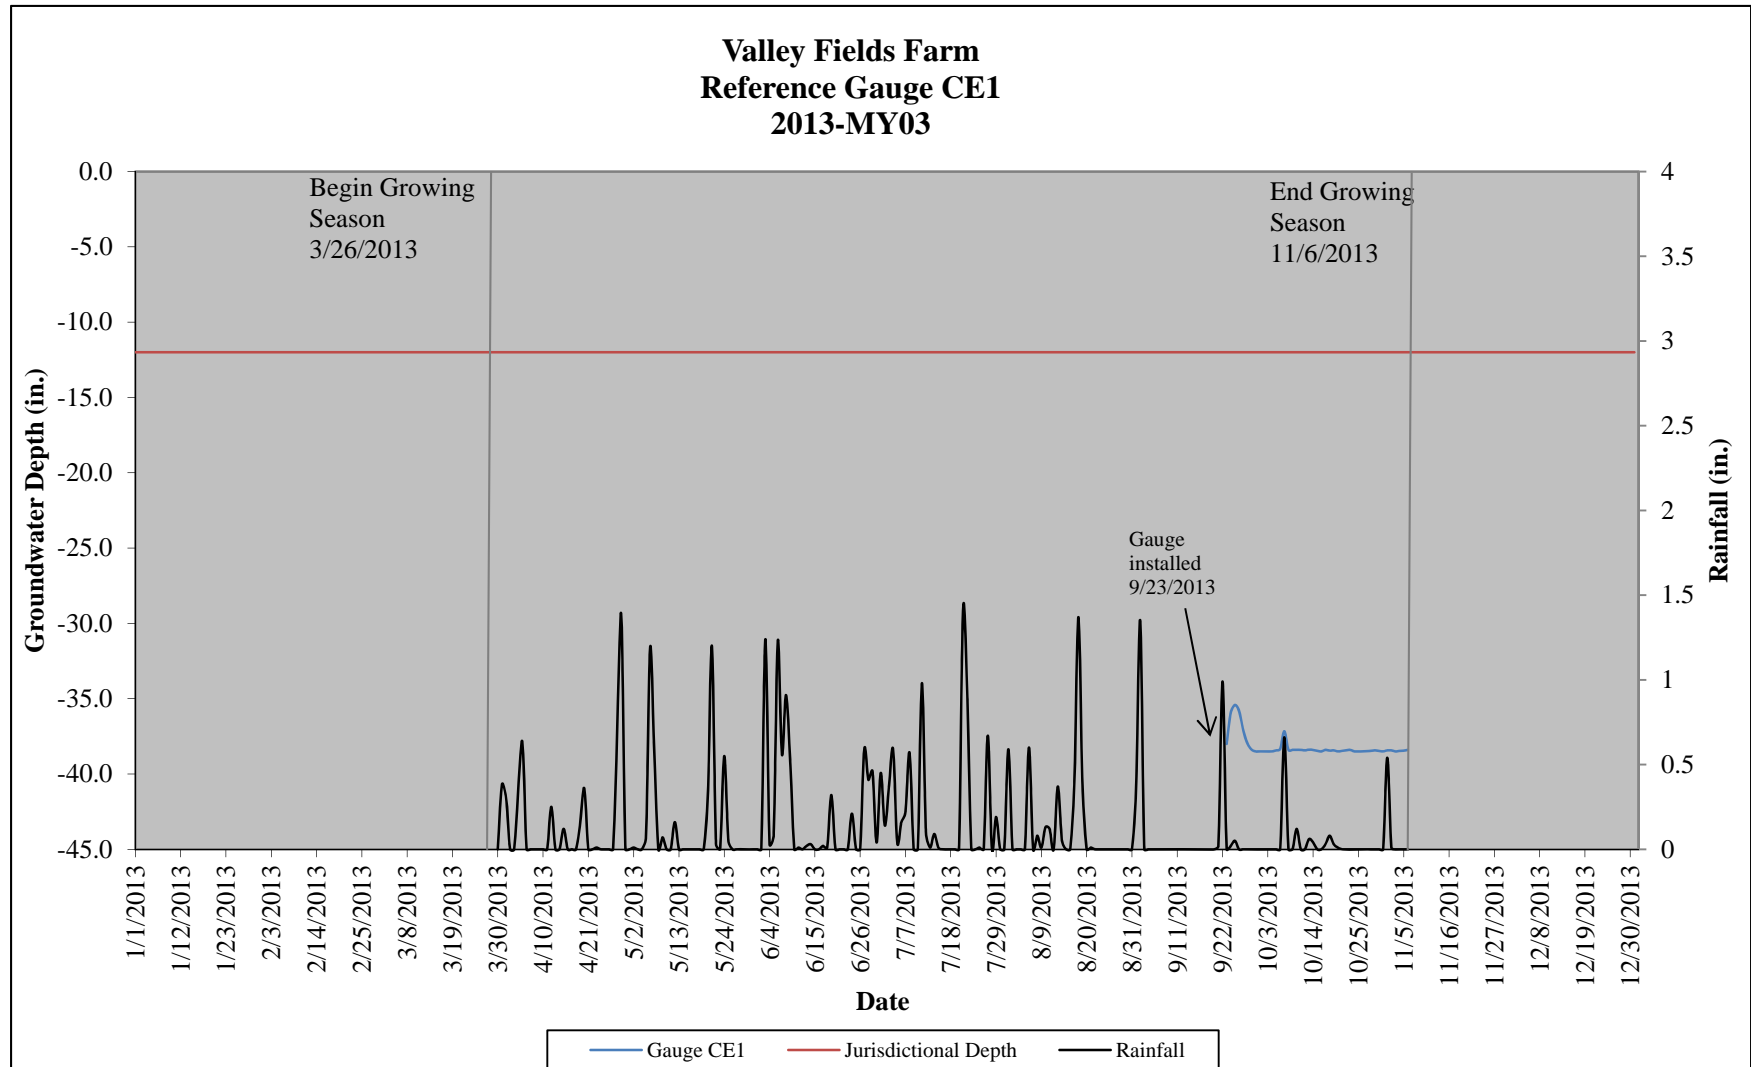
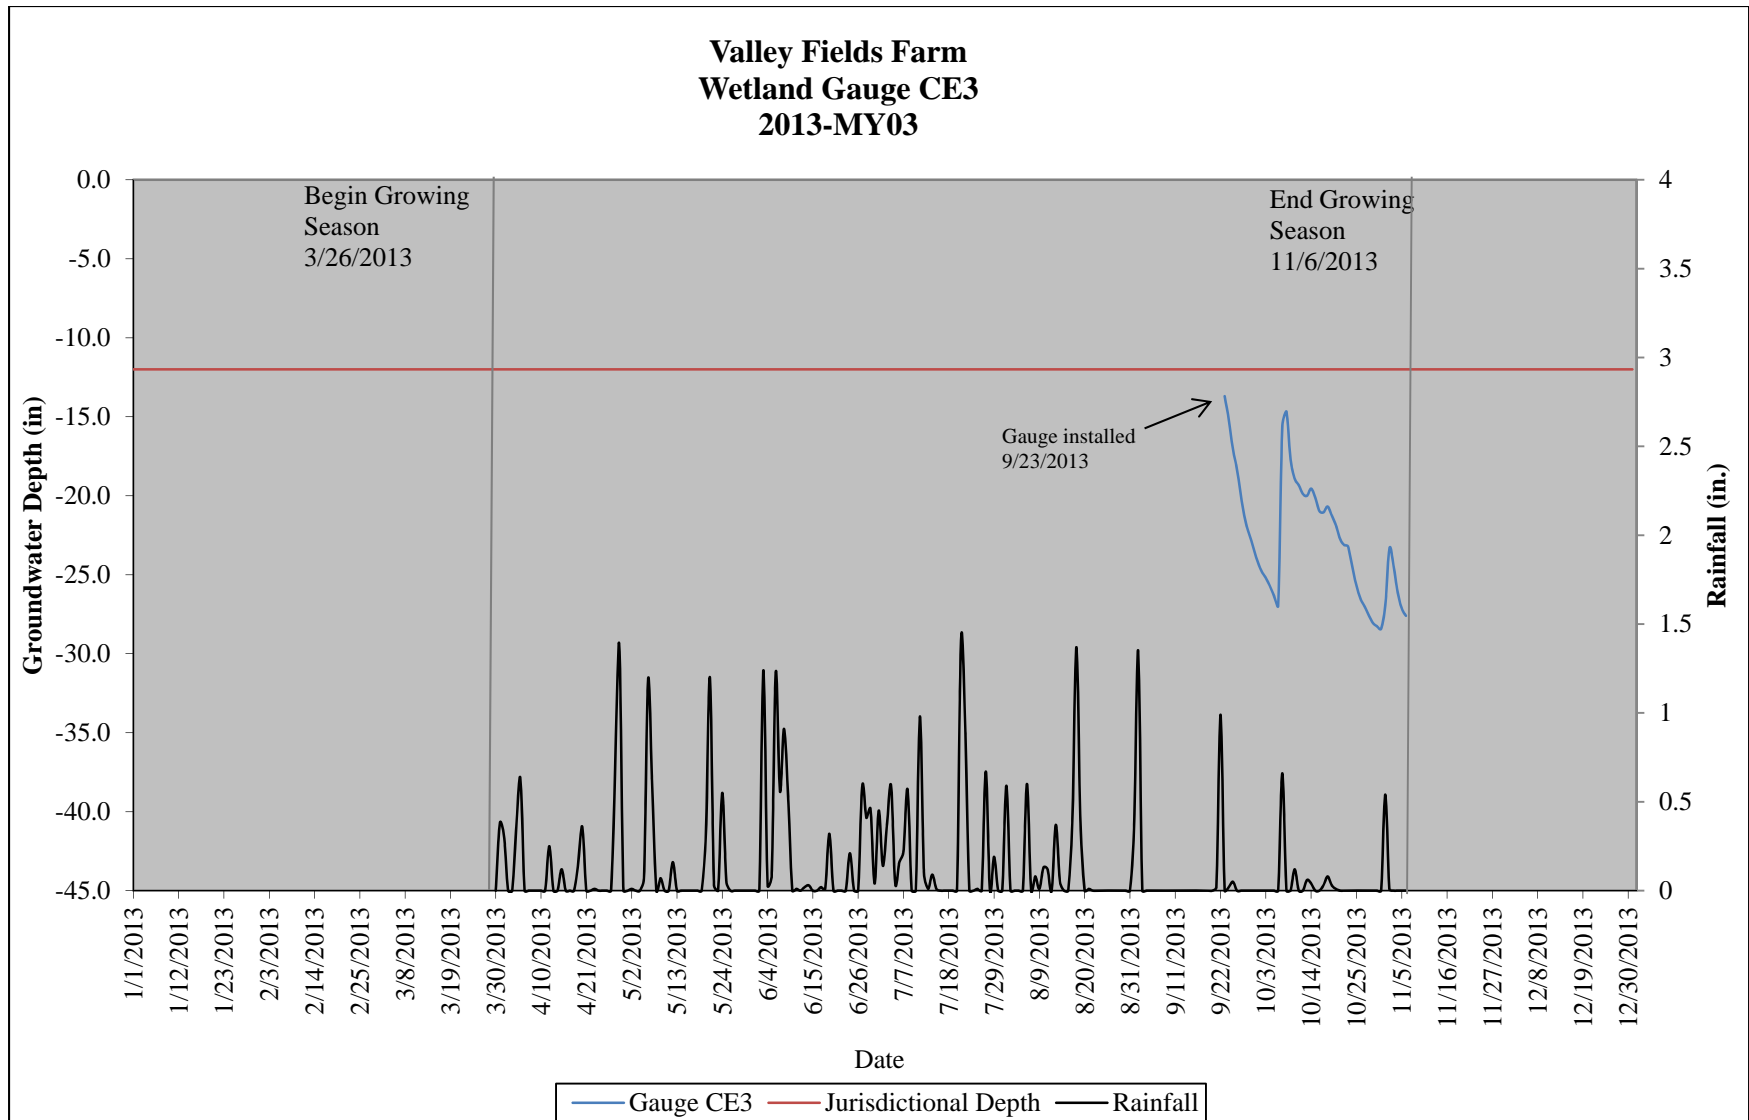
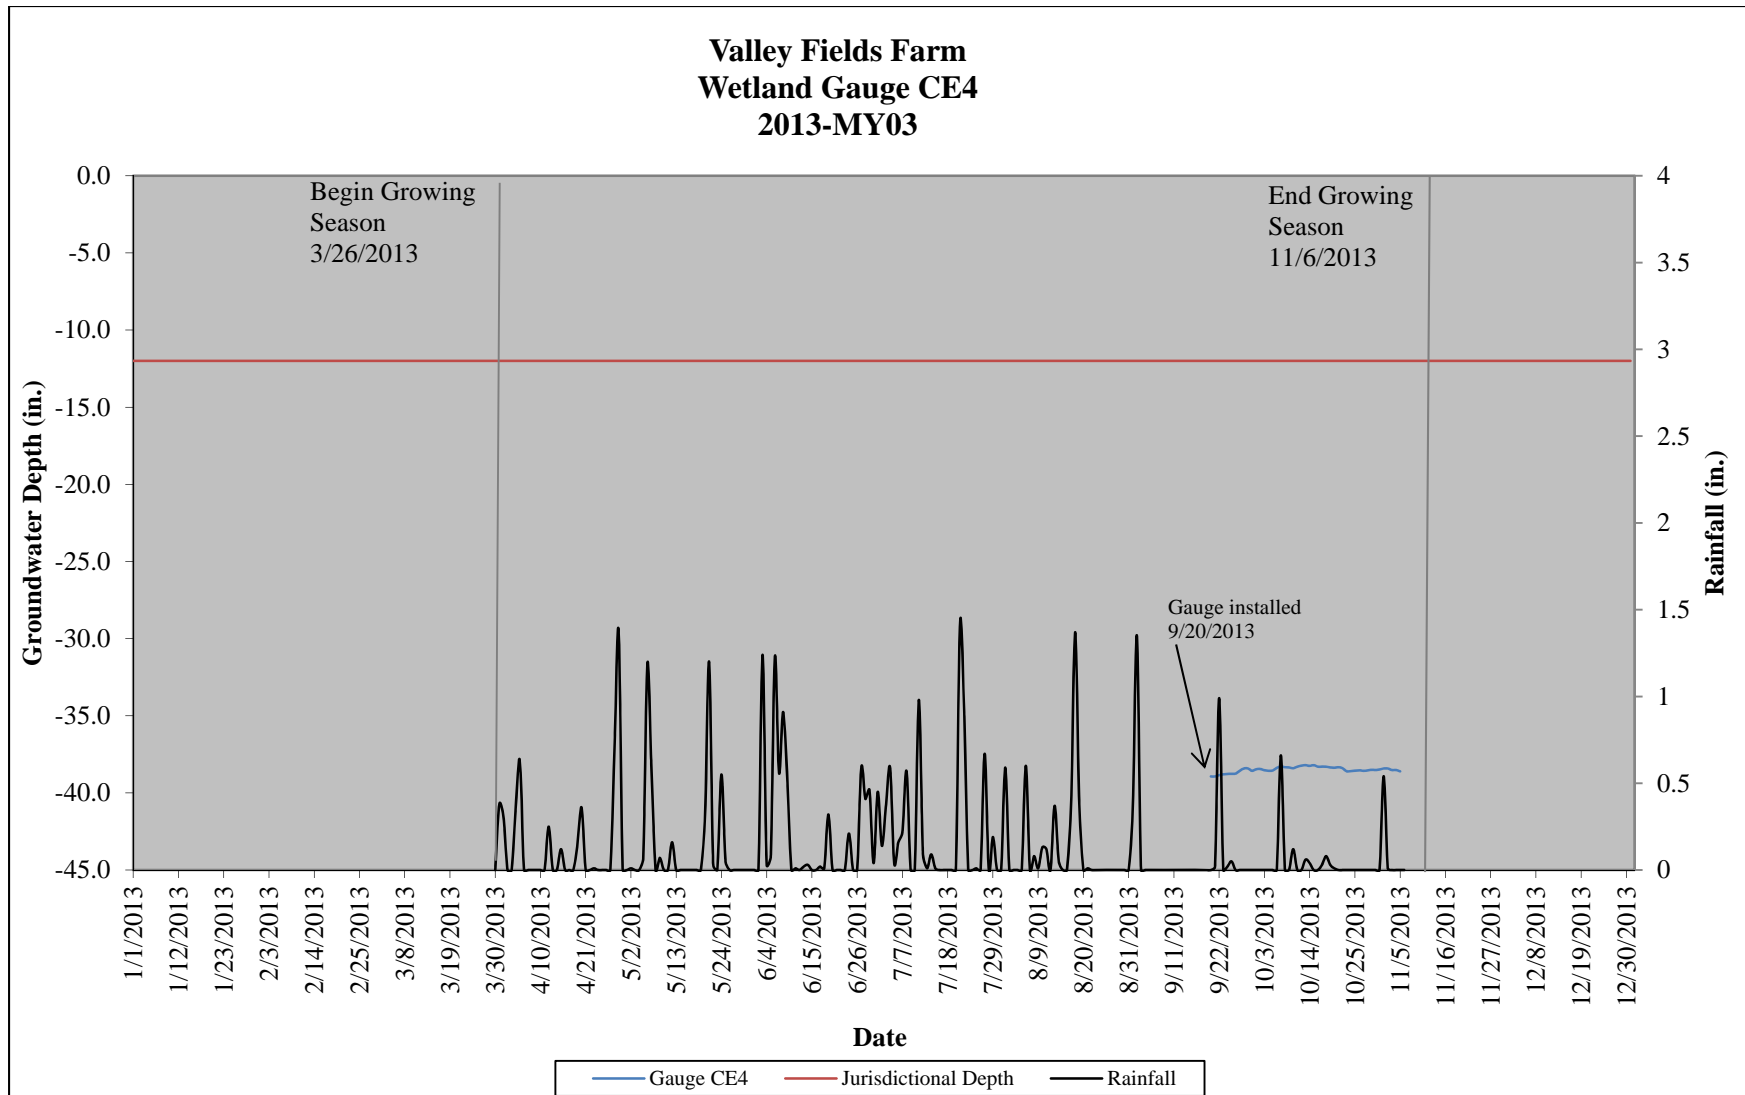
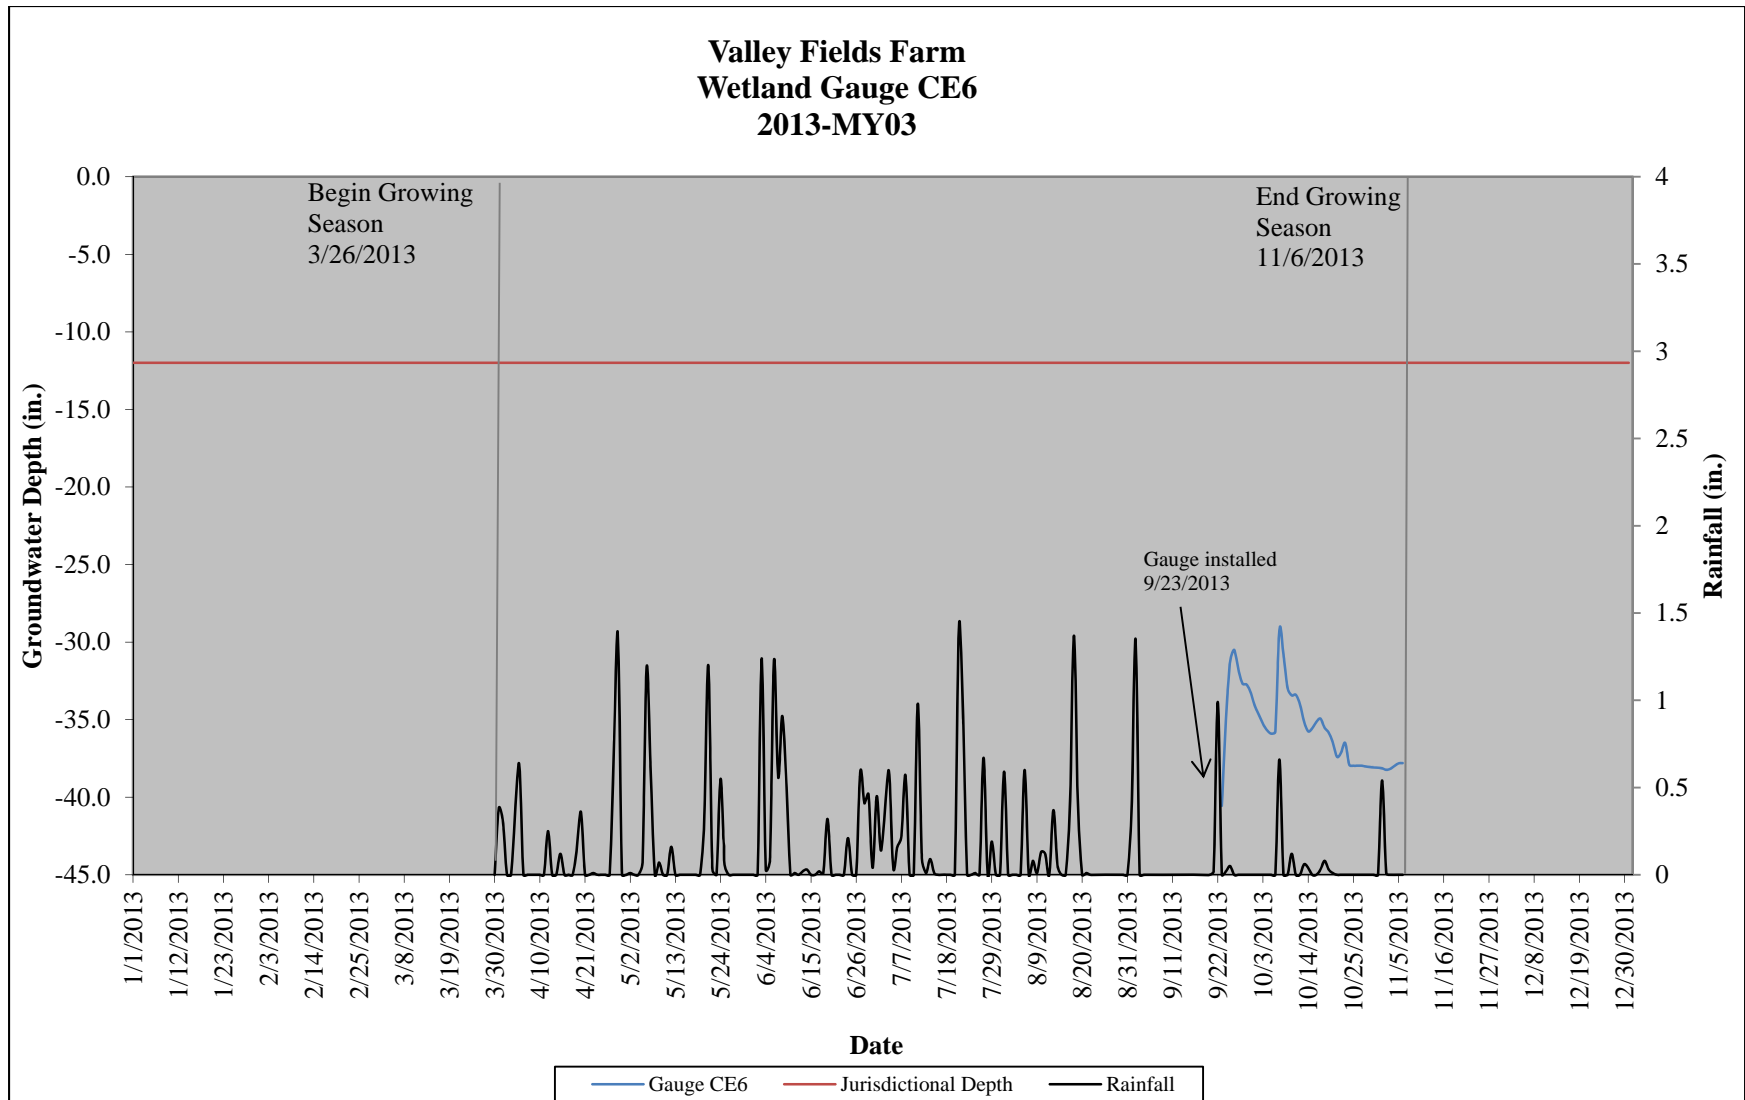
GROUNDWATER LEVEL MONITORING WELL PLOTS

\*Gauges reinstalled 9/23/2013, monitoring only occurred for 21% of growing season
