Valley Fields Farm Stream Restoration Project

Monitoring Report: Year 05

Davidson County, North Carolina
Upper Yadkin River Basin
Cataloging Unit 030401030
DMS Project ID #407

December 2015

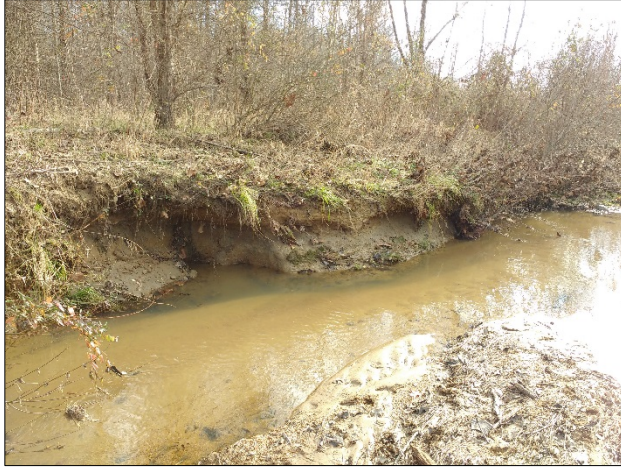
Bank erosion (Station 55+00) – 12/7/2015

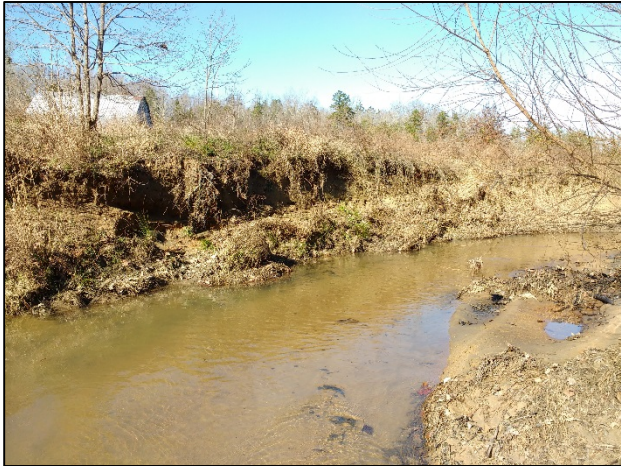
Bank erosion (Station 95+75) – 12/7/2015

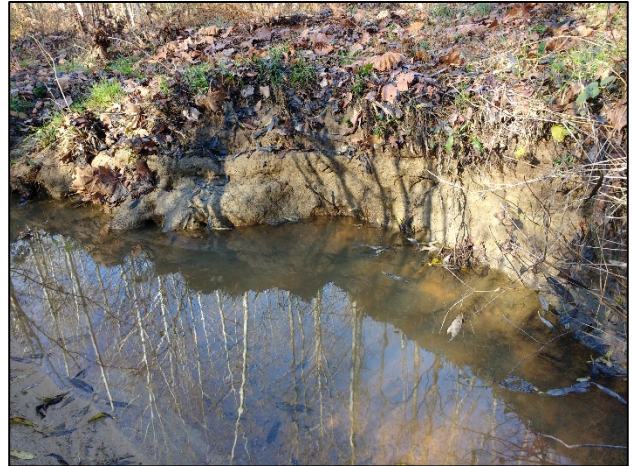
Bank erosion (Station 100+50) – 12/7/2015

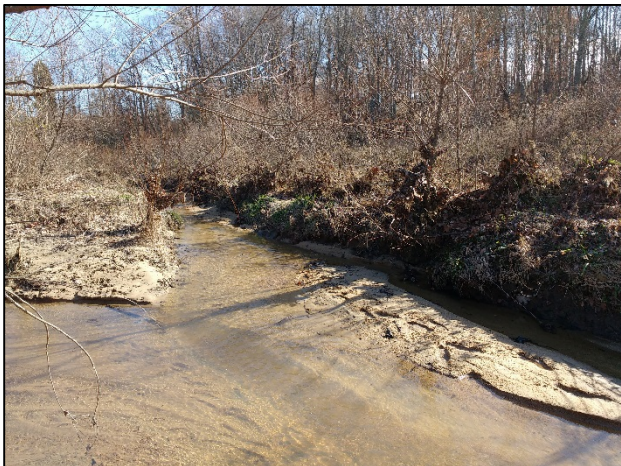
Deposition and bank aggradation (typical along Reaches A and B) – 12/7/2015
