MONITORING YEAR 6 ANNUAL REPORT

VILE CREEK MITIGATION SITE

Alleghany County, NC
DEQ Contract No. 5999
DMS Project No. 96582

Data Collection Period: April – October 2022
Submission Date: February 3, 2023

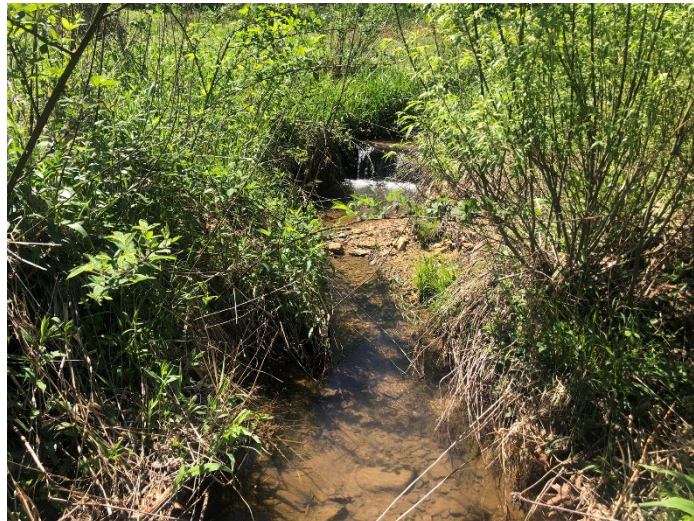
Photo Point 38 – UT1 Reach 1 stream realignment (2/11/2022)

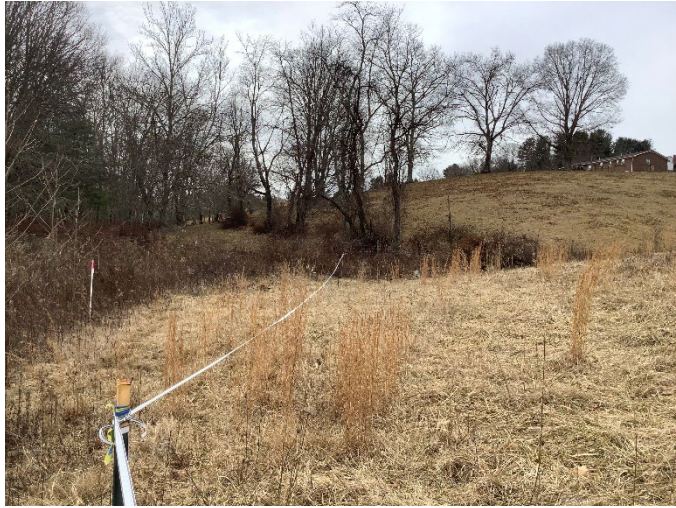
Wildlands Response: The Site was monitored for easement integrity in MY6. One easement encroachment was observed along the upstream section of UT1. Wildlands was informed of additional issues after a DMS easement inspection of the Site on October 12, 2022. In reference to listed action items, monument caps with missing markings will be stamped in MY7 by the contracted surveyor per agency requirements. Wildlands will repair damaged fencing along UT1 Reach 2 and the damaged sign along UT1c. There was no vegetation trimming observed around the mobile deer stand in the easement along Vile Creek Reach 2 and no damage due to easement access. An explanation of UT1 and UT2 easement concerns is available in the comment response below. Wildlands will continue to closely monitor these areas and conduct detailed easement inspections in MY7. Refer to Appendix 2 for encroachment details and Appendix 6 for email correspondence.

UT1 R1: Easement encroachment- additional signage and horse tape added in January 2023
