AS-BUILT BASELINE MONITORING REPORT

VILE CREEK MITIGATION SITE

Alleghany County, NC
DEQ Contract No. 5999
DMS Project No. 96582
DWR No. 14-0869
USACE Action ID 2014-01585

Data Collection Period: February - May 2017
Final Submission Date: June 14, 2017

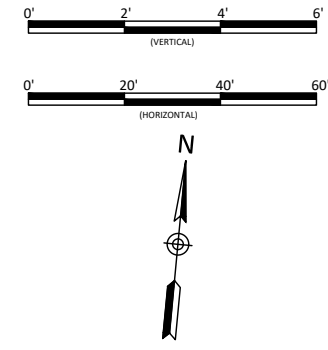
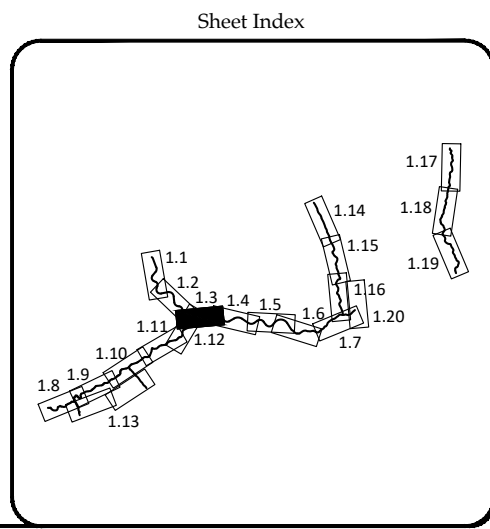
NOTE:
 SOD MATS ADDED ON MOST BANKS WHERE NO BANK REVETMENTS EXIST.
 ALIGNMENT REVISION IN FIELD TO UTILIZE AND MAINTAIN BEDROCK.
 STA: 109+64 - 110+83

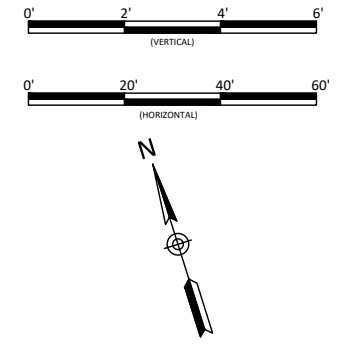
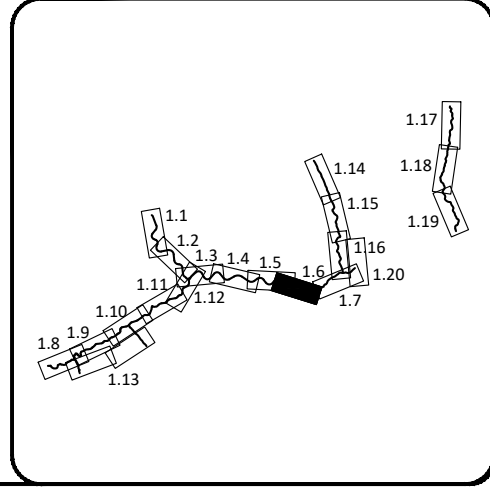
NOTE:
 STA: 126+00 - 127+50 - ADDITIONAL BANK GRADING PERFORMED AND BOULDER TOE ADDED ON LEFT BANK
 Sheet Index

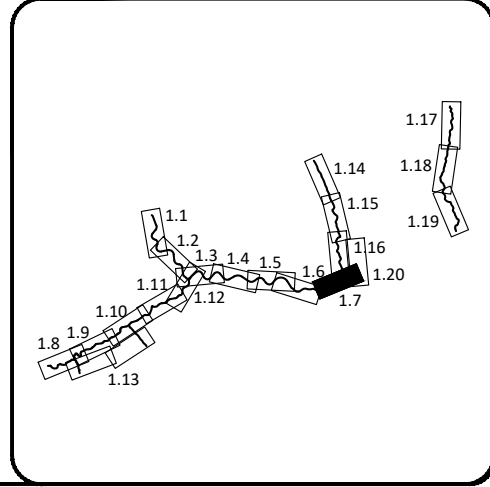
NOTE:
 STA: 126+00 - 127+50 - BANK GRADING ON LEFT BANK

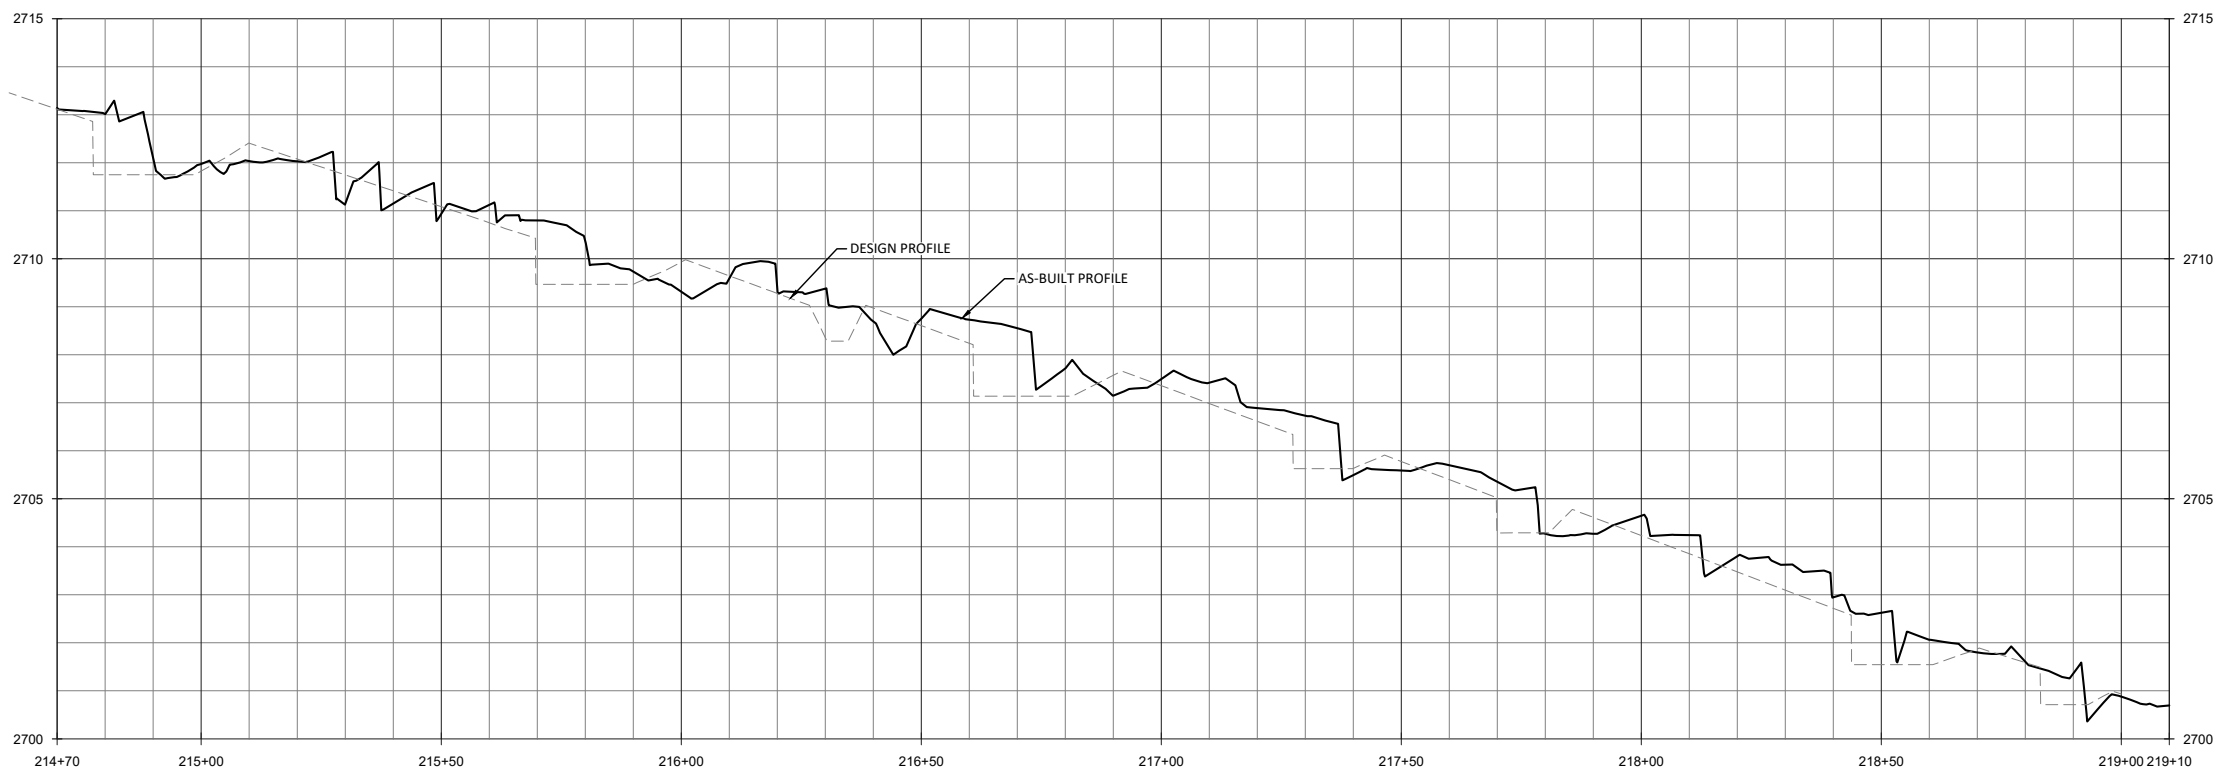
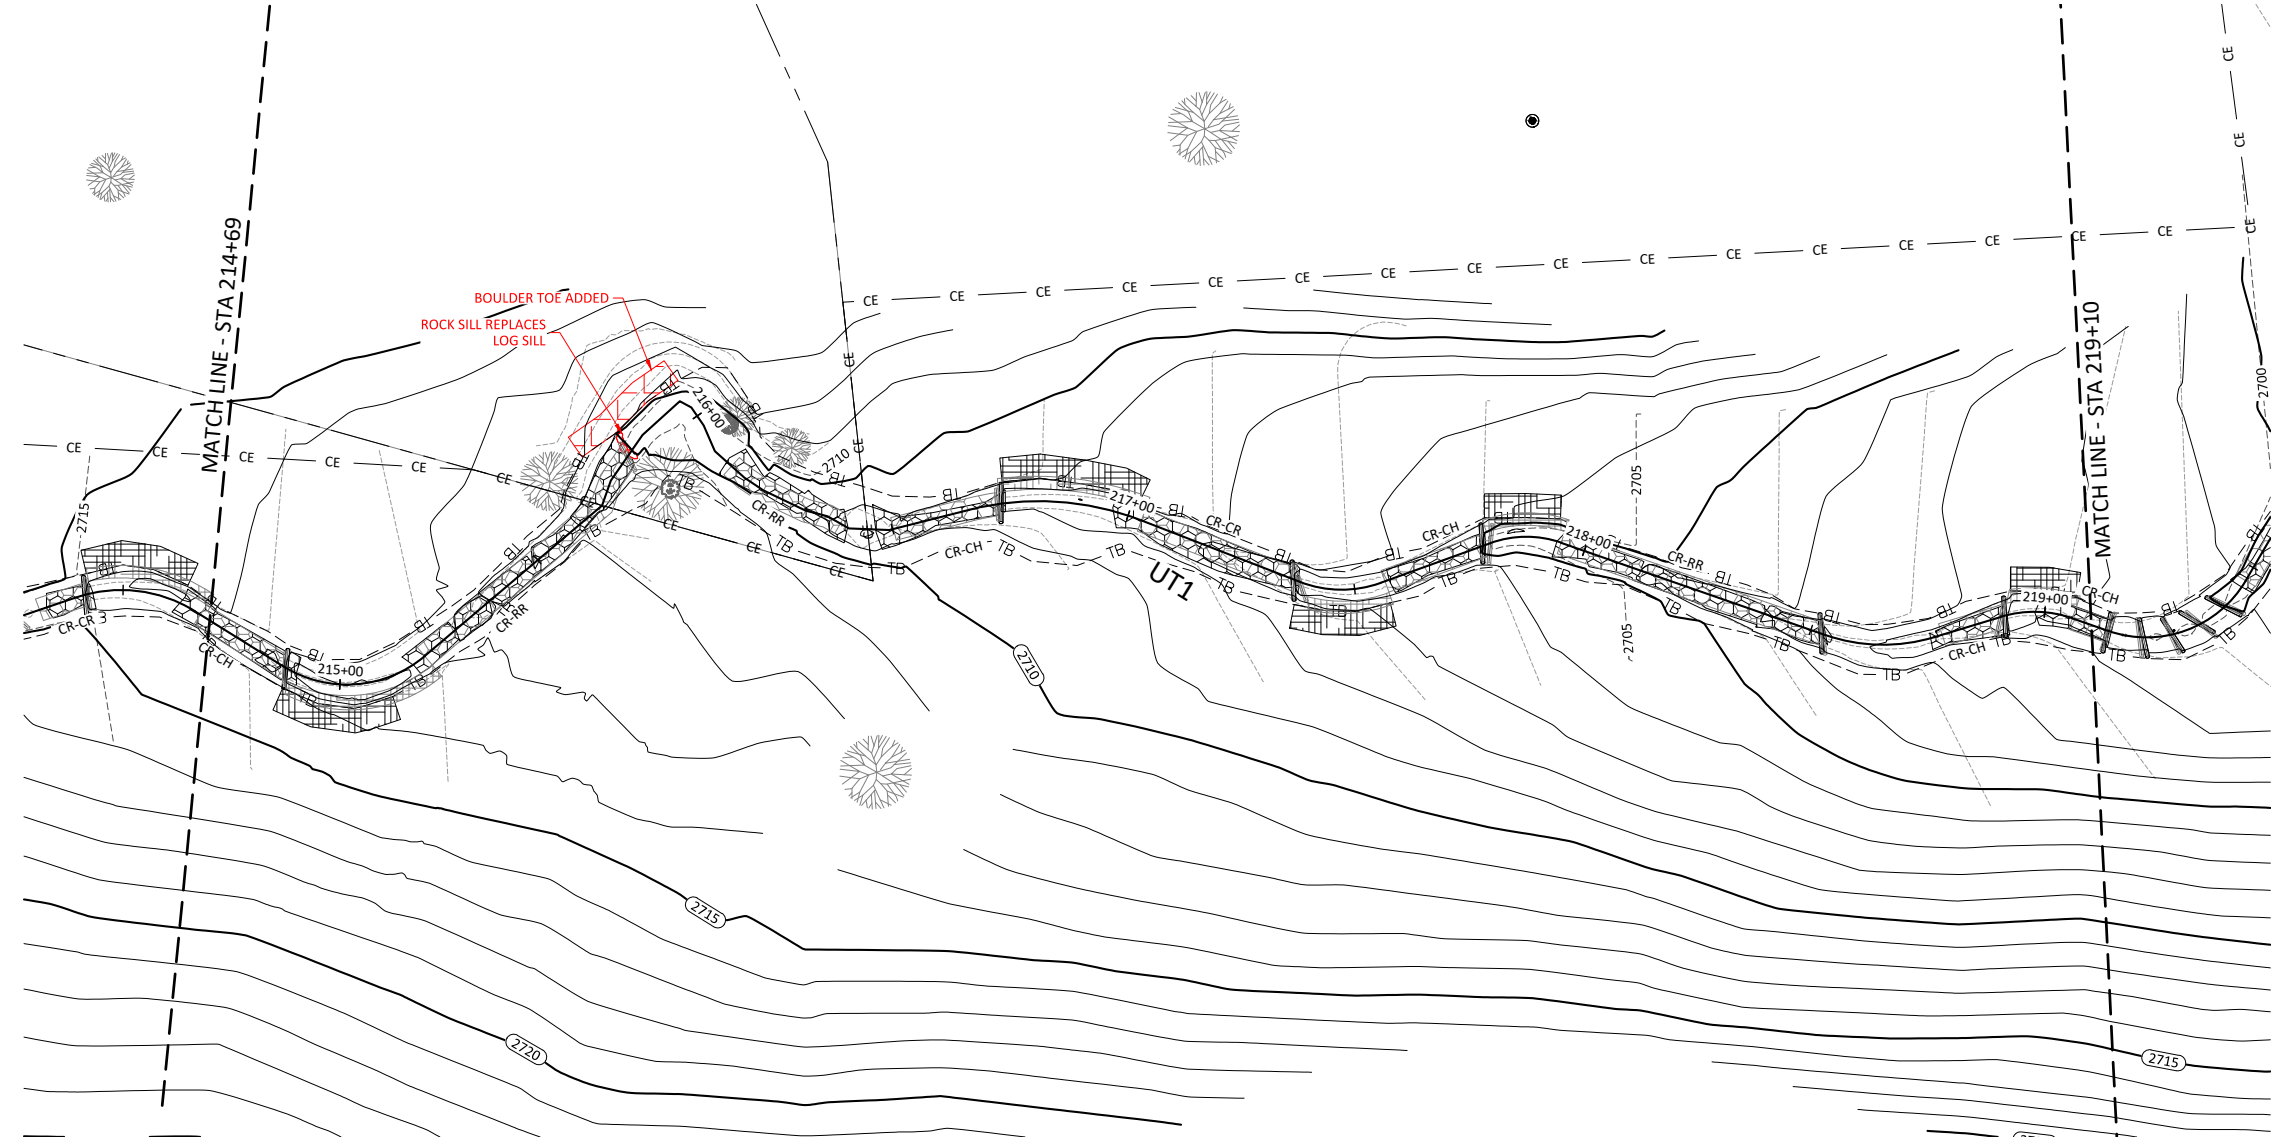
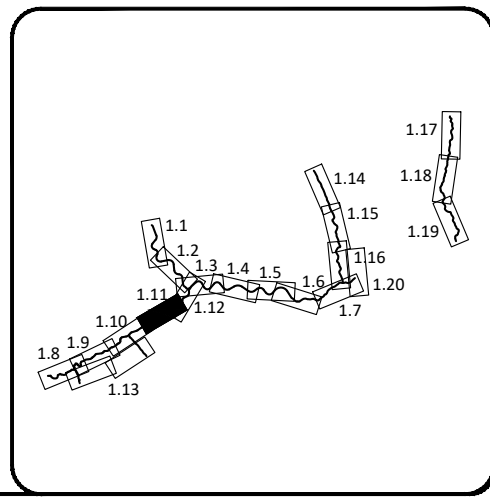
NOTE:
STARTING AT STA: 217+15 DOWNSTREAM - SOD MATS
ADDED ON MOST BANKS WHERE NO BANK
REVETMENTS EXIST.

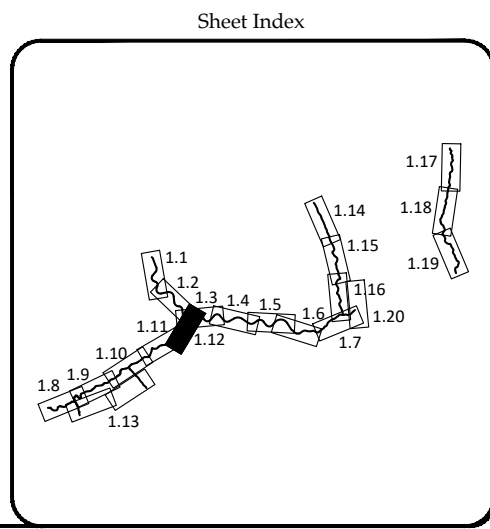
NOTE:
SOD MATS ADDED ON MOST BANKS WHERE NO BANK REVETMENTS EXIST.
STA: 220+69 - 221+28 - ALIGNMENT REVISION IN FIELD IN ORDER TO UTILIZE AND MAINTAIN BEDROCK

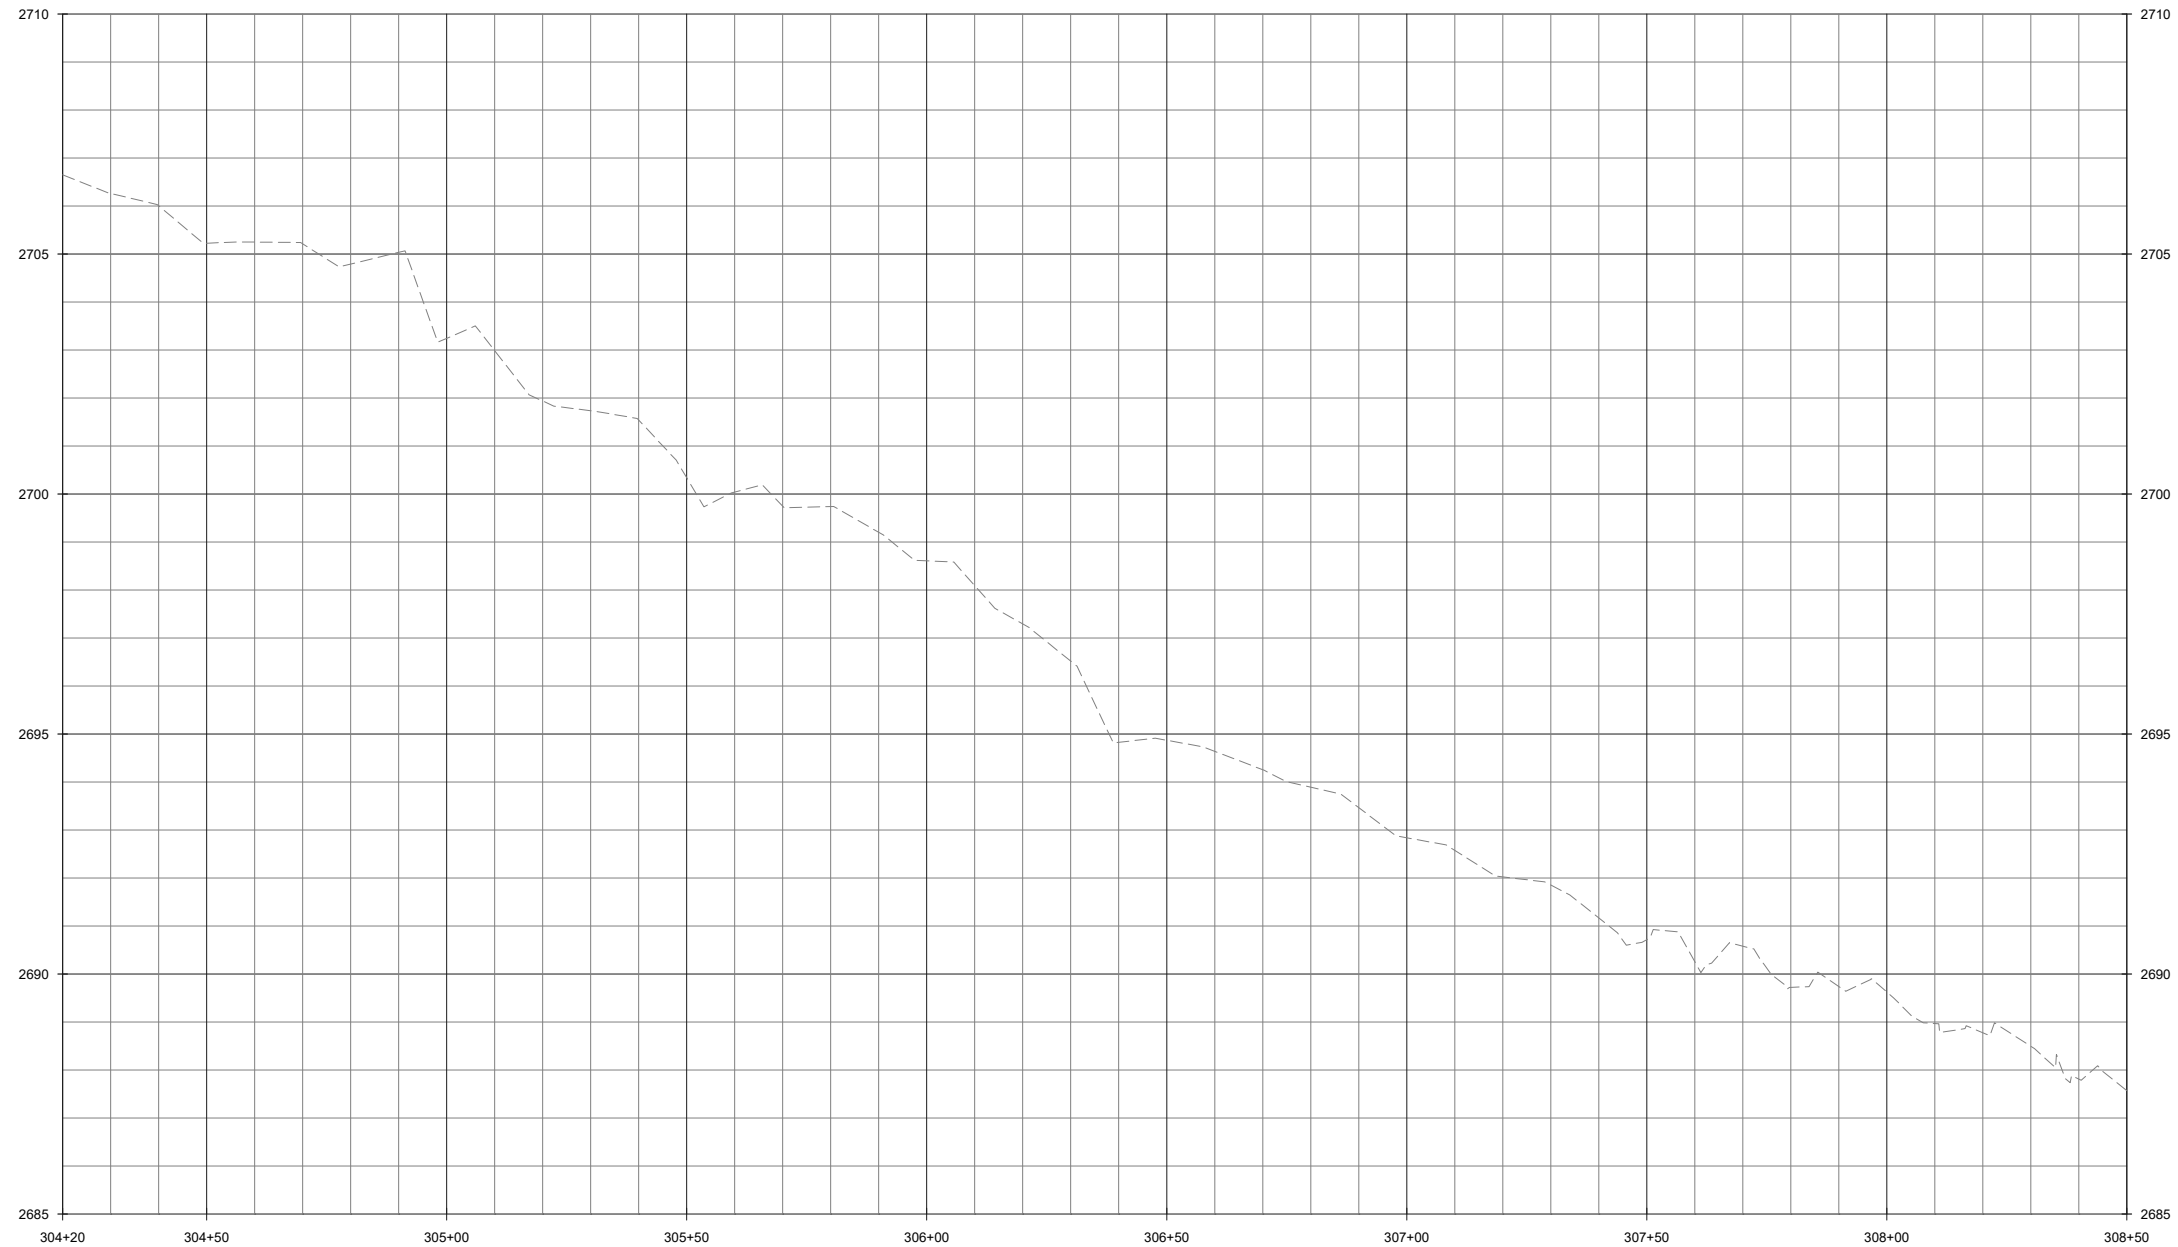
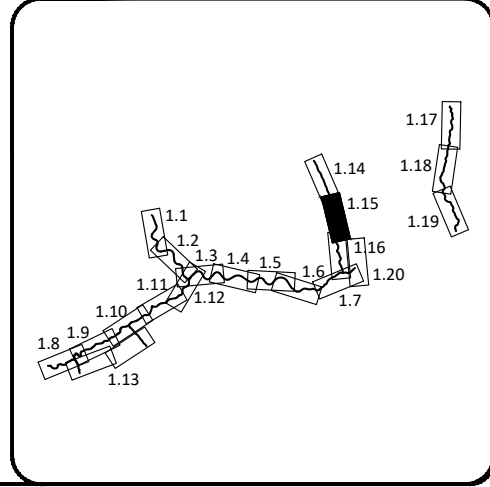
NOTE:
STA: 305+25 - 306+75 - BANK GRADING AND LIGHT MATTING ON RIGHT BANK
STA: 306+50 - BOULDER TOE ADDED TO LEFT BANK
STA: 307+00 - 307+50 - BANK GRADING AND LIGHT MATTING ON BOTH BANKS

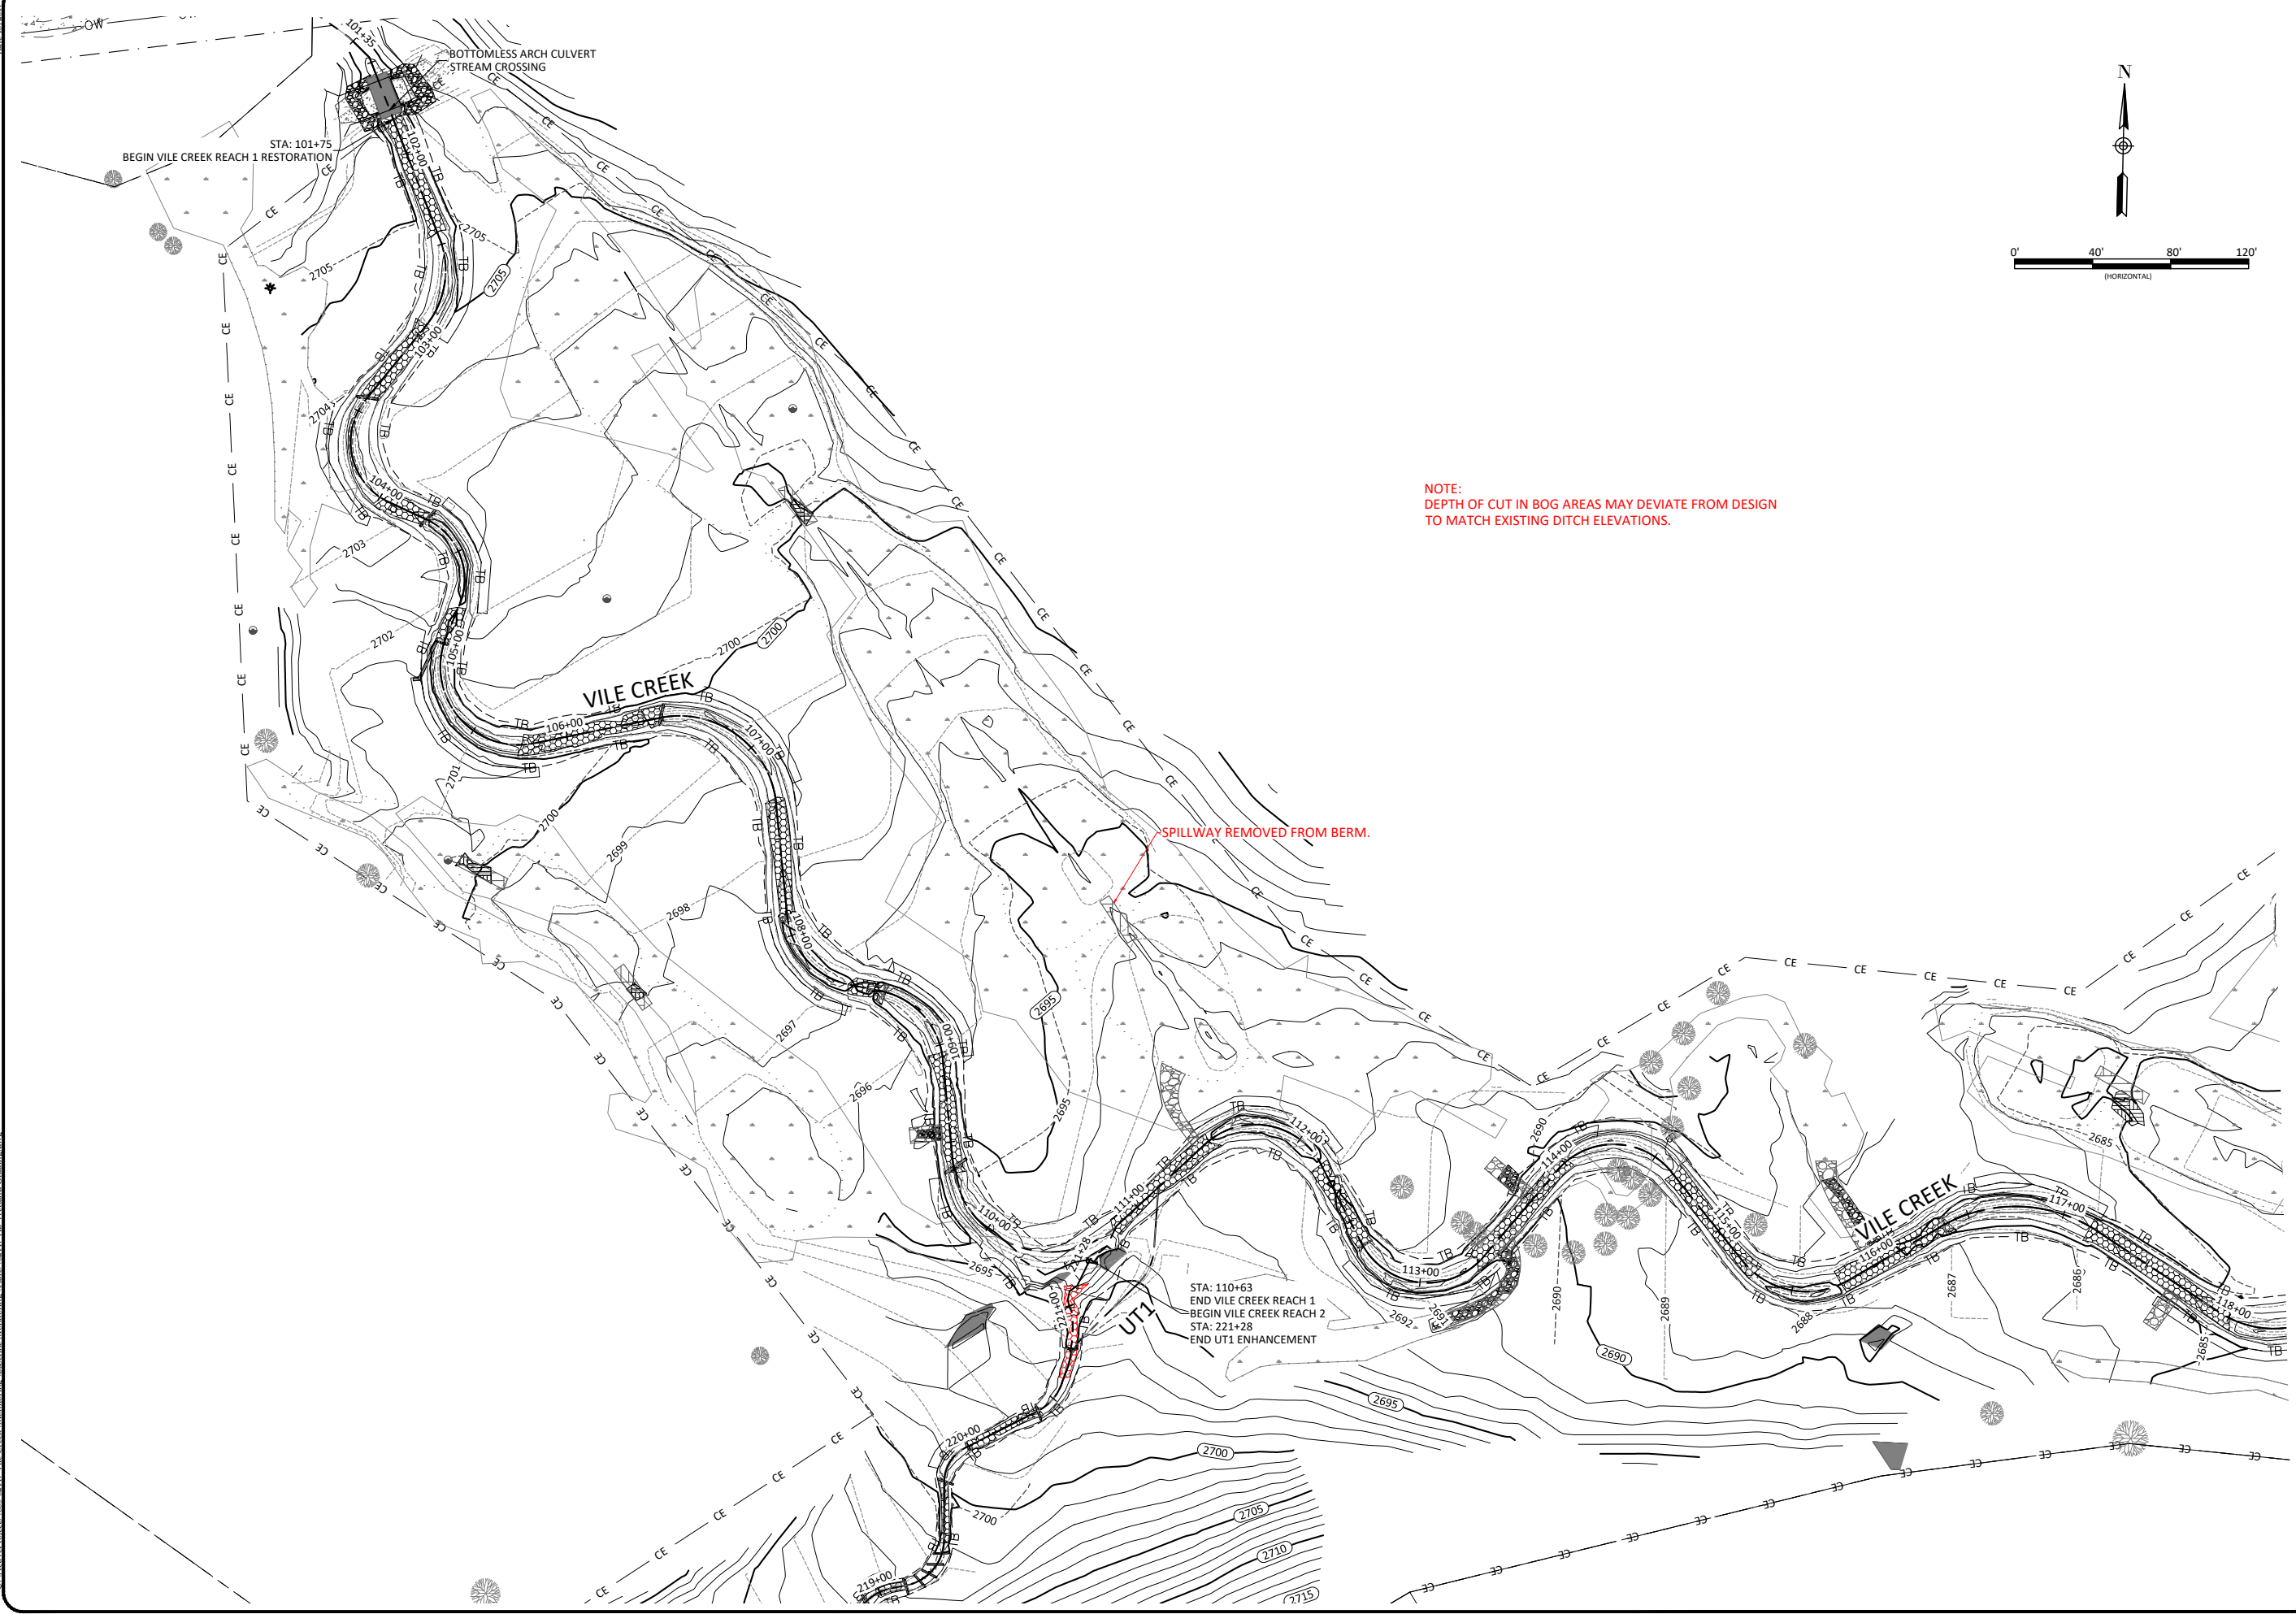
Vile Creek Mitigation Site Record Drawings
Allegheny County, North Carolina
Wetland Grading

NOTE:
DEPTH OF CUT IN BOG AREAS MAY DEVIATE FROM DESIGN
TO MATCH EXISTING DITCH ELEVATIONS.

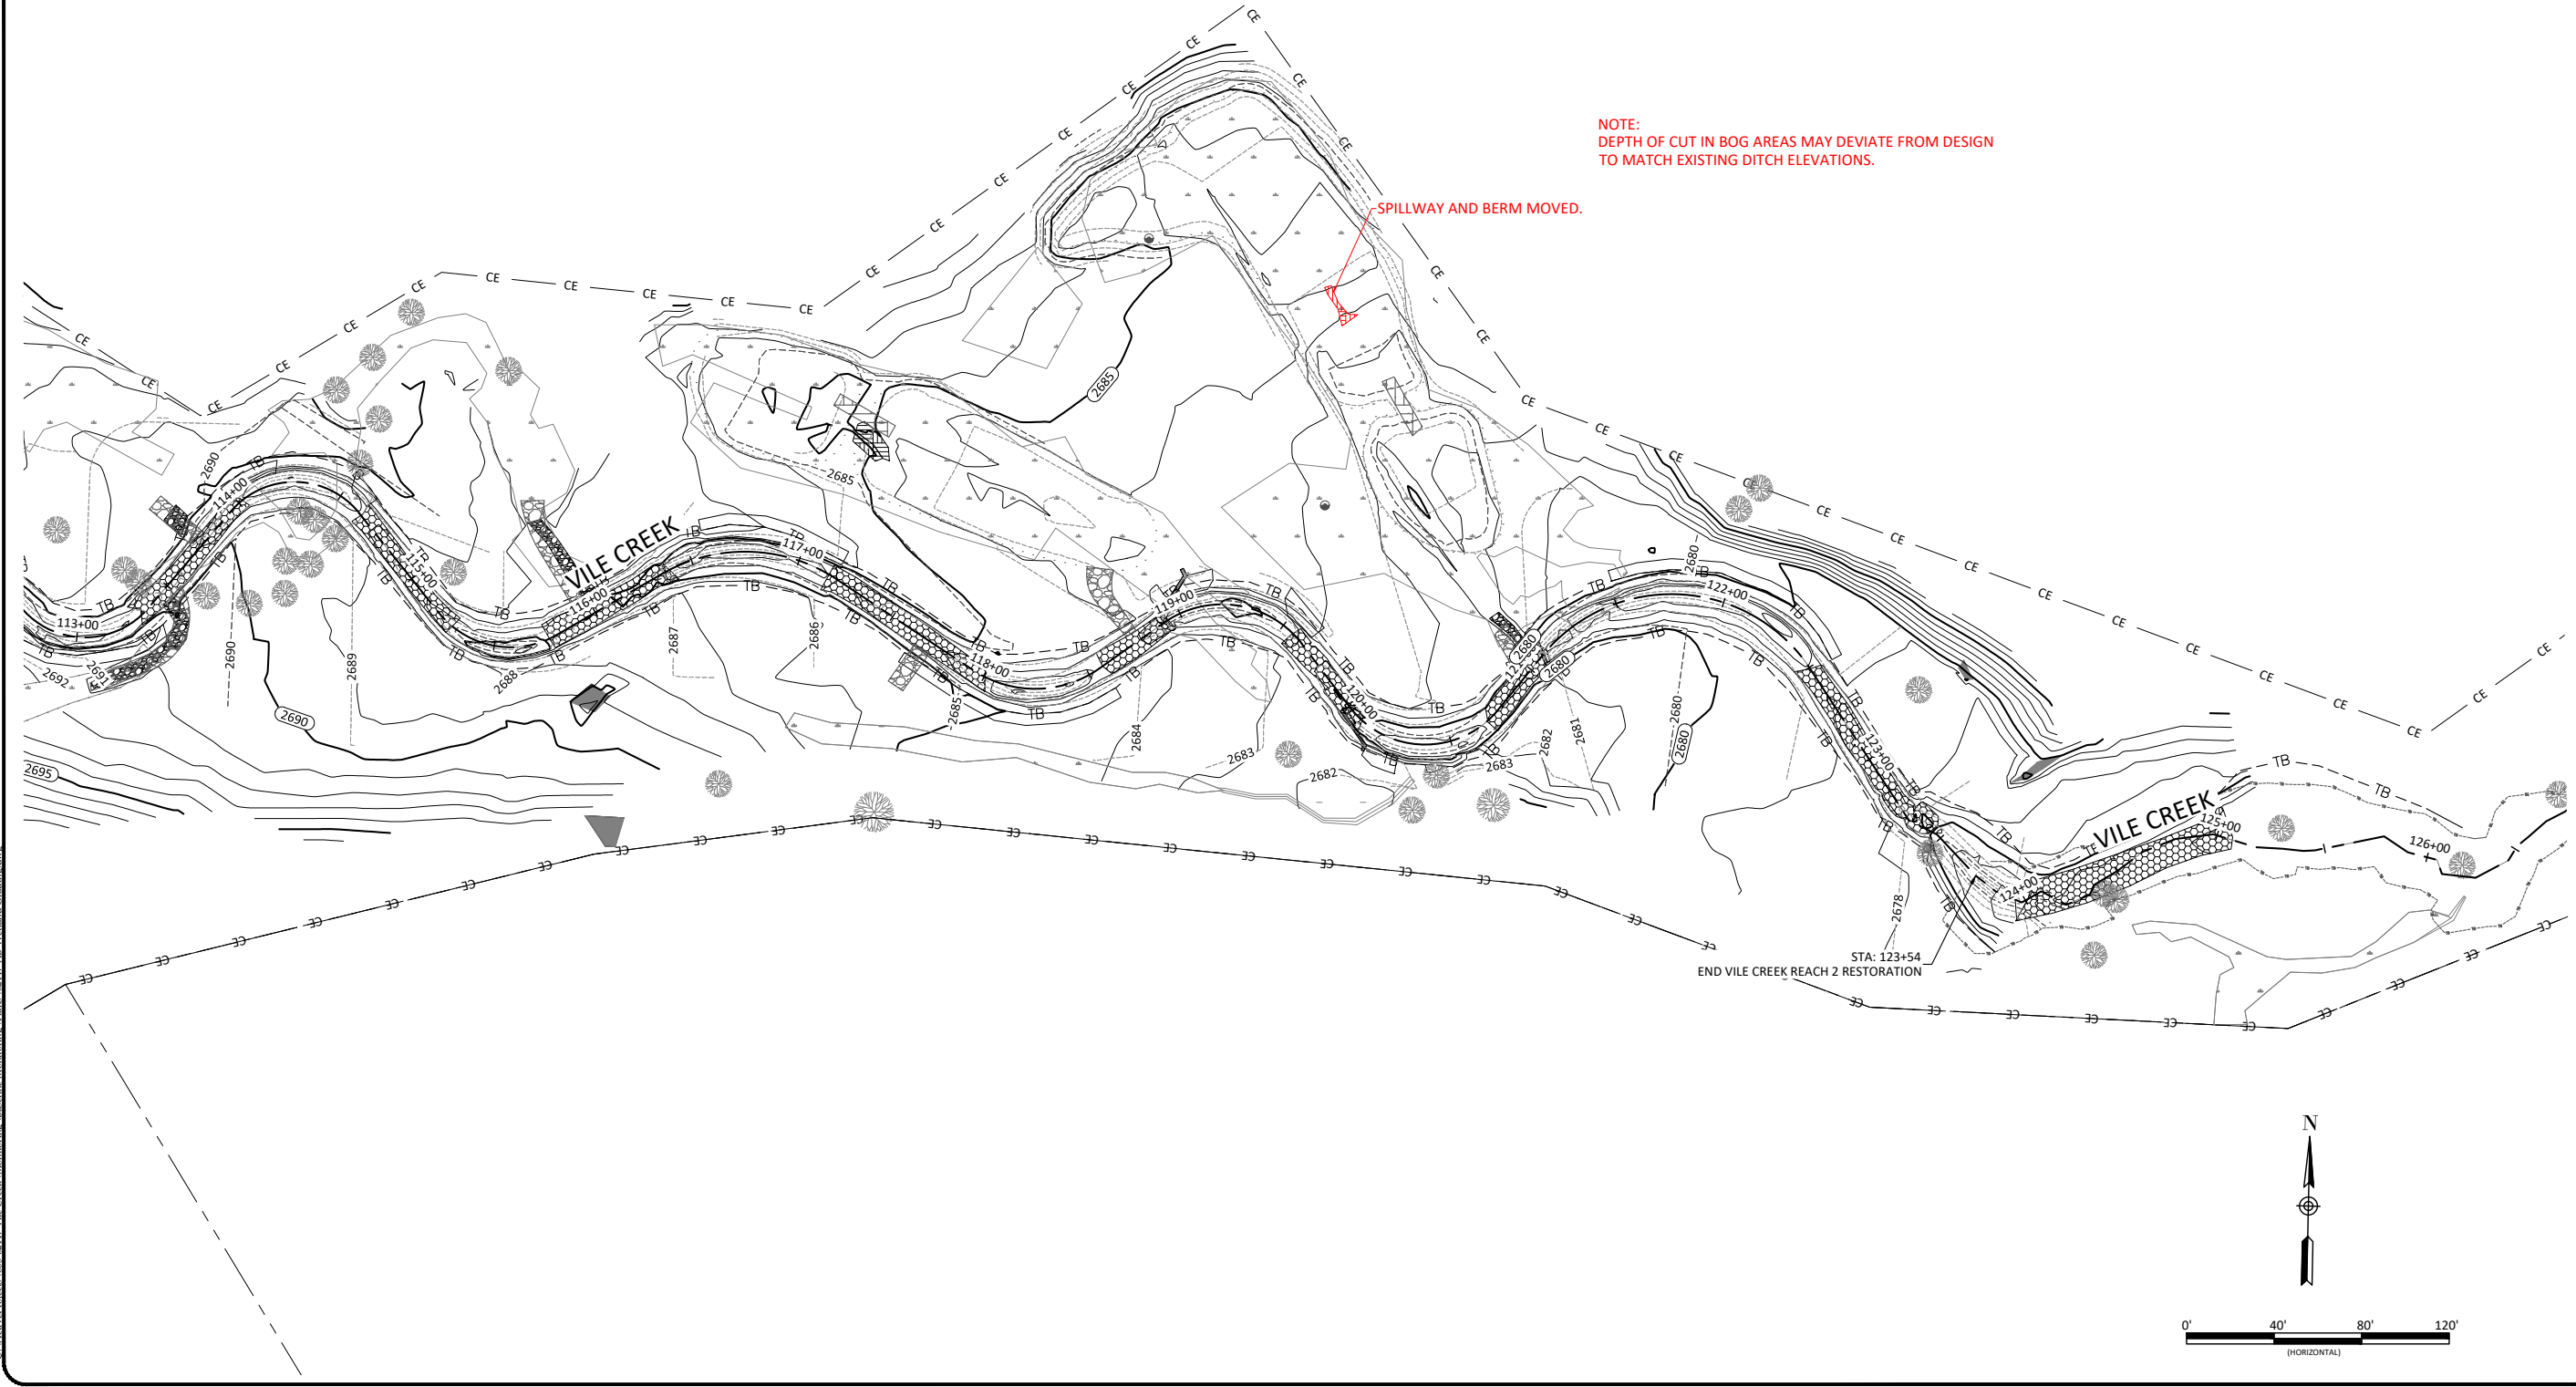
Vile Creek Mitigation Site Record Drawings
 Allegheny County, North Carolina
 Wetland Grading

NOTE:
 DEPTH OF CUT IN BOG AREAS MAY DEVIATE FROM DESIGN
 TO MATCH EXISTING DITCH ELEVATIONS.

SPILLWAY AND BERM MOVED.
