MONITORING YEAR 4 ANNUAL REPORT

VILE CREEK MITIGATION SITE

Alleghany County, NC
DEQ Contract No. 5999
DMS Project No. 96582

Data Collection Period: April – November 2020
Submission Date: January 19, 2021

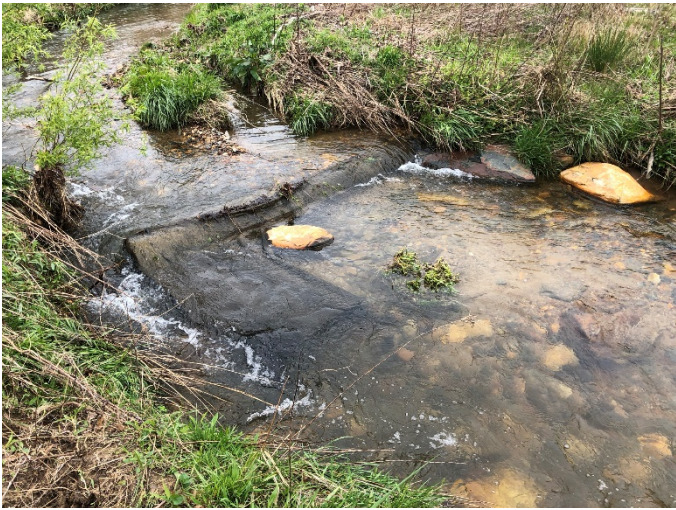
Photo 1 – Vile Creek R1: Station 103+90 – Right bank piping and scour around log sill. 4-14-2020

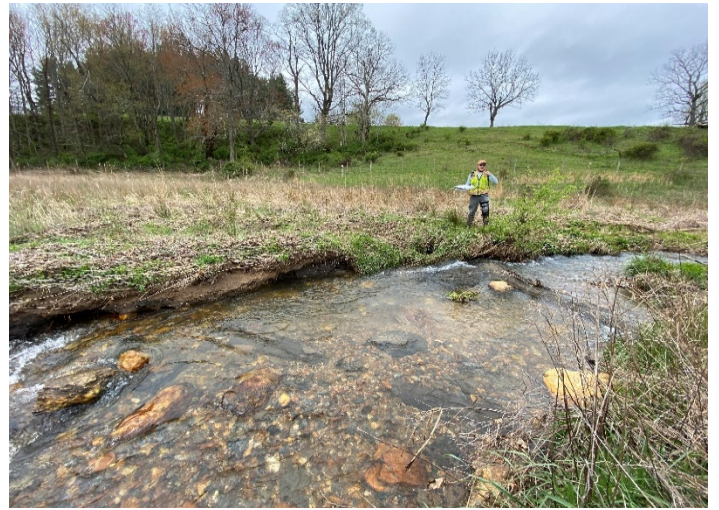
Overall, the streams are geomorphically stable and riparian and wetland vegetation is performing well. However, isolated stream and vegetation problem areas do exist on-site. The following areas are experiencing localized bank instability and include: Vile Creek Reach 1 station 103+90-104+20, Vile Creek Reach 2 stations 118+50-118+80, 120+70-121+00, and 122+80-123+00, UT1 Reach 1 station 206+40-206+60, UT2 stations 305+00-305+50, 306+30-306+70, and 310+00-310+15. Localized areas of aggradation along enhancement II reaches, UT2 (Stations 309+70 (32'), UT1b (station 251+20 (51')), and UT1c (Station 271+50 (115')), have resulted in sheet flow onto the floodplain rather than maintaining flow within a single thread channel. The stormwater best management practice (BMP) at the top of UT2 has formed a headcut at the intake from a natural crenulation flowing into the BMP. An area of instability along UT1 Reach 1 (Station 205+10-205+60) that was previously mention in the MY3 report, naturally realigned itself (Approximately 21-feet) in MY4; thereby, abandoning an existing meander bend and creating an ox bow. The newly created channel appears to be stable and will be closely monitored for instability. If necessary, soil amendments and live stakes will be added to the abandoned oxbow channel, see areas of concern photos 7 & 8. Stream structures currently failing include: Log sill UT1 Reach 1 station 204+90, Rock Sill UT1 Reach 2 station 220+98, and Log sill Vile Creek Reach 1 station 104+10. Wildlands plans to address areas of localized bank instability across the Site and further evaluate headcut/s, structure failures, and aggradational areas of concern during winter 2020/2021. All completed repairs will be included in MY5 monitoring report.

Photo 2 – Vile Creek R1: Station 103+90-104+20 – Right bank scour and piping around structures in constructed riffle. 4-14-2020

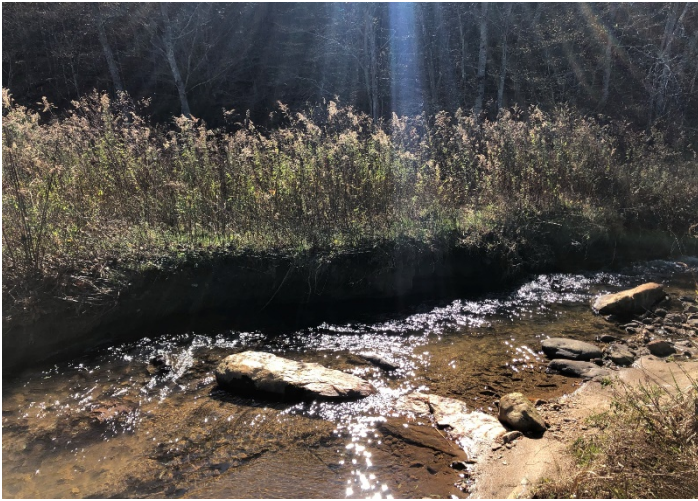
Photo 3 – Vile Creek R2: Station 118+50 – 118+80 – Bank scour. 11-6-2020

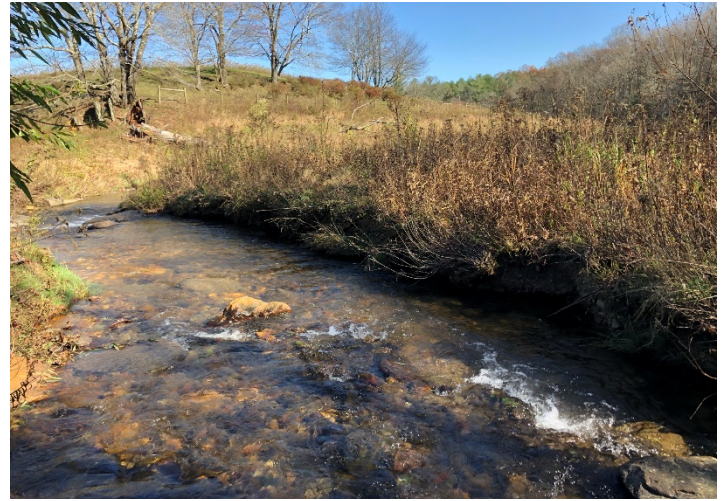
Photo 4 – Vile Creek R2: Station 120+70-121+00 – Bank scour. 11-6-2020

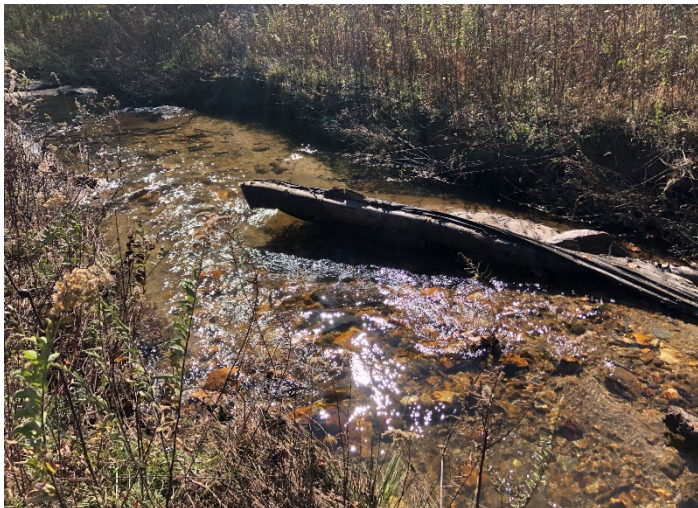
Photo 5 – Vile Creek R2: Station 122+80-123+00 – Bank scour. 11-6-2020

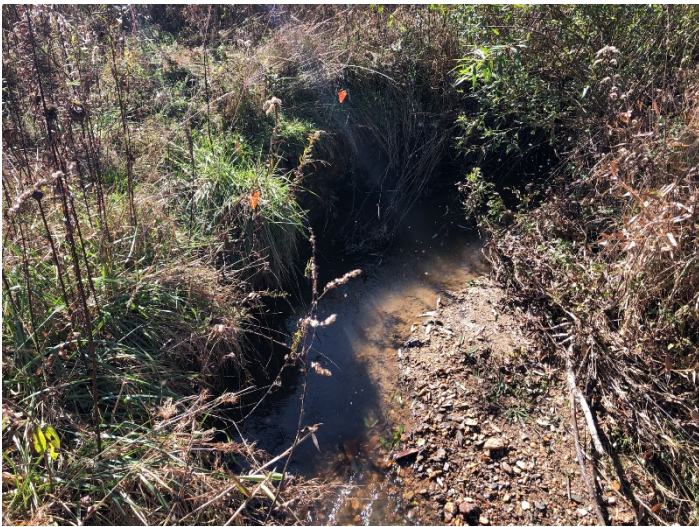
Photo 9 – UT1 R1: Station 206+40 – 206+60 – Bank Scour 11-6-2020

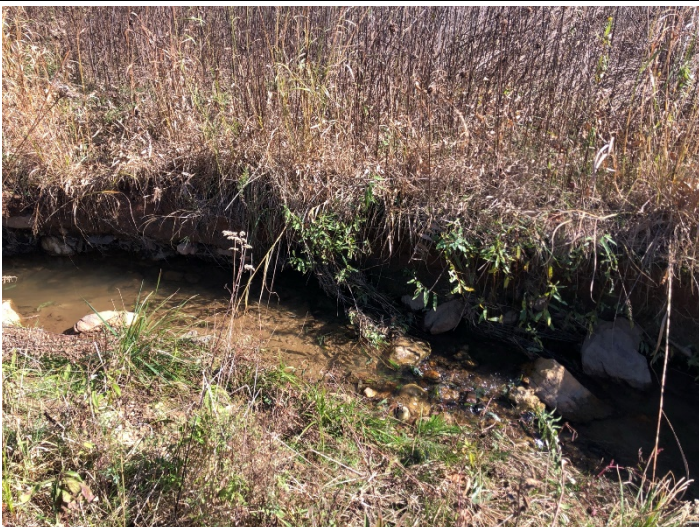
Photo 11 – UT2: Station 305+00 – 305+50 – Bank scour. 11-6-2020

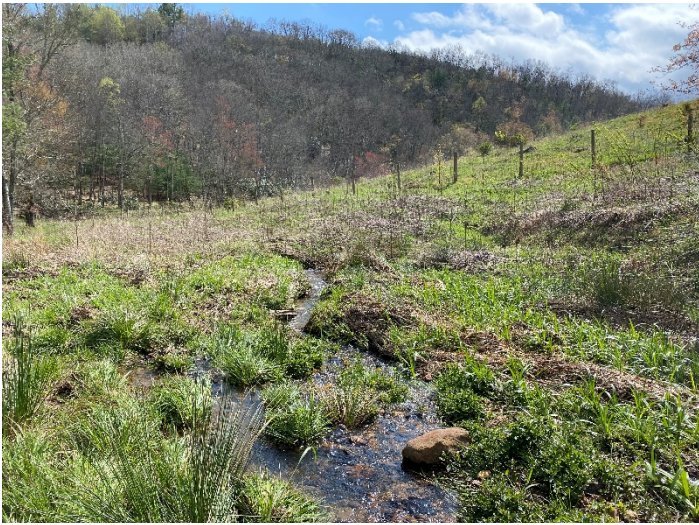
Photo 13 – UT2 Station 309+70: Stream aggradation. 4-14-2020

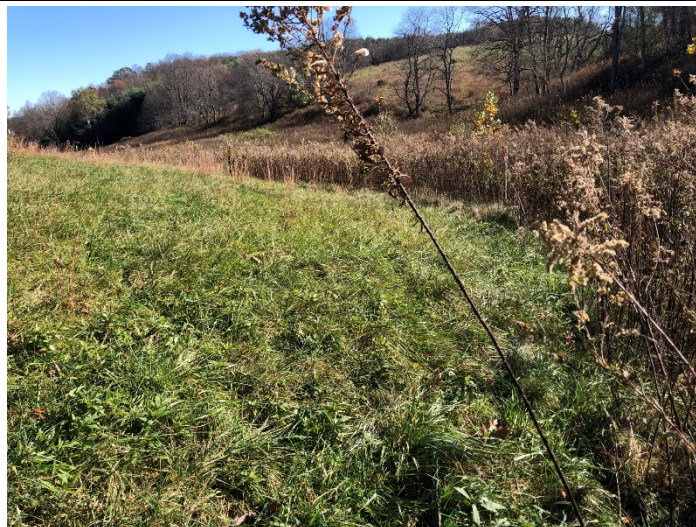
Photo 17 – UT1 R1: Easement encroachment. 11-6-2020
