**Horse Creek Stream Restoration
Mitigation Plan (Baseline Monitoring)
Wake County, North Carolina**

**North Carolina Department of Environment and Natural Resources
Ecosystem Enhancement Program**

August 14, 2006

**NCEEP Project # 182
Dewberry Project # 02050**

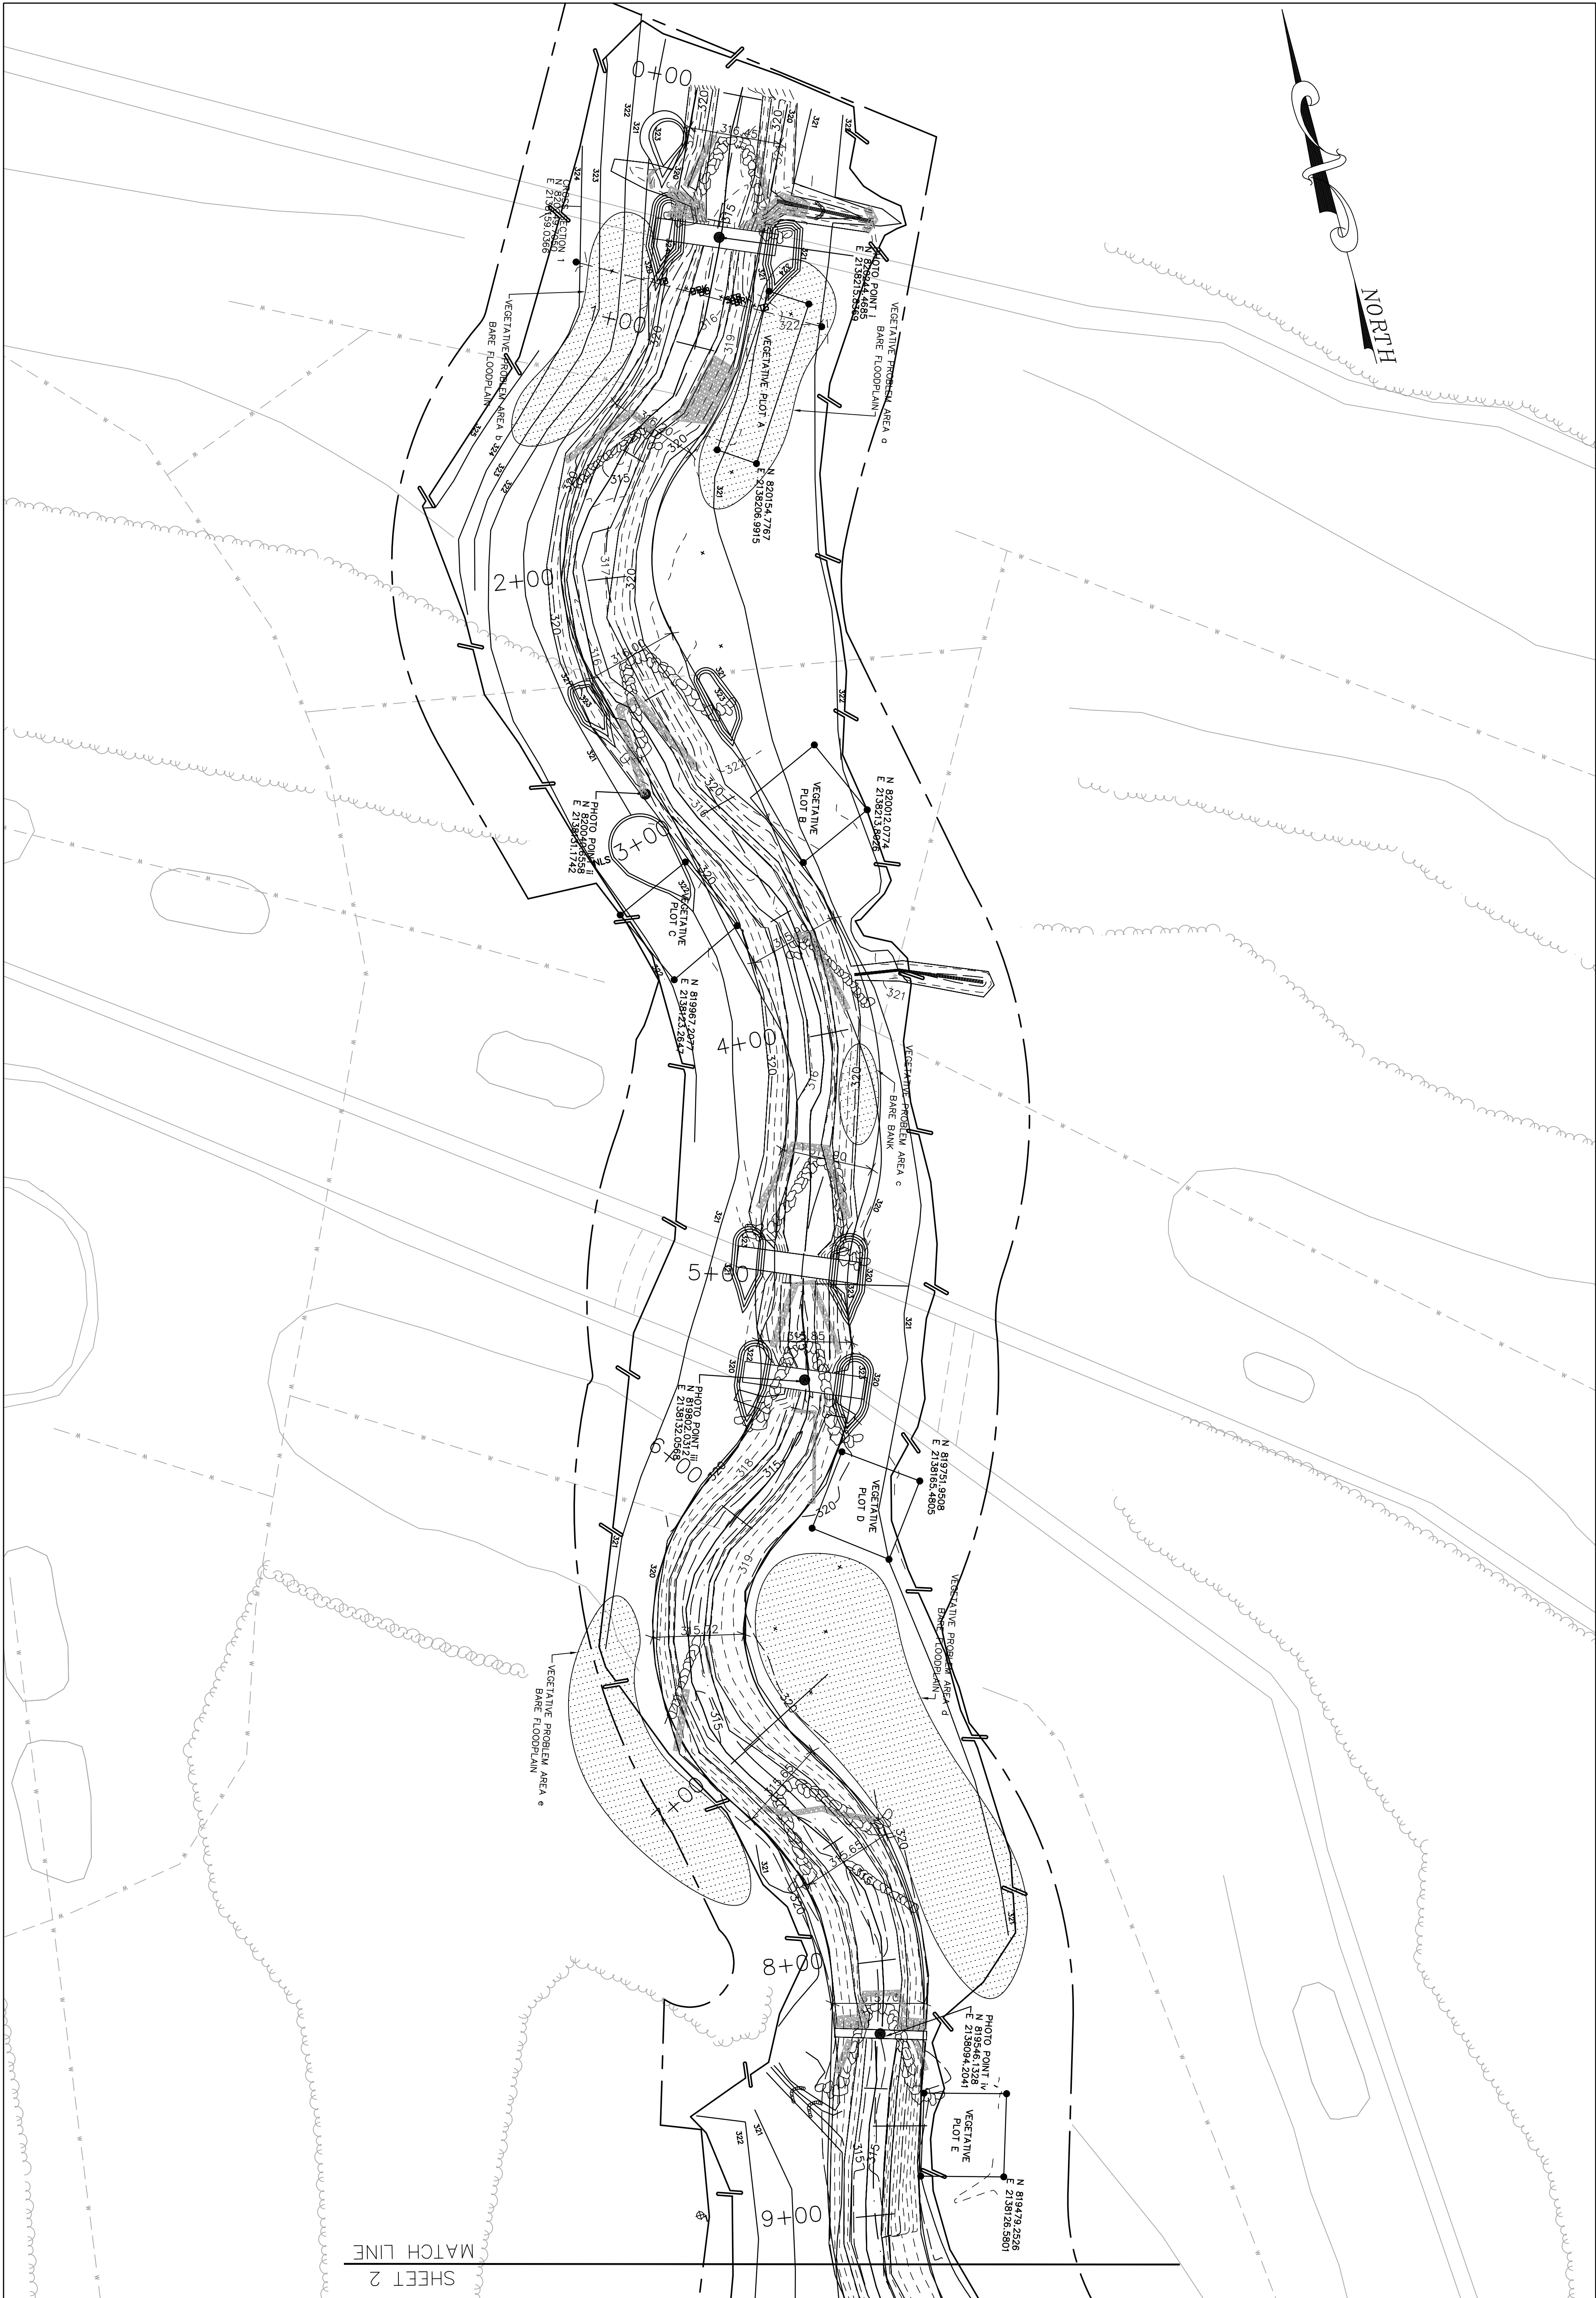
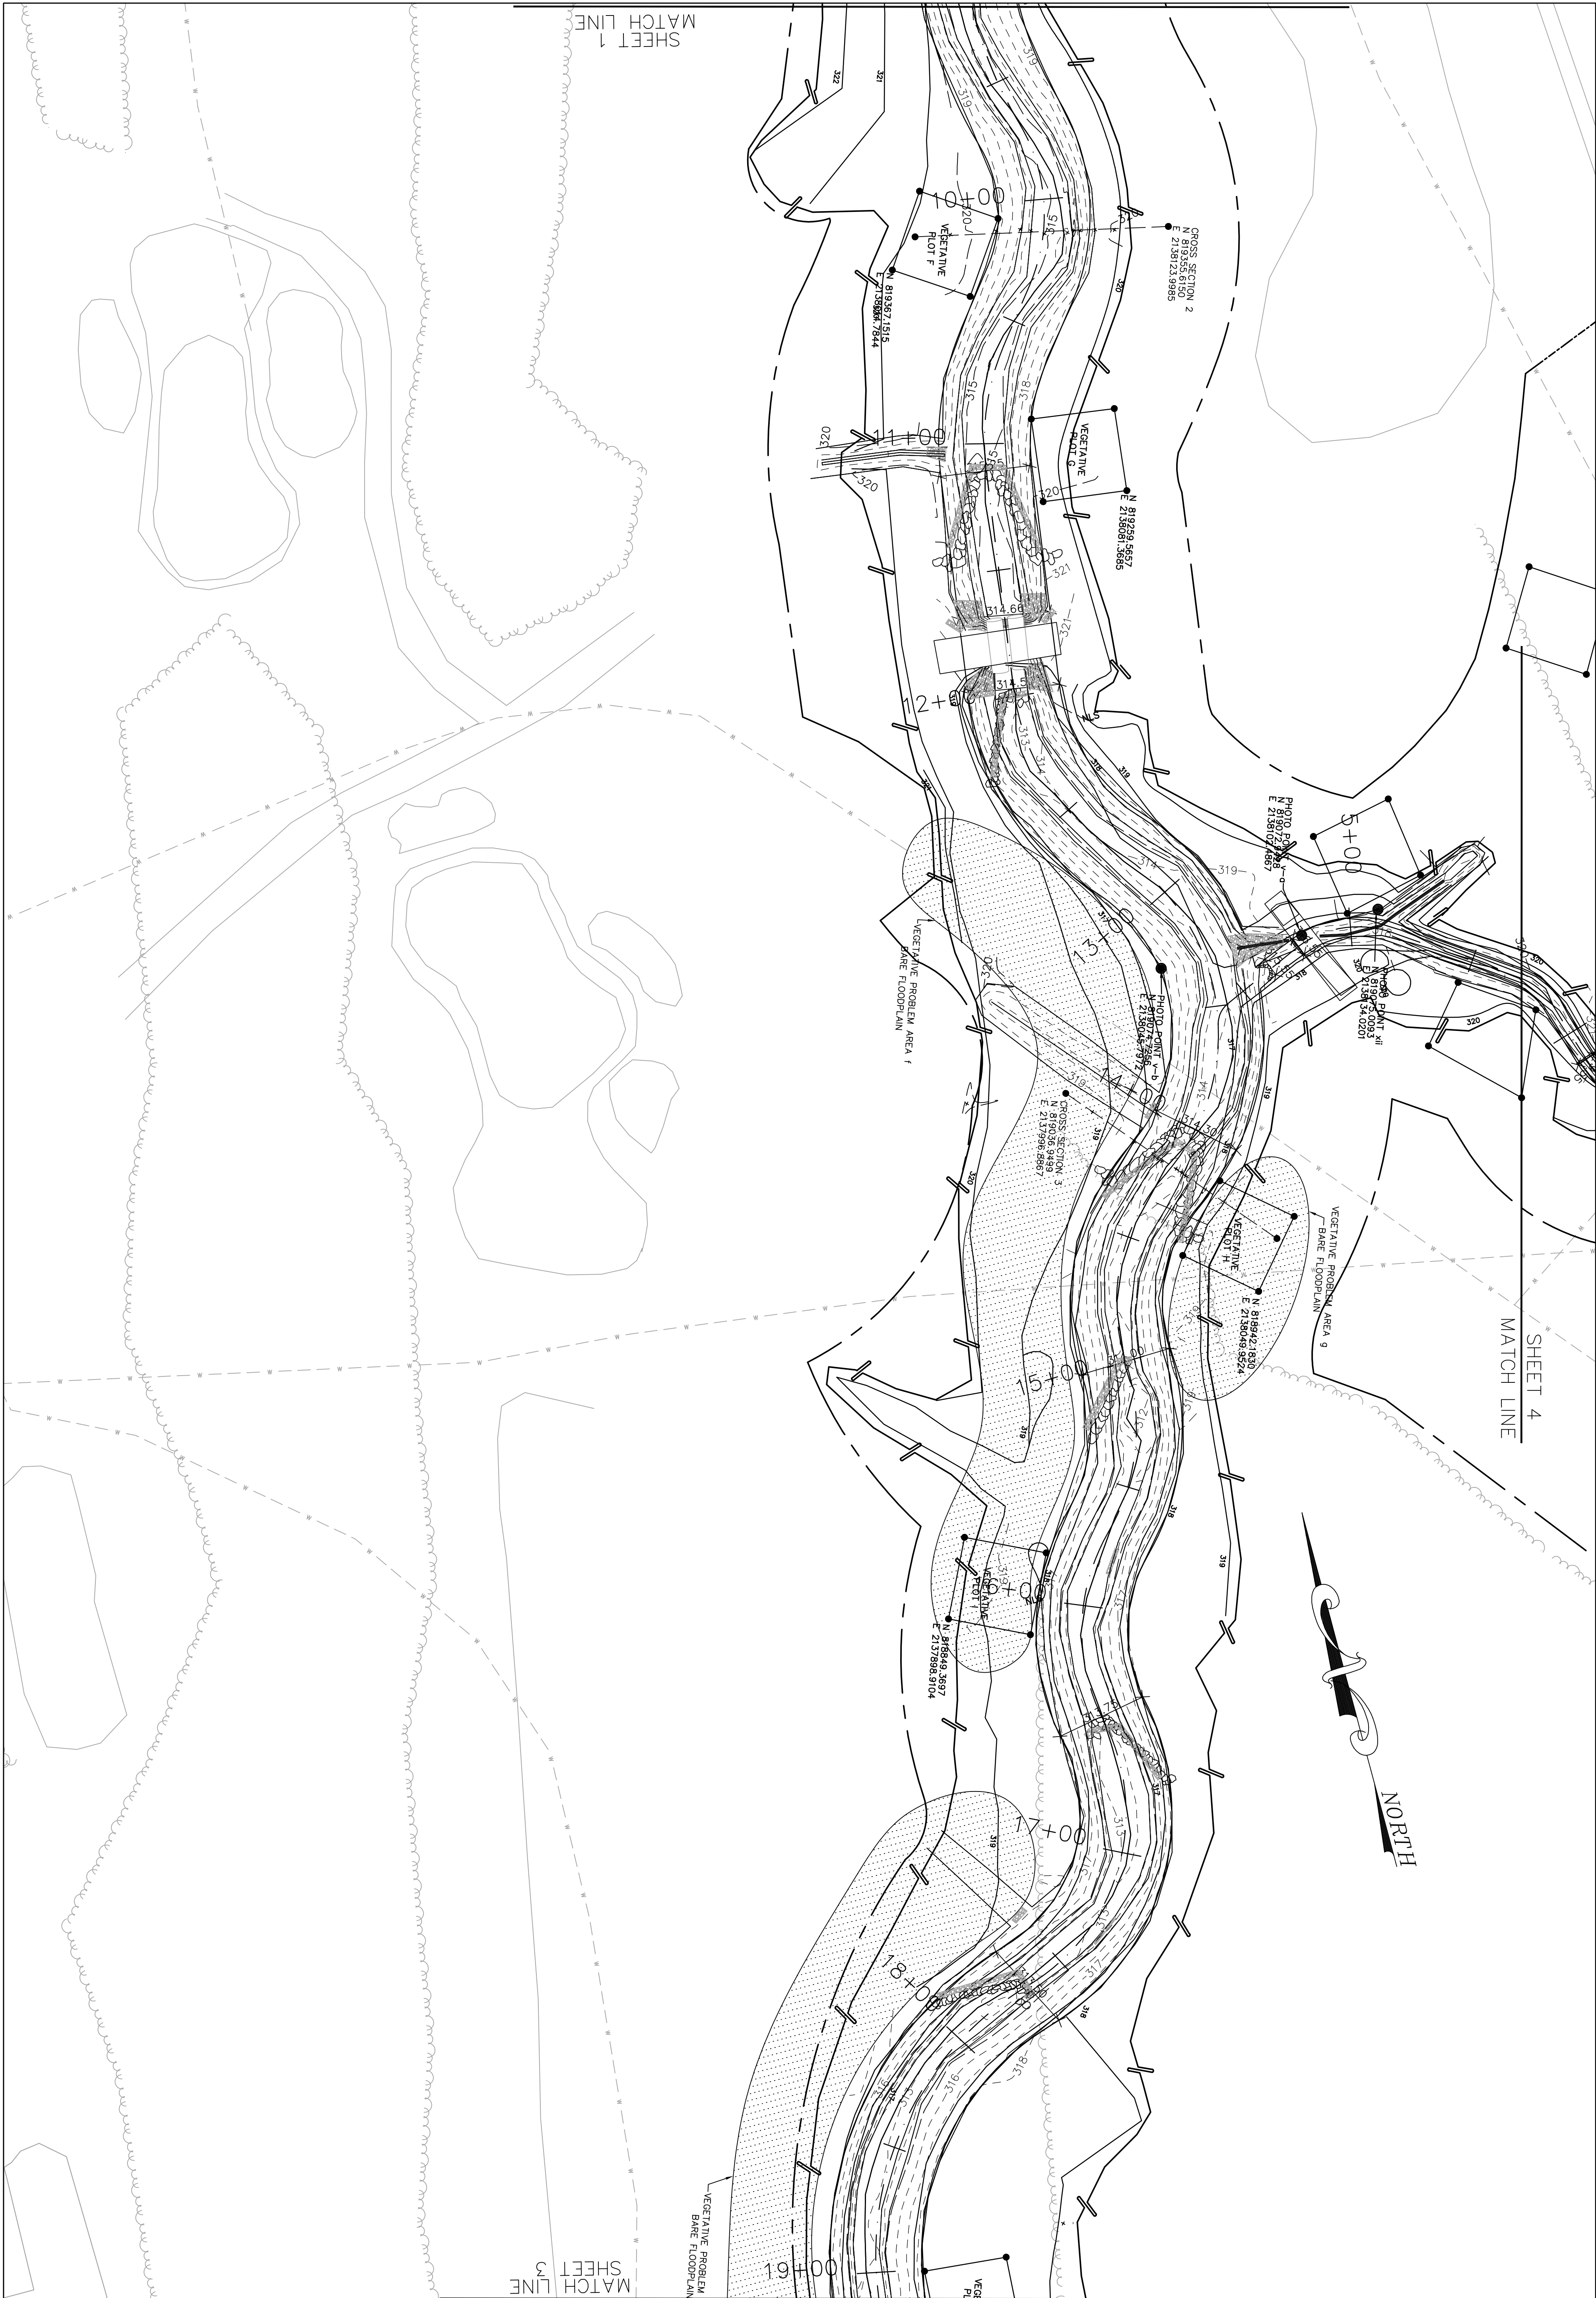
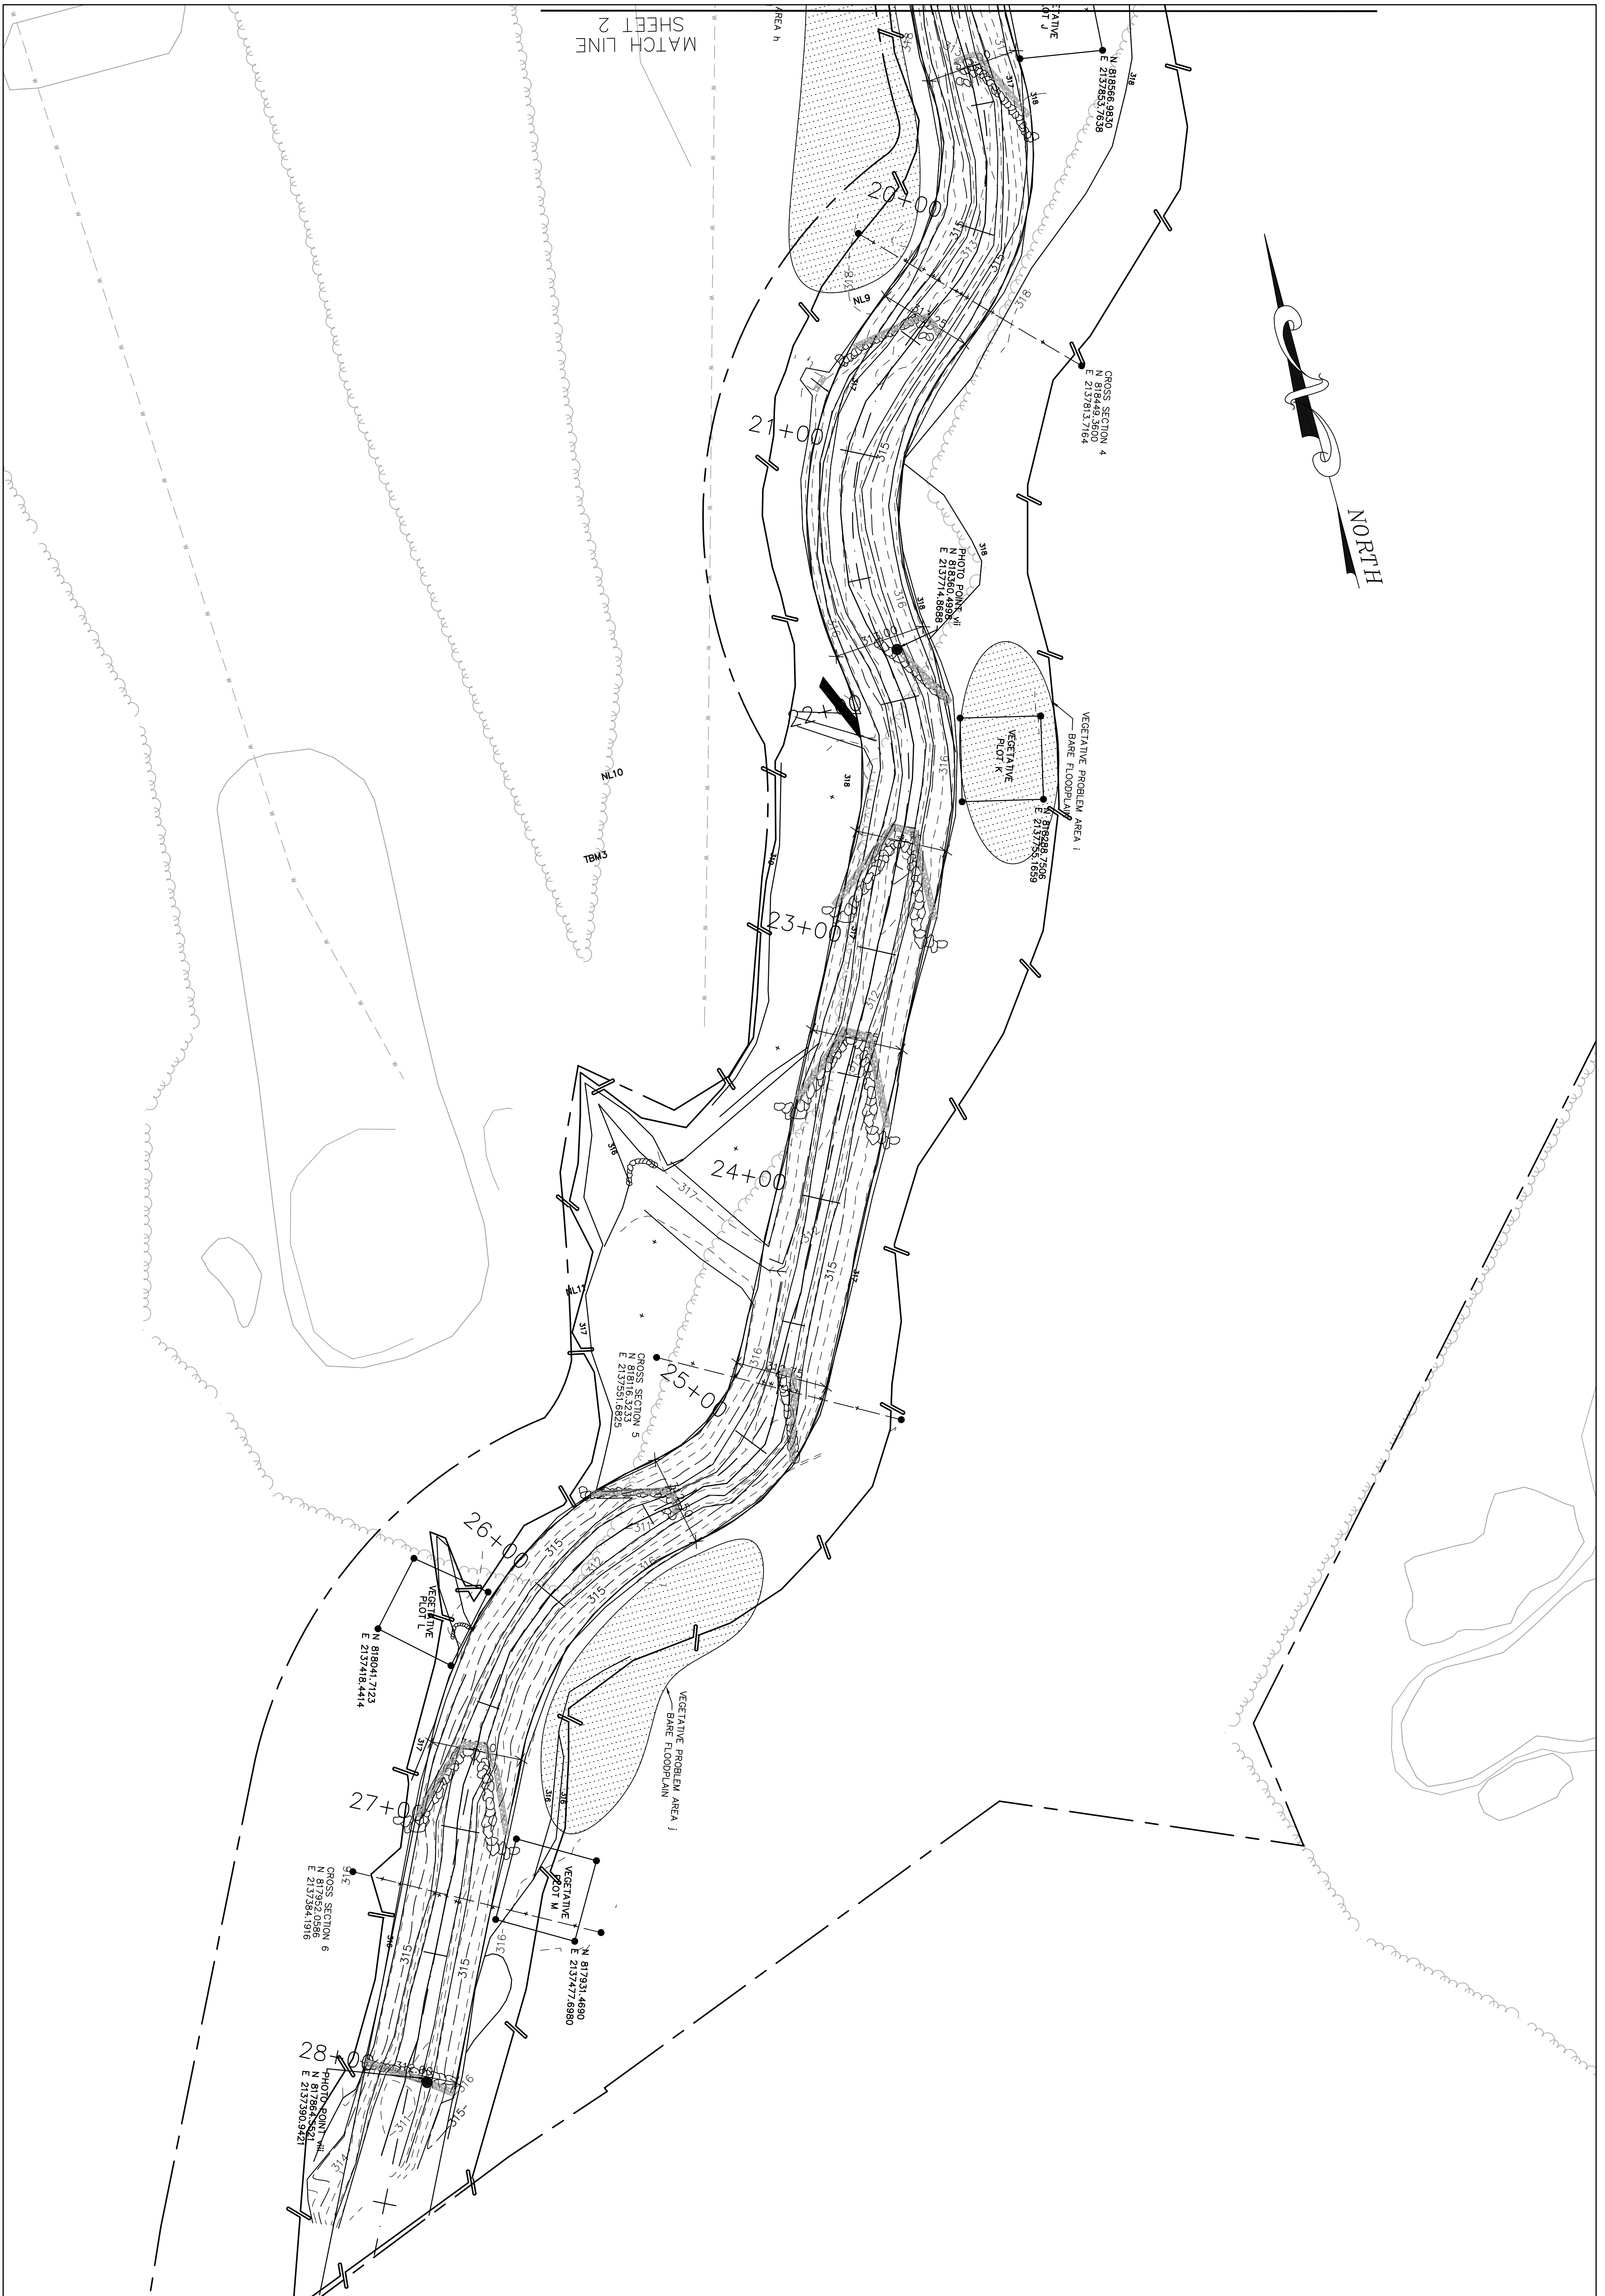
Figure 3: Vegetative Problem Areas Plan View Sheets

Vegetative Problem Areas Project Number 71082 (Horse Creek)						
Feature/Issue	Area	Station #/Range	Bank	Probable Cause	Comments	Photo #
Bare Bank	c	4+00 - 4+50	Left	Cause undetermined		788
Bare Bench	NA	None Observed	NA	NA		NA
Bare Floodplain	a	0+80 - 1+40	Left	Land owner maintenance or grazing by wildlife	No sign of wildlife grazing.	780
	b	0+80 - 1+40	Right	Land owner maintenance or grazing by wildlife	No sign of wildlife grazing.	783
	d	5+80 - 8+00	Left	Land owner maintenance or grazing by wildlife	No sign of wildlife grazing.	791
	e	5+00 - 6+00	Right	Land owner maintenance	Approx 15 ft unmowed	875
	f	14+00 - 17+00	Right	Land owner maintenance	Vegetation on 2 ft spacing and mowed around	813
	g	14+00 - 15+00	Left	Land owner maintenance		811
	h	17+00 - 20+50	Right	Land owner maintenance	Planted vegetation mowed around	832
	i	22+50 - 23+80	Left	Does not appear to be maintained or suffer from predation. Lack of sun and water not deemed to be issues. Possible soil deficiencies.		819

j	25+50 - 26+50	Left	Does not appear to be maintained or suffer from predation. Lack of sun and water not deemed to be issues. Possible soil deficiencies.		822
	k	0+80 - 2+00 (UT)	Right	Plot lacked planted species; however, it had an abundance of good volunteer species.		848
l	1+50 - 2+50 (UT)	Left	Possible lack of sunlight. Possible land owner maintenance.		849	
Invasive/Exotic Population	NA	NA	NA	Chinesee privet (<i>ligustrum sinense</i>) and Japanese honeysuckle (<i>Lonicera japonica</i>) were spotted within the project reach, but none was found within vegetative plots. Currently, invasive/exotic populations were not large enough to constitute problem areas of their own.		NA

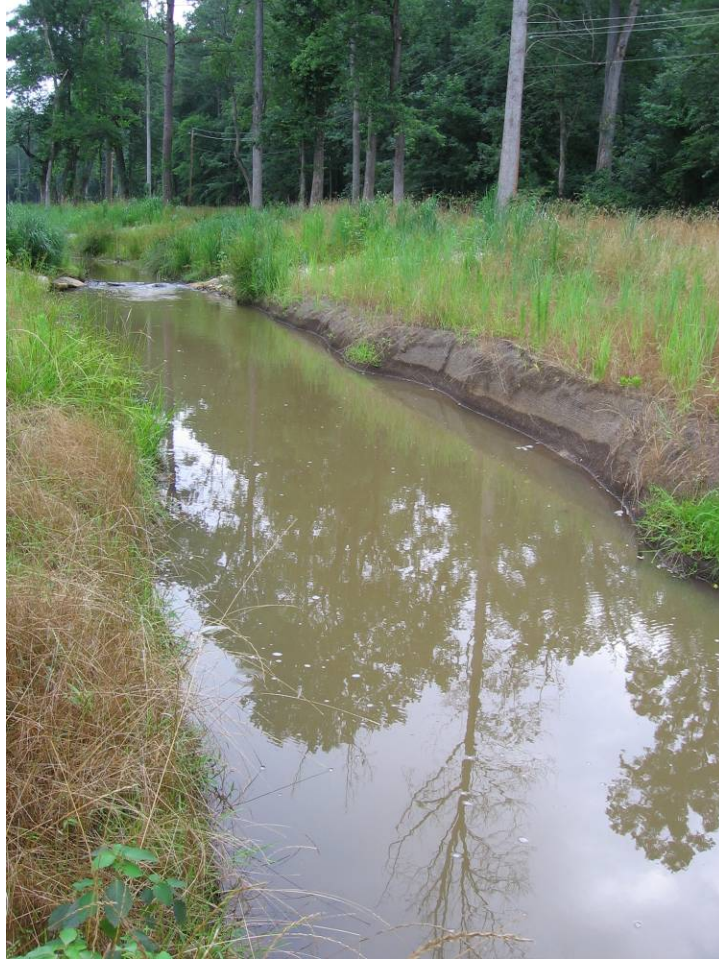
Photo 2: Bank Scour, 23+10 (0904) 06/22/05

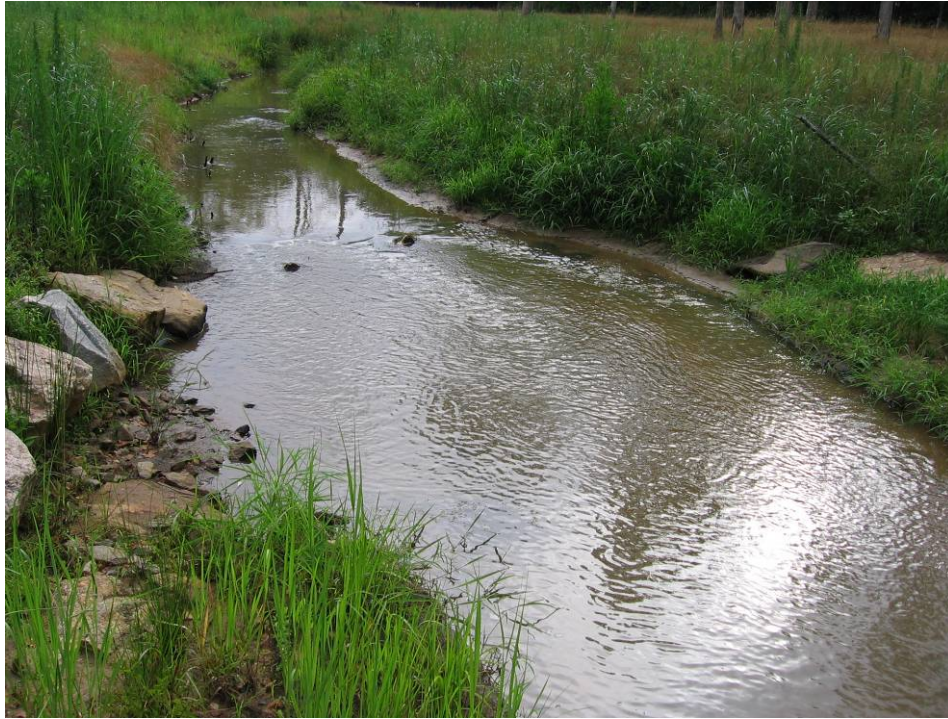
Photo 3: Engineered Structure – back or arm scour, 26+70 (0920) 06/22/05

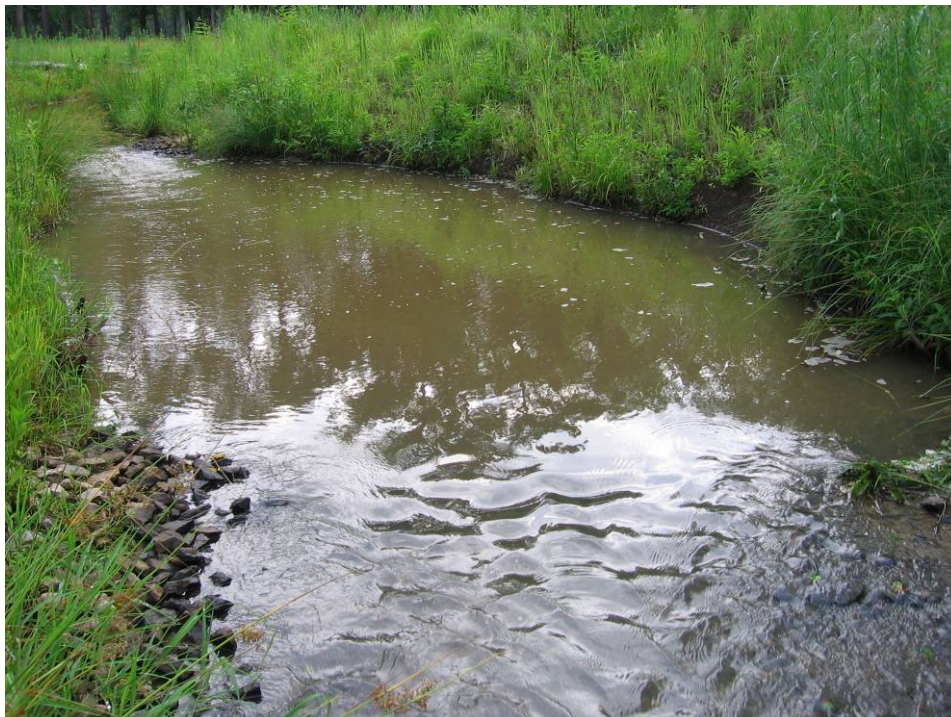
Photo 4: Channel Over widening, 15+40 (0898) 06/22/05

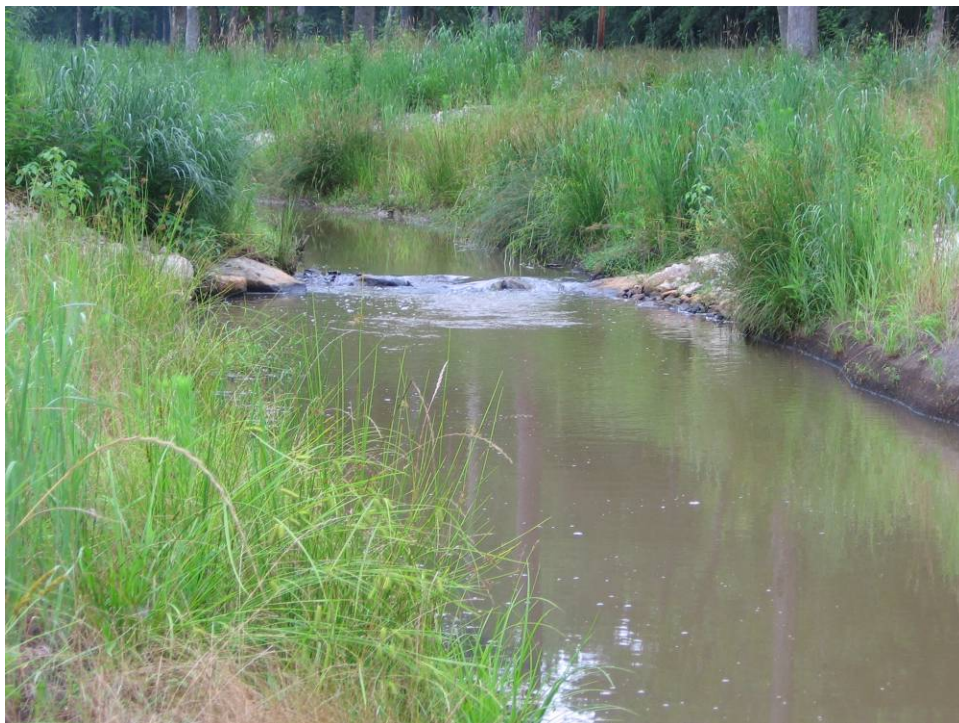
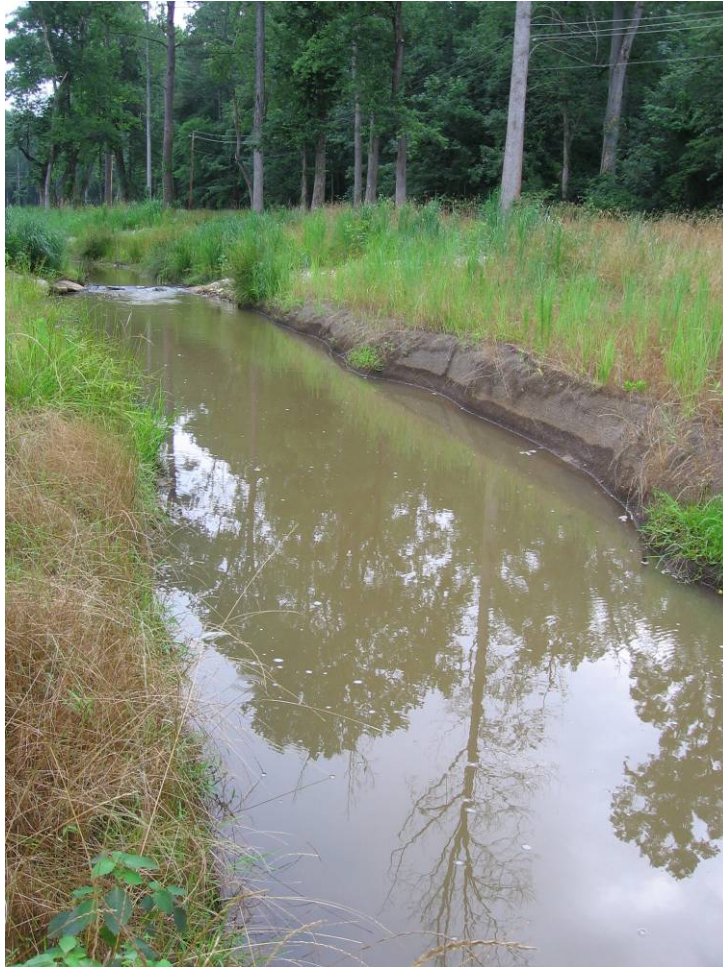
Probable Cause: The area immediately upstream of the rock-vane has over widened and the flow has begun to run parallel to the vane instead of across it. This change in flow vector has rendered the vane ineffective. Consequently the bank protection below the structure is not occurring.

Photo 61: Problem Area IX, 23+10 (0905 – Looking upstream) 06/22/05

Photo 62: Problem Area IX, 23+10 (0904 – Looking upstream) 06/22/05

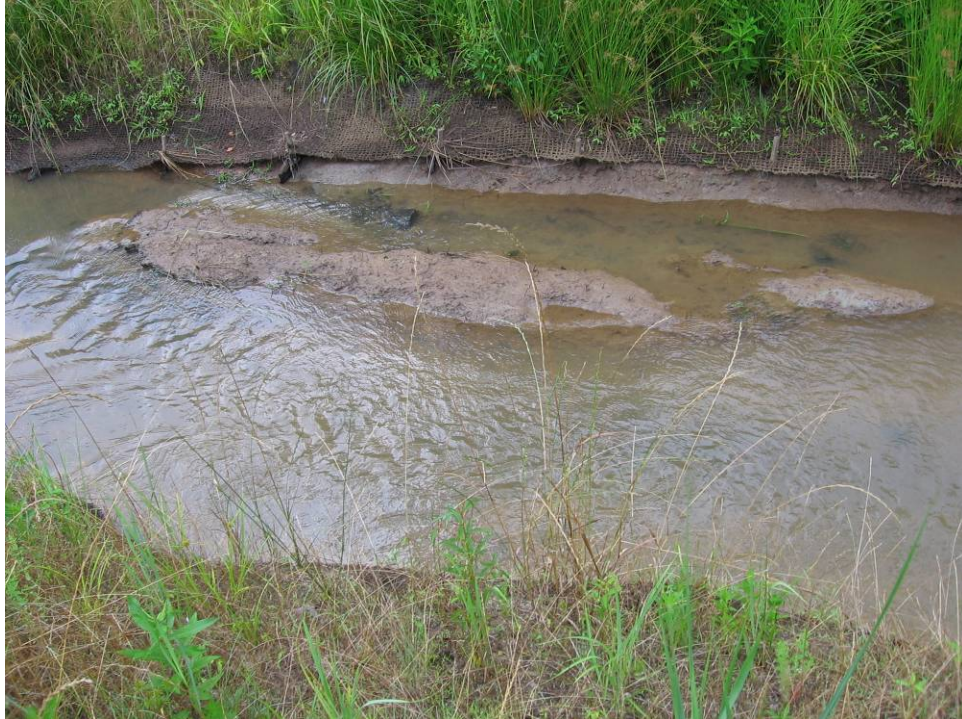
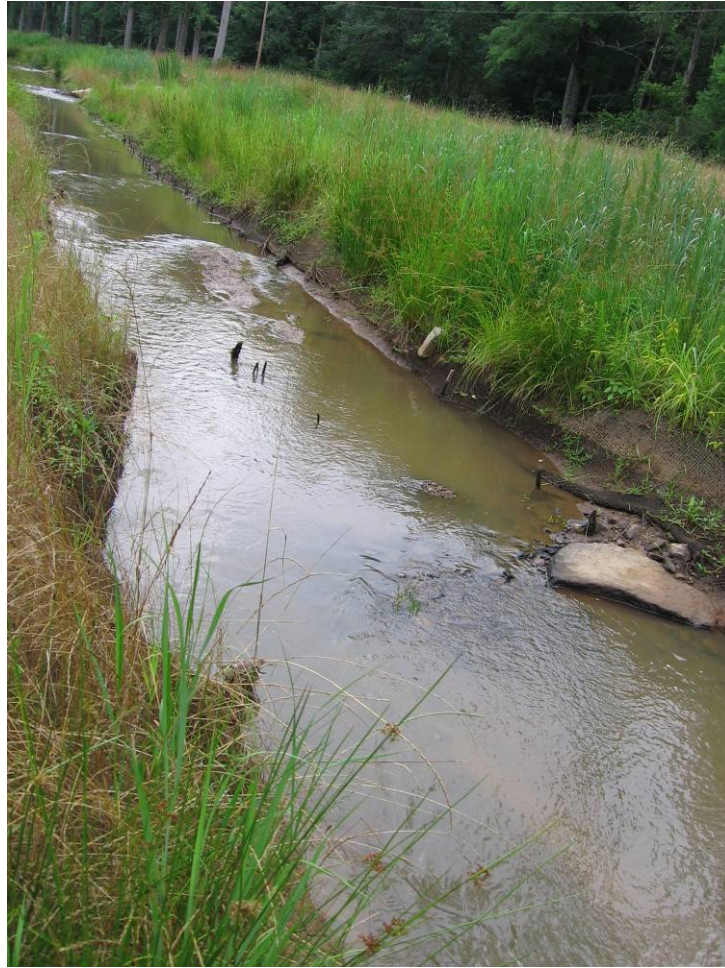
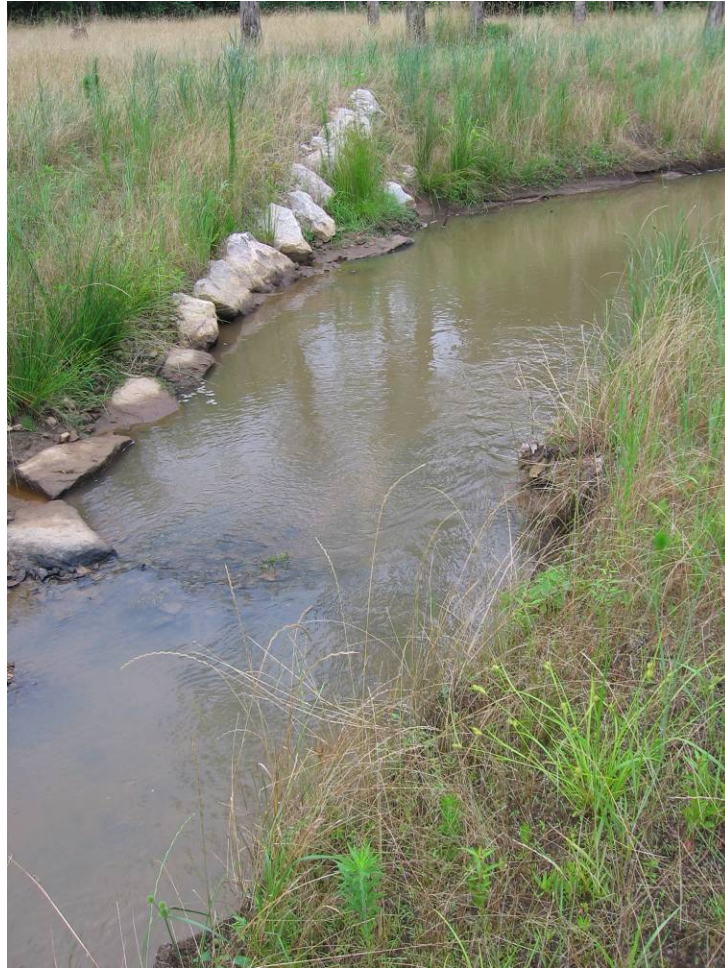
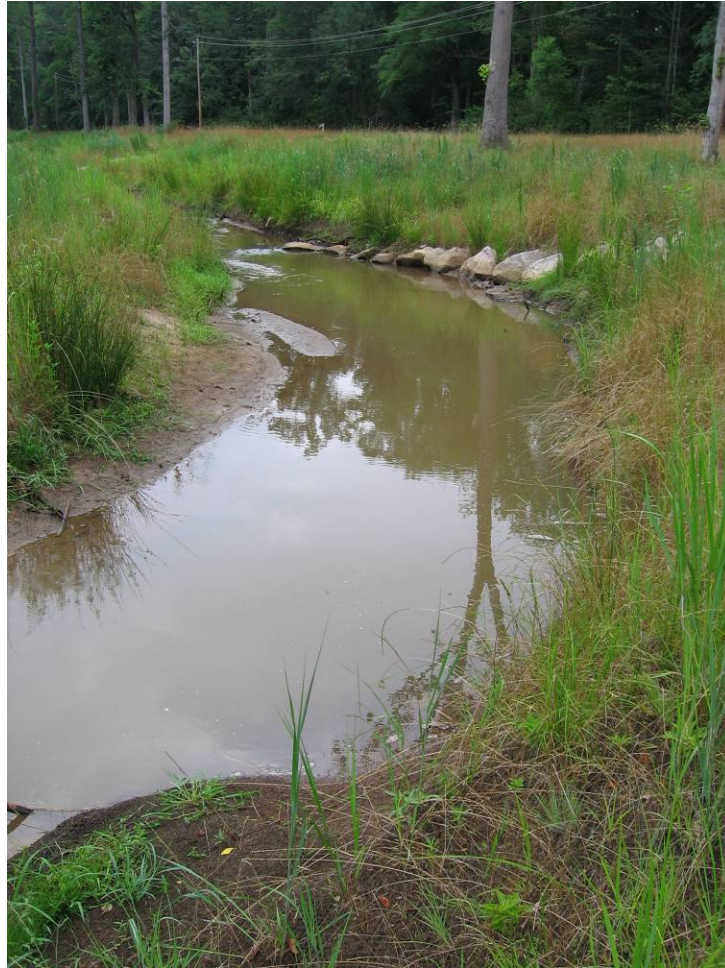
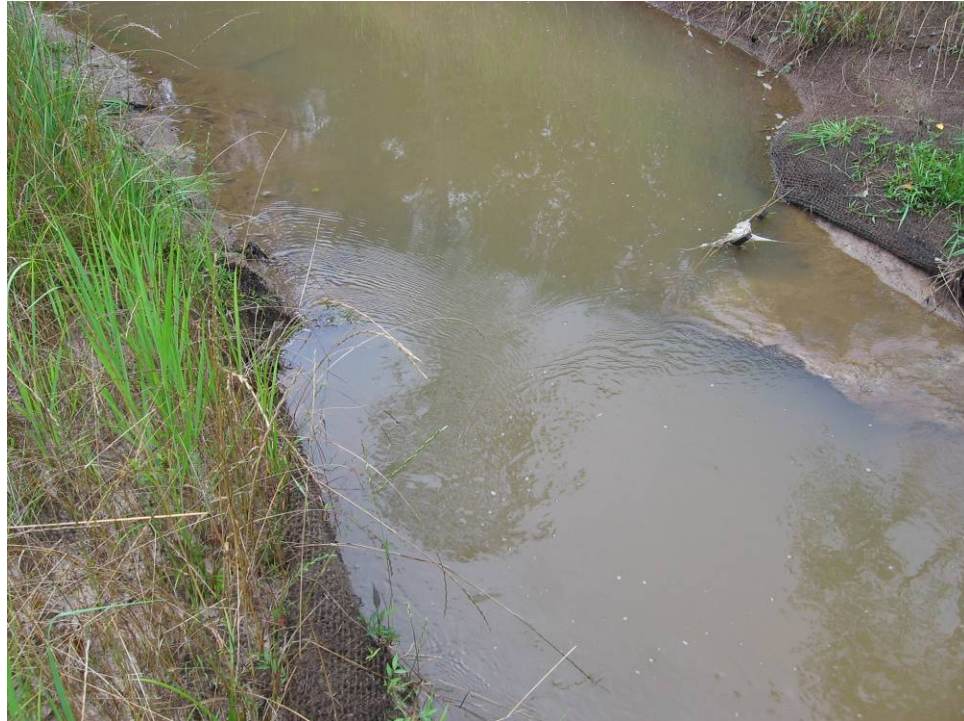
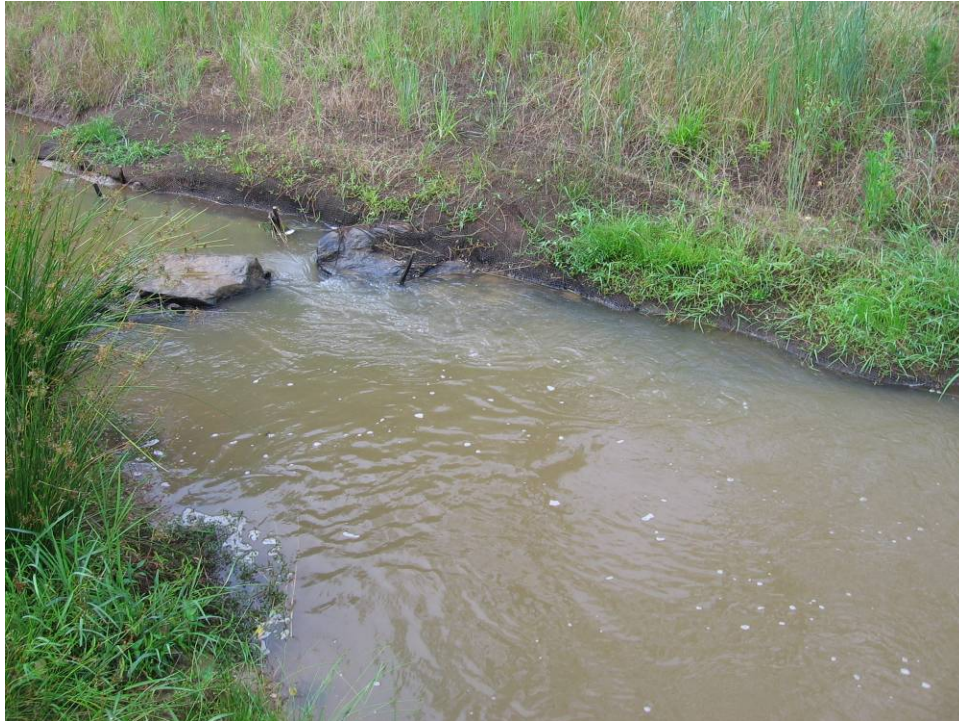
Probable Cause: The construction of the Cross-vane directs the stream at the right bank at low flow conditions. The flow then bounces to the opposite bank. The flow direction coupled with the lack of vegetation on the left bank has resulted in undercutting. This reach is too narrow and a small amount of widening, in this case through bank erosion, probably would not be the worst thing that could happen; as long as the vegetation is able to stabilize the section before it over widens. If the reach straightens itself out, it would also alleviate some of the damaging effects that are transferring downstream. While not the only cause of the downstream problems, Area IX is are putting additional stress on Area X.

Photo 63: Problem Area X, 25+00 (0911 – Looking downstream) 06/22/05

Photo 64: Problem Area X, 25+00 (0910 – Looking upstream) 06/22/05

Photo 65: Problem Area X, 25+00 (0912 – Looking downstream) 06/22/05

Photo 66: Problem Area X, 25+00 (0914 – Looking upstream) 06/22/05

Photo 67: Problem Area X, 25+00 (0918 – From Right Bank) 06/22/05

Photo 68: Problem Area X, 25+00 (0919 – Looking upstream) 06/22/05

Category: Problem Area.

Problem: Aggradation, Flow redirection, and erosion.

Probable Cause: A middle channel bar has formed in the channel, presumably using the bank failure immediately upstream as its sediment supply, and has redirected flow towards the right bank (Photo 0911). This has scoured the bank and bounces the flow back across the channel parallel to the rock-vane, rendering the vane ineffective (Photo 0910). At this point the right bank is scouring while the left bank aggrades upstream of the vane (Photo 0912). Without the influence of the vane, the flow has been angled too sharply towards the outside of the bend and is causing erosion of the left (outer) bank and the migration of the point bar (Photo 0914). After leaving the eroding bank the flow is squeezed through what appears to be a clay “projection” that directs the flow back into the right bank at an unfortunate angle again and then again toward the left bank (Photo 0918). With this added stress both the right and left banks are eroding at this point. Finally the flow vector is improved by passing through a J-hook vane (Photo 0919).

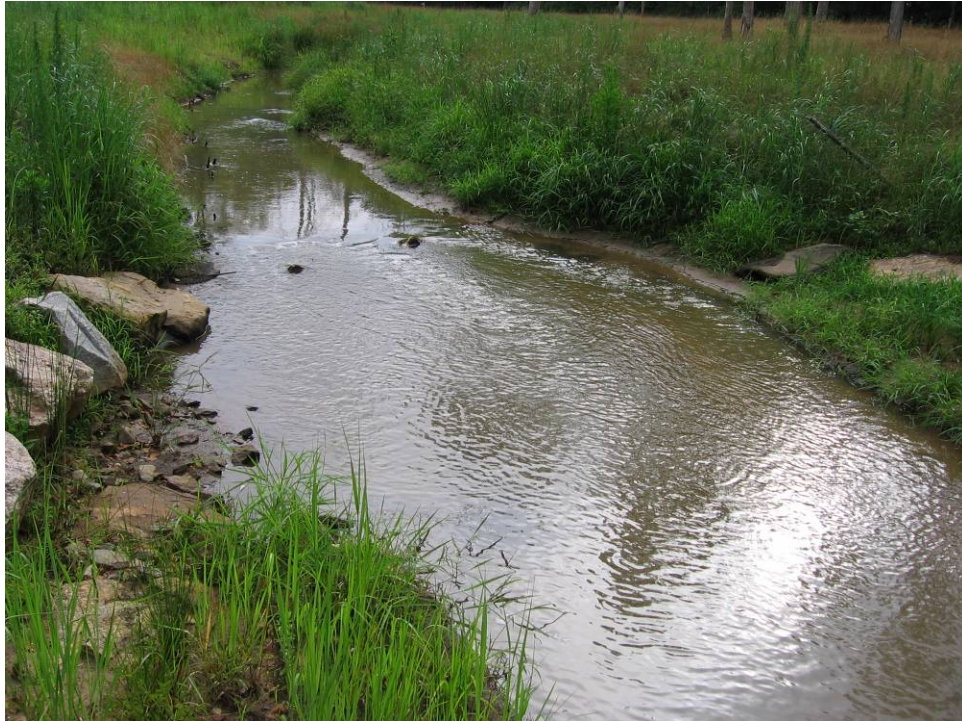
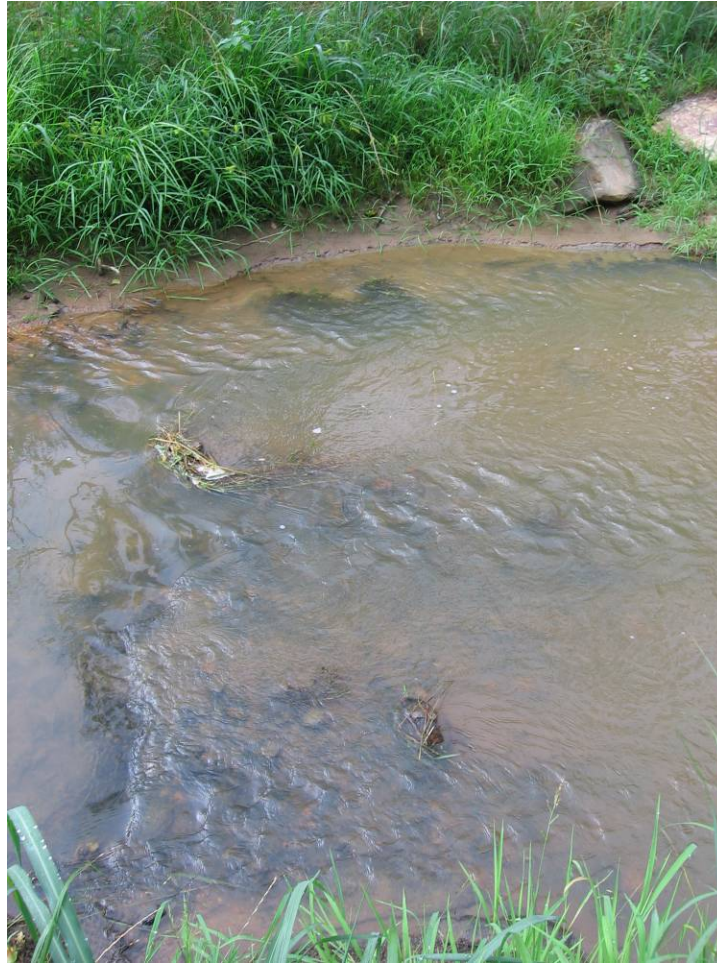
Photo 69: Problem Area XI, 26+70 (0920 – Looking upstream) 06/22/05

Photo 70: Problem Area XI, 26+70 (0921 – From Right Bank) 06/22/05

Category: Area of Concern.

Problem: Channel has widened at pool.

Probable Cause: Cross-vane lacks appropriate structure, (Photo 0920) most notably header rocks are missing (Photo 0921). Vegetation appears to have stabilized banks, so at this point in time there does not seem to be any lateral migration occurring. Currently, this is more an area of concern to be watched than a problem area, but should the pool continue to widen or should the concentration of flow be shifted inappropriately the stability of the channel could be compromised.
