**HORSE CREEK STREAM RESTORATION
MONITORING REPORT
EEP Project No. 71082
Monitoring Year – 01
2006**

September 2006

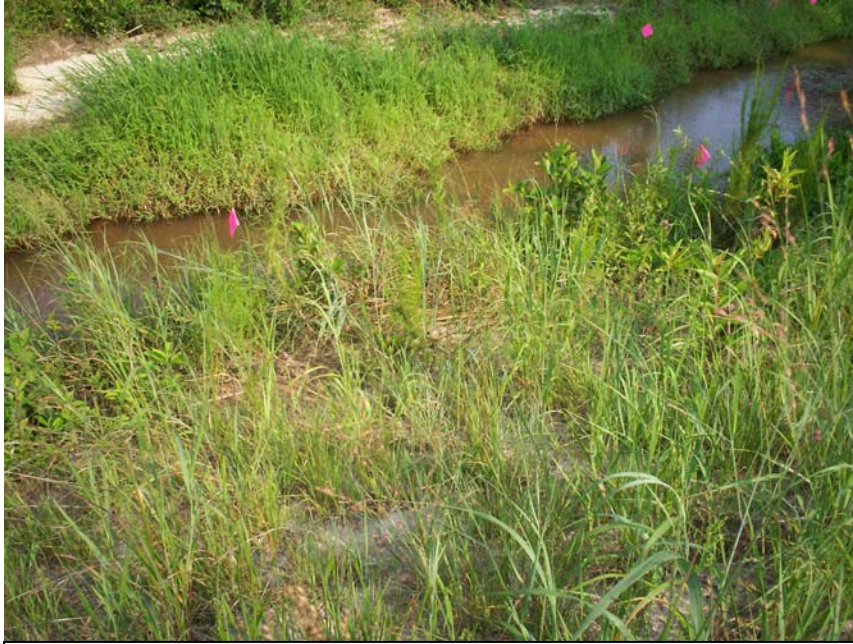
VPA 1: Vegetative Problem Area "c" 4+00 – 4+50

Problem areas where bare banks were observed are limited to Areas "c" and "i." Area "a" continues to undergo landowner maintenance by golf course personnel, and has expanded from its original size identified in the Year 0 report to include additional areas downstream. Further, bankfull event(s) have resulted in a large amount of sediment accumulation along the floodplain in this area. As a result of similar landowner maintenance and regular mowing, Areas "b" and "c" have expanded downstream to encompass additional floodplain.

Horse Creek Stream Restoration EEP Project No. 71082					
Feature/Issue	Area	Station No. /Range	Bank	Probable Cause	Photograph No.
Bare Bank	c	4+00 - 4+50	Left	Sediment accumulation from flood event(s).	VPA 1
	i	22+00 - 22+50	Left	Sediment accumulation from flood event(s).	VPA 2
Bare Bench	--	None Observed	--	--	--
Bare Floodplain	a	0+80 - 3+50	Left	Land owner maintenance, sediment accumulation from flood event(s).	VPA 3
	b	0+80 - 4+80	Right	Land owner maintenance.	VPA 4

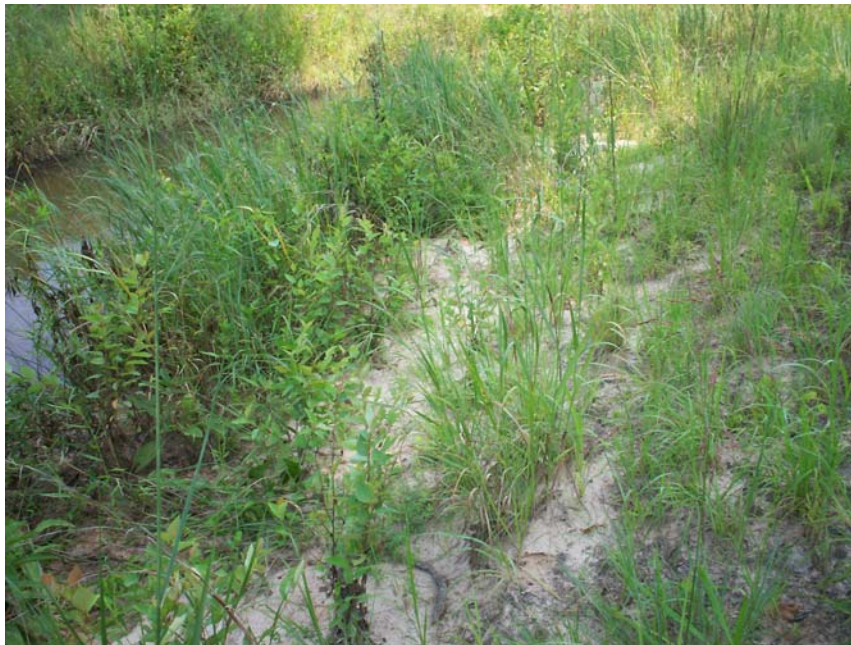
VPA 2: Vegetative Problem Area "i" 22+00 – 22+50

Area "i" may still be experiencing possible soil deficiencies within the floodplain. This area is adjacent to a sewer and power line easement. A large amount of sediment accumulation was also observed at this location. A portion of this area near Station 22+50 has shown improvement and was no longer considered part of the problem area.

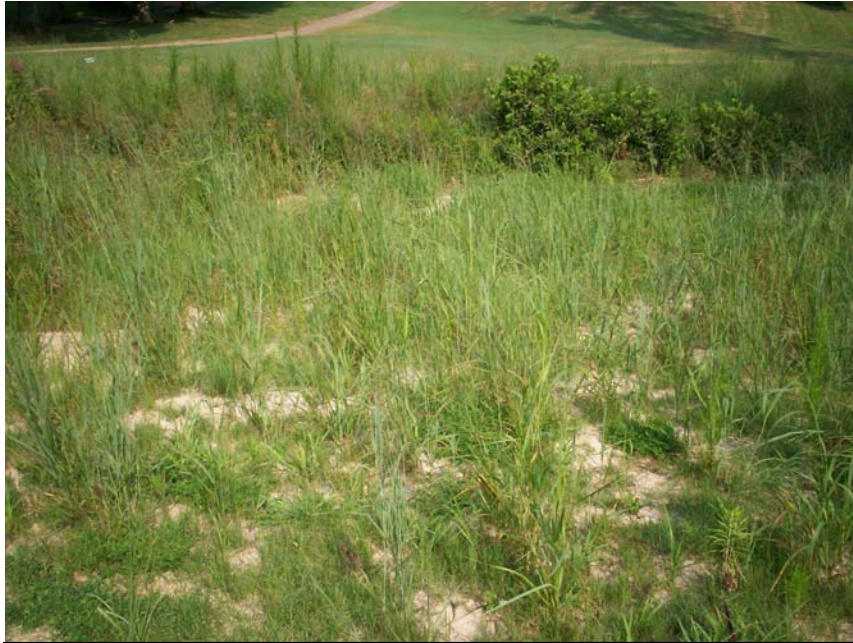
VPA 5: Vegetative Problem Area "c" 4+00 – 4+50

c	4+00 – 4+50	Left	Land owner maintenance, sediment accumulation from flood event(s).	VPA 5
	d	6+00 - 10+00	Left	Land owner maintenance, sediment accumulation from flood event(s).	VPA 6
	e	5+50 - 7+50	Right	Land owner maintenance.	VPA 7
	f	12+50 - 16+50	Right	Land owner maintenance.	VPA 8
	g	13+50 - 15+30	Left	Land owner maintenance.	VPA 9
	h	17+00 - 20+50	Right	Land owner maintenance.	VPA 10
	i	21+80 - 22+50	Left	Possible soil deficiency; adjacent to power and sewer line right-of-way.	VPA 11
	j	25+50 - 27+00	Left	Sewer line right-of-way vegetation spreading.	VPA 12
	k	Throughout UT	Right	Land owner maintenance.	VPA 13
	l	Throughout UT	Left	Land owner maintenance.	VPA 14
Invasive/Exotic Populations				During Year 1 monitoring activities, invasive/exotic populations did not appear to constitute problem areas.	NA

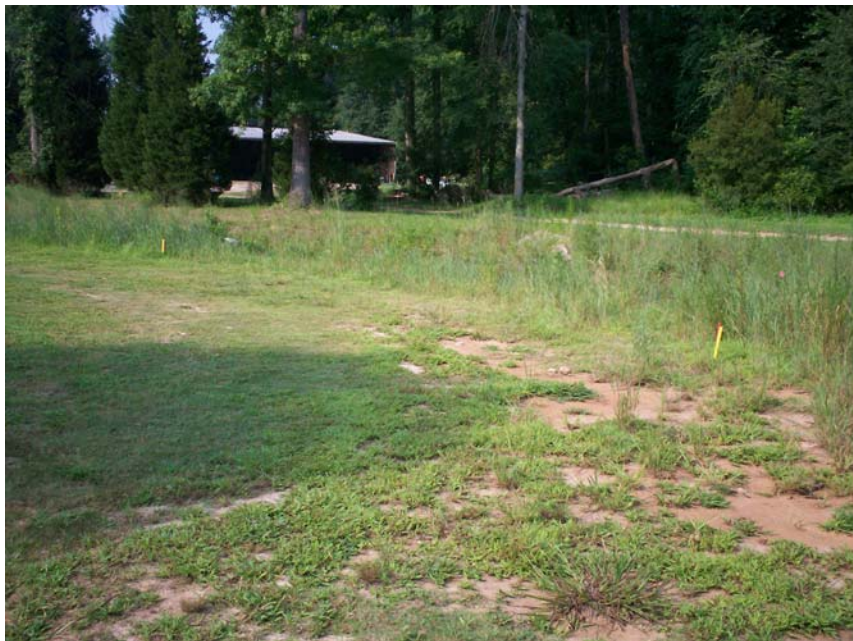
VPA 6: Vegetative Problem Area "d" 6+00 – 10+00

Bare floodplain was observed within the remaining problem areas. Areas "d," "e," "g," "k" and "l" have expanded from their original Year 0 dimensions as mowing and landowner maintenance practices continue to encroach within the buffer.

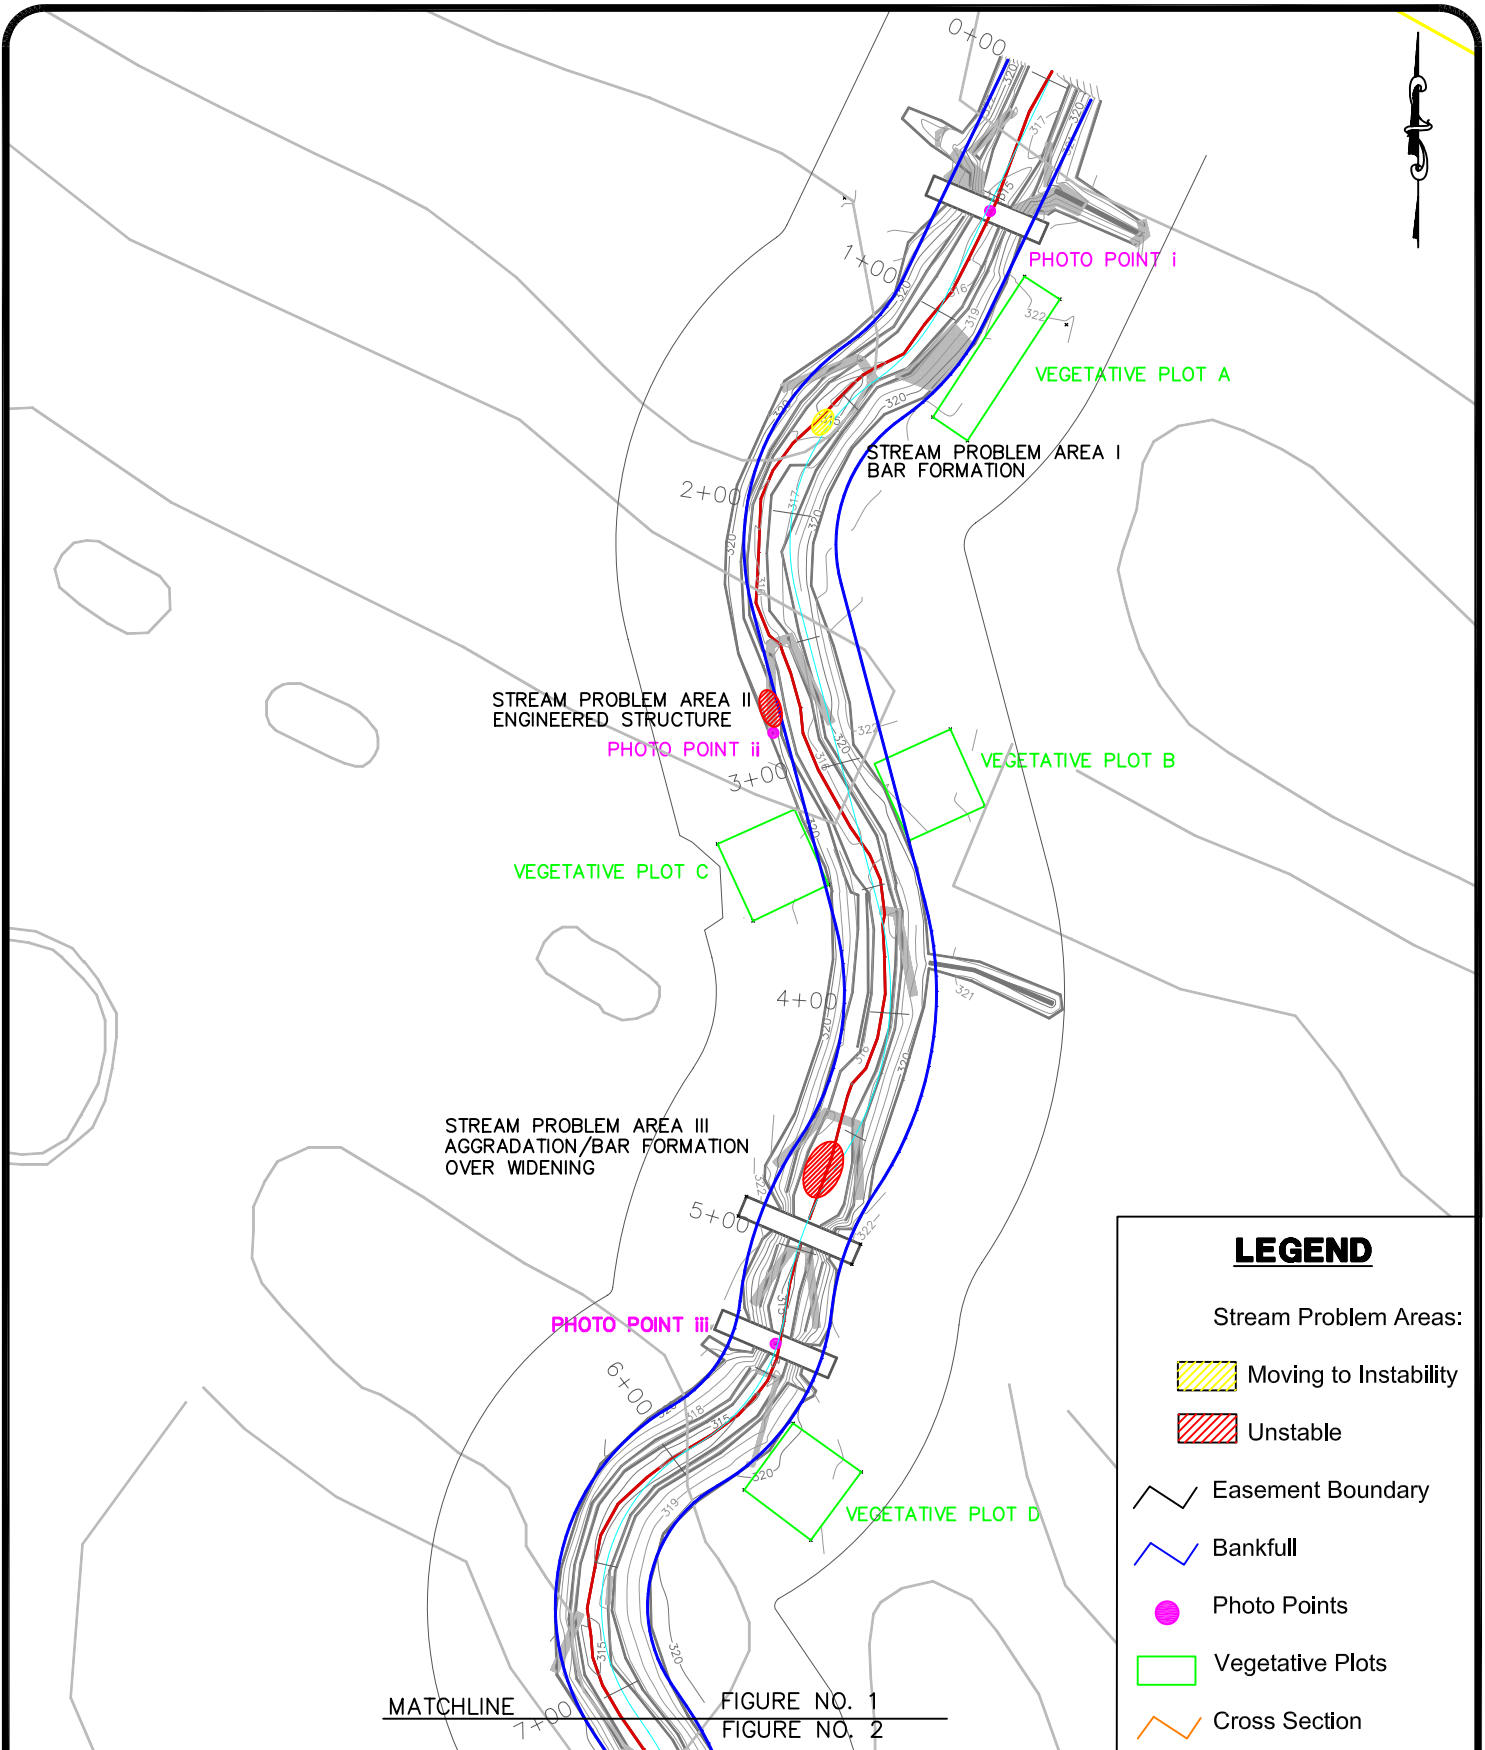
SHEET NO.
1 of 5

Problem Area XIV	27+10	Bank slumping before establishment of vegetation.	
Engineered structures-back or arm scour			
Problem Area II	2+85	Bank failure around right arm of structure and exposed footer rocks.	SPA-3
Problem Area VI	14+20	Construction deviated from Design - structure arms too high.	
Problem Area IX	22+00	Downstream vegetated mid-channel bar (Problem Area VIII) is causing restricted flow and backwater areas upstream.	
Problem Area X	23+50	Construction deviated from Design - structure too high.	
Problem Area XII	25+60	Construction deviated from Design - structure too high.

Channel over widening			
Problem Area III	4+90	See aggradation/bar formation	SPA-4
Problem Area V	13+80	Suspected bank failure before vegetation established; angle discharge from UT.	
Problem Area VII	15+30	Suspected bank failure before vegetation established.	
Problem Area X	23+50	See engineered structures - back or arm scour.

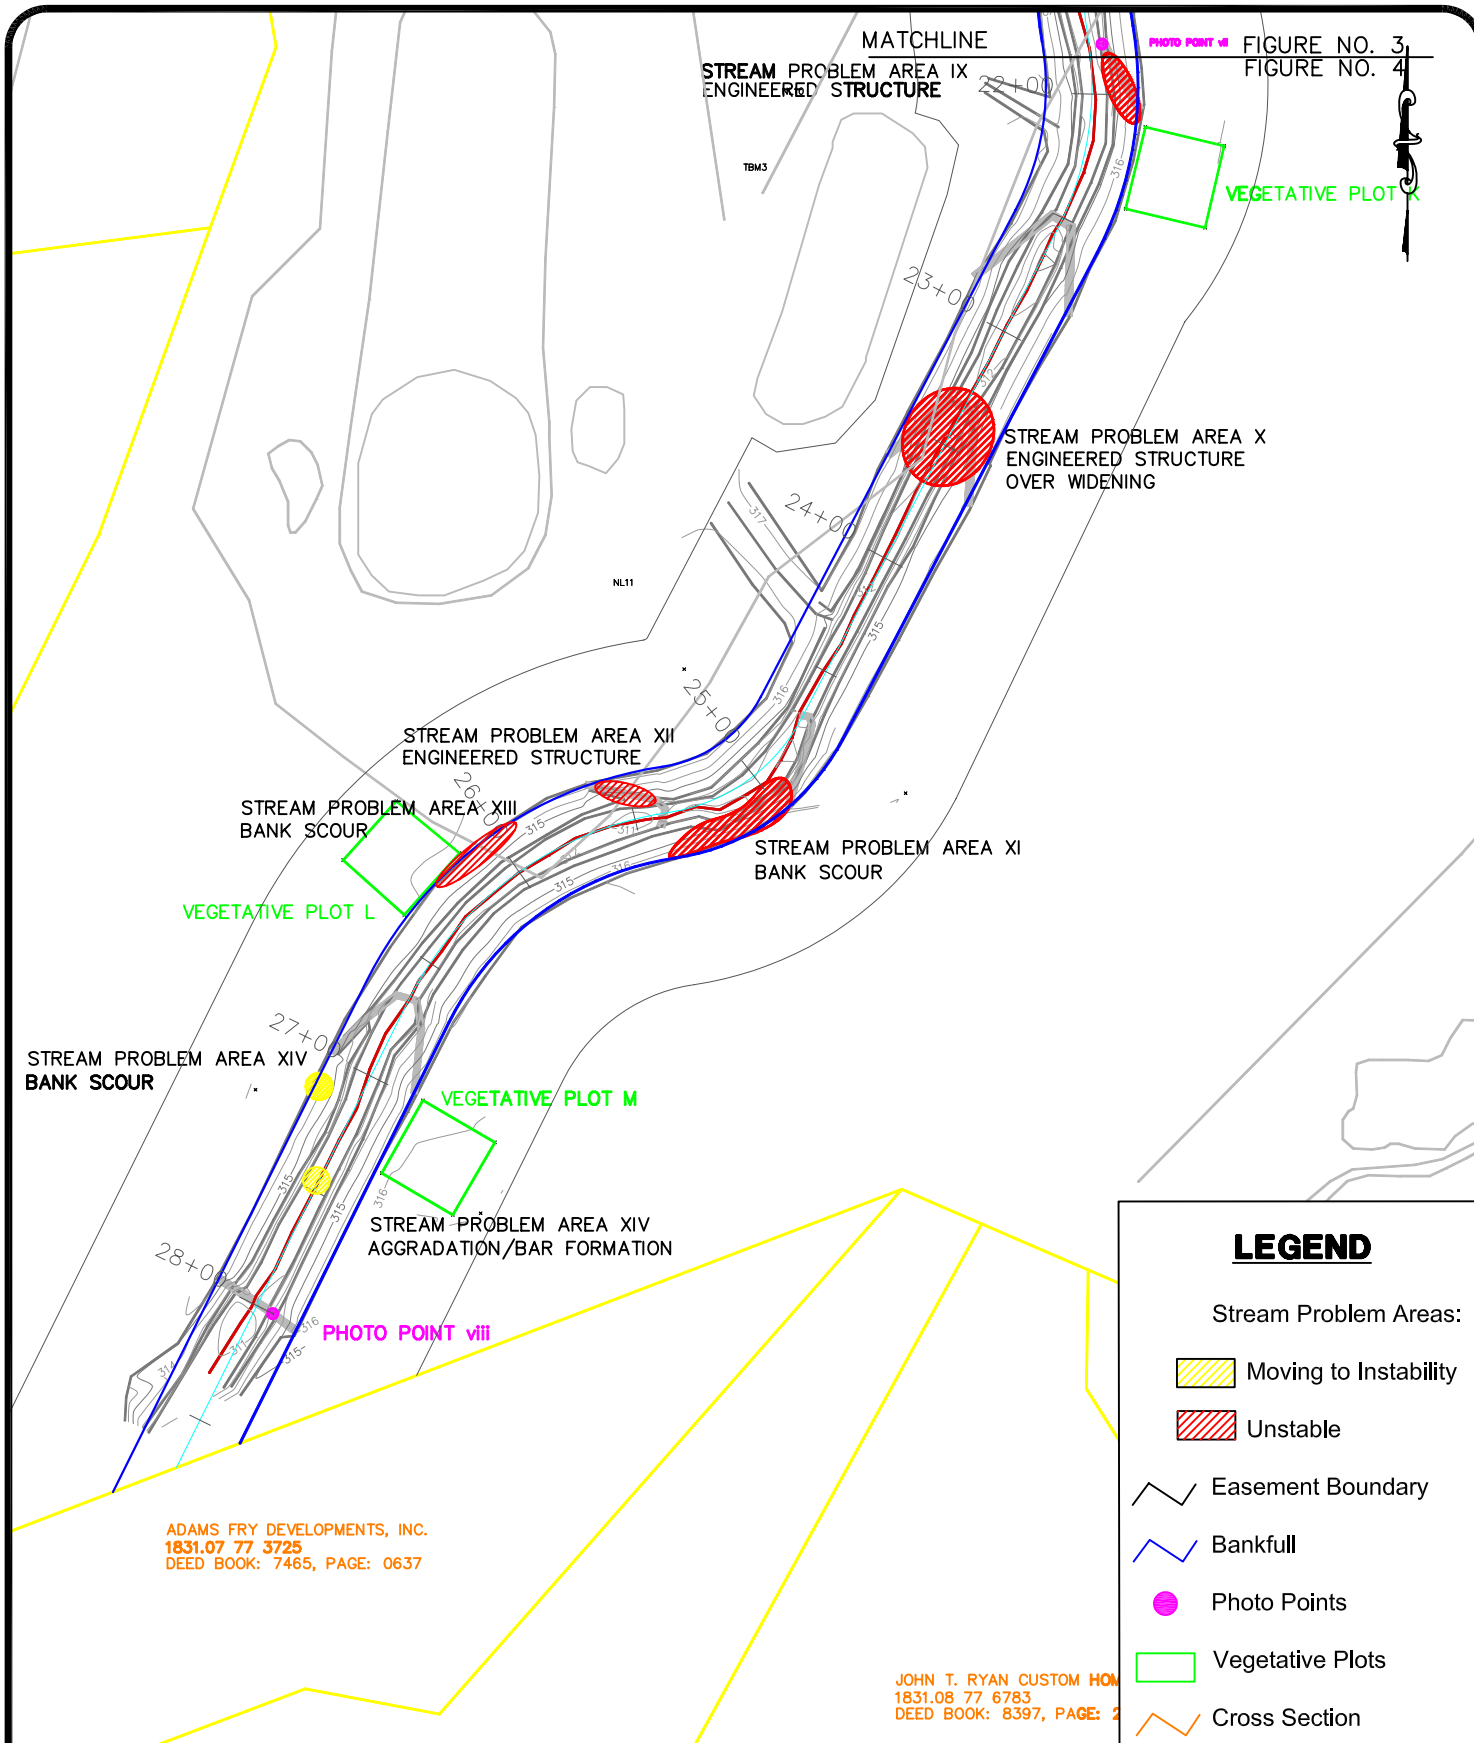
SHEET NO.
4 of 5

MATCHLINE
 STREAM PROBLEM AREA IX
 ENGINEERED STRUCTURE
 PHOTO POINT vi
 FIGURE NO. 3
 FIGURE NO. 4

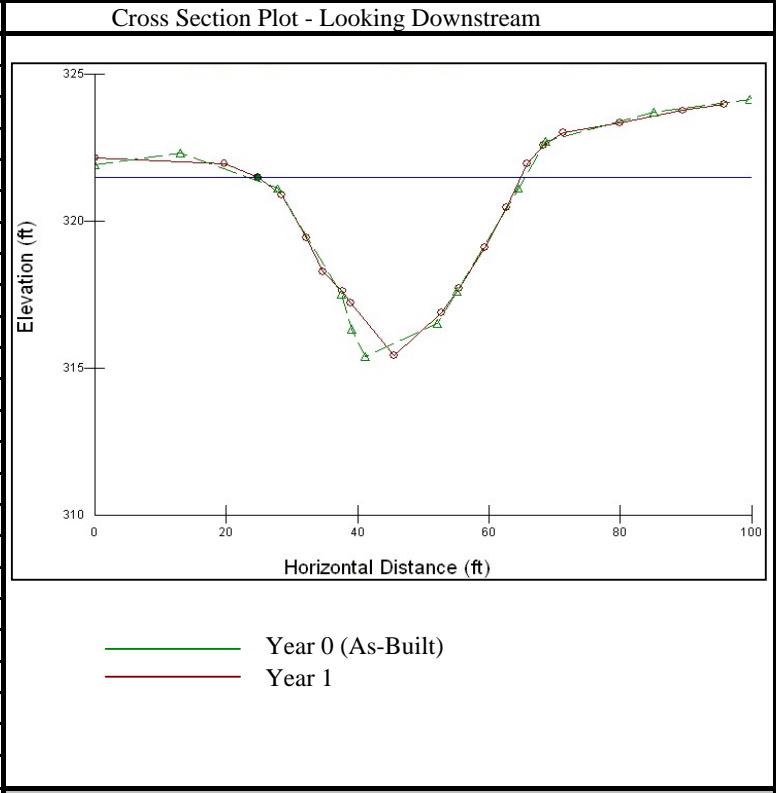
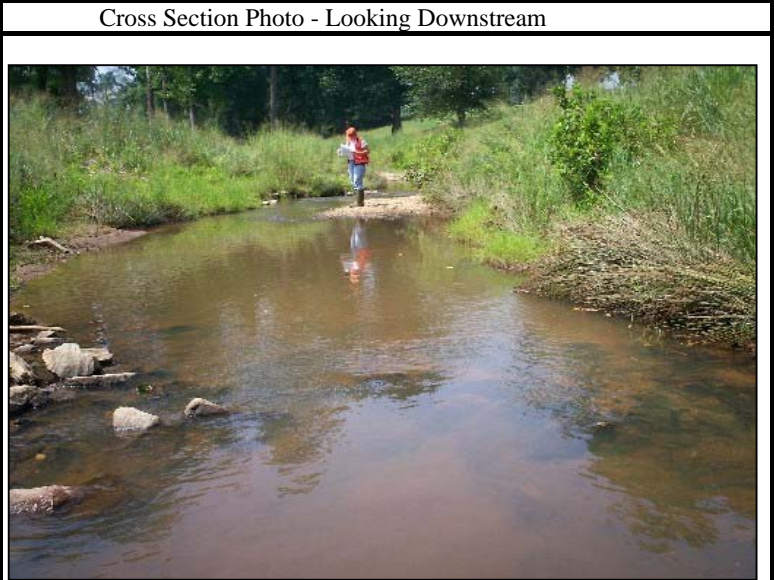
Cross Section 1 - Riffle, 0+83

Summary Data	
Bankfull Cross-Sectional Area:	131.49
Bankfull Width:	39.98
Bankfull Mean Depth:	3.29
Bankfull Max Depth:	6.08
Width/Depth Ratio:	12.15
Entrenchment Ratio:	2.4
Classification:	C5

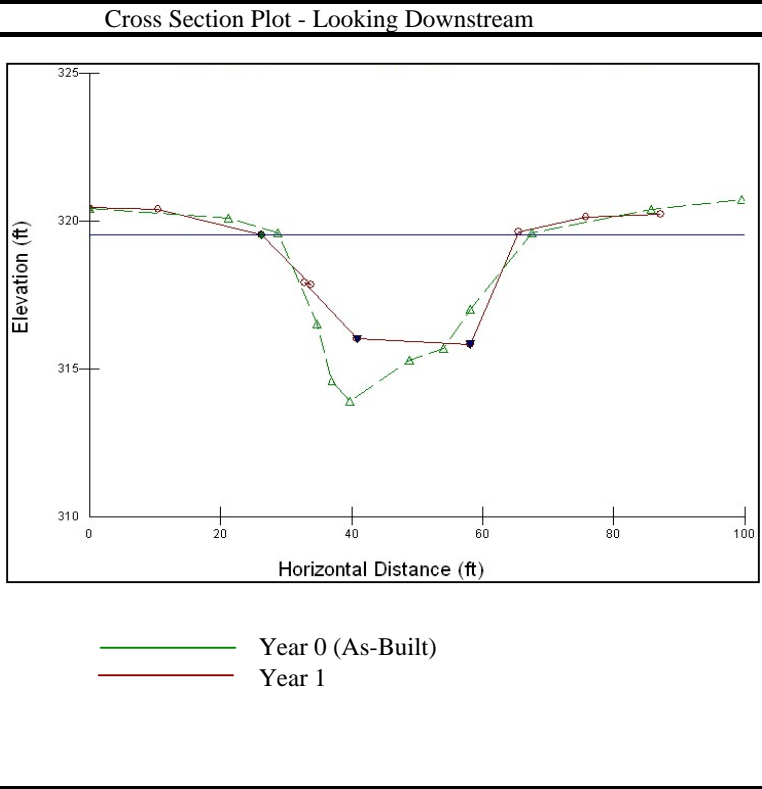
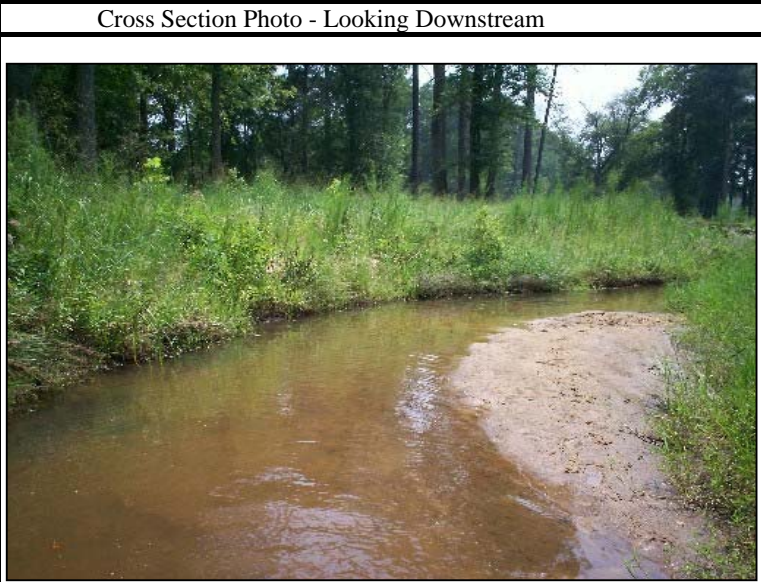
Cross Section 2 - Pool, 10+46

Summary Data		
Bankfull Cross-Sectional Area:	101.53	
Bankfull Width:	39.1	
Bankfull Mean Depth:	2.6	
Bankfull Max Depth:	3.71	
Width/Depth Ratio:	15.04	
Entrenchment Ratio:	2.23	
Classification:	C5

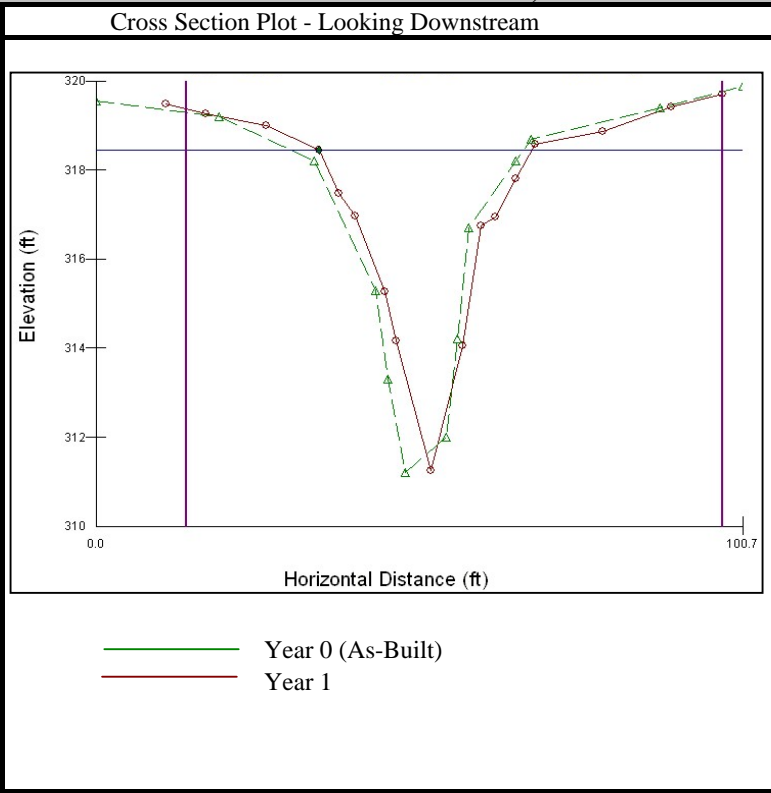
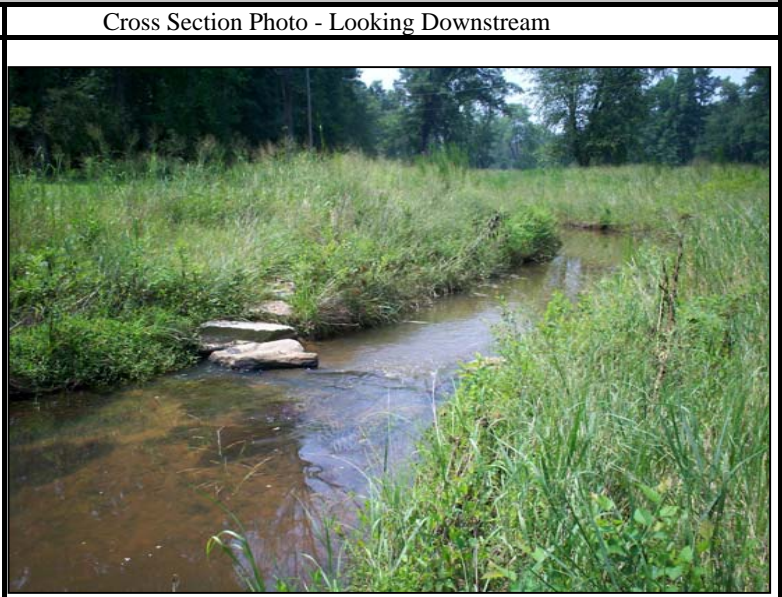
Cross Section 3 - Pool, 14+65

Summary Data	
Bankfull Cross-Sectional Area:	98.01
Bankfull Width:	86.68
Bankfull Mean Depth:	2.96
Bankfull Max Depth:	7.19
Width/Depth Ratio:	11.2
Entrenchment Ratio:	2.61
Classification:	C5

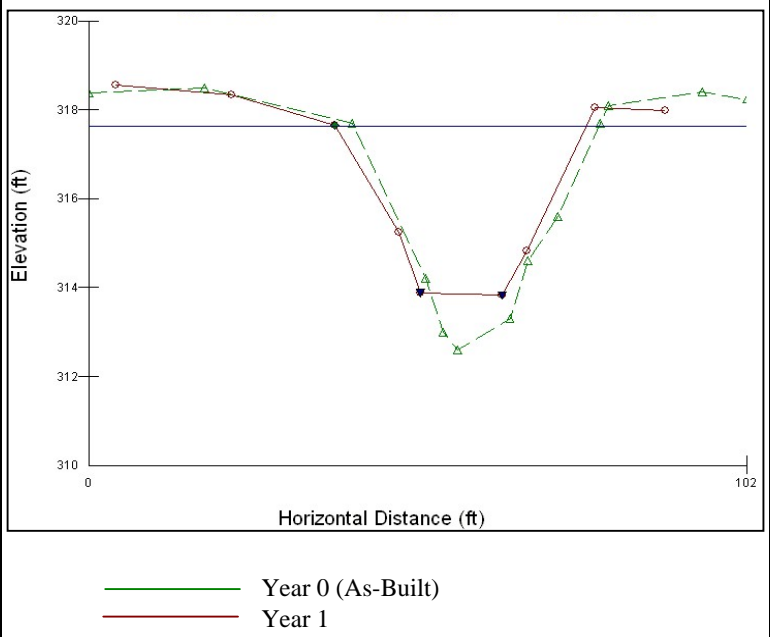
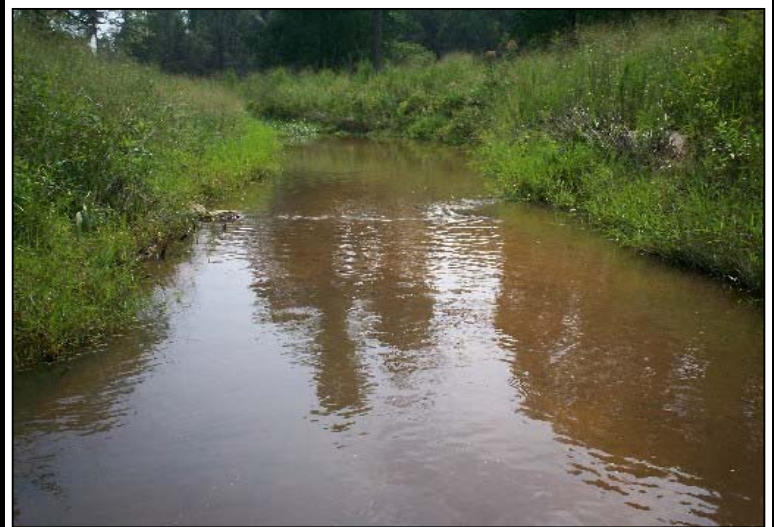
Cross Section Plot - Looking Downstream

Summary Data	
Bankfull Cross-Sectional Area:	95.7
Bankfull Width:	38.92
Bankfull Mean Depth:	2.46
Bankfull Max Depth:	3.82
Width/Depth Ratio:	15.82
Entrenchment Ratio:	2.19
Classification:	C5

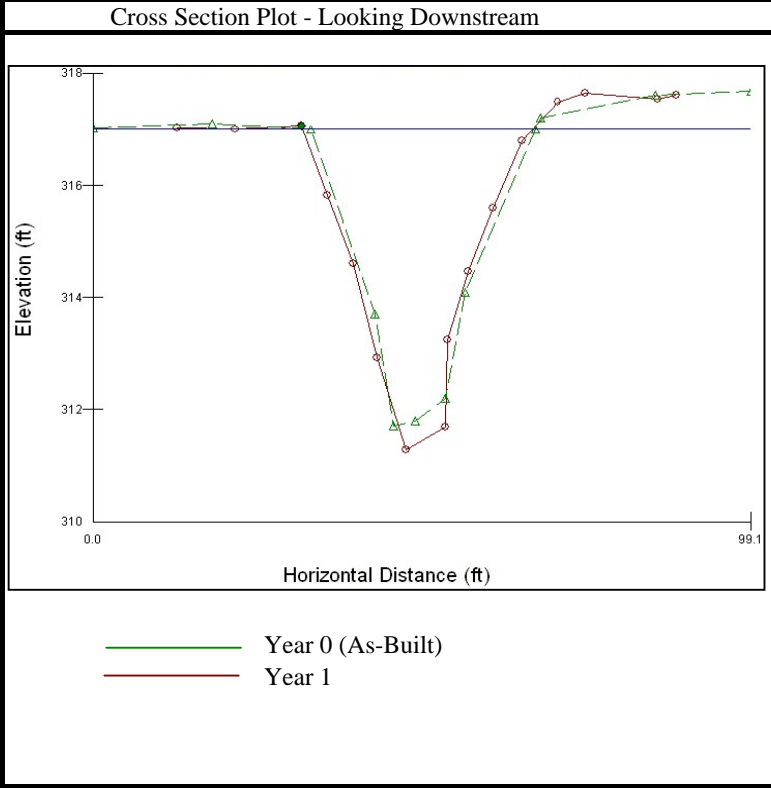
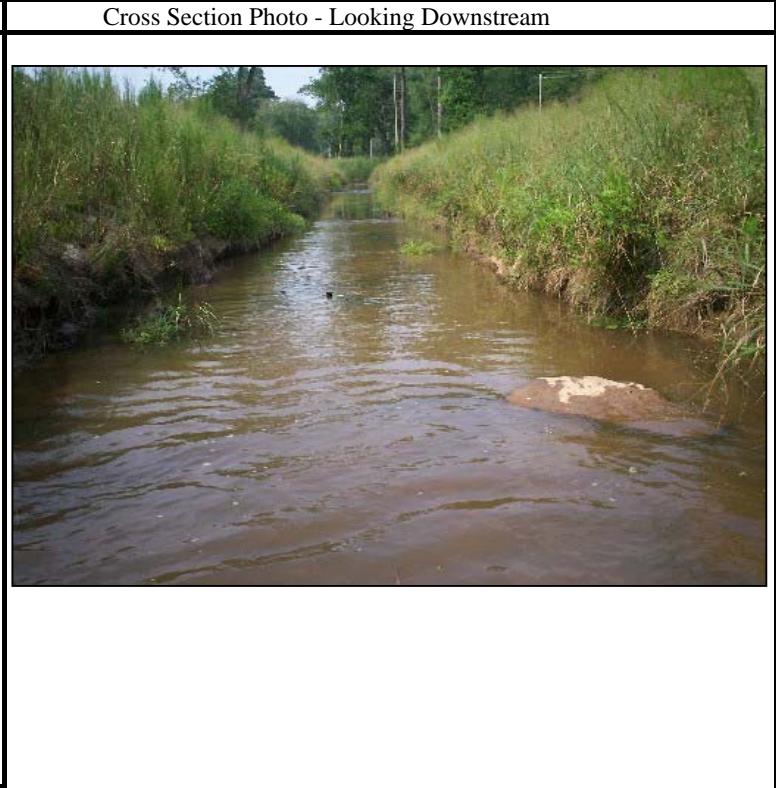
Cross Section 5 - Riffle, 25+38

Summary Data	
Bankfull Cross-Sectional Area:	97.44
Bankfull Width:	39.35
Bankfull Mean Depth:	2.48
Bankfull Max Depth:	5.73
Width/Depth Ratio:	15.87
Entrenchment Ratio:	1.91
Classification:	C5

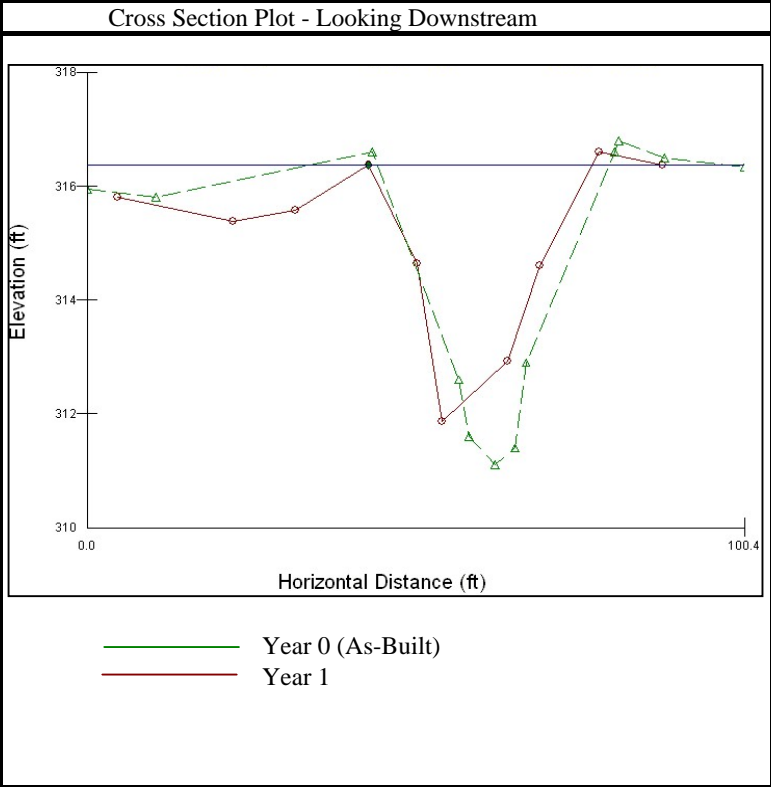
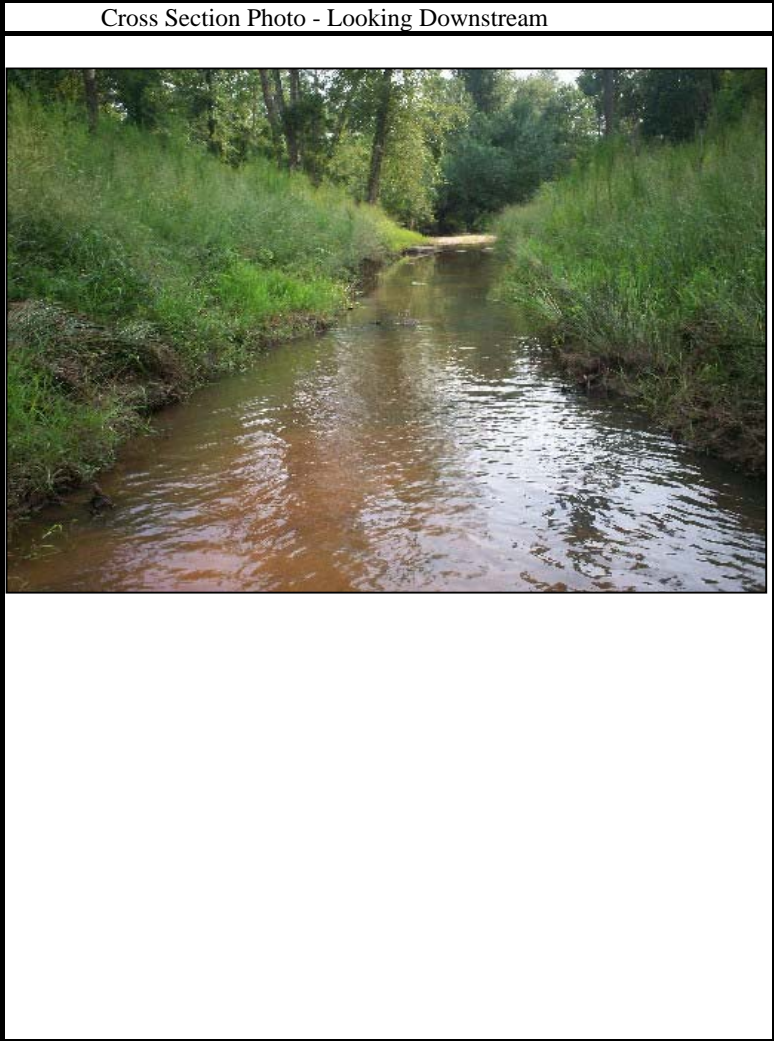
Cross Section 6 - Riffle, 27+93

Bankfull Cross-Sectional Area:	78.21
Bankfull Width:	35.21
Bankfull Mean Depth:	2.22
Bankfull Max Depth:	4.51
Width/Depth Ratio:	15.86
Entrenchment Ratio:	2.37
Classification:	C5

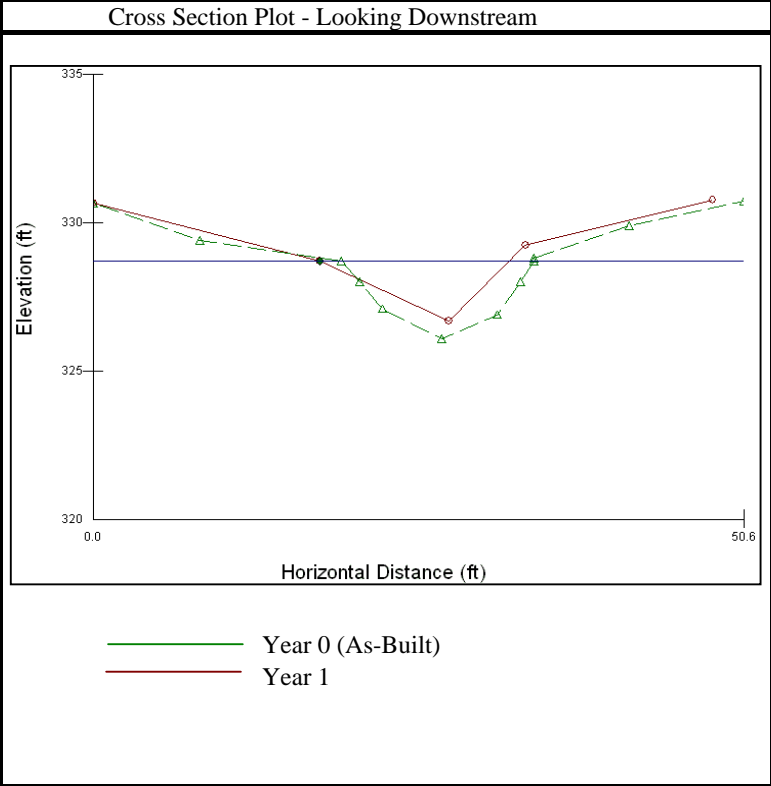
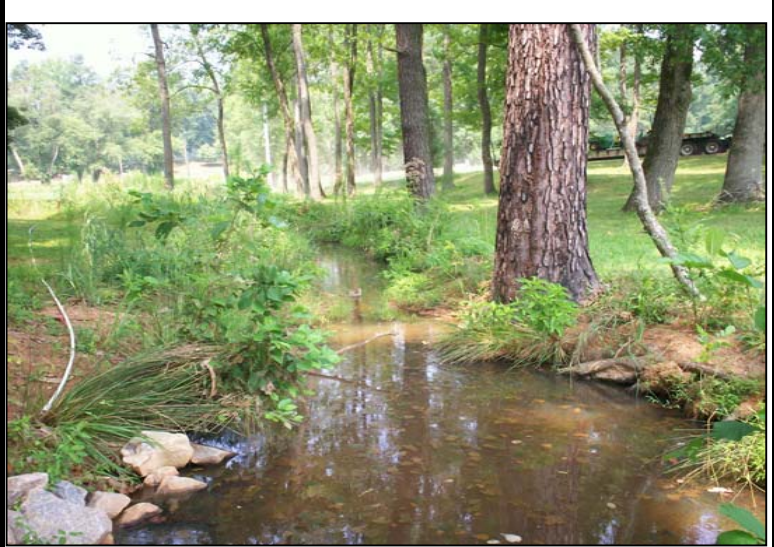
Cross Section 7 - Riffle, 0+08

Summary Data	
Bankfull Cross-Sectional Area:	14.8
Bankfull Width:	14.72
Bankfull Mean Depth:	1
Bankfull Max Depth:	2.01
Width/Depth Ratio:	14.72
Entrenchment Ratio:	3.23
Classification:	E5
