**HORSE CREEK (WAKE FOREST COUNTRY CLUB)
2007 FINAL MONTORING REPORT
YEAR 2 OF 5
2007**

EEP Project # 409
Wake County, North Carolina

HORSE CREEK (WAKE FOREST COUNTRY CLUB) STREAM RESTORATION YEAR 2 MONITORING REPORT

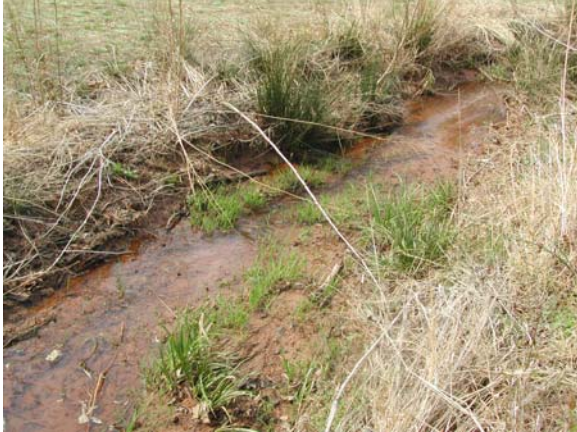
Photo 1: Representative grass aggradation problem area (11+85 along unnamed tributary).

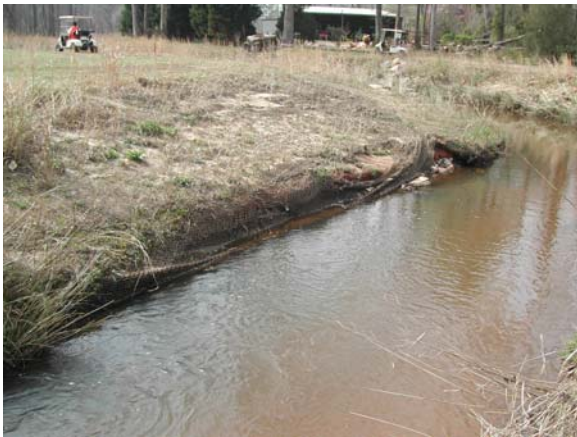
Photo 3: Representative bank erosion problem area (16+16 along mainstem).

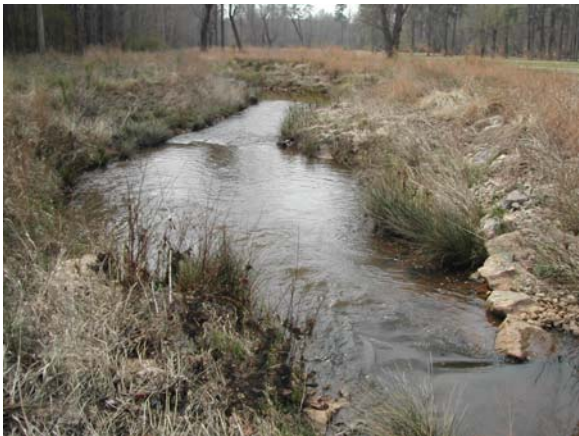
Photo 7: Representative over-widening of the channel (26+19 along mainstem).
