**HORSE CREEK (WAKE FOREST COUNTRY CLUB)
FINAL MONTORING REPORT**

YEAR 3

EEP Project # 409

Wake County, North Carolina

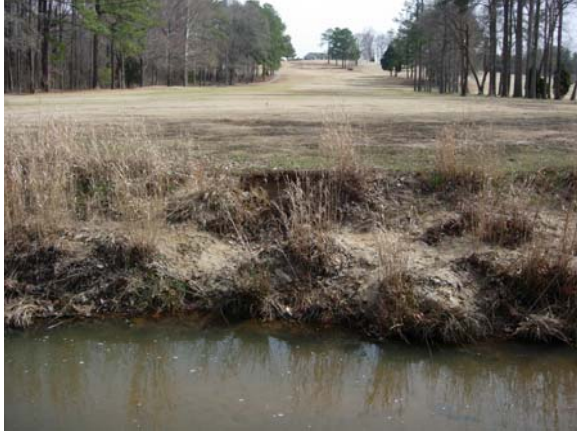
Photo 1: Representative past mowed/maintained floodplain problem area (Approximate Station 11+00 view upstream along main stem; 2-15-2008).

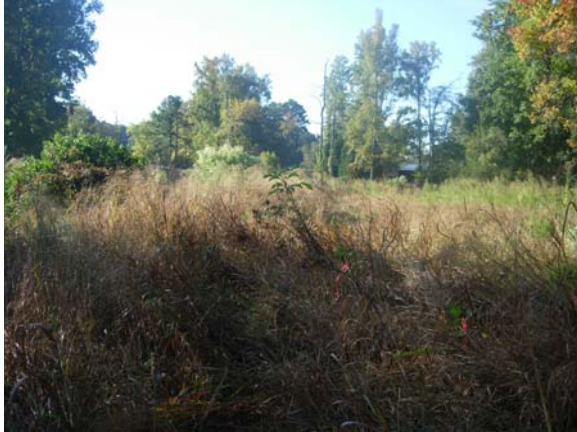
The vegetation plots (VP) impacted by past-mowing (i.e., VP C, E, and O) have stem densities below 260 stems/acre (Monitoring Year 5 goal). However, if natural volunteer stems are included in the density calculations, all vegetation plots pass the Monitoring Year 5 stem density goal. Therefore, planted stem densities of less than the Monitoring Year 5 goal should not be interpreted as an indication of the planted species being completely inappropriate, or the growing conditions being severely inhospitable. In fact, the evidence of naturalization of volunteer stems suggests the growing conditions are suitable for good herbaceous and woody vegetative growth

Photo 1: Vegetation Plot C (10-15-2008).

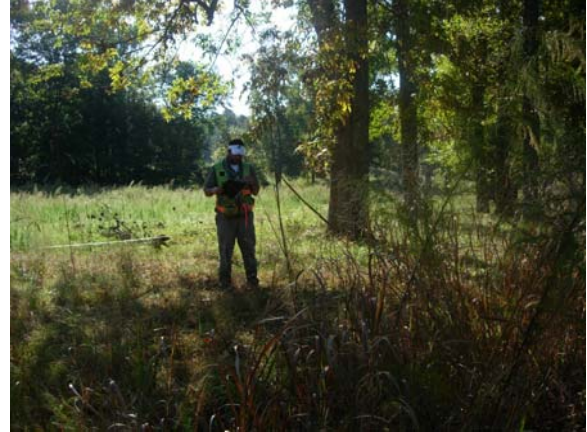
Photo 2: Vegetation Plot E (10-15-2008).

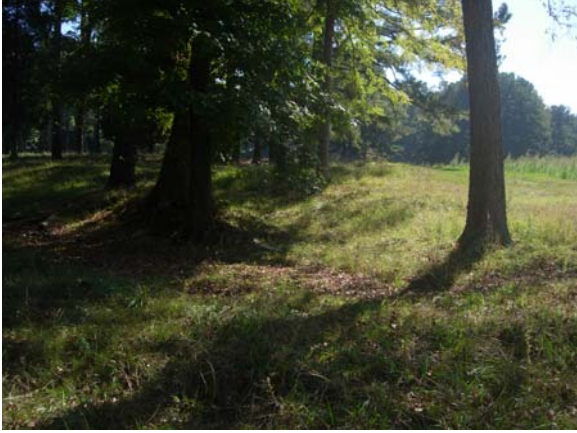
Photo 7: Vegetation Plot O (10-16-2008).

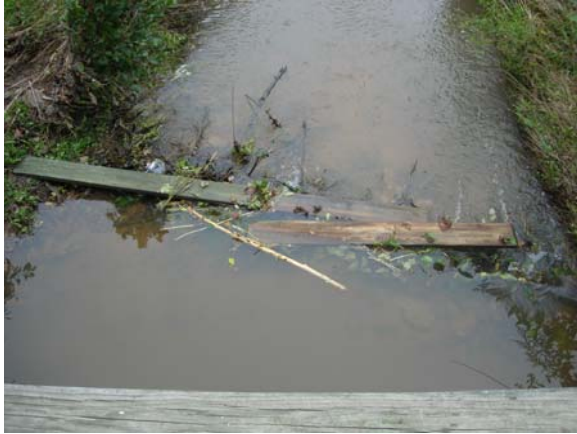
The overall water surface slope for both streams remained consistent since Monitoring Year 2. The main development in Monitoring Year 3 has been the building of beaver dams at 4 locations along the Horse Creek mainstem. These dams have effectively caused an increase in total pool length of 30% in mainstem Horse Creek reach (i.e., from 2,028 ft to 2,626 ft) and reduced the total length of riffle habitat by 43% (i.e., from 585 ft to 331 ft) between Monitoring Years 2 and 3. Median pool length increased from 57.4 ft to 89.9 ft, and median riffle length decreased from 20.3 ft to 12.2 ft between Monitoring Years 2 and 3. In addition, water surface slopes of the remaining riffles have increased as a result of the beaver dams (i.e., slope increased as a function of decreased riffle length).

Photo 1: Representative beaver-dam problem area (Station 10+98; view downstream along Horse Creek; 9-30-2008).

Monitoring Year 3 monitoring showed that the Horse Creek mainstem section had a stable dimension and pattern, with the exception of extensive areas of bank slumping. The bank slumping areas were concentrated downstream of Station 26+25. There are two crossvanes and two J-hooks that have piping and/or backarm scour that may warrant repair assessment. There have been changes in profile, presumably as a result of the construction of beaver dams in Monitoring Year 3. The result of this damming has been an 30% increase in the total length of pool habitat and a 43% reduction in total length of riffle habitat. Removal of the beaver dams may be warranted.

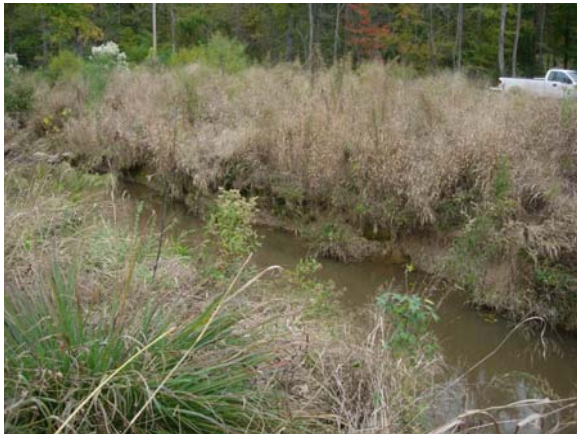
downcutting occurred between Monitoring Years 0 and 2. This downcutting may be one of the causes of the significant amount of on-going bank erosion observed in this section of the project (i.e. as stream downcuts width/depth ratio decreases, leaving the reach prone to widening). The cross-section graphs are located in Appendix B4.

Photo 3: Representative severe bank erosion problem area (Station 34+28; view upstream of left bank along Horse Creek; 10-29-2008).

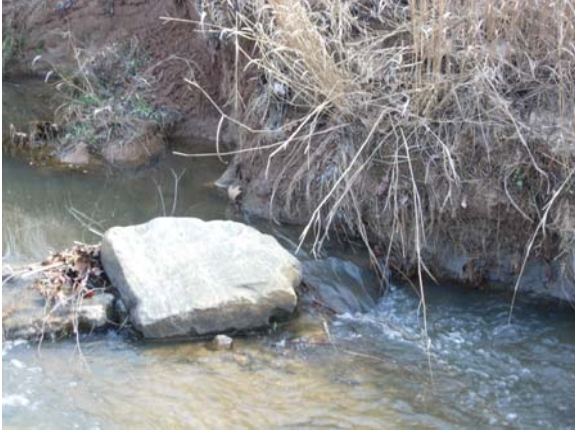
Photo 5: Representative j-hook problem area, Horse Creek (Station 37+07 view upstream of piping along left side of structure; 2-15-2008).

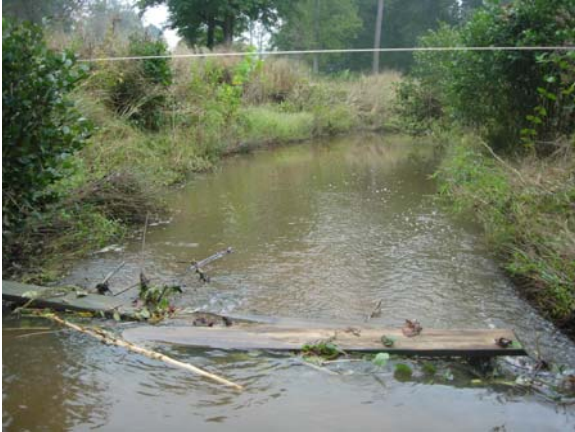
Cross-Section 1: View downstream. Horse Creek (9-30-2008). Note beaver dam at Station 10+98.

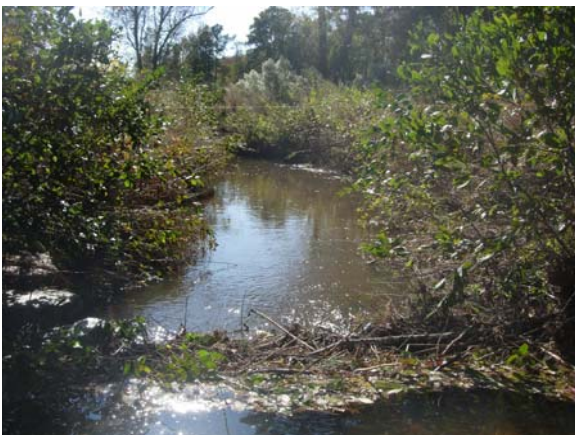
Cross-Section 3: View downstream. Horse Creek (10-28-2008). Note beaver dam at Station 25+14.

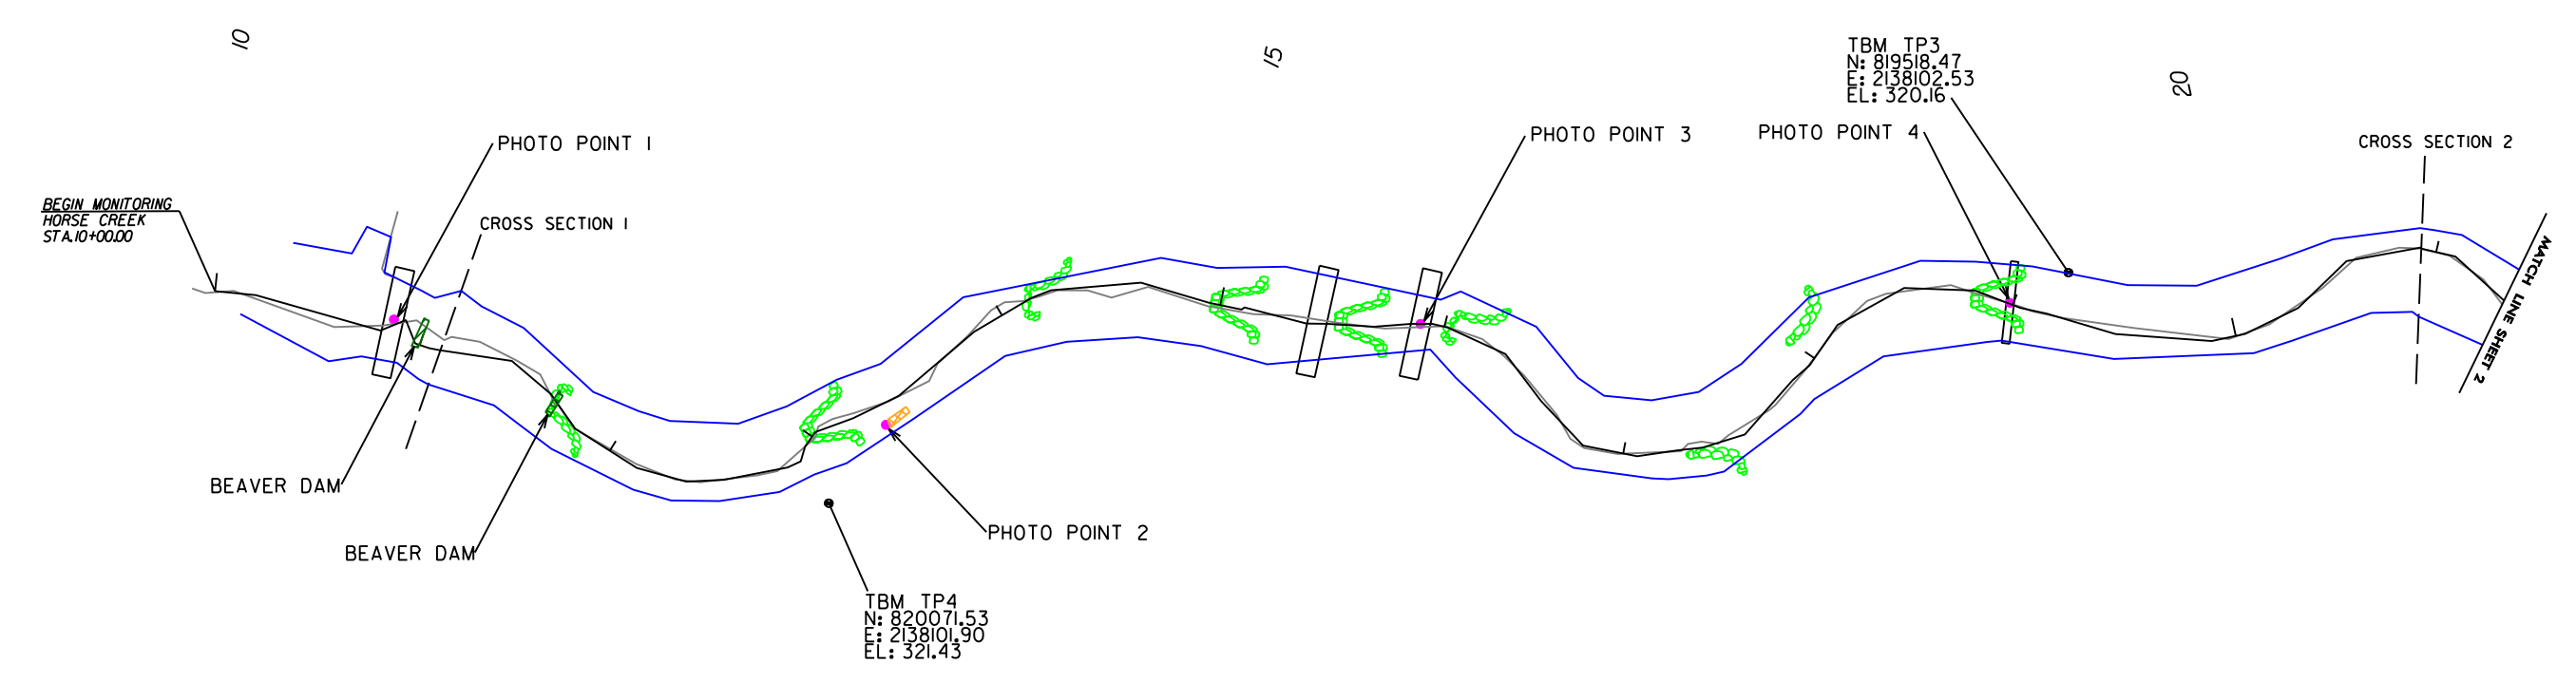
LOCATION:	HORSE CREEK	
	CURRENT CONDITIONS PLAN VIEW	
	STREAM MONITORING - YEAR 3	
PROJ #:	182	COUNTY: WAKE
PREPARED BY:	IPJ	
CHECKED BY:	PDB	DATE: 2/10/09

Table X, located in Appendix B3, describes the problem areas, station numbers, and respective probable causes. The most major problem along mainstem Horse Creek was the slumping of banks along the bottom third of the reach. Most bank erosion upstream of the UT Horse Creek confluence has healed over with new vegetation. Much of the bank erosion observed in the lower mainstem was rated severe. It appears that the main causes of erosion were a lack of deeply rooted vegetation at stress points, soil stability, bank angle, and/or overwidening due to possible downcutting along this section of the project. In addition, beaver dams have been a new development in Monitoring Year 3. There are four dams, located at Stations 10+98, 11+66, 22+56, and 25+14. As described in Section 3.2.1, the result has been an 30% increase in the total length of pool habitat and a 43% reduction in total length of riffle habitat. In addition, median pool length and median riffle slope have both increased, and median riffle length has decreased, presumably as a result of beaver damming. In addition, there were two problem crossvanes and two problem j-hooks noted in Monitoring Year 3. The most severe of these was a crossvane located at Station 34+07 where piping and back arm scour of the right arm (facing downstream). The crossvane located at Station 34+91 had significant piping and back arm scour of the left arm (facing downstream). The problem j-hooks are located at Stations 36+28 and 37+07 and had piping of water/scour around a piece of the structure.

The most major problem to note along UT Horse Creek was a long section of aggradation between Stations 14+18 and 15+14. This area will be observed during future monitoring efforts. In addition, the crossvane at Station 12+27 along UT Horse Creek has piping of water around the right arm (facing downstream), a rock missing from the right arm, and the pool is filled in with sediment. The other two crossvanes (i.e., Station 12+75 and 14+00) both have piping of water around or under a piece of the structure. The stream problem area plan view, located in Appendix C, shows the locations and severity of these problem area.
