**HORSE CREEK (WAKE FOREST COUNTRY CLUB)
FINAL MONITORING REPORT
YEAR 4 OF 5
2009**

EEP Project # 409
Wake County, North Carolina

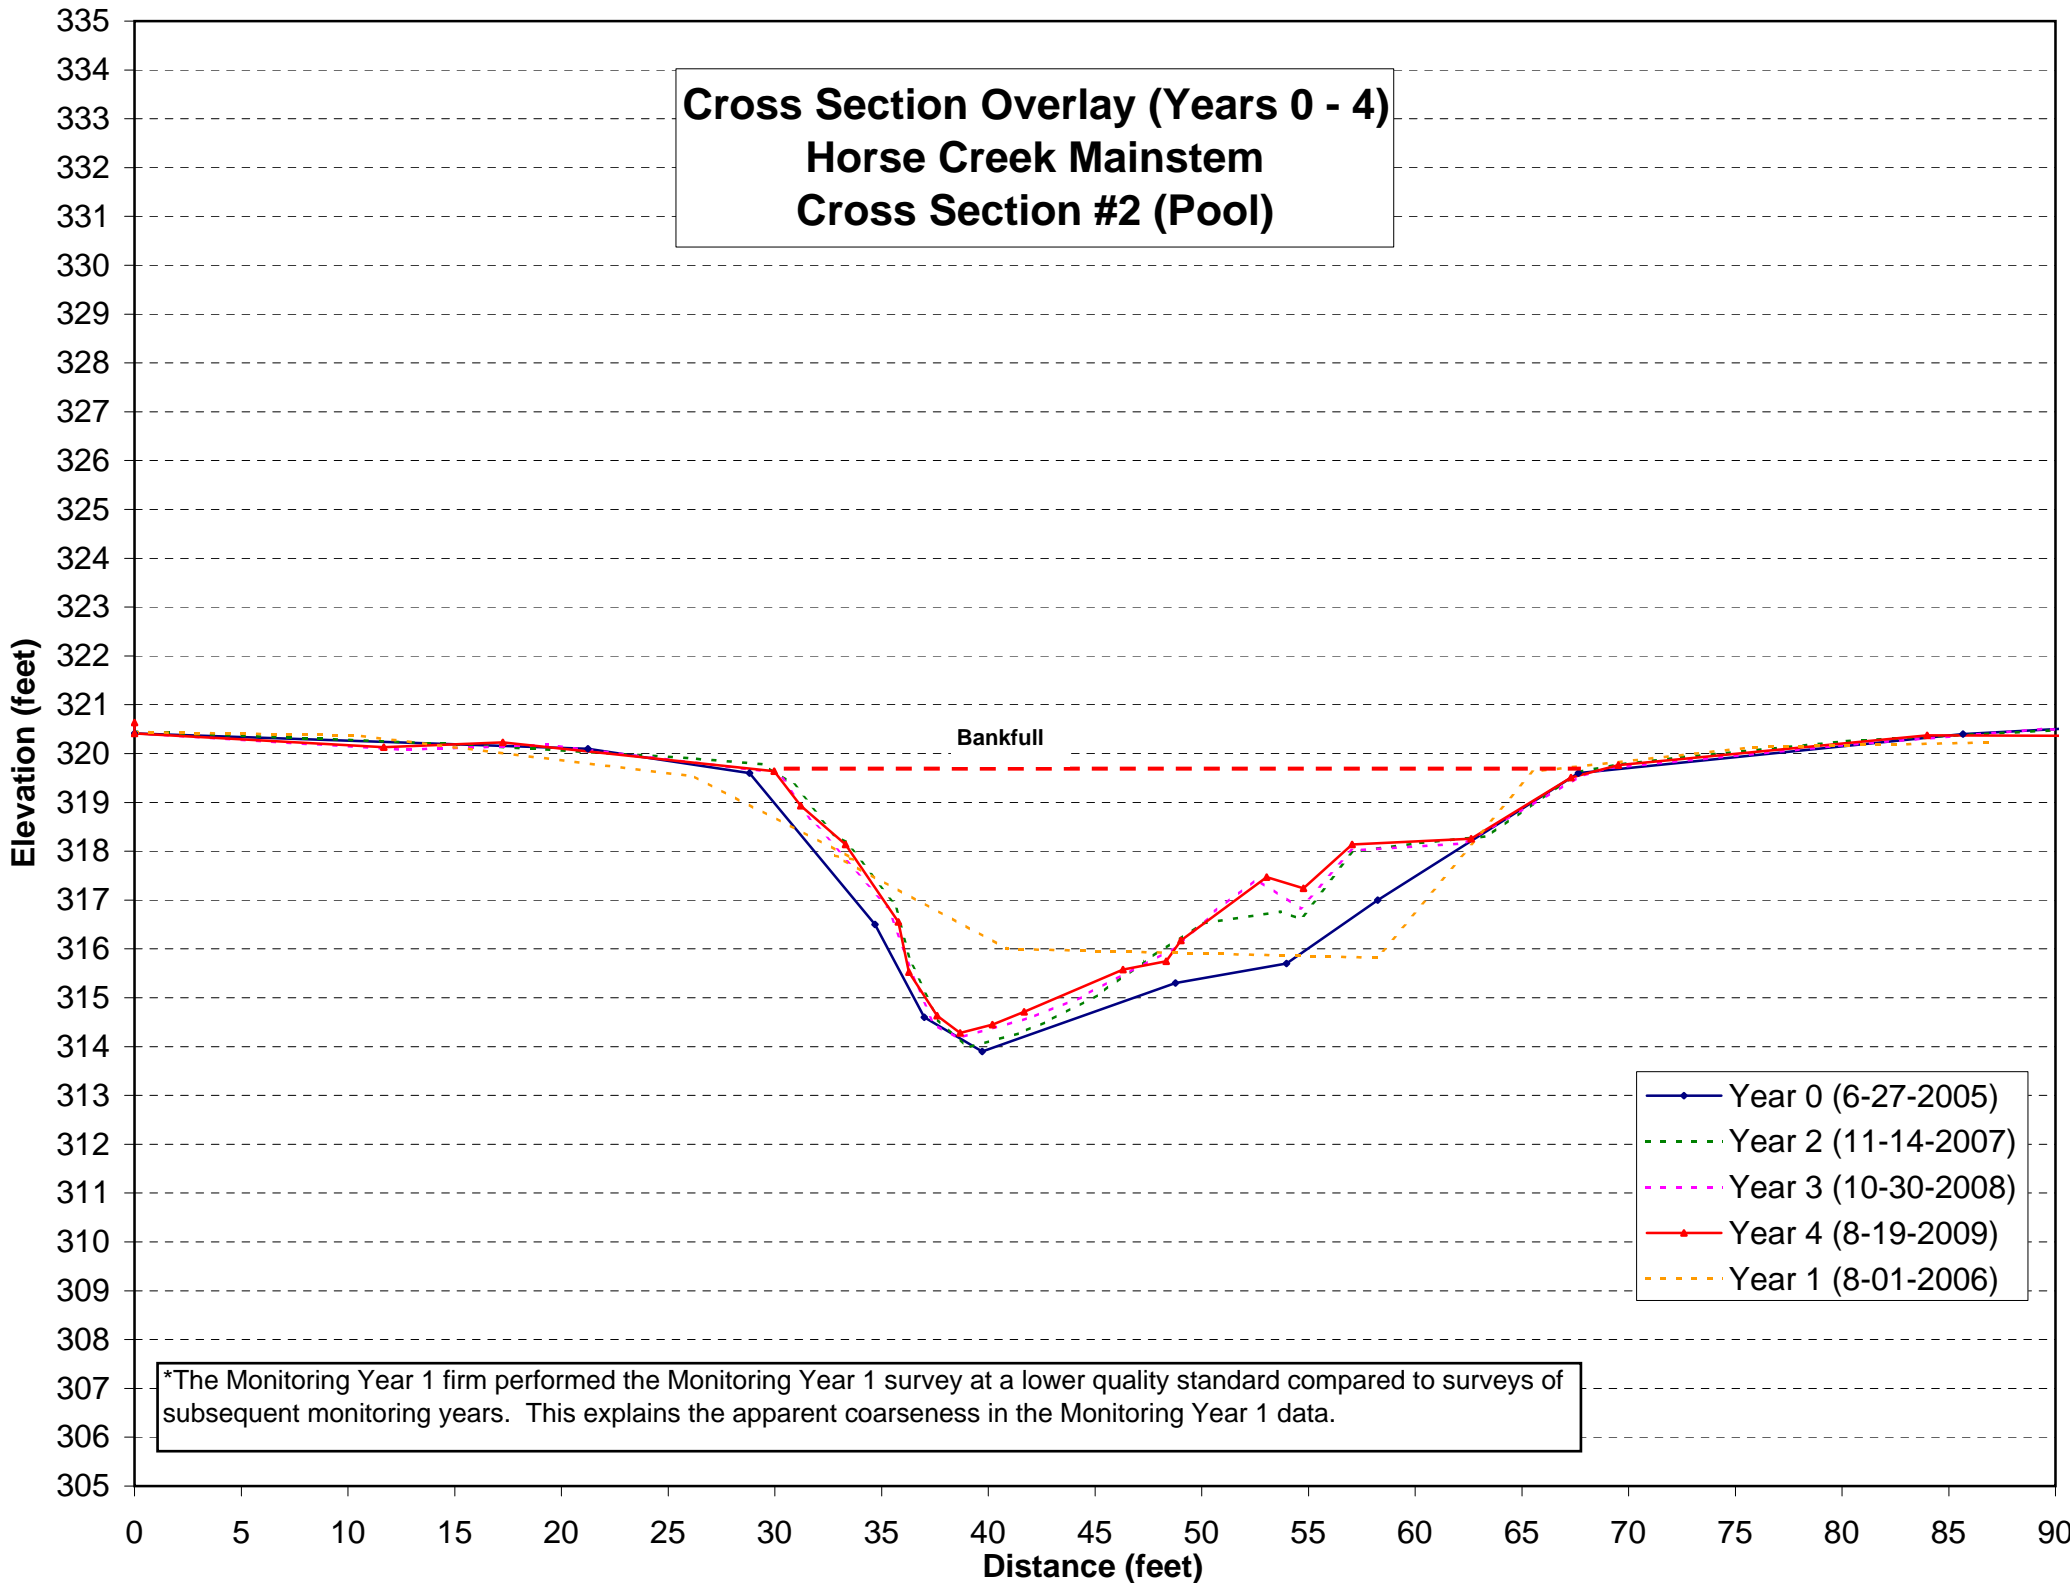
Cross Section Overlay (Years 0 - 4)
Horse Creek Mainstem
Cross Section #2 (Pool)

*The Monitoring Year 1 firm performed the Monitoring Year 1 survey at a lower quality standard compared to surveys of subsequent monitoring years. This explains the apparent coarseness in the Monitoring Year 1 data.

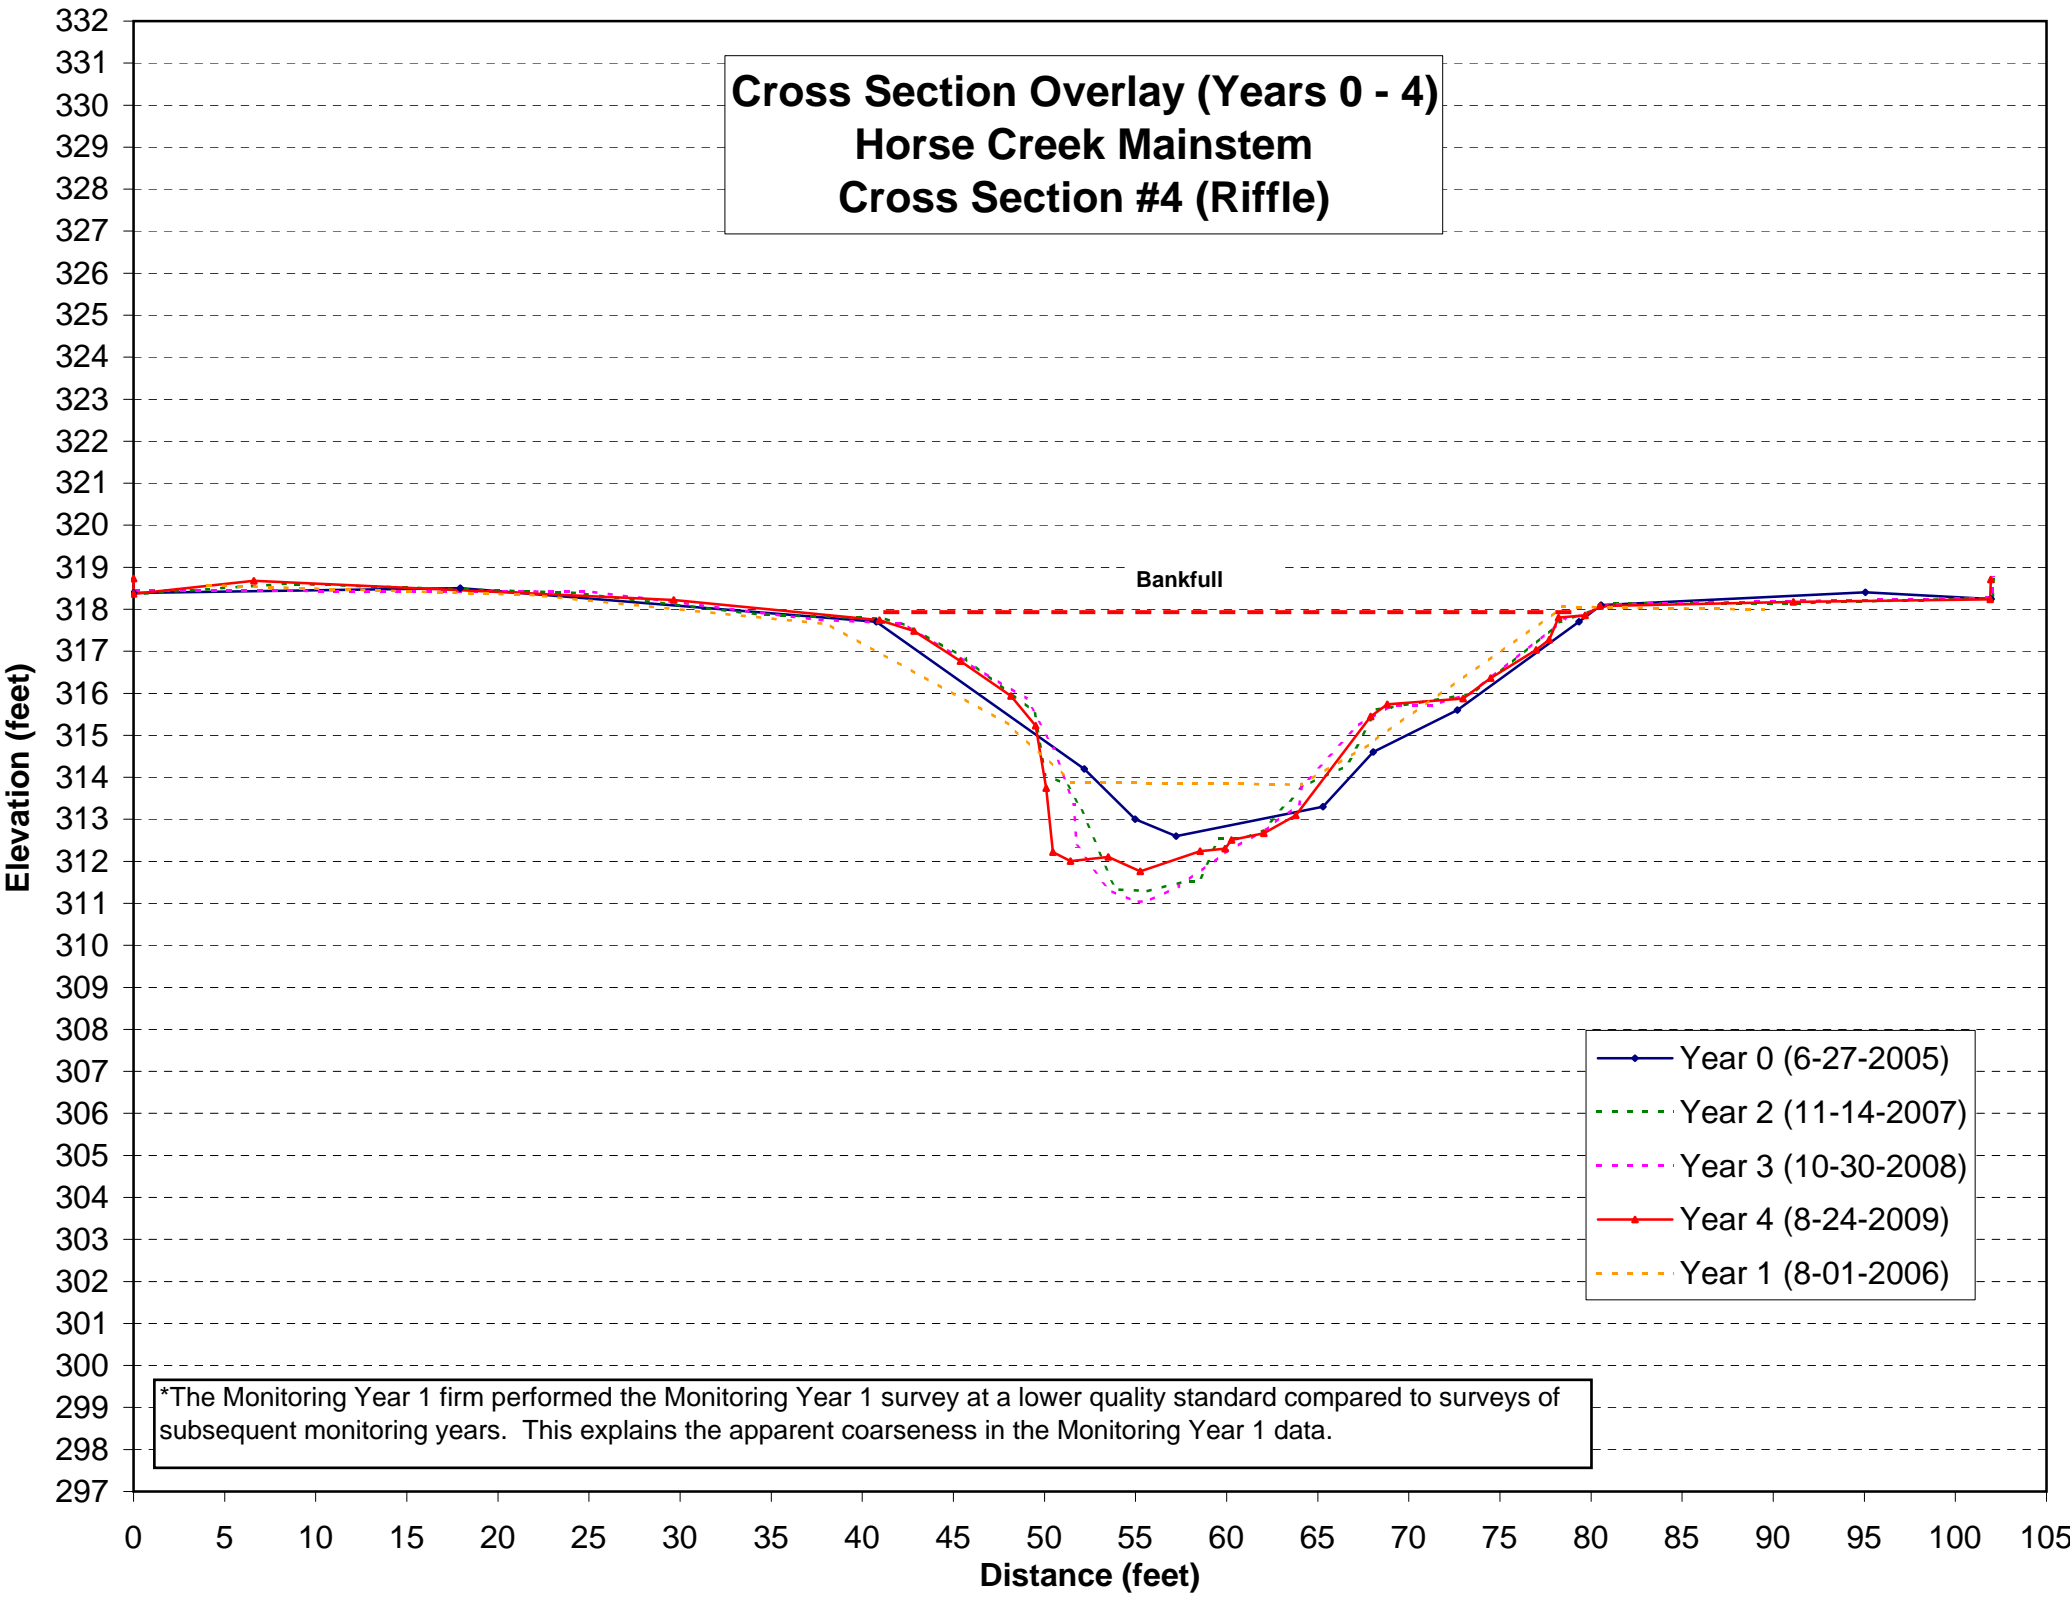
**Cross Section Overlay (Years 0 - 4)
Horse Creek Mainstem
Cross Section #4 (Riffle)**

*The Monitoring Year 1 firm performed the Monitoring Year 1 survey at a lower quality standard compared to surveys of subsequent monitoring years. This explains the apparent coarseness in the Monitoring Year 1 data.

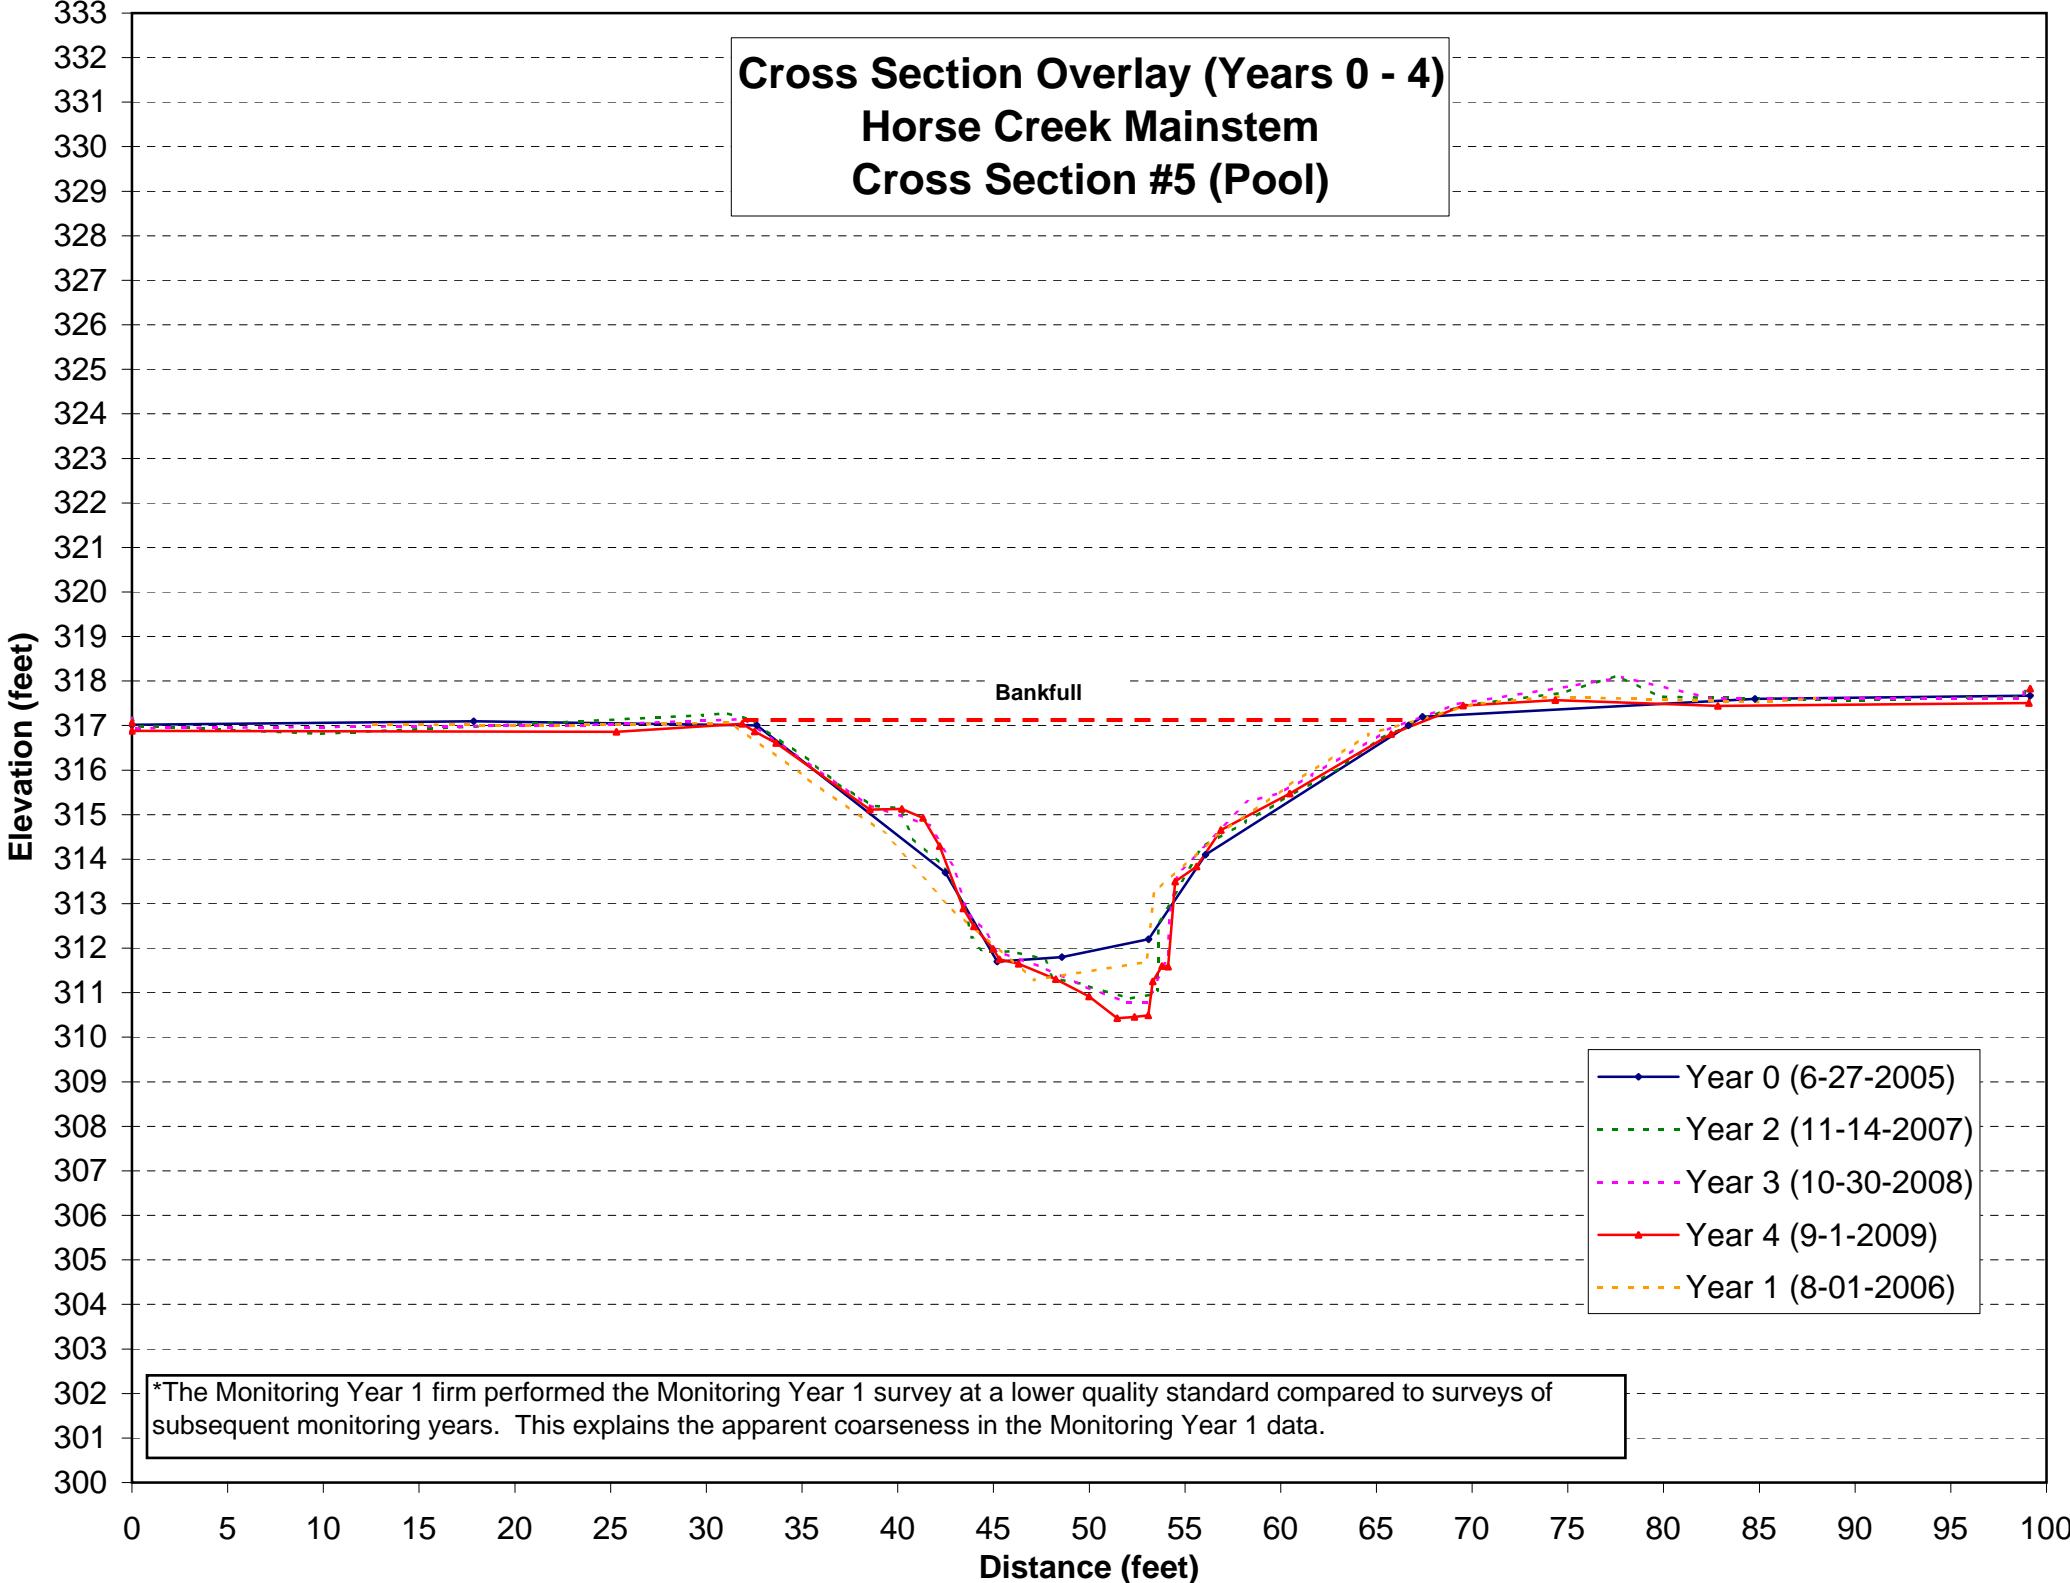
Cross Section Overlay (Years 0 - 4)
Horse Creek Mainstem
Cross Section #5 (Pool)

*The Monitoring Year 1 firm performed the Monitoring Year 1 survey at a lower quality standard compared to surveys of subsequent monitoring years. This explains the apparent coarseness in the Monitoring Year 1 data.

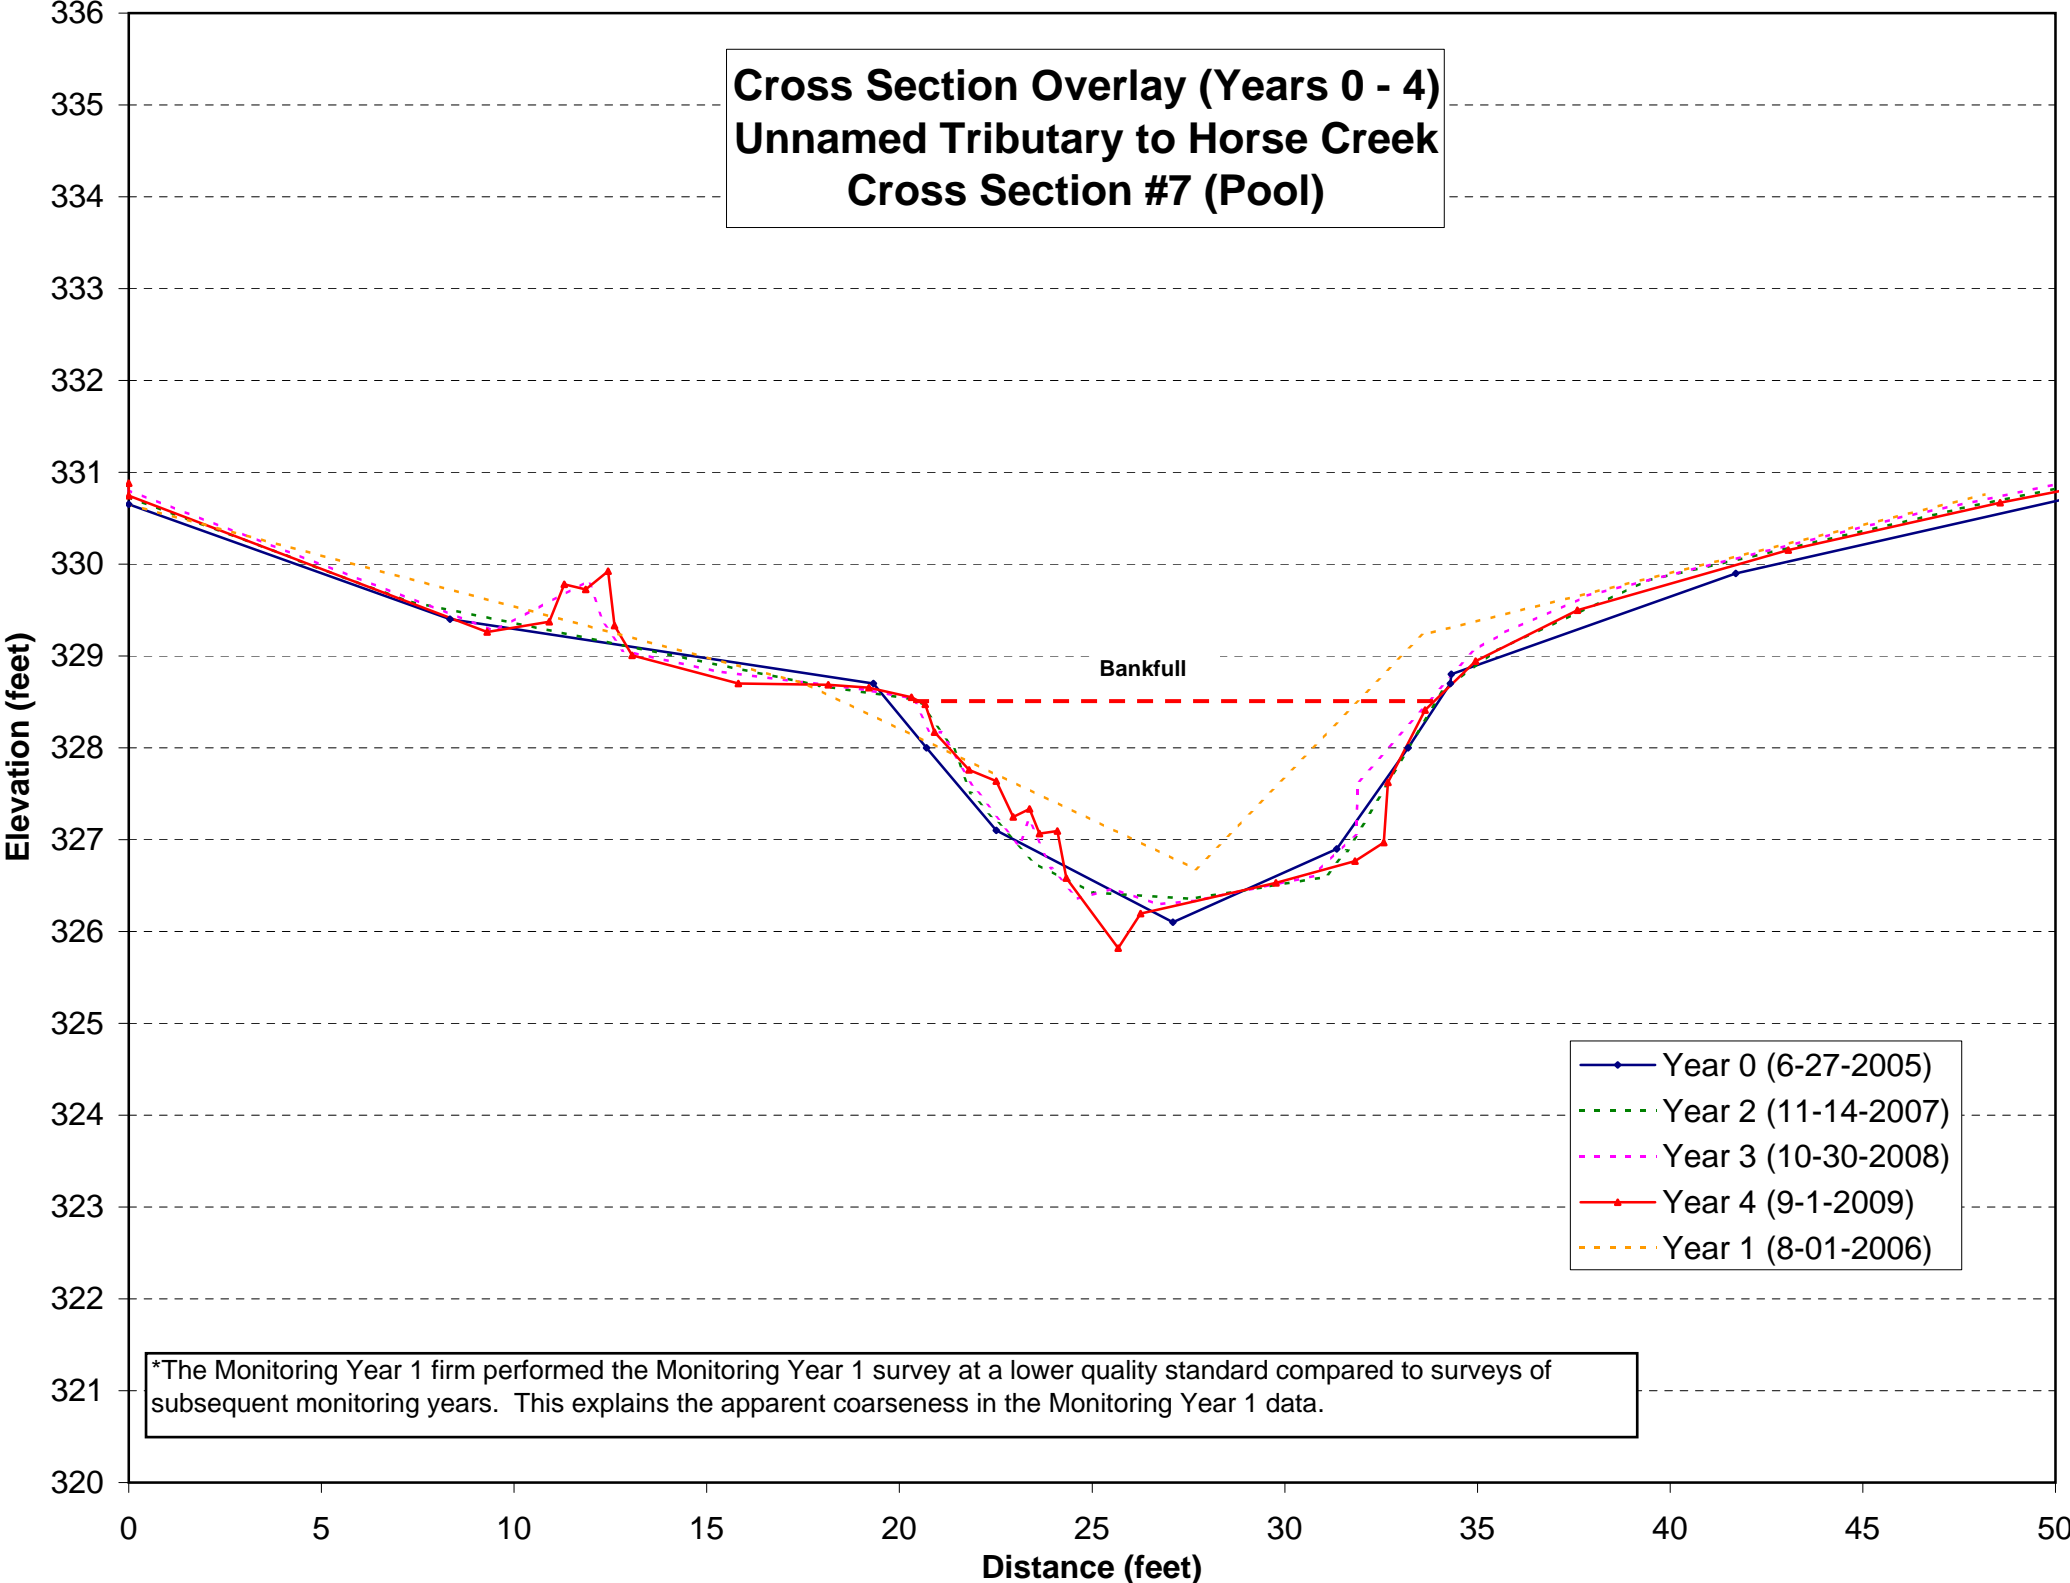
**Cross Section Overlay (Years 0 - 4)
Unnamed Tributary to Horse Creek
Cross Section #7 (Pool)**

*The Monitoring Year 1 firm performed the Monitoring Year 1 survey at a lower quality standard compared to surveys of subsequent monitoring years. This explains the apparent coarseness in the Monitoring Year 1 data.

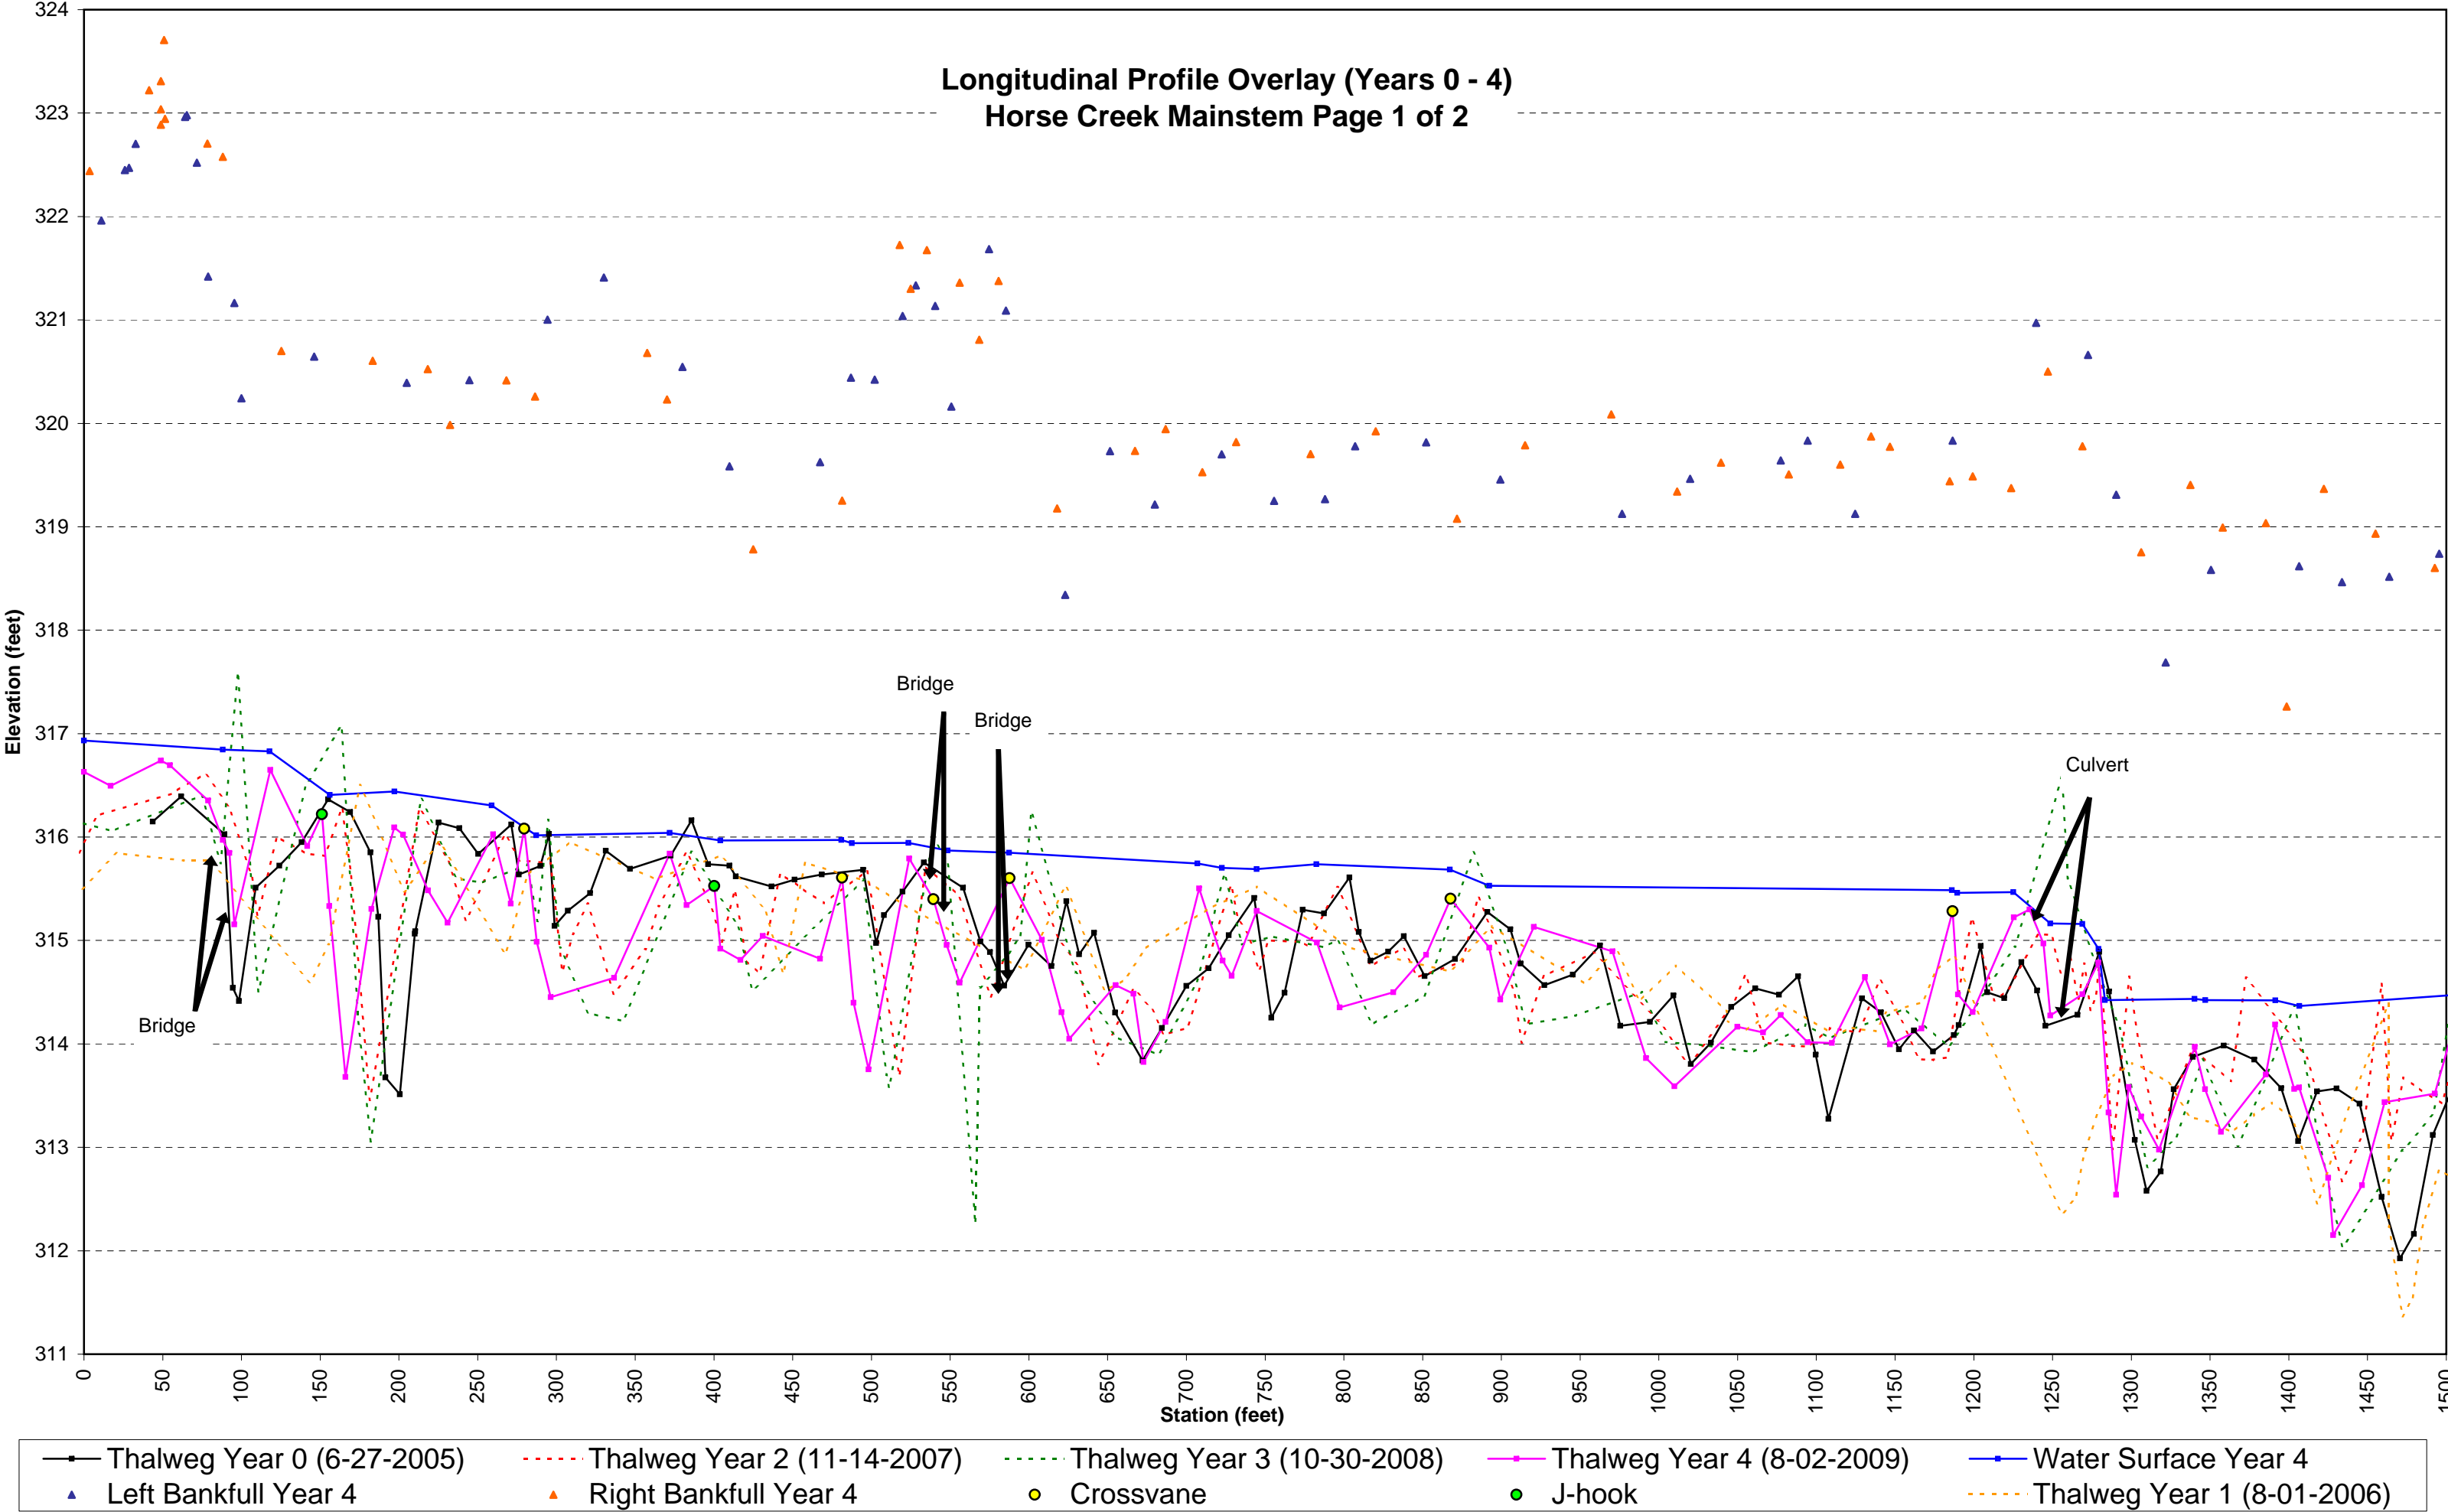
Longitudinal Profile Overlay (Years 0 - 4) Horse Creek Mainstem Page 1 of 2

*The Monitoring Year 1 firm performed the Monitoring Year 1 survey at a lower quality standard compared to surveys of subsequent monitoring years. This

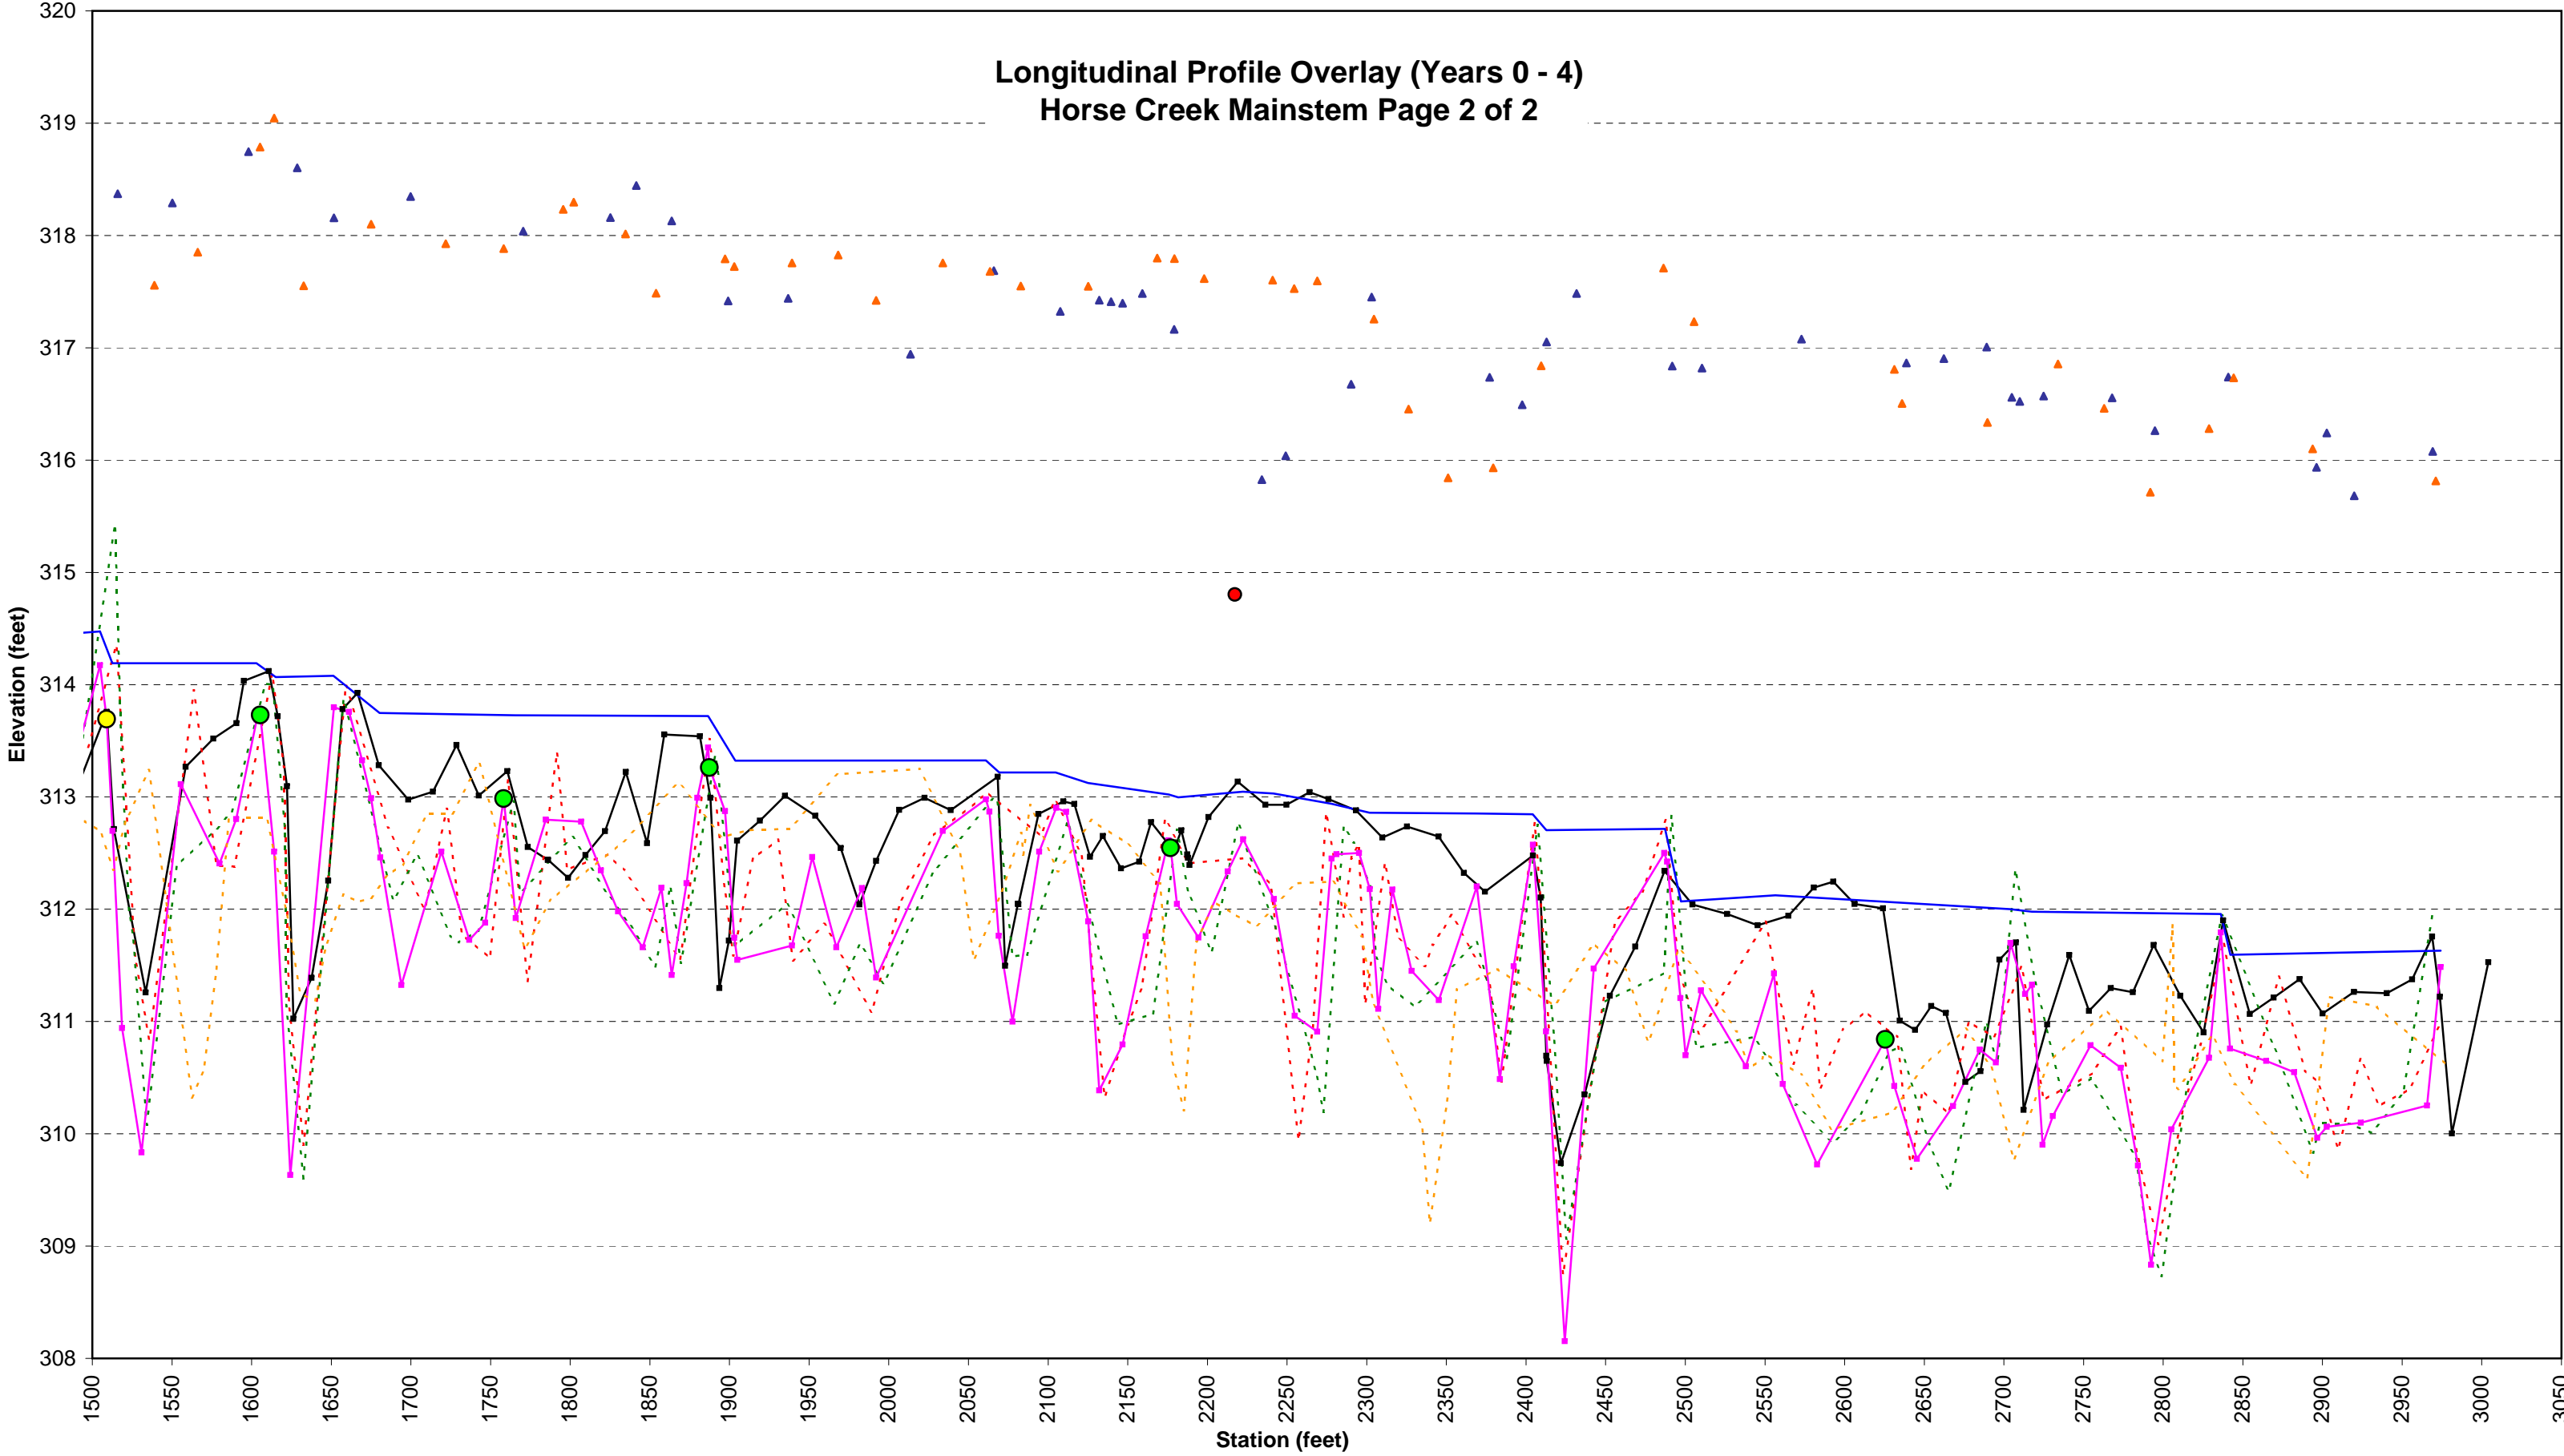
Longitudinal Profile Overlay (Years 0 - 4)
Horse Creek Mainstem Page 2 of 2

*The Monitoring Year 1 firm performed the Monitoring Year 1 survey at a lower quality standard compared to surveys of subsequent monitoring years. This
