**HORSE CREEK (WAKE FOREST COUNTRY CLUB)
FINAL MONITORING REPORT
YEAR 4 OF 5
2009**

EEP Project # 409
Wake County, North Carolina

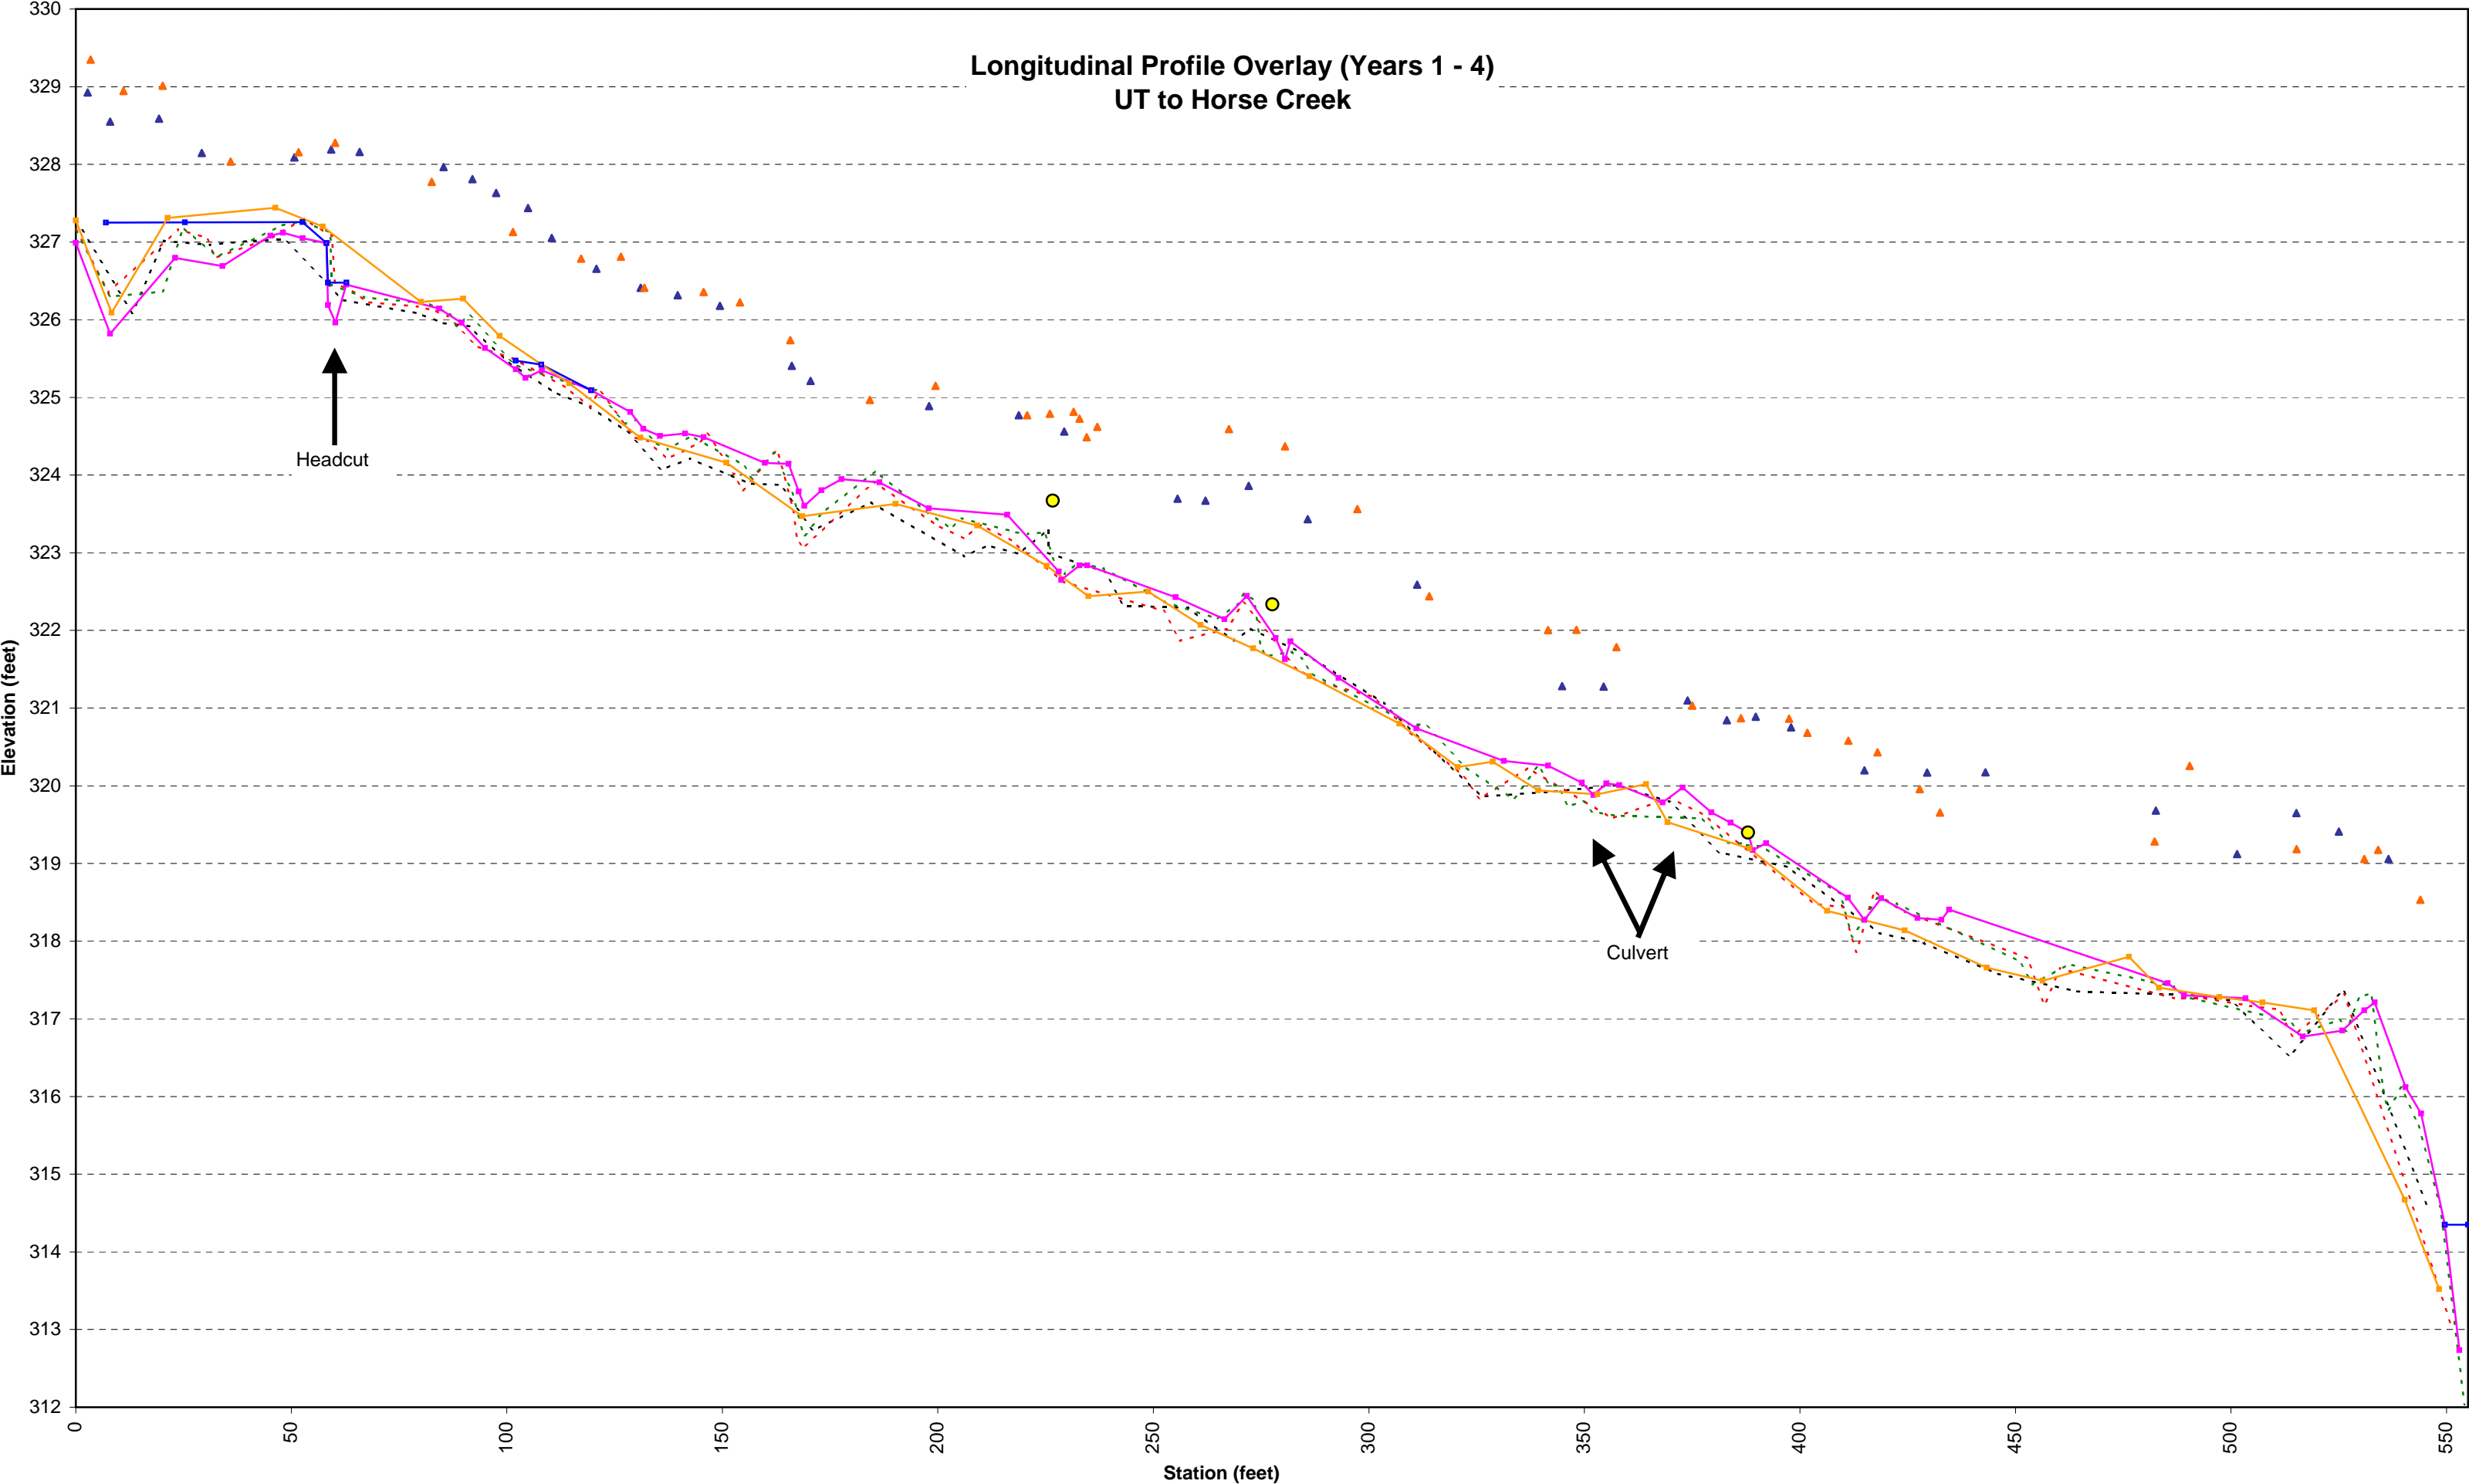
Longitudinal Profile Overlay (Years 1 - 4) UT to Horse Creek

The UT Horse Creek reach has remained stable for Monitoring year 4. The headcut observed in Monitoring Years 2 and 3 has progressed upstream only a couple of inches, but will be observed closely during Monitoring Year 5. The channel bed appears to have risen significantly along one section toward the downstream end of the UT reach during Monitoring Year 4 (see longitudinal profile overlay figure; Appendix D). It should be noted that the UT reach was essentially dry at the time of surveying, and appeared to have been dry for a while as grass was growing in the channel along nearly the entire reach. Only the upstream portion of the channel, from the culvert outlet at the upstream end to the headcut (Station 10+59), had water in the channel. This grass growth and resulting soil development within the channel may have contributed to the observed streambed rise in the downstream aggradational area. In addition, all three cross vanes had water piping around and/or under some part of the structure.
