**HORSE CREEK (WAKE FOREST COUNTRY CLUB)
FINAL MONITORING REPORT
YEAR 5 OF 5
2010**

EEP Project #409
Wake County, North Carolina

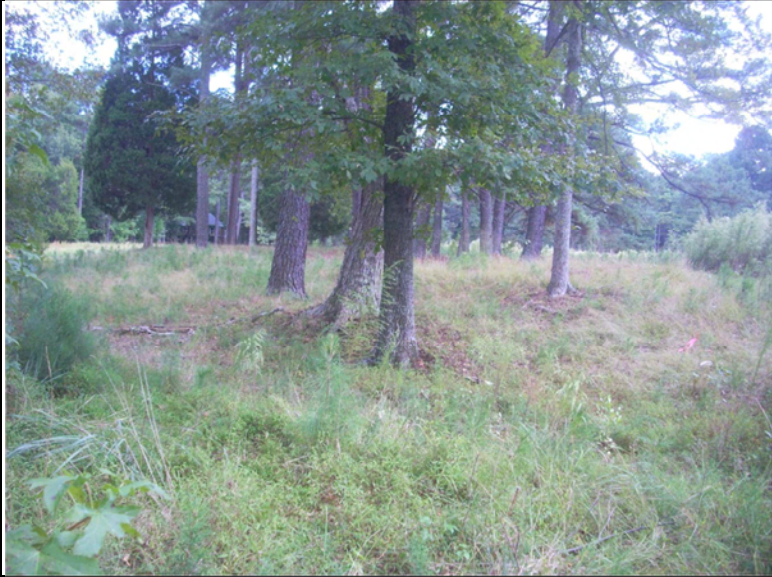
Photo 7: Vegetation Plot O (10-4-2010)

The vegetation plots (VP) impacted by past-mowing (i.e., VP C, E, I, and O) have stem densities below 260 stems/acre (Monitoring Year 5 goal). Planted stems across all plots were measured at 243 stems / acre. Although planted stem densities were less than the Monitoring Year 5 goal, overall stem densities including native volunteers exceeded 260 stems / acre. Growing conditions appear to support locally adapted species. However, supplemental plantings will benefit several regions.

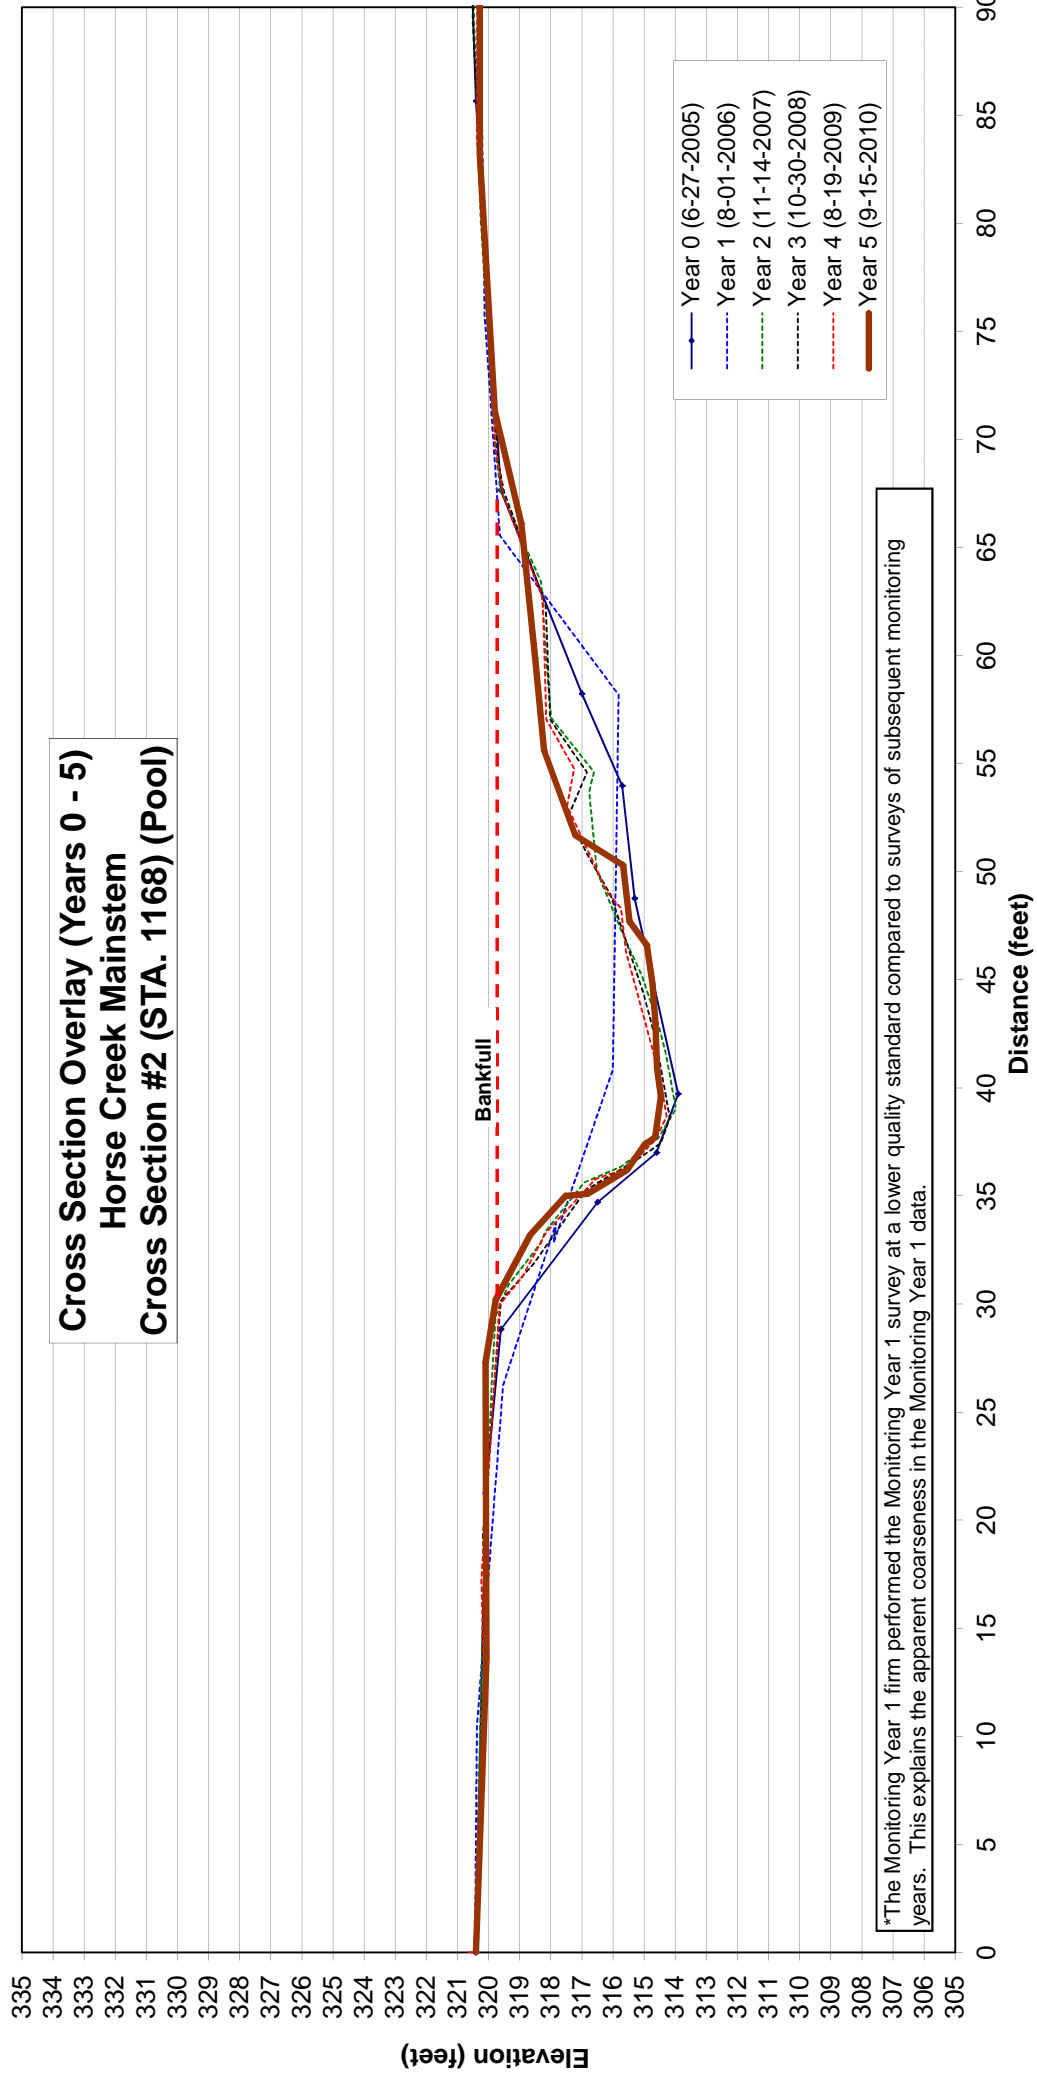
**Cross Section Overlay (Years 0 - 5)
Horse Creek Mainstem
Cross Section #2 (STA. 1168) (Pool)**

*The Monitoring Year 1 firm performed the Monitoring Year 1 survey at a lower quality standard compared to surveys of subsequent monitoring years. This explains the apparent coarseness in the Monitoring Year 1 data.

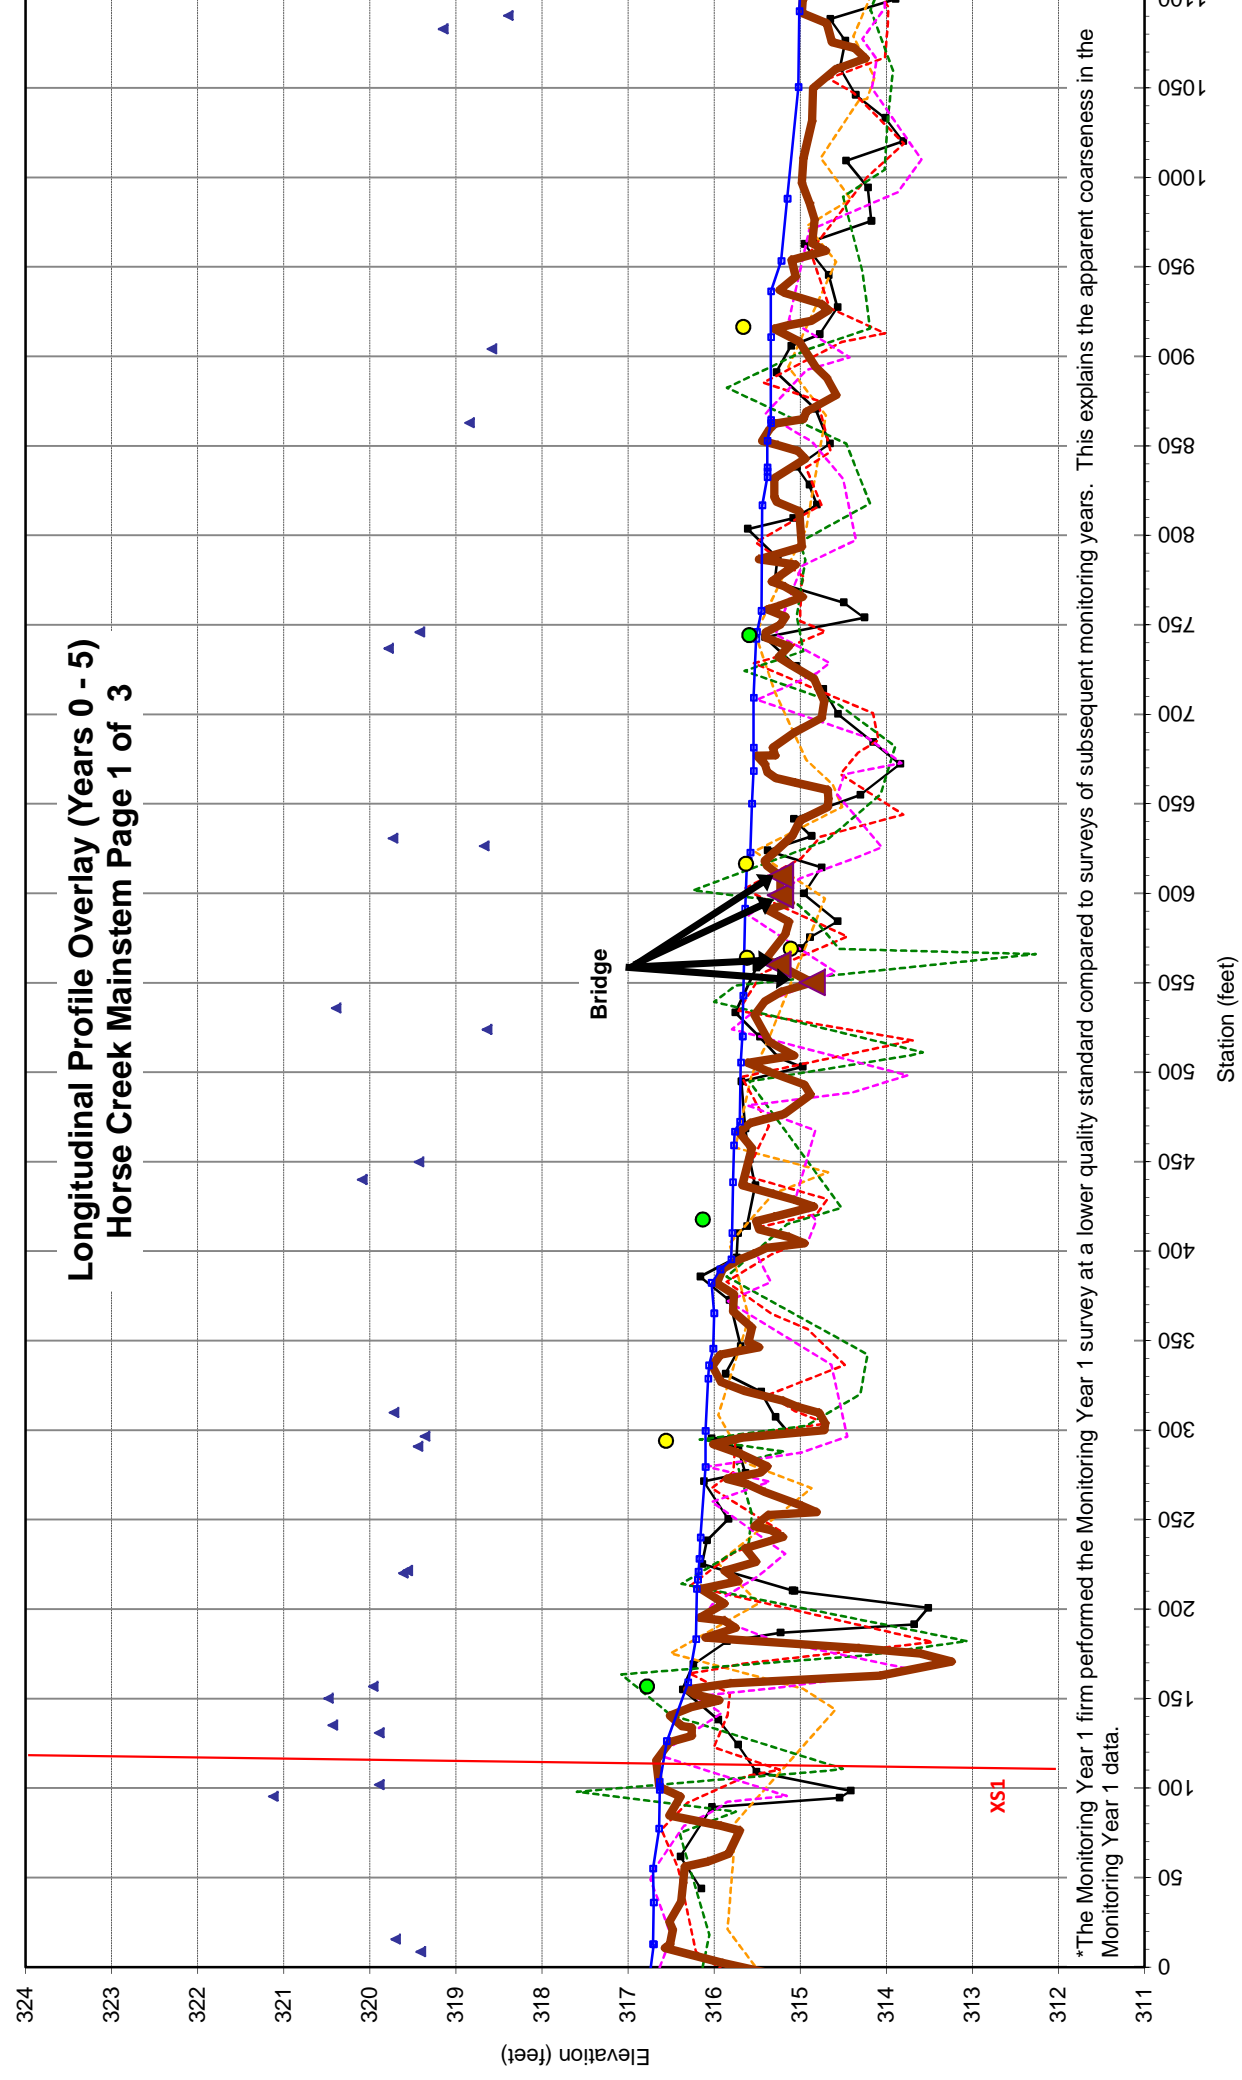
Longitudinal Profile Overlay (Years 0 - 5) Horse Creek Mainstem Page 1 of 3

Year 5 monitoring continued to show that the Horse Creek main stem continues to exhibit bank instability in the form of bank erosion and slumping. Overall approximately 8% of the stream banks can be classified as unstable. The actual cause of these erosional areas may be attributed to a combination of steep banks, a lack of soil stability, and/or a lack of deeply rooted vegetation in these areas. In-stream structures instability was observed in two sections: within the UT between stations 12+00 and 13+00 and within the main stem between stations 34+00 and 39+00. Bank protection and piping are the dominant failures within the project reaches. Evidence of new Beaver dams along the main stem was observed below the Station 25+00.

*The Monitoring Year 1 firm performed the Monitoring Year 1 survey at a lower quality standard compared to surveys of subsequent monitoring years. This explains the apparent coarseness in the Monitoring Year 1 data.

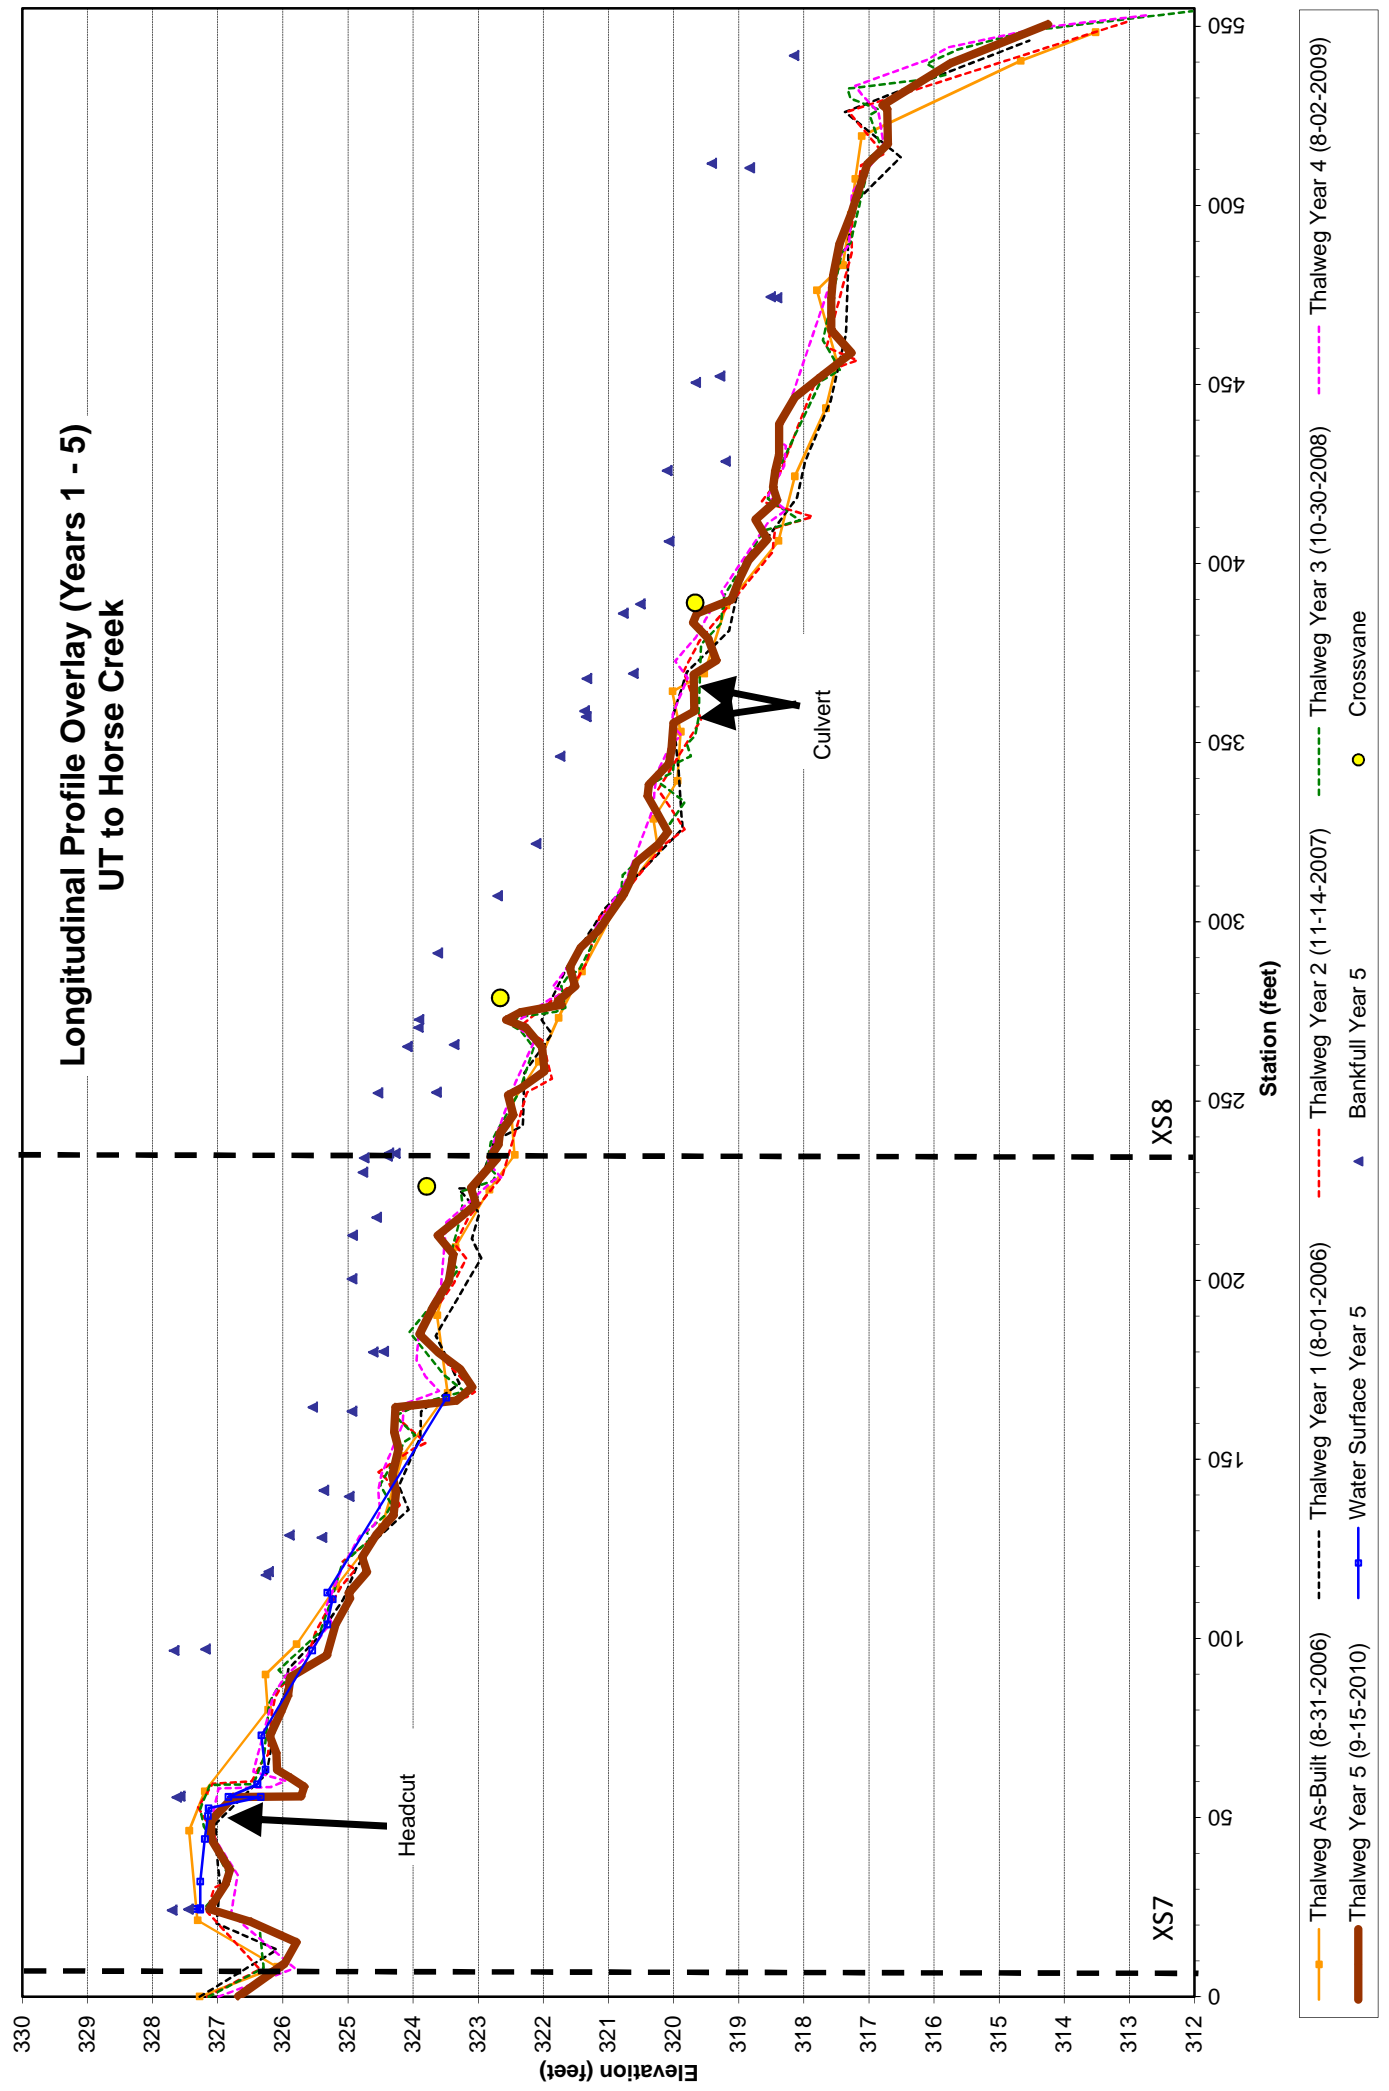
Longitudinal Profile Overlay (Years 1 - 5) UT to Horse Creek

The UT Horse Creek reach has remained stable for Monitoring year 5. The headcut observed in Monitoring Years 2,3, and 4 has progressed upstream only a couple of inches during Year 5. As in Year 4, the UT reach was essentially dry at the time of surveying, and appeared to have been dry for a while as grass was growing in the channel along nearly the entire reach. The section of rising stream bed mentioned in Year 4 has maintained grade. Only the upstream portion of the channel, from the culvert outlet at the upstream end to the headcut (Station 10+59), had water in the channel. This grass growth and resulting soil development within the channel may have contributed to the observed streambed rise in the downstream aggradational area. In addition, two cross vanes (Stations 12+28 and 12+77) had water piping around and/or under some part of the structure.
