**FINAL  
MY4 (2023) MONITORING REPORT**

**WARREN WILSON COLLEGE STREAM MITIGATION SITE**

Buncombe County, North Carolina

NCDMS Project ID No. 100019

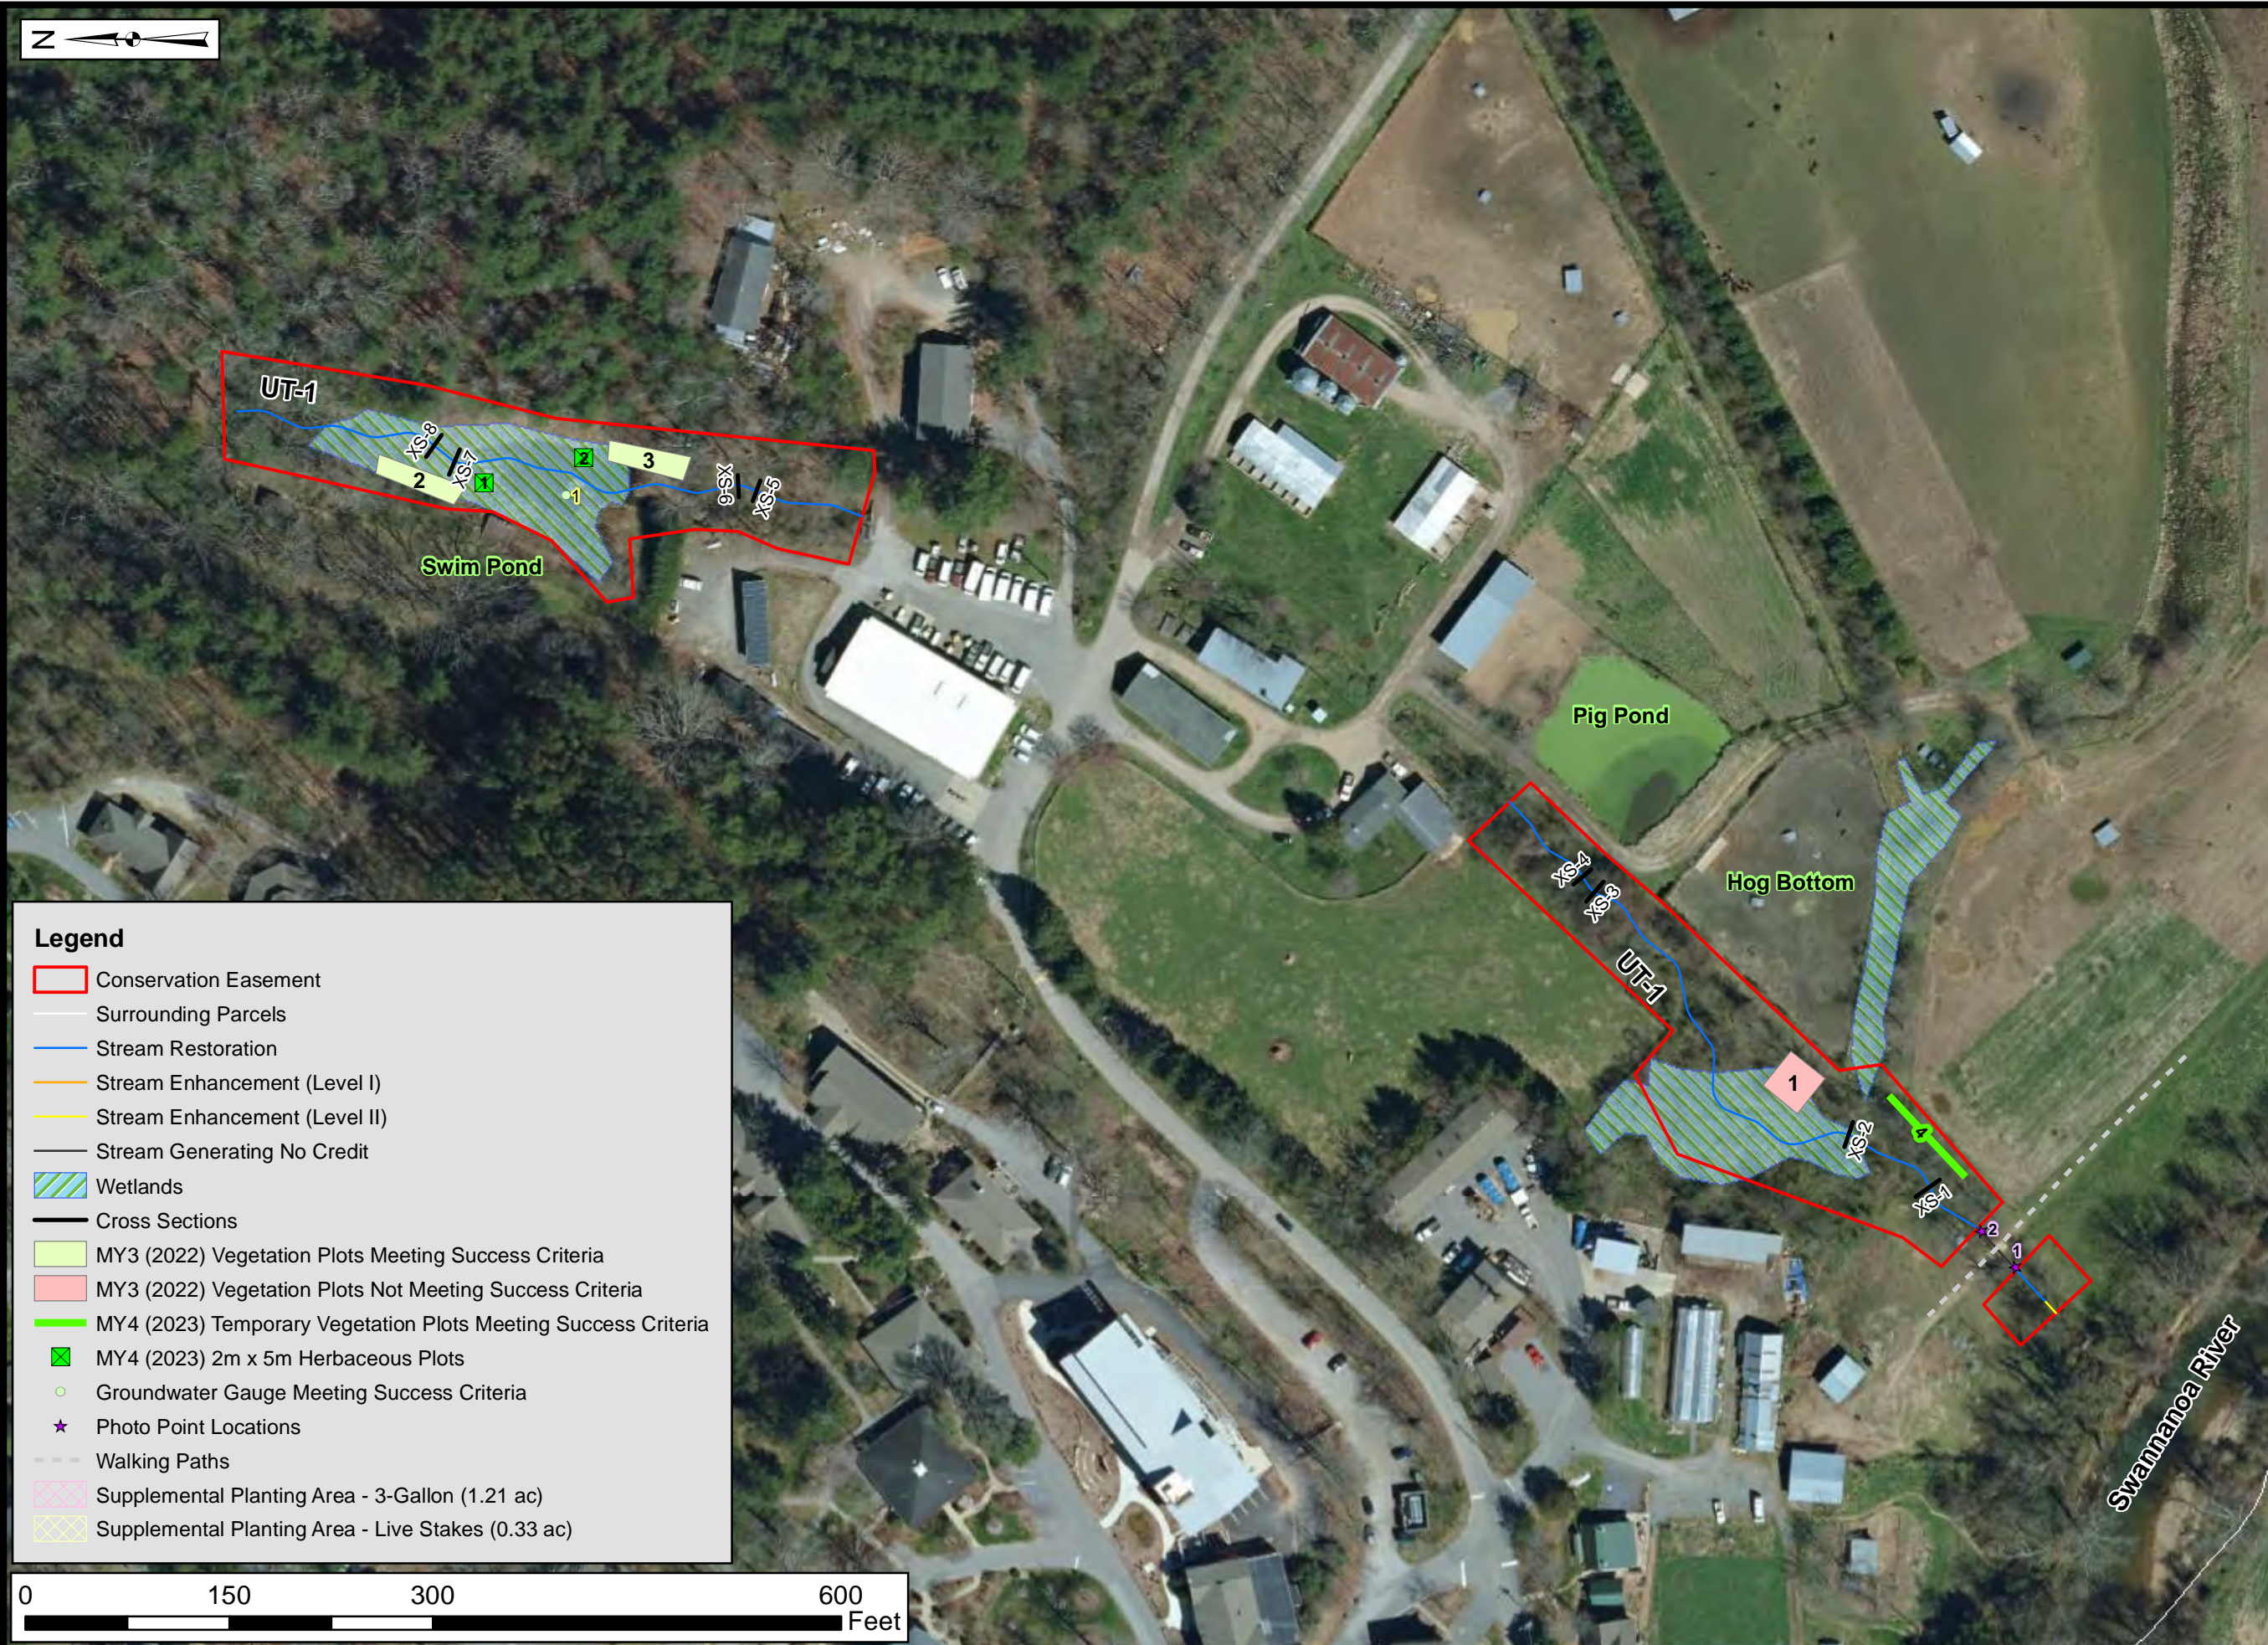
**2E**

**Response:** The title of Table 7 has been updated to “MY0 Planted Bare Root Woody Vegetation”.
7. Table 8B Herbaceous Vegetation Plots & CCPV Maps: Please include the species common names in the table and define the Herbaceous Vegetation Plot “Success Criteria” in the revised report text and as a table footnote. Only three (3) herbaceous plots are shown on Figure 2A and they are not labeled. The additional two (2) plots should be added (with labels) to figure 2E. Please review and update the report and figures accordingly.

**Response:** Common names for species have been added to Table 8B. Success criteria for herbaceous plots has been added to the vegetation summary and as a footnote to Table 8B. Herbaceous plots have been labeled, and plots 1 and 2 have been added to Figure 2E.

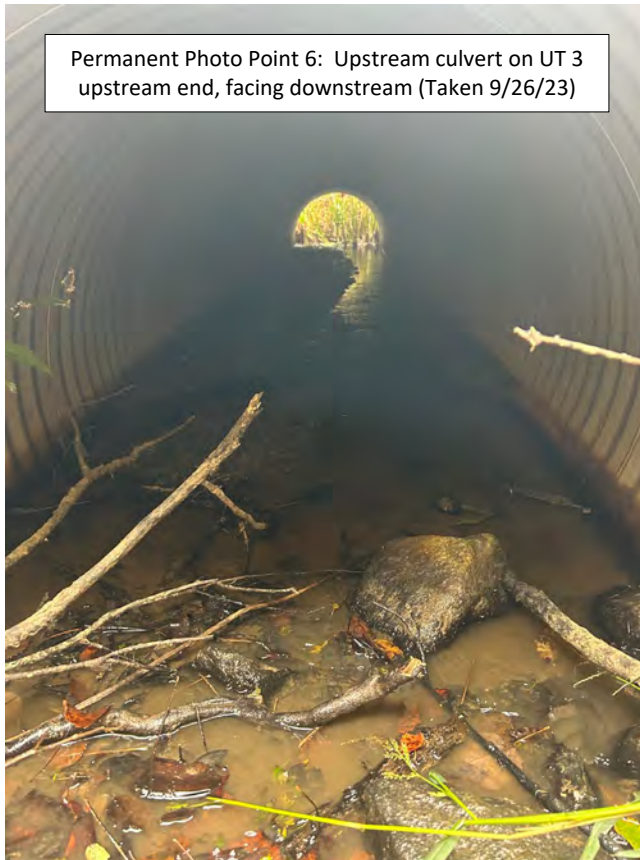
Within the Site, stressors prior to construction could further be attributed to soil instability, increased runoff, and water quality impairments in the receiving watersheds. The project is not located in a Regional or Local Watershed Planning Area; however, the RBRP goals outlined below are addressed by project activities as follows (Site-specific information follows each RBRP goal in parentheses).

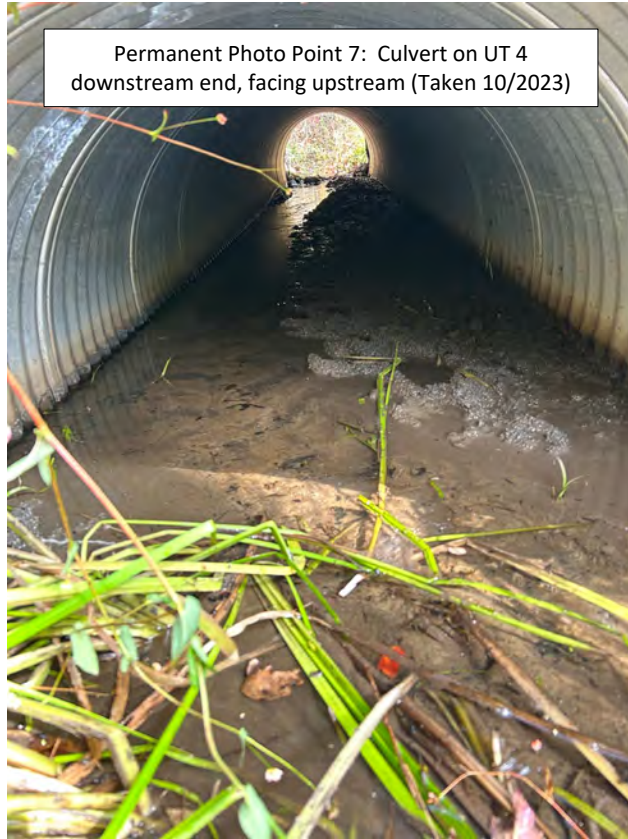
4. Stabilize streambanks (restored stable channels at the historic floodplain elevation, and enhanced oversized and incised channels by raising the stream invert and using grade control/habitat structures)

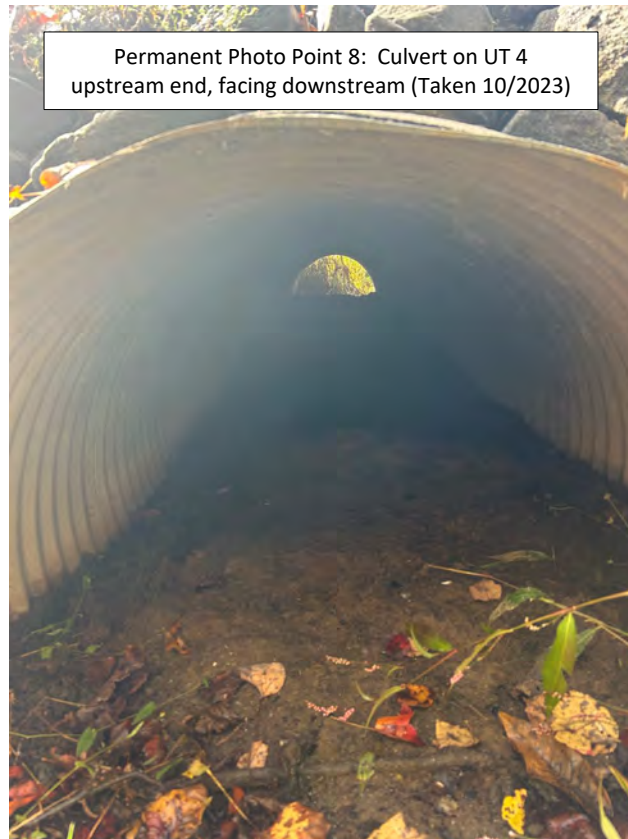
6. Reduce fecal coliform inputs (based on the nutrient model, Site construction eliminates  $31.2 \times 10^{11}$  colonies [col] of fecal coliform per day by removing preconstruction land uses and livestock and treating agricultural runoff with marsh treatment areas)

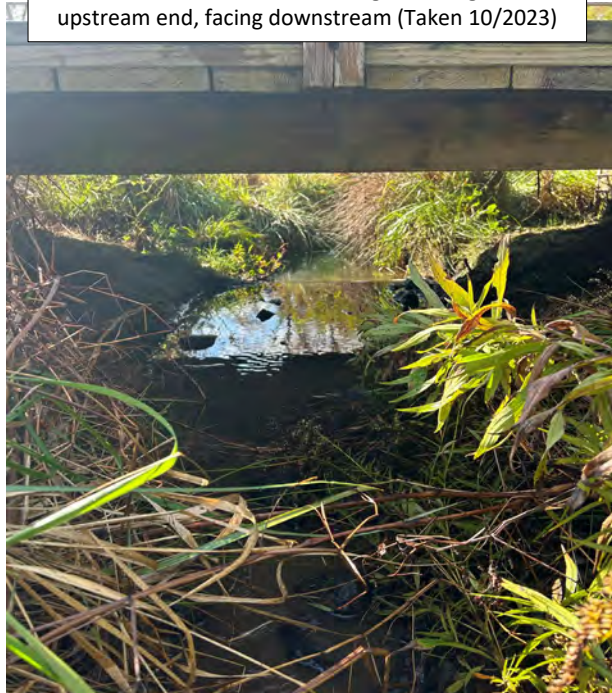
(3) Streamside Area Attenuation			
(4) Floodplain Access			
(4) Wooded Riparian Buffer			
(4) Microtopography			
(3) Stream Stability	<ul style="list-style-type: none"> <li>Increase stream stability within the Site so that channels are neither aggrading nor degrading.</li> </ul>	<ul style="list-style-type: none"> <li>Construct channels with proper pattern, dimension, longitudinal profile, and substrate</li> <li>Remove livestock and cease agricultural practices within areas protected by the conservation easement.</li> <li>Construct stable channels with gravel substrate</li> <li>Stabilize streambanks</li> <li>Plant woody riparian buffer</li> </ul>	<ul style="list-style-type: none"> <li>Cross-section measurements and visual assessments indicate stable channels and structures</li> <li>BHR not to exceed 1.2</li> <li>ER of 1.4 or greater</li> <li>&lt; 10% change in BHR and ER</li> <li>Livestock excluded from the easement</li> <li>Attain Vegetation Success Criteria</li> </ul>

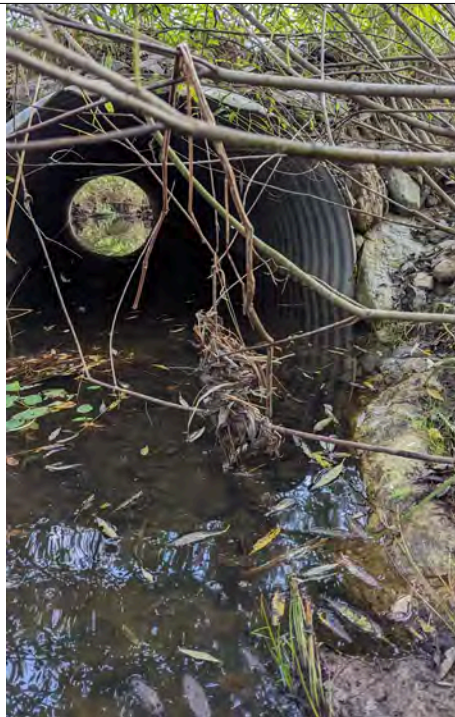
During the initial DMS as-built review, it was discovered that several culvert pipes extend into the recorded conservation easement. Once the encroachments were located and documented via GPS, easement modifications were initiated to remove any crossing materials from the conservation easement. Creditable stream removed from the easement were also removed from mitigation assets. A mitigation plan addendum for the reduction in project credit was submitted to the IRT as part of the MY0/ As-Built Baseline Monitoring Report review and was approved by the IRT via email on October 5, 2020.

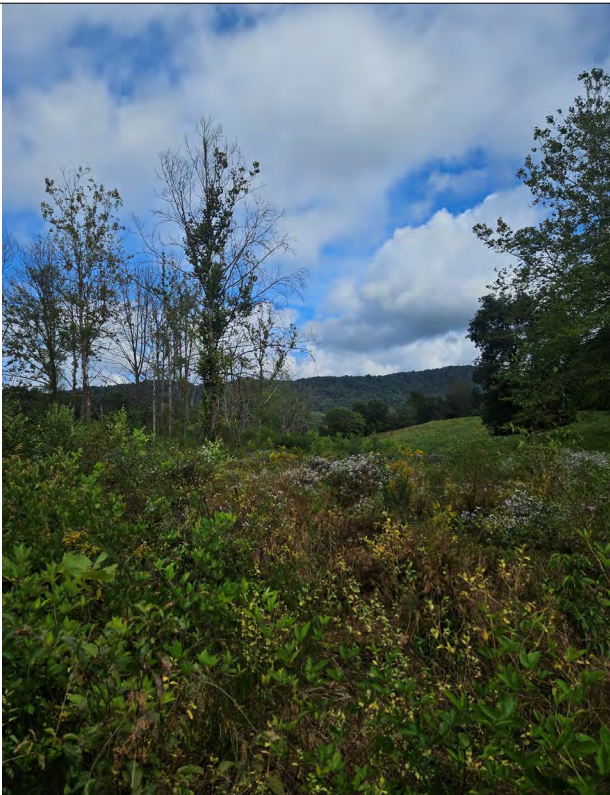
Photo 22: Wetland mosaic along UT3 Clingmans (Sept 2023)

- The IRT observed the development of riparian wetlands along UT 3, near PVMP 9, 10, and 11.
- The IRT agreed that the current scrub-shrub habitat is fine in these wet areas; however, a live-stake shrub diversity planting was recommended.

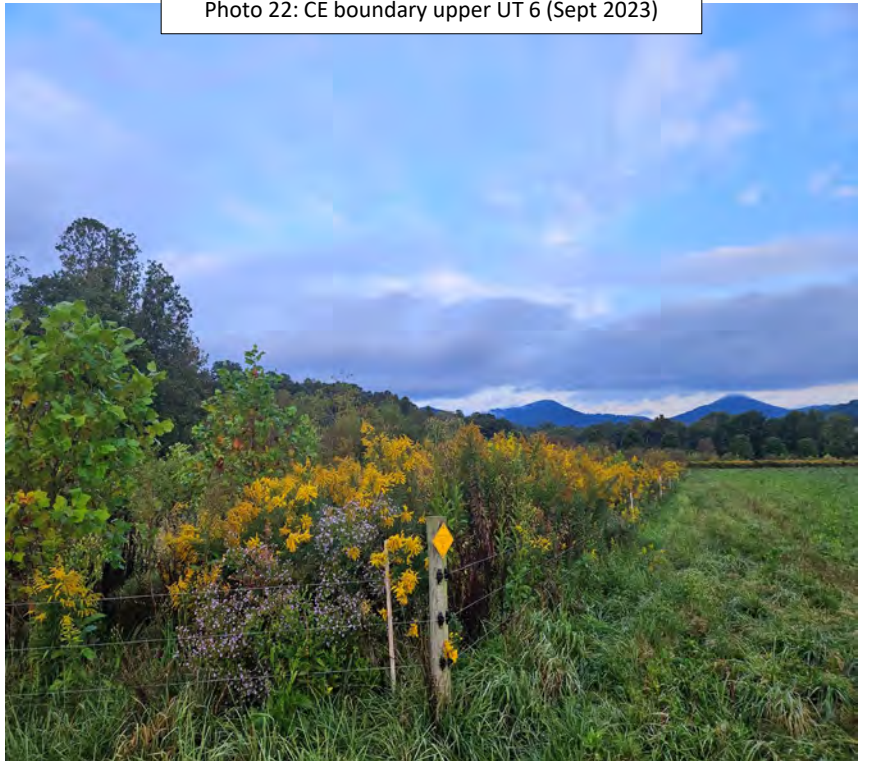
Photo 22: CE boundary upper UT 6 (Sept 2023)

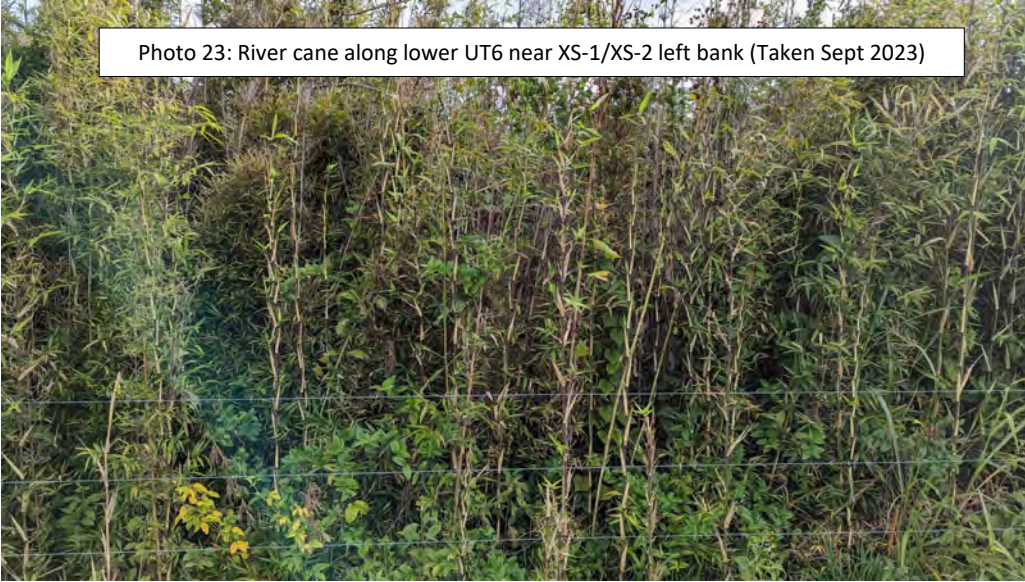
Photo 23: River cane along lower UT6 near XS-1/XS-2 left bank (Taken Sept 2023)

- Areas of River cane transplant were observed by the IRT around UT6B.
- The IRT had no issues with the amount of Rivercane nor its current potential to outcompete planted vegetation.
- RS will add a narrative to the MY4 (2023) monitoring report (and all future monitoring reports) to discuss the Rivercane transplant effort, the current condition of the Rivercane, and lessons learned, i.e., what worked best, what we would change, etc. In addition, RS will map the extent of Rivercane on the MY4 (2023) CCPV Figure. During future monitoring years, RS will survey the Rivercane to document its growth and update each monitoring year's CCPV accordingly.

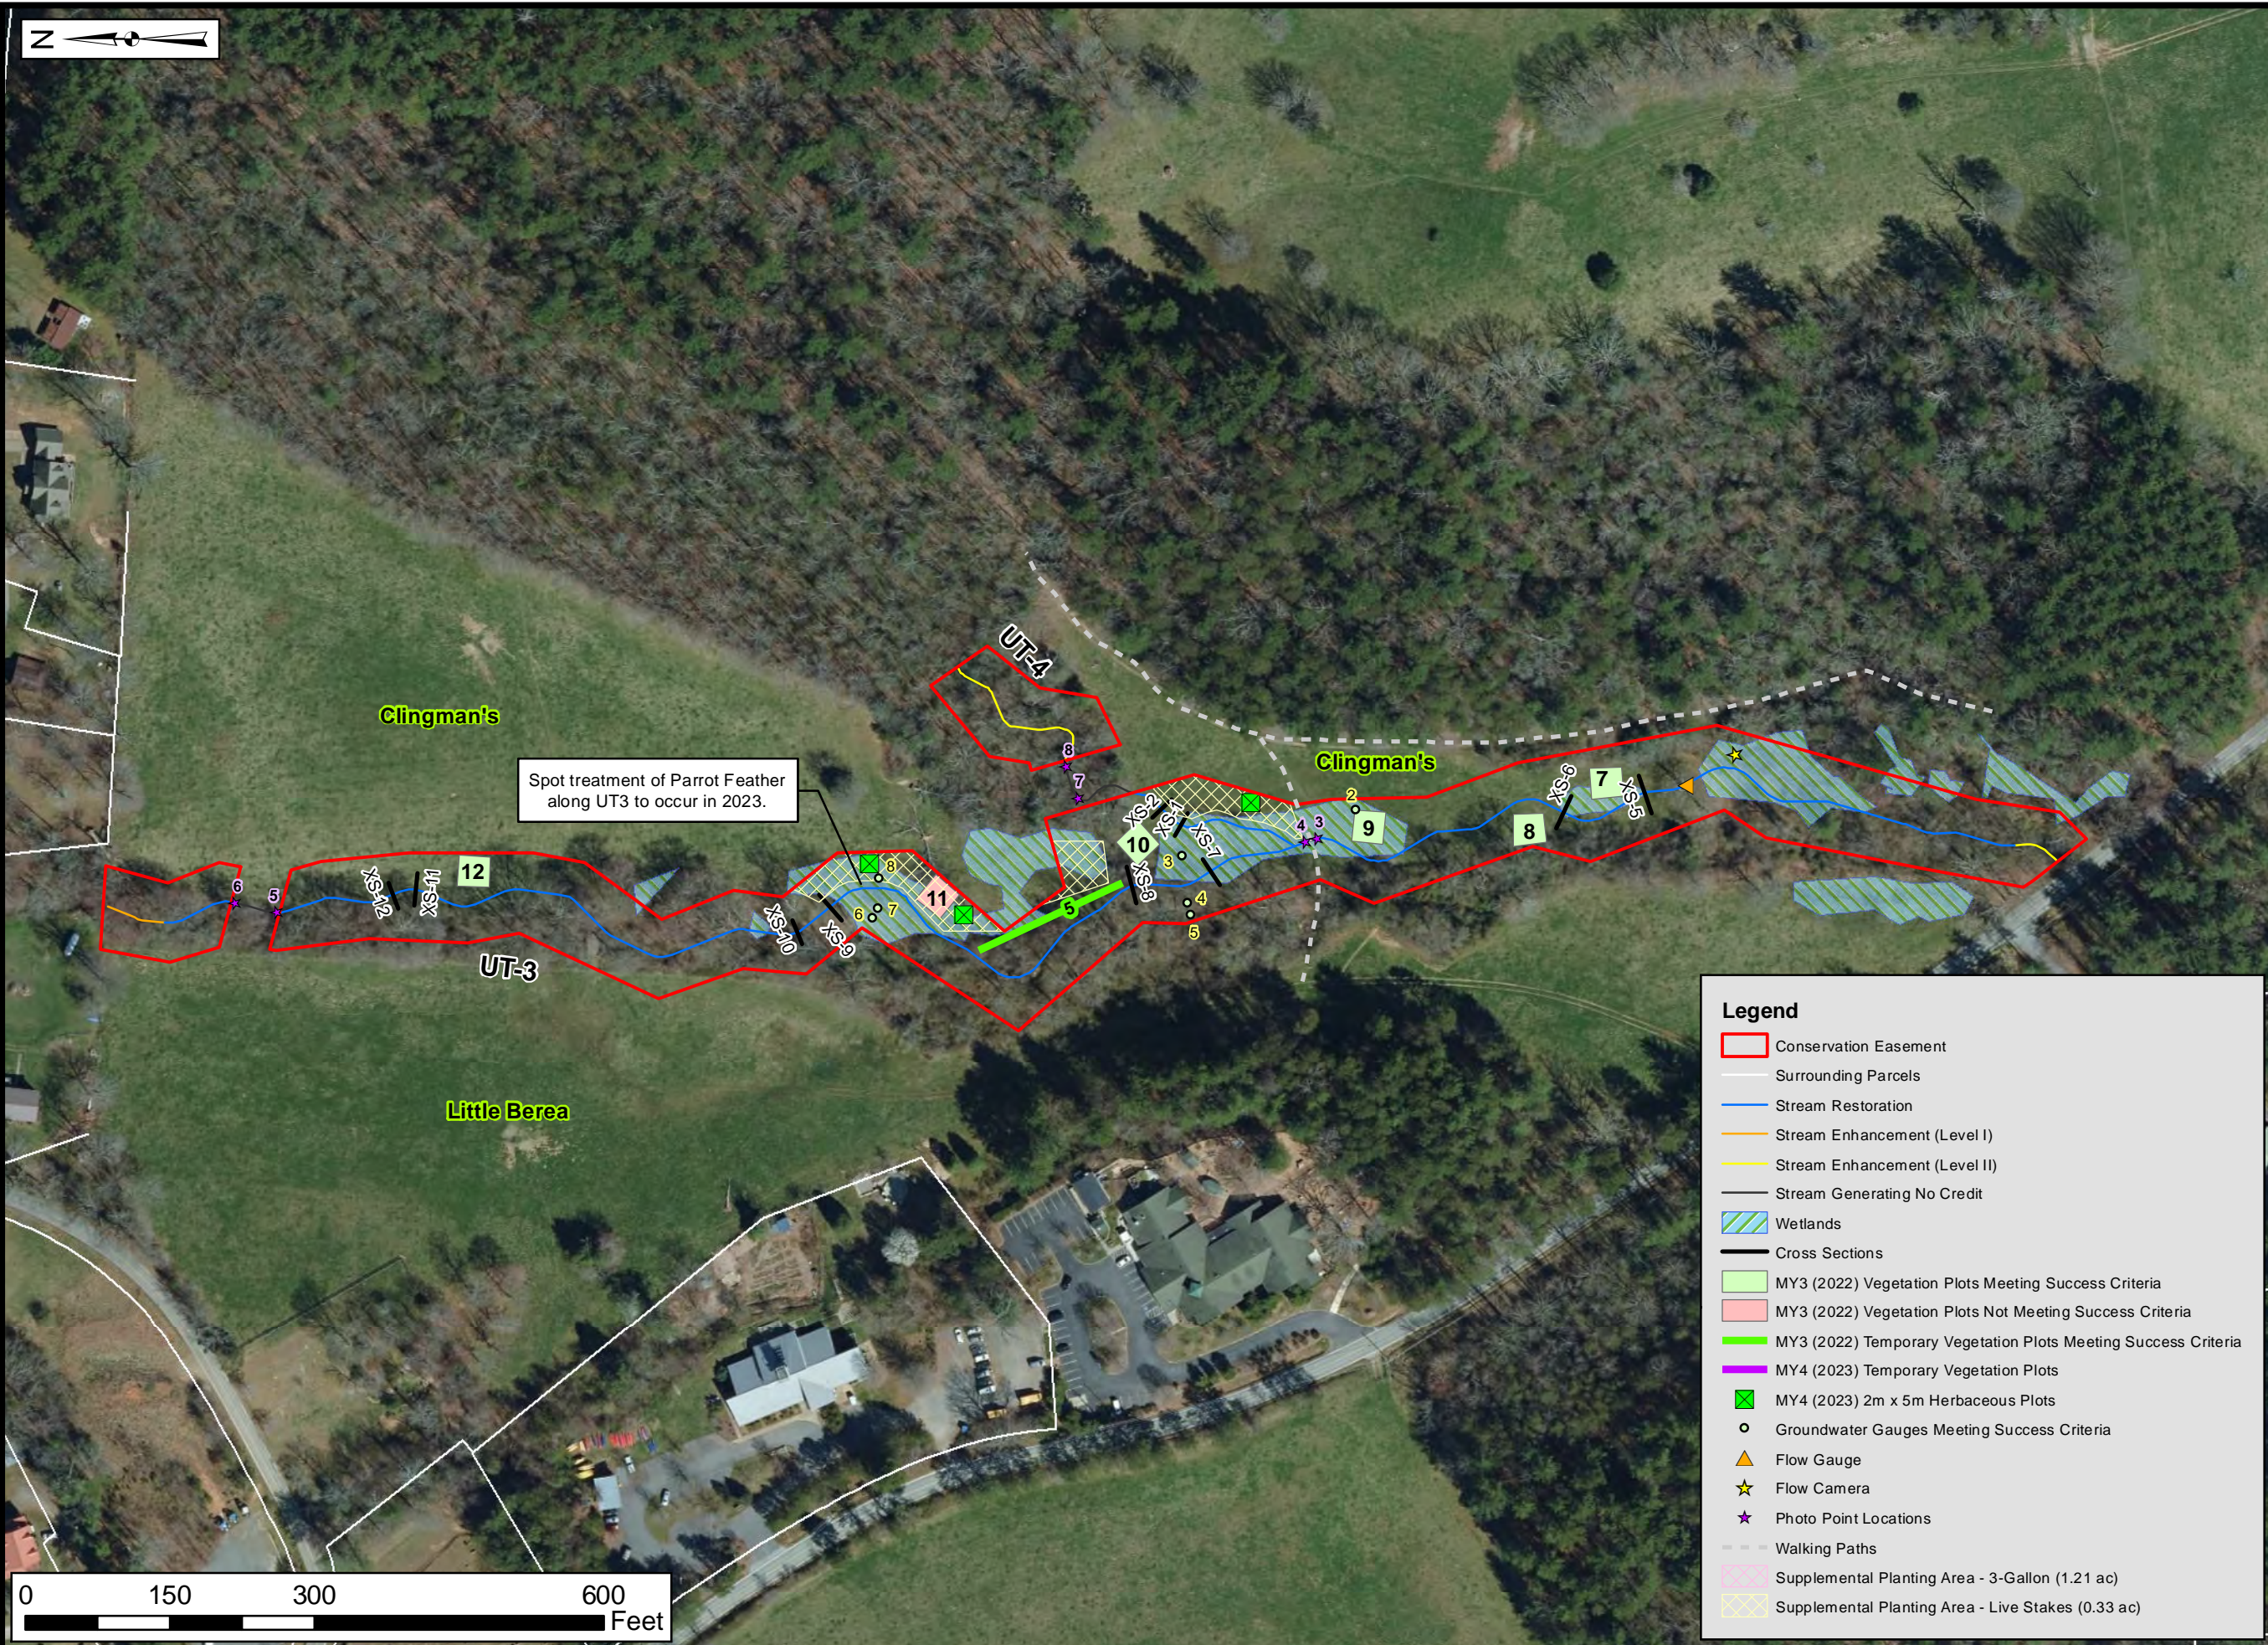
**2**

- Before the IRT Site visit, RS walked Upper UT 3 to evaluate the current extent of Parrot-Feather (*Myriophyllum aquaticum*) within the channel. Great progress has been made to control the extent of Parrot-Feather via herbicide treatments during MY1-3. RS observed and took the IRT to a small patch between UT 3 cross sections 9 and 10. Treatment of the species will continue throughout the reach as needed. However, channel shading and previous treatments have drastically reduced the extent of Parrot-Feather within the channel.

Spot treatment of Parrot Feather along UT3 to occur in 2023.
