FINAL
MONITORING REPORT (MY1)

WARREN WILSON COLLEGE STREAM MITIGATION SITE
Buncombe County, North Carolina

NCDMS Project ID No. 100019
Full Delivery Contract No. 7188
USACE Action ID No. SAW-2017-01557
NCDWR No. 20171158
RFP No. 16-006991 (Issued: 9/16/16)

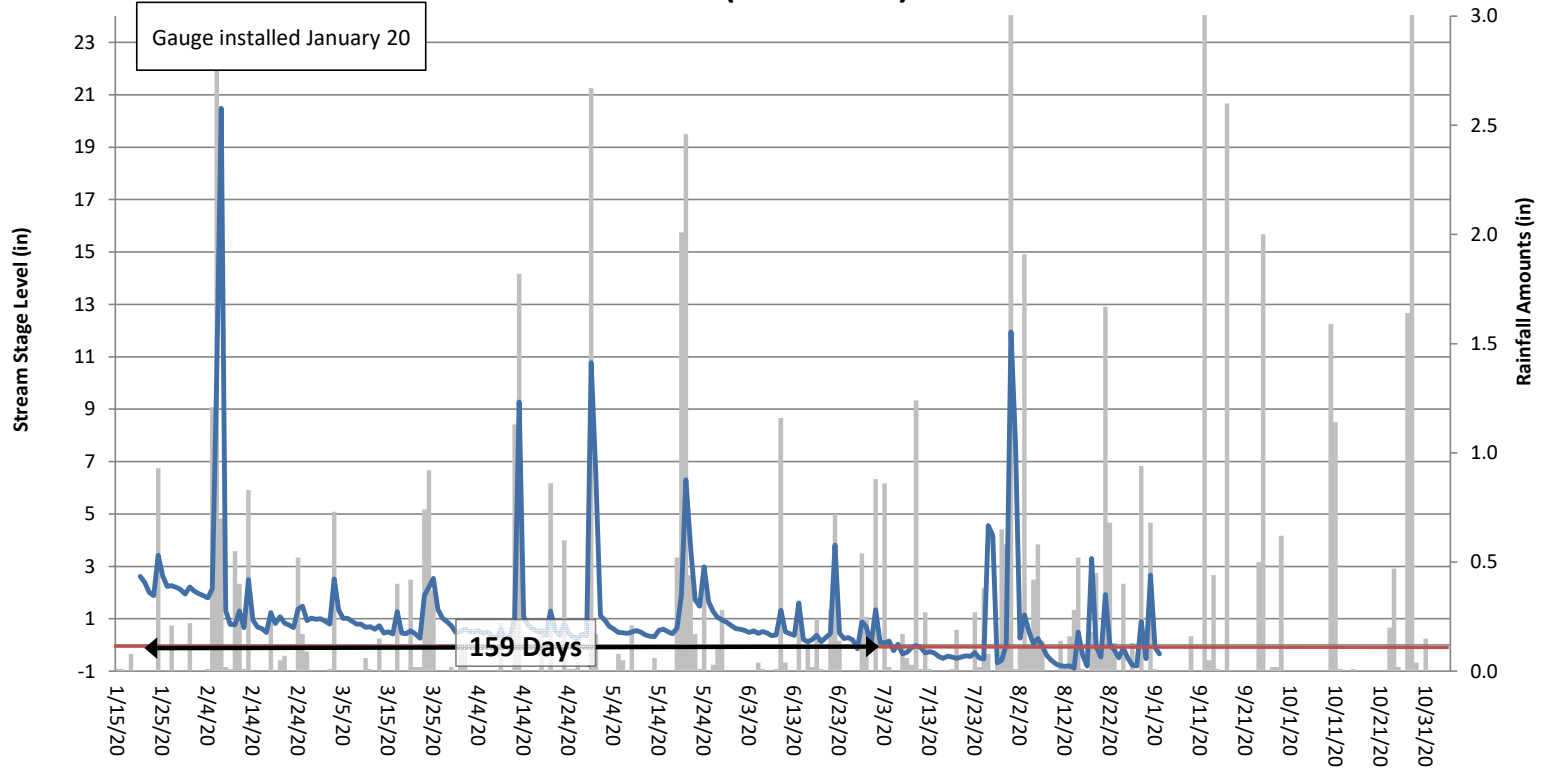
Warren Wilson Creek UT3 Stream Flow Gauge Year 1 (2020 Data)

UT3 Channel Evidence	Year 1 (2020)	Year 2 (2021)	Year 3 (2022)	Year 4 (2023)	Year 5 (2024)	Year 6 (2025)	Year 7 (2026)
Max consecutive days channel flow	159						
Presence of litter and debris (wracking)	Yes						
Leaf litter disturbed or washed away	Yes						
Matted, bent, or absence of vegetation (herbaceous or otherwise)	Yes						
Sediment deposition and/or scour indicating sediment transport	Yes						
Water staining due to continual presence of water	Yes						
Formation of channel bed and banks	Yes						
Sediment sorting within the primary path of flow	Yes						
Sediment shelving or a natural line impressed on the banks	Yes						
Change in plant community (absence or destruction of terrestrial vegetation and/or transition to species adapted for flow or inundation for a long duration, including hydrophytes)	Yes						
Development of channel pattern (meander bends and/or channel braiding) at natural topographic breaks, woody debris piles, or plant root systems	Yes

Exposure of woody plant roots within the primary path of flow	No						
Other:

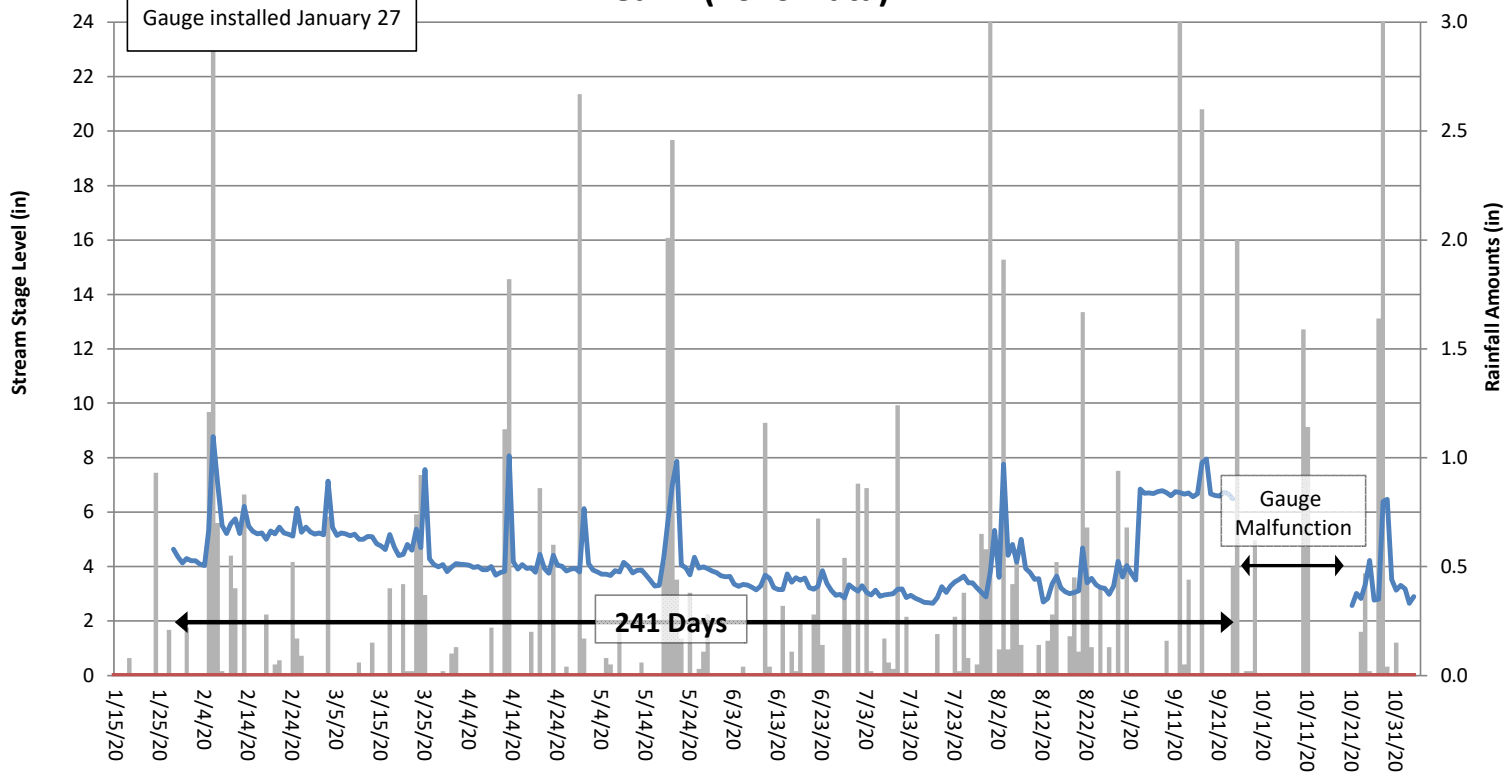
Warren Wilson Creek UT8 Stream Flow Gauge Year 1 (2020 Data)

UT8 Channel Evidence	Year 1 (2020)	Year 2 (2021)	Year 3 (2022)	Year 4 (2023)	Year 5 (2024)	Year 6 (2025)	Year 7 (2026)
Max consecutive days channel flow	241						
Presence of litter and debris (wracking)	Yes						
Leaf litter disturbed or washed away	Yes						
Matted, bent, or absence of vegetation (herbaceous or otherwise)	Yes						
Sediment deposition and/or scour indicating sediment transport	Yes						
Water staining due to continual presence of water	Yes						
Formation of channel bed and banks	Yes						
Sediment sorting within the primary path of flow	Yes						
Sediment shelving or a natural line impressed on the banks	Yes						
Change in plant community (absence or destruction of terrestrial vegetation and/or transition to species adapted for flow or inundation for a long duration, including hydrophytes)	Yes						
Development of channel pattern (meander bends and/or channel braiding) at natural topographic breaks, woody debris piles, or plant root systems	Yes

Exposure of woody plant roots within the primary path of flow	No						
Other:

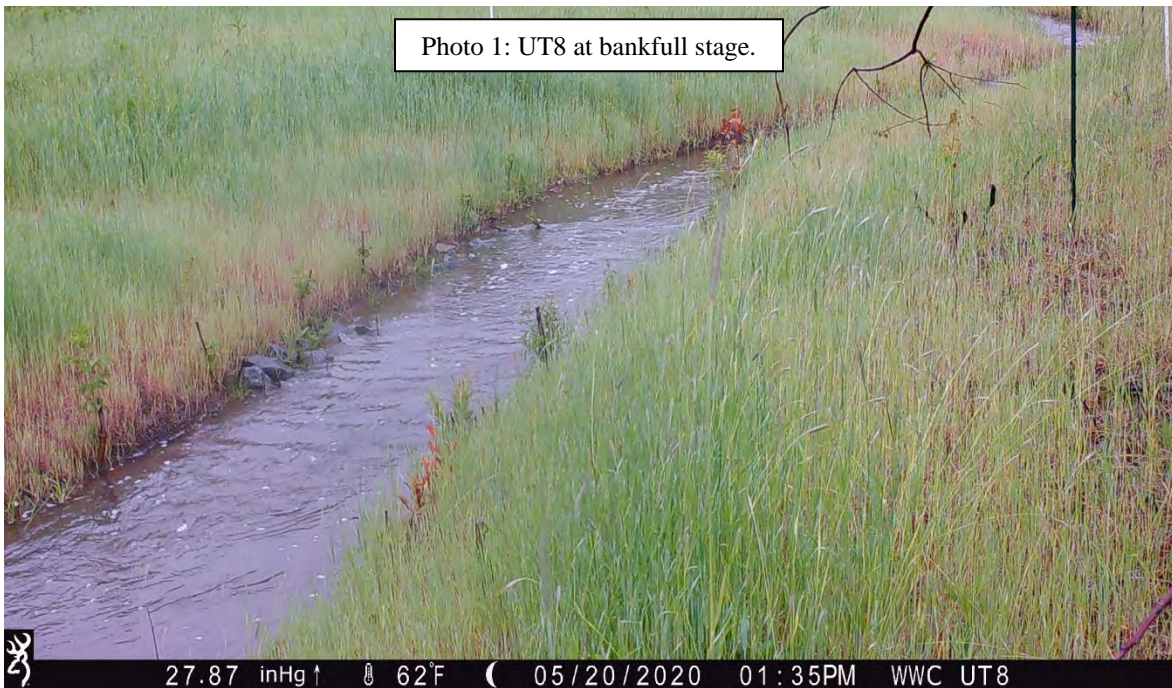
Date of Data Collection	Date of Occurrence	Method	Photo (if available)
May 20, 2020	May 20, 2020	Stream gauges and trail cameras captured a bankfull event at UT8 after 4.47 inches of rain was documented between May 19 and 20, 2020 at a nearby weather station.	1
November 4, 2020	October 27, 2020	Wrack and laid-back vegetation were observed outside the TOB of UT3 after 4.7 inches of rain was documented between October 27 and 28, 2020 at a nearby weather station.	2
